WATERVILLE AIRPORT
2005 PAVEMENT MANAGEMENT REPORT

February 2006

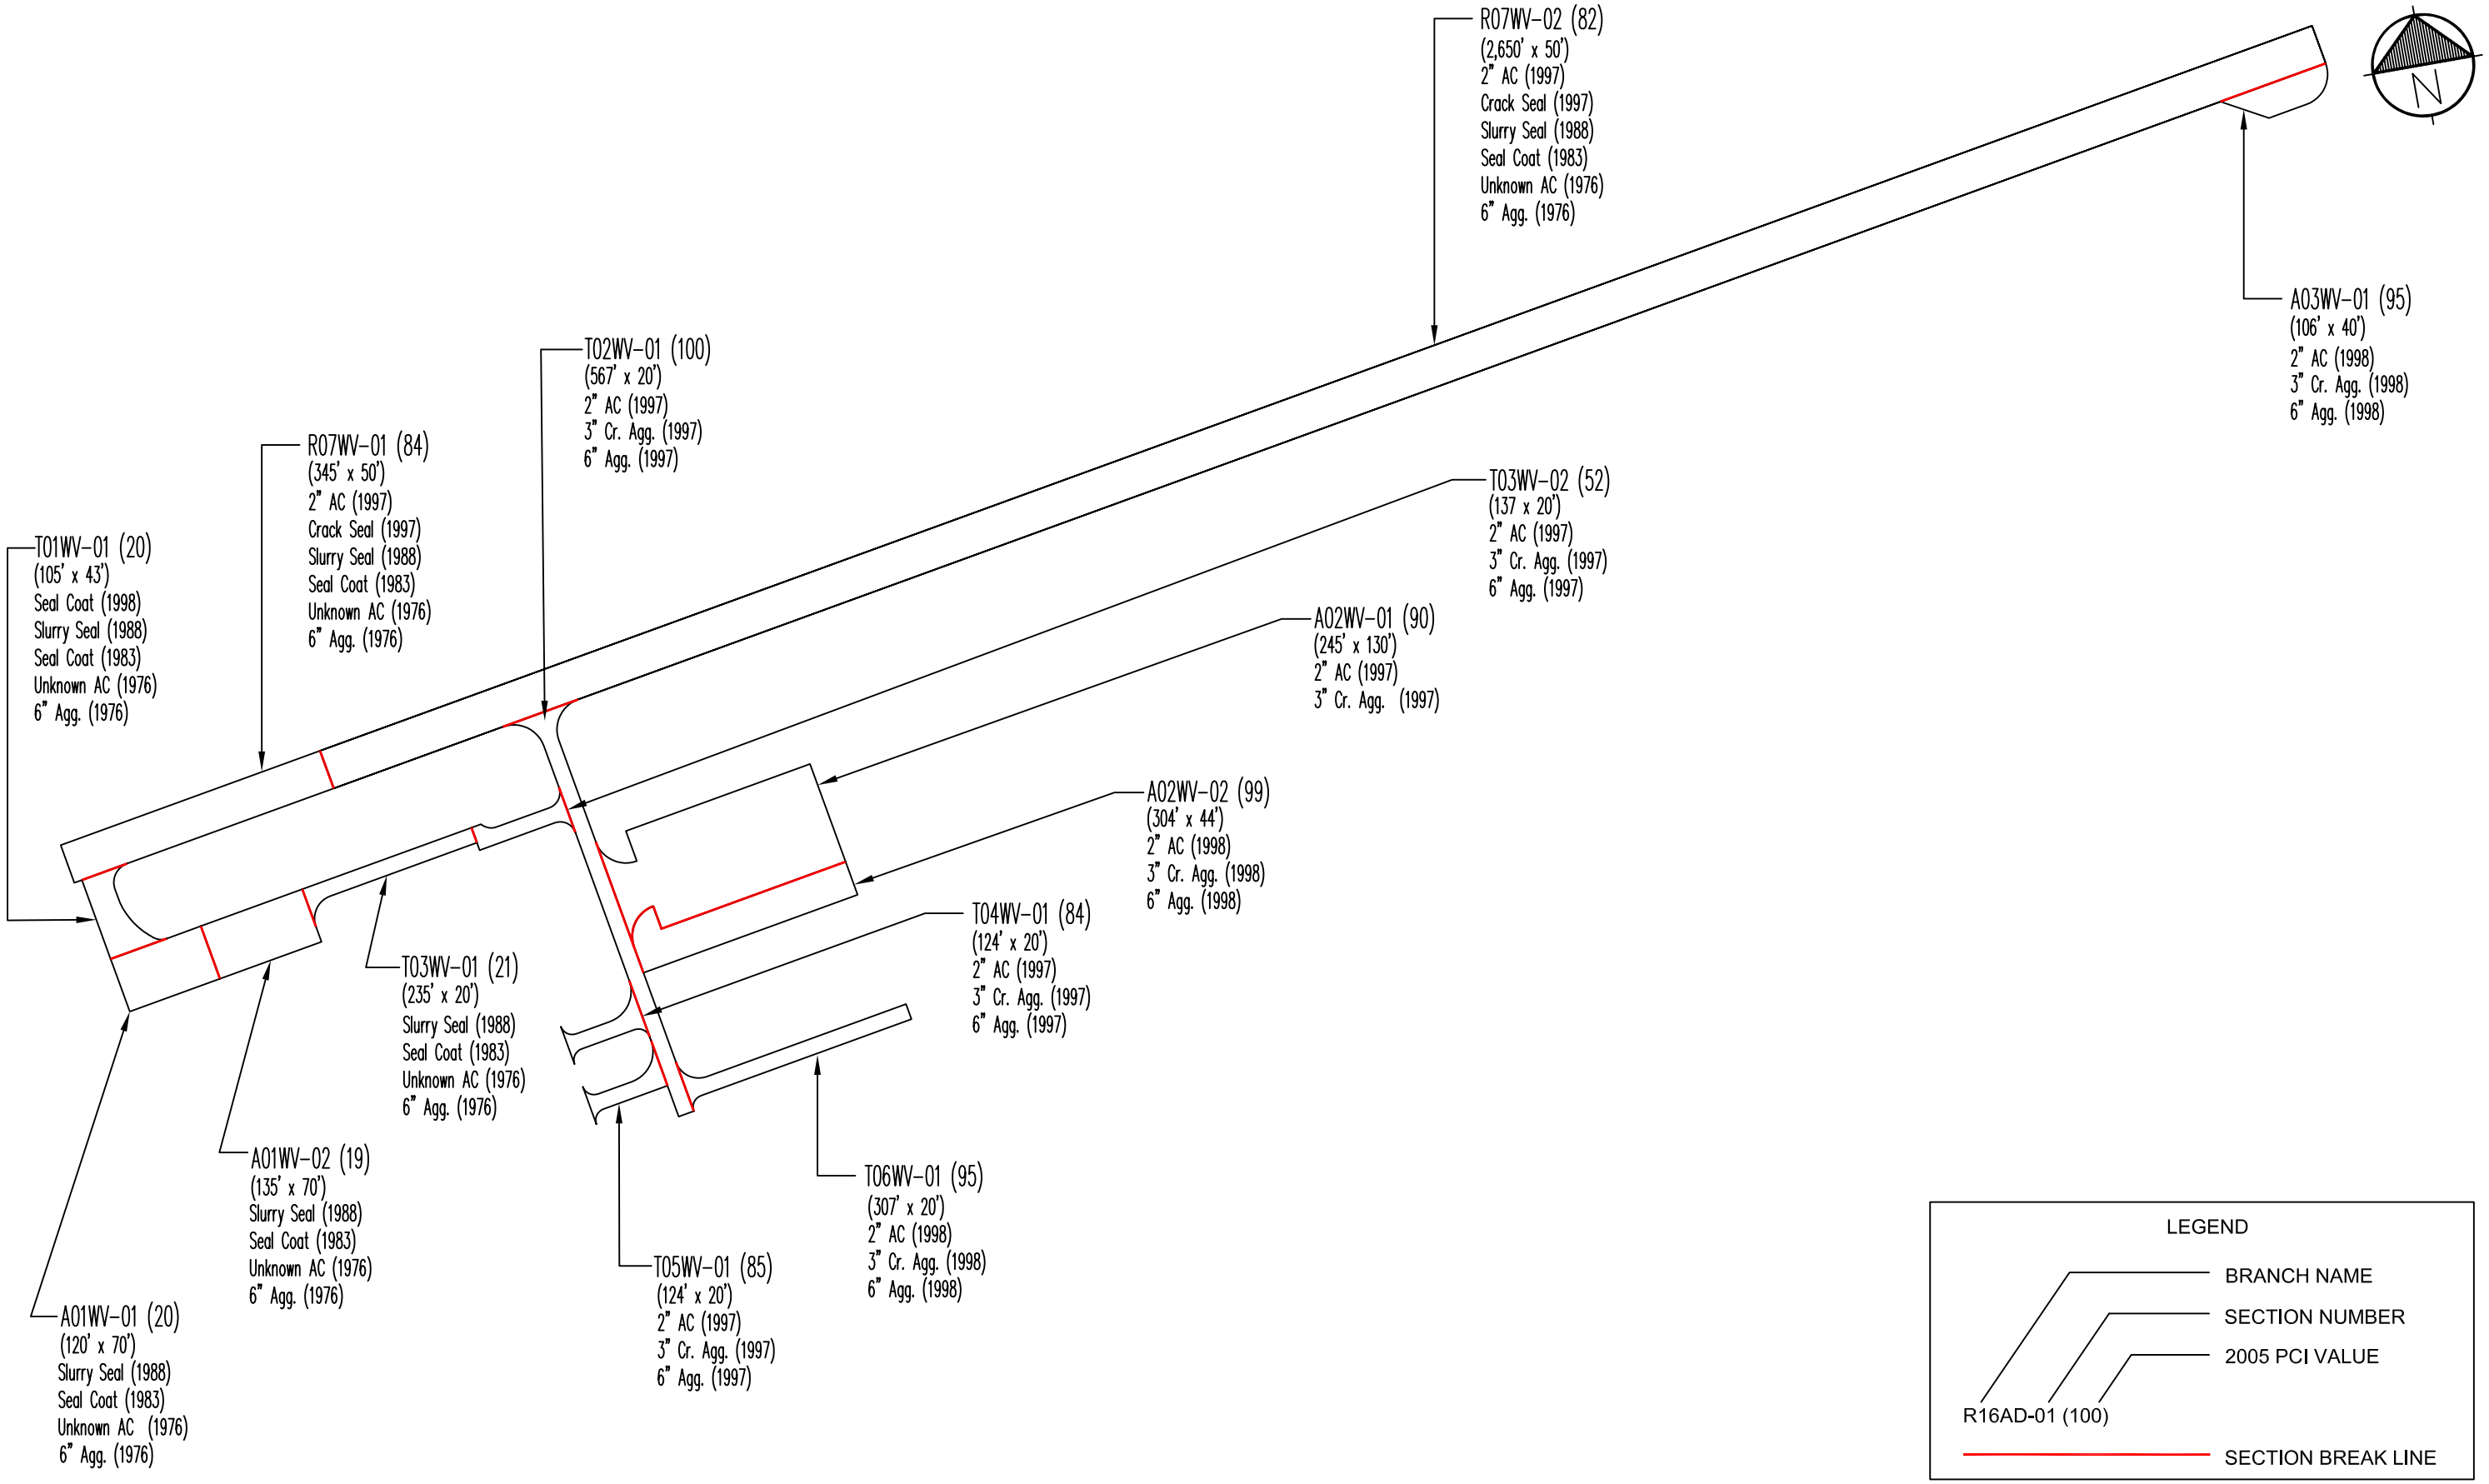
LOCATION: Waterville Airport, Waterville, Washington			
PAGE TITLE: 2005 Work History Map			
DRAWING SCALE: 1" = 200'	DATE: February 2006	REVISED BY: TJS	DRAWN BY: JR
FILENAME: Waterville.dwg	AIRPORT ID: 2S5	LAYOUT NAME/NUMBER: Waterville (WH)	PAGE NUMBER: 4

Figure 3 presents the records review results in the form of a work history map. The Micro PAVER database (see the inside back cover of this report) contains detailed inventory information about the pavement system at the airport.

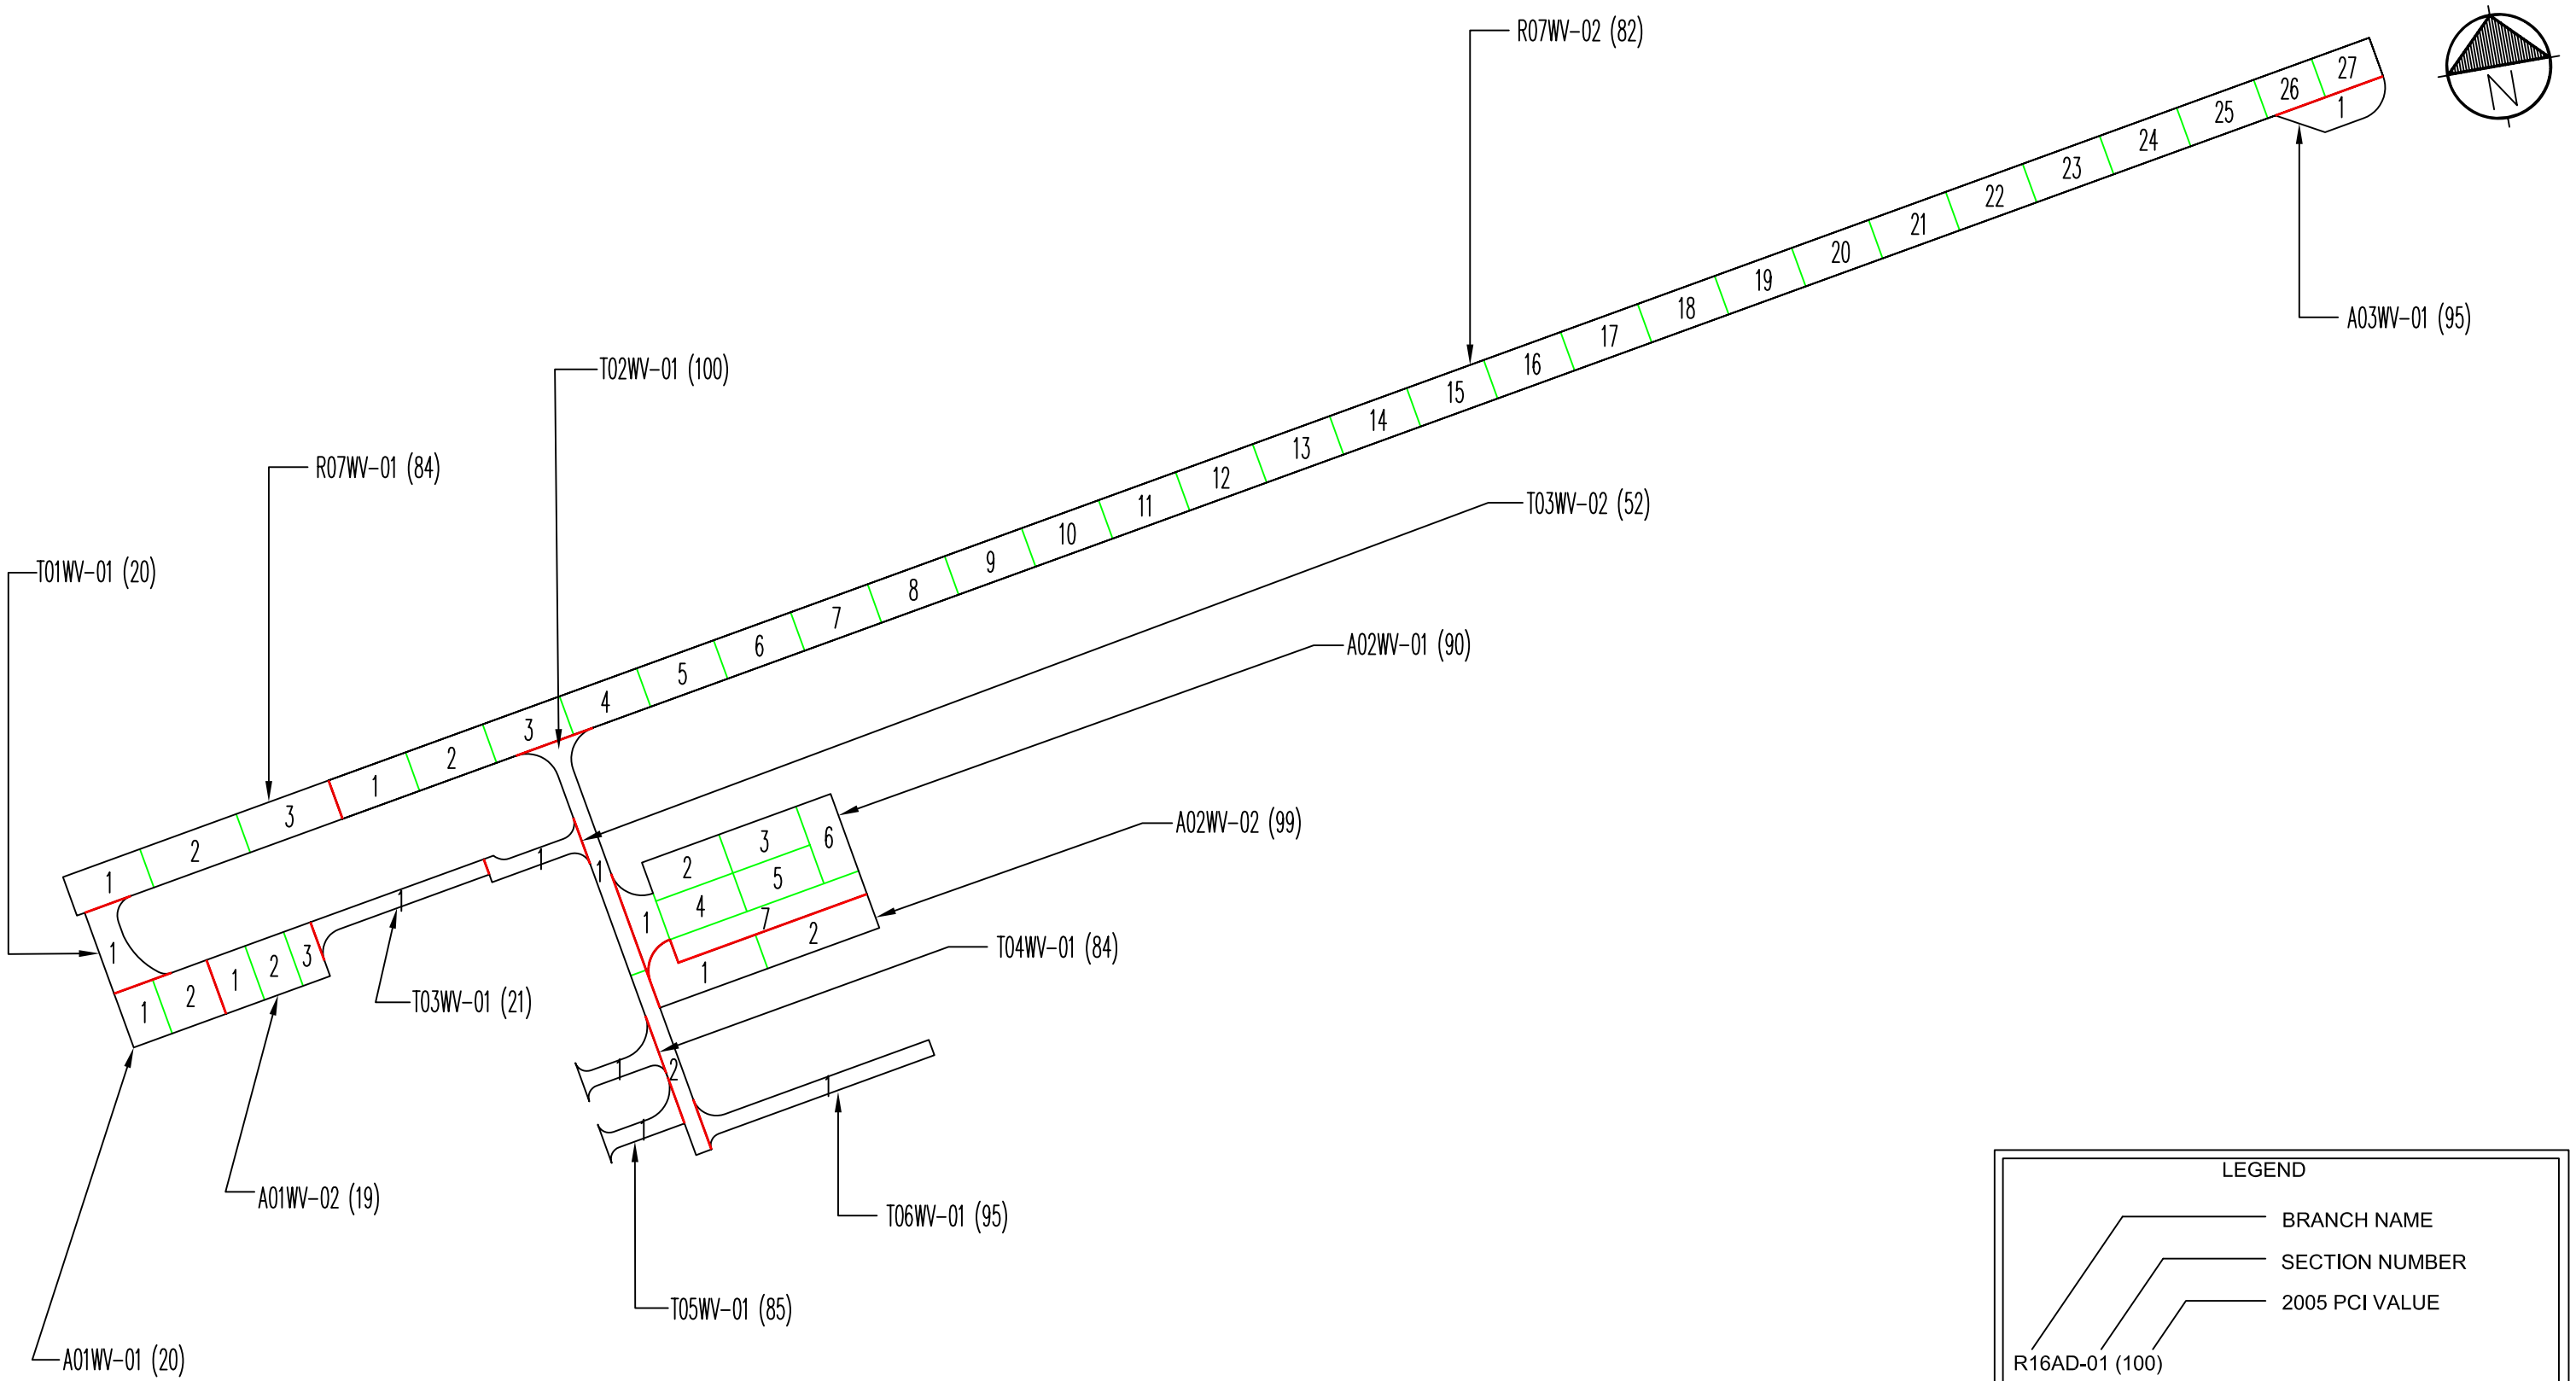
Figure 4 shows how the pavement network was divided into these units and it also shows the nomenclature used in the Micro PAVER pavement management database to identify the different pavement areas.

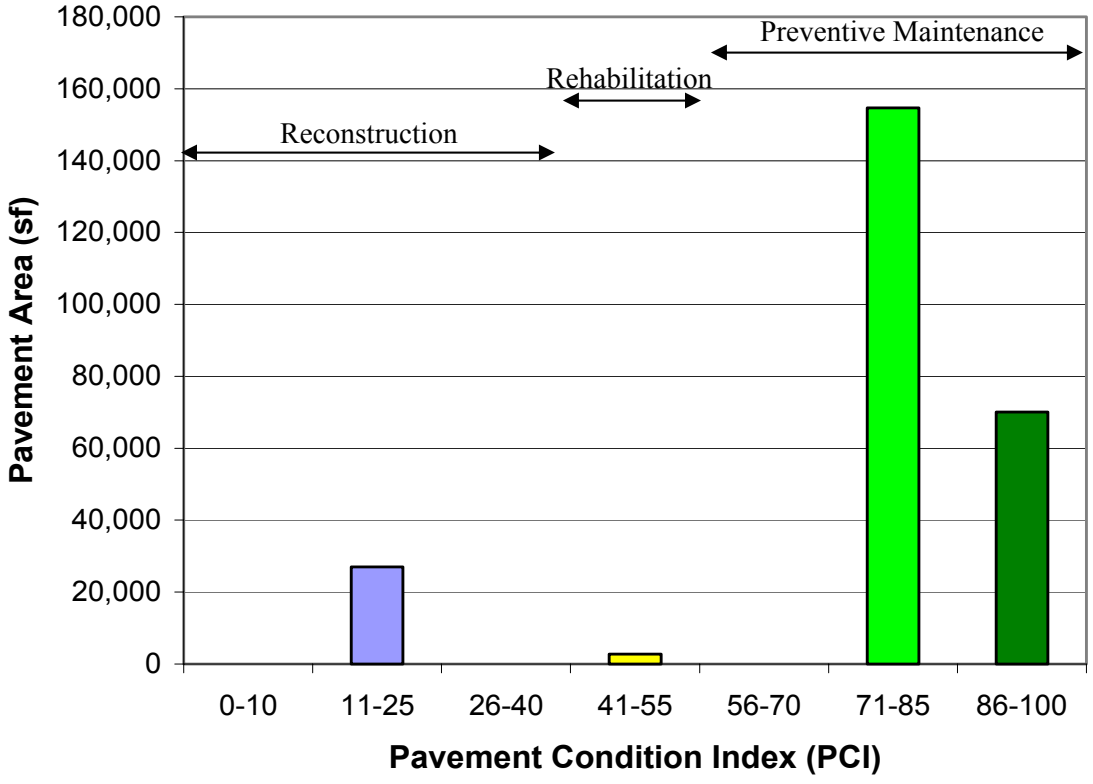
Figure 6. Waterville Airport overall condition.

The pavements at Waterville Airport were inspected on June 2, 2005. The 2005 area-weighted condition of Waterville Airport is 79, with conditions ranging from 19 to 100 (on a scale of 0 [failed] to 100 [excellent]). During the previous inspection in 1999, the area-weighted condition was 89.

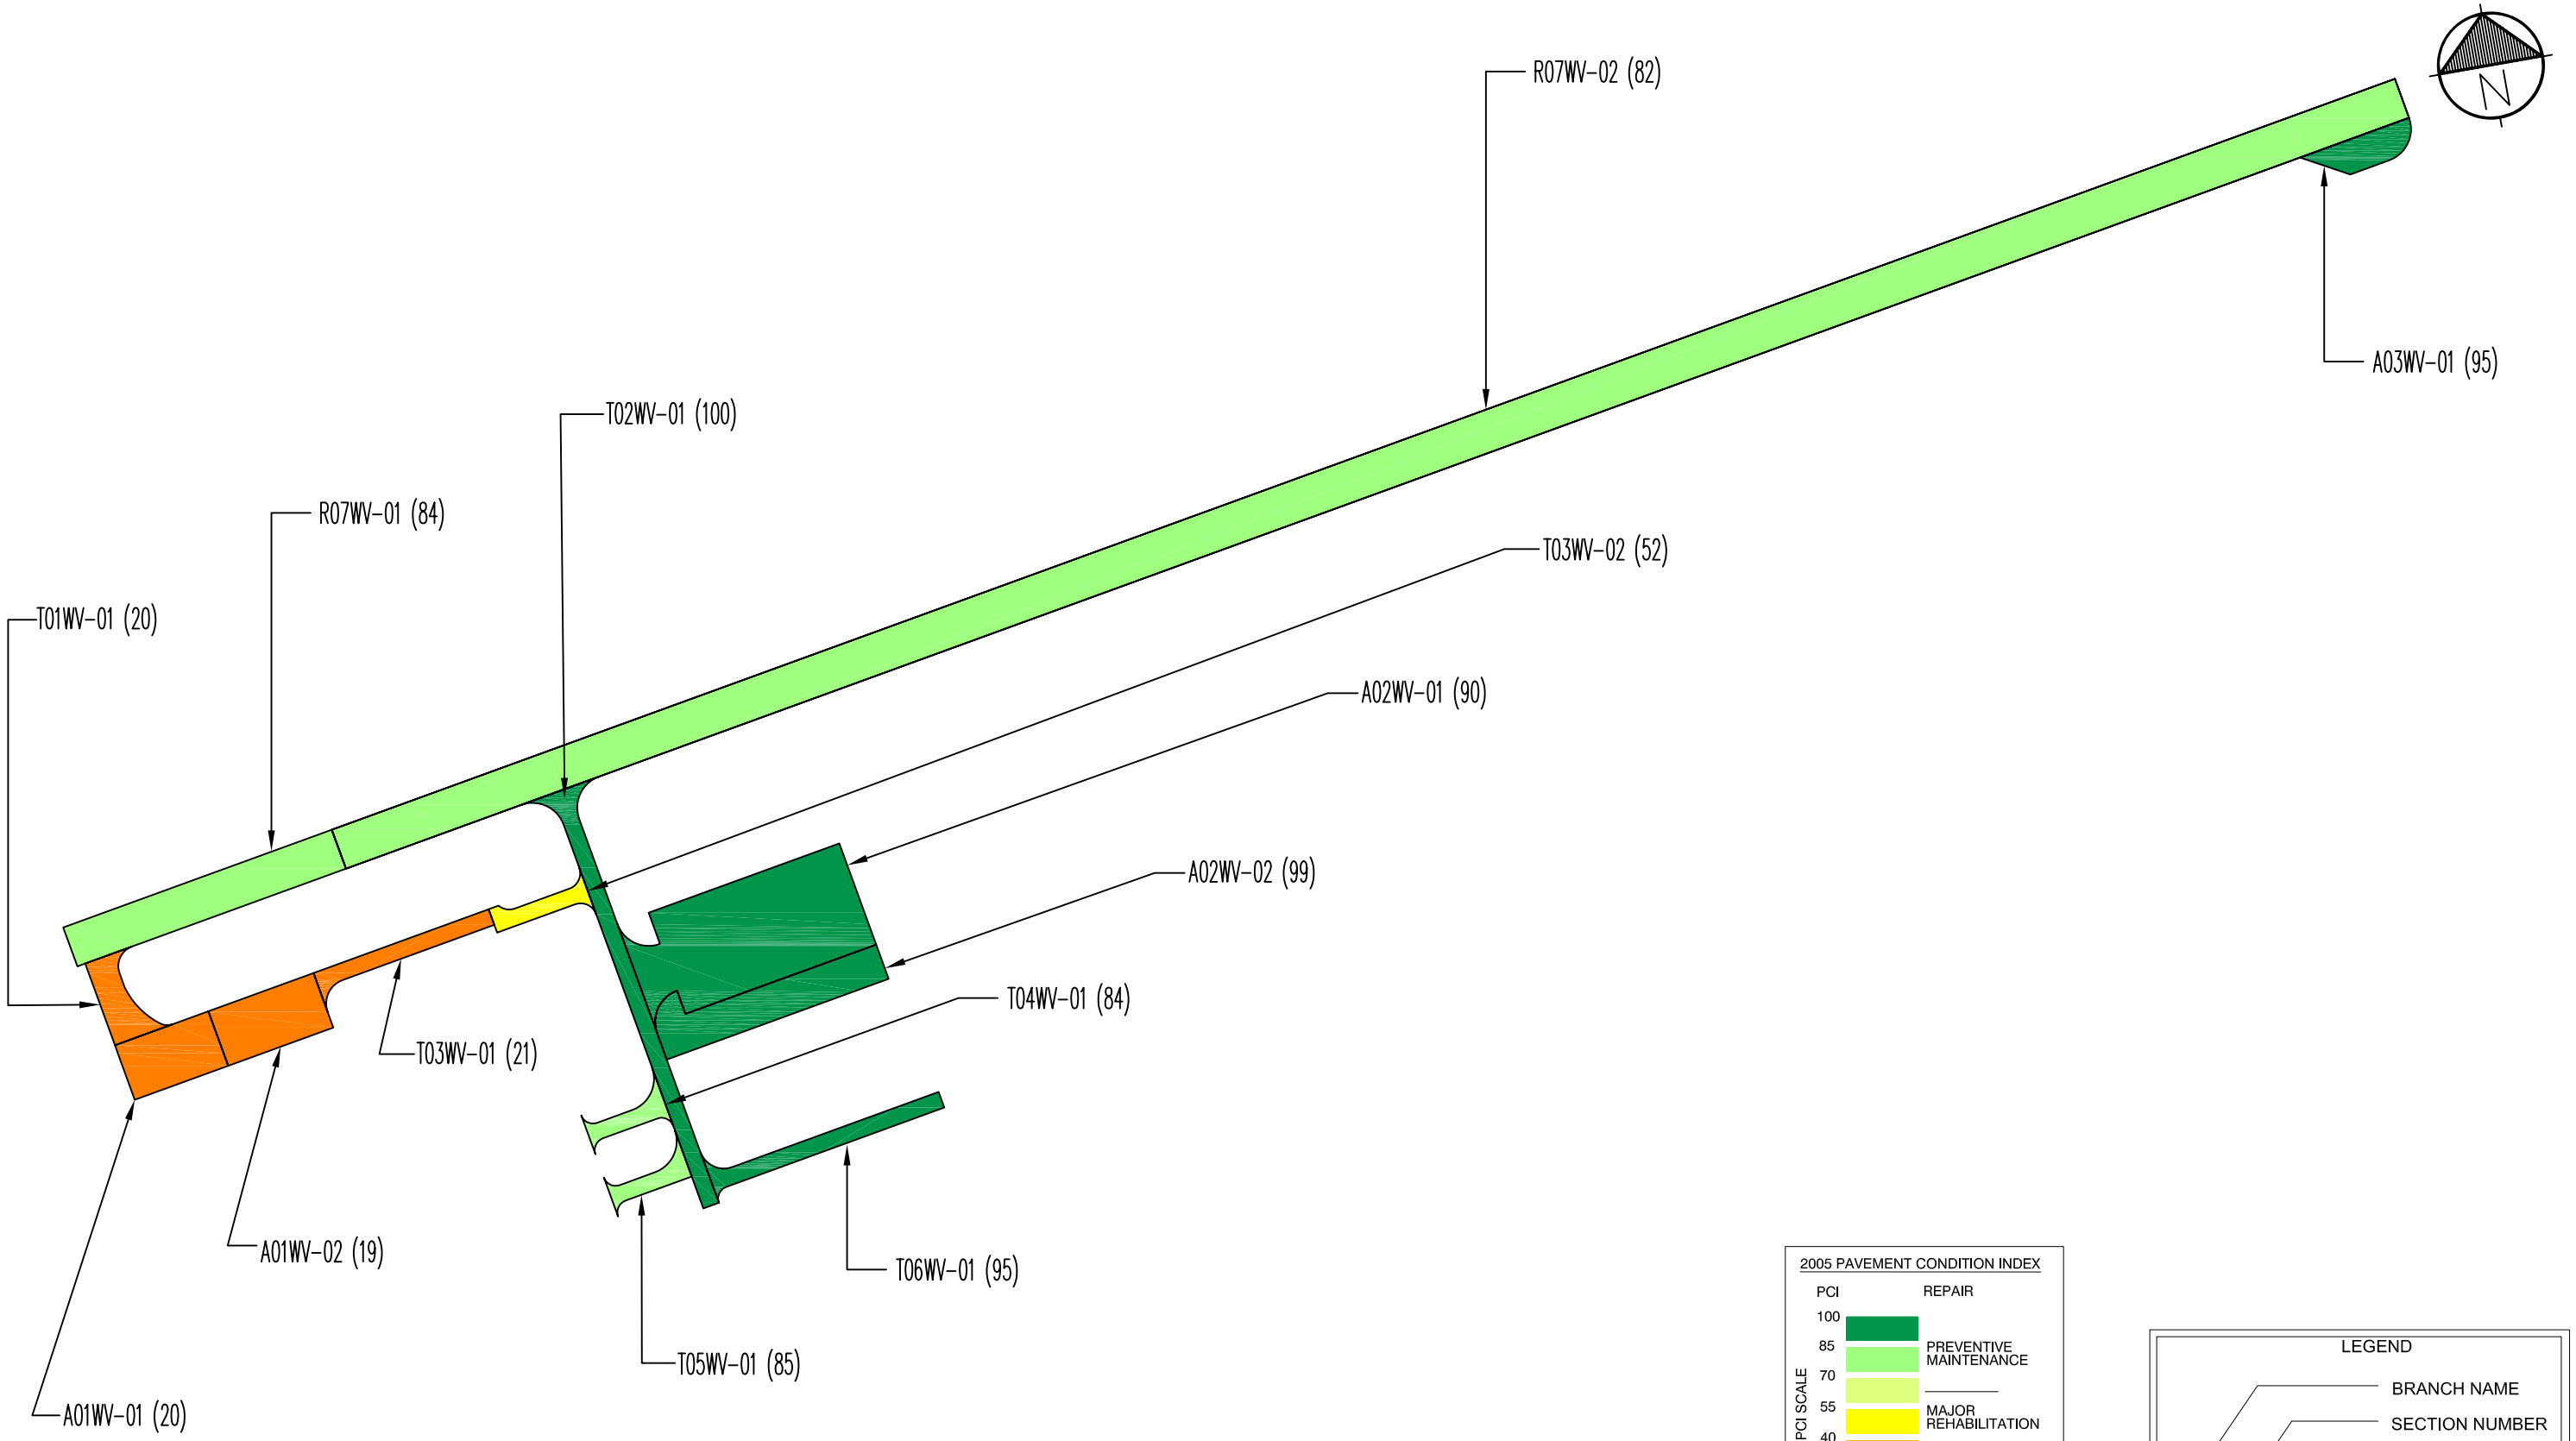
2005 PAVEMENT CONDITION INDEX

Figures 6 and 7 summarize the overall condition of the pavements at the Waterville Airport. Figure 8 displays the condition of the pavements evaluated. Table 1 summarizes the results of the pavement evaluation. Appendix C presents photographs taken during the PCI inspection and Appendix D details the distresses observed during the visual survey.
