WILLARD FIELD AIRPORT
2005 PAVEMENT MANAGEMENT REPORT

February 2006

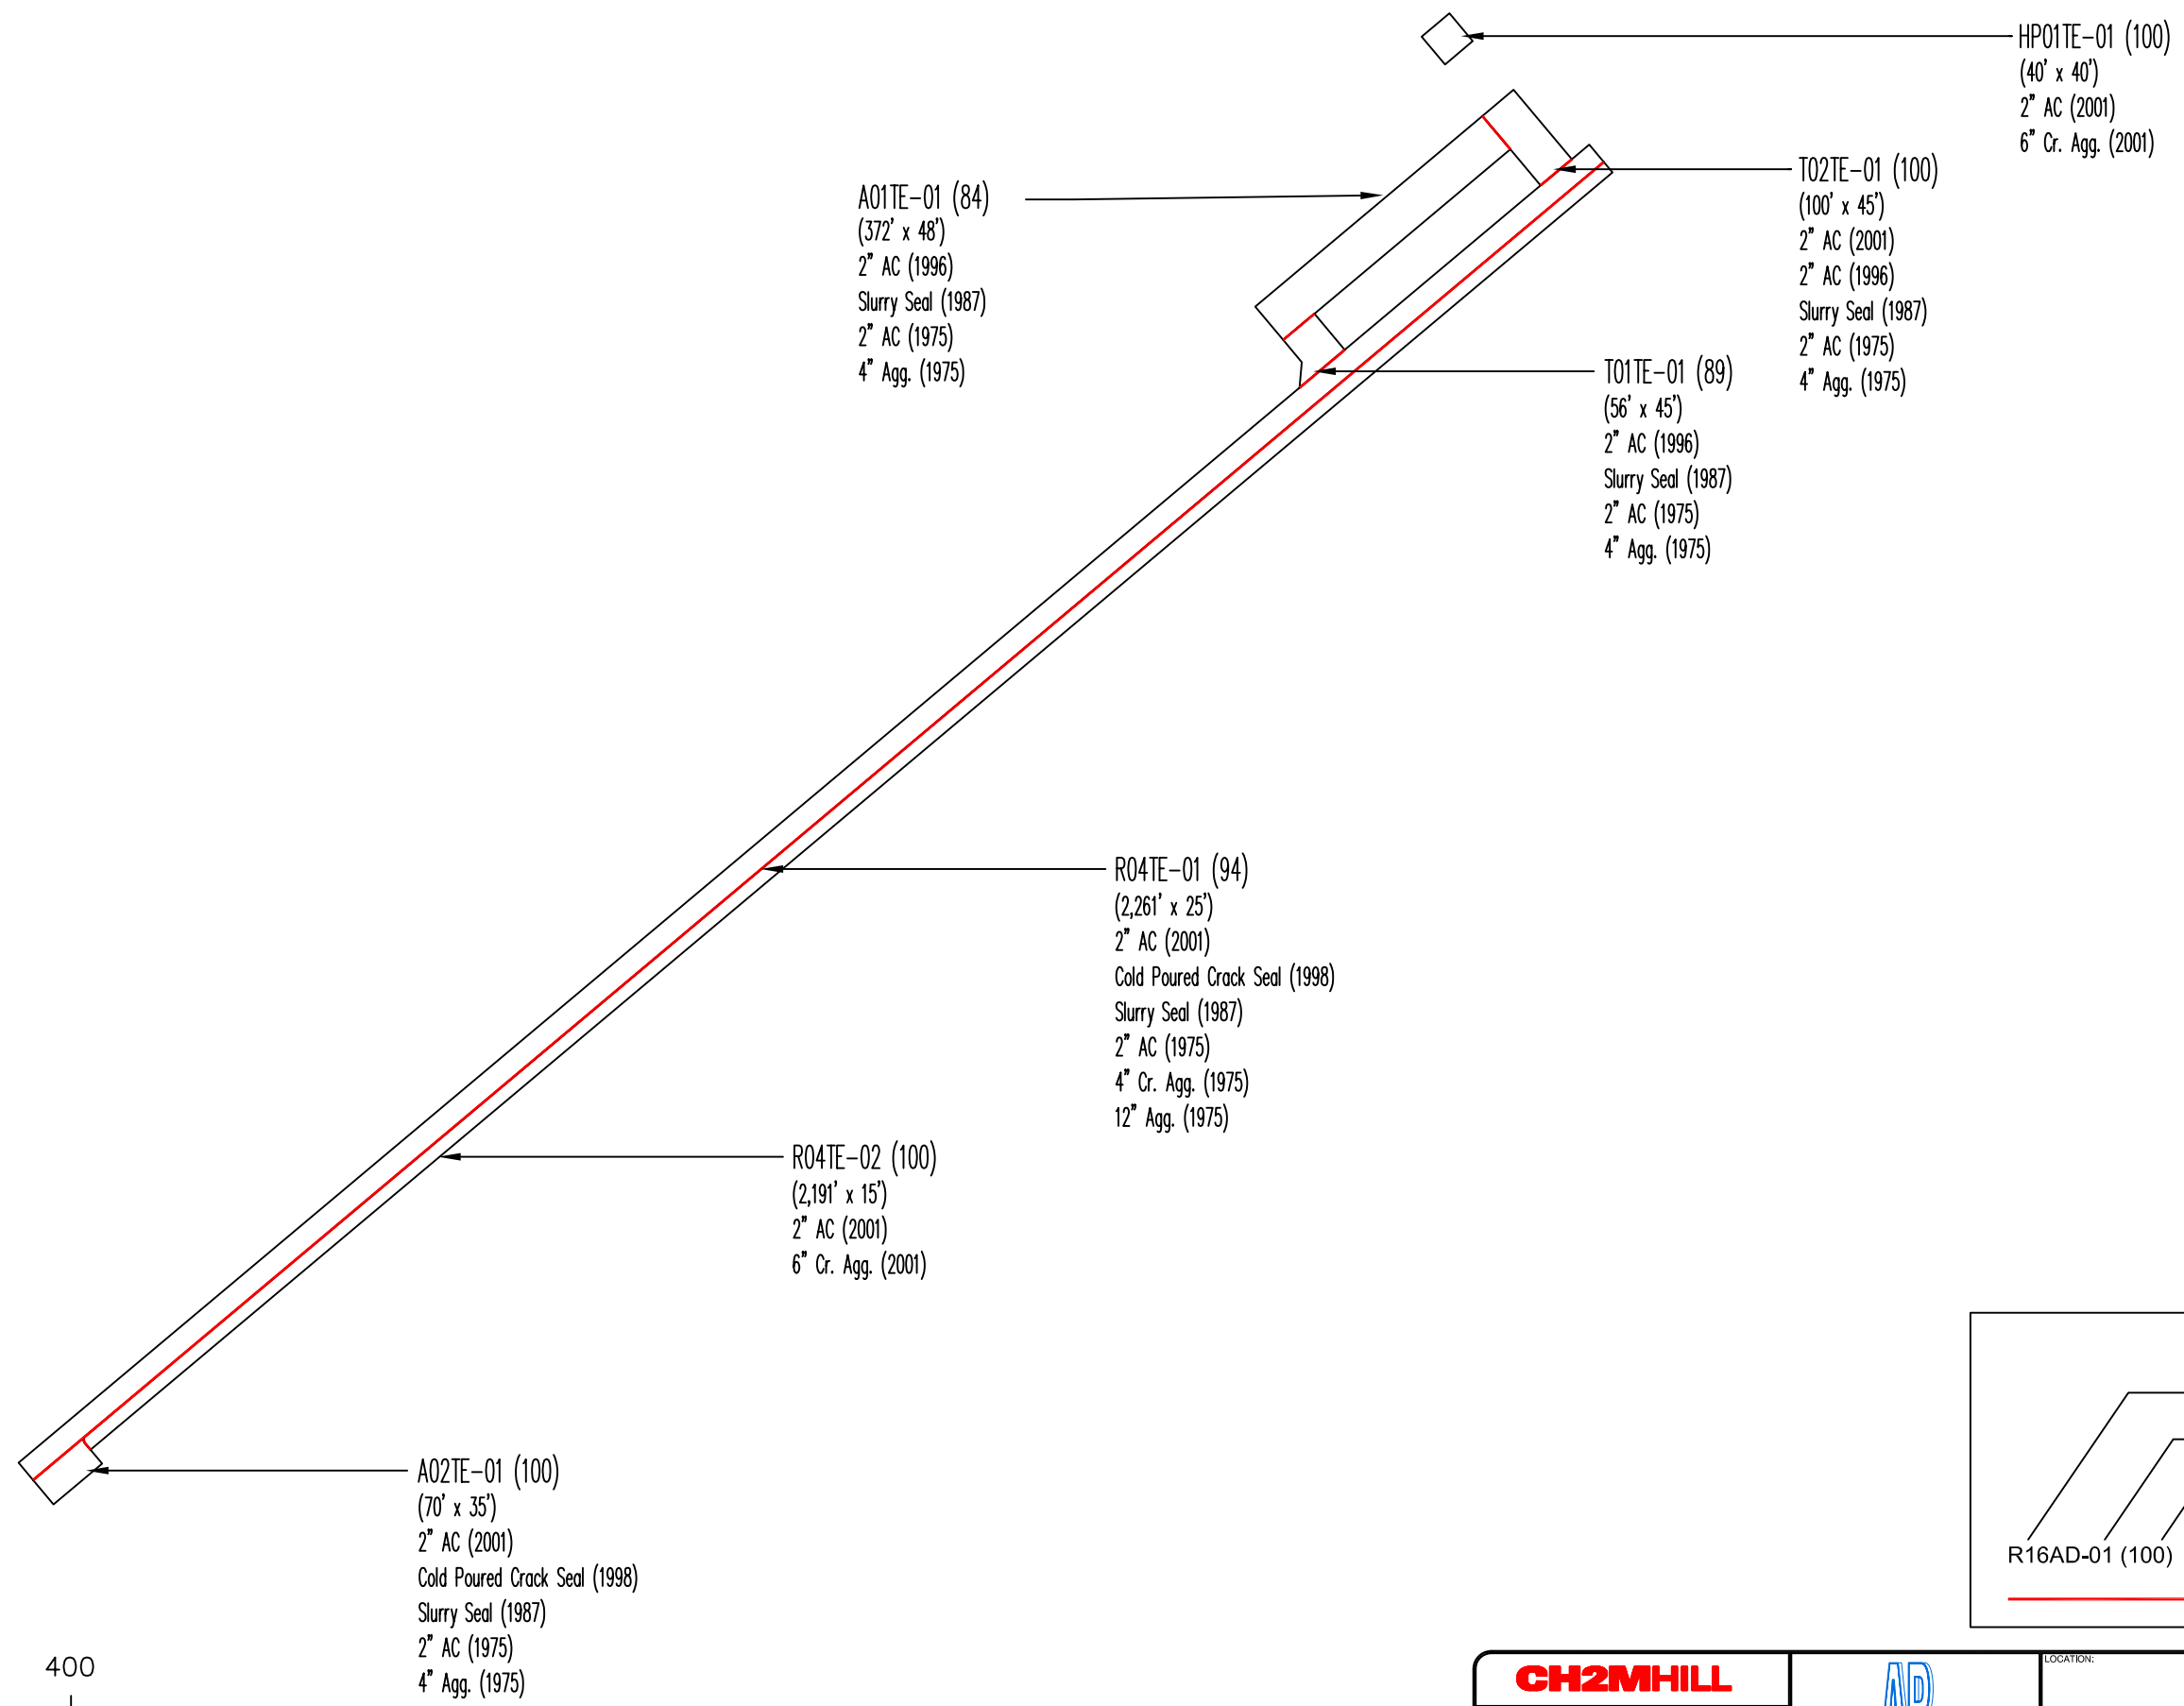
Figure 3 presents the records review results in the form of a work history map. The Micro PAVER database (see the inside back cover of this report) contains detailed inventory information about the pavement system at the airport.

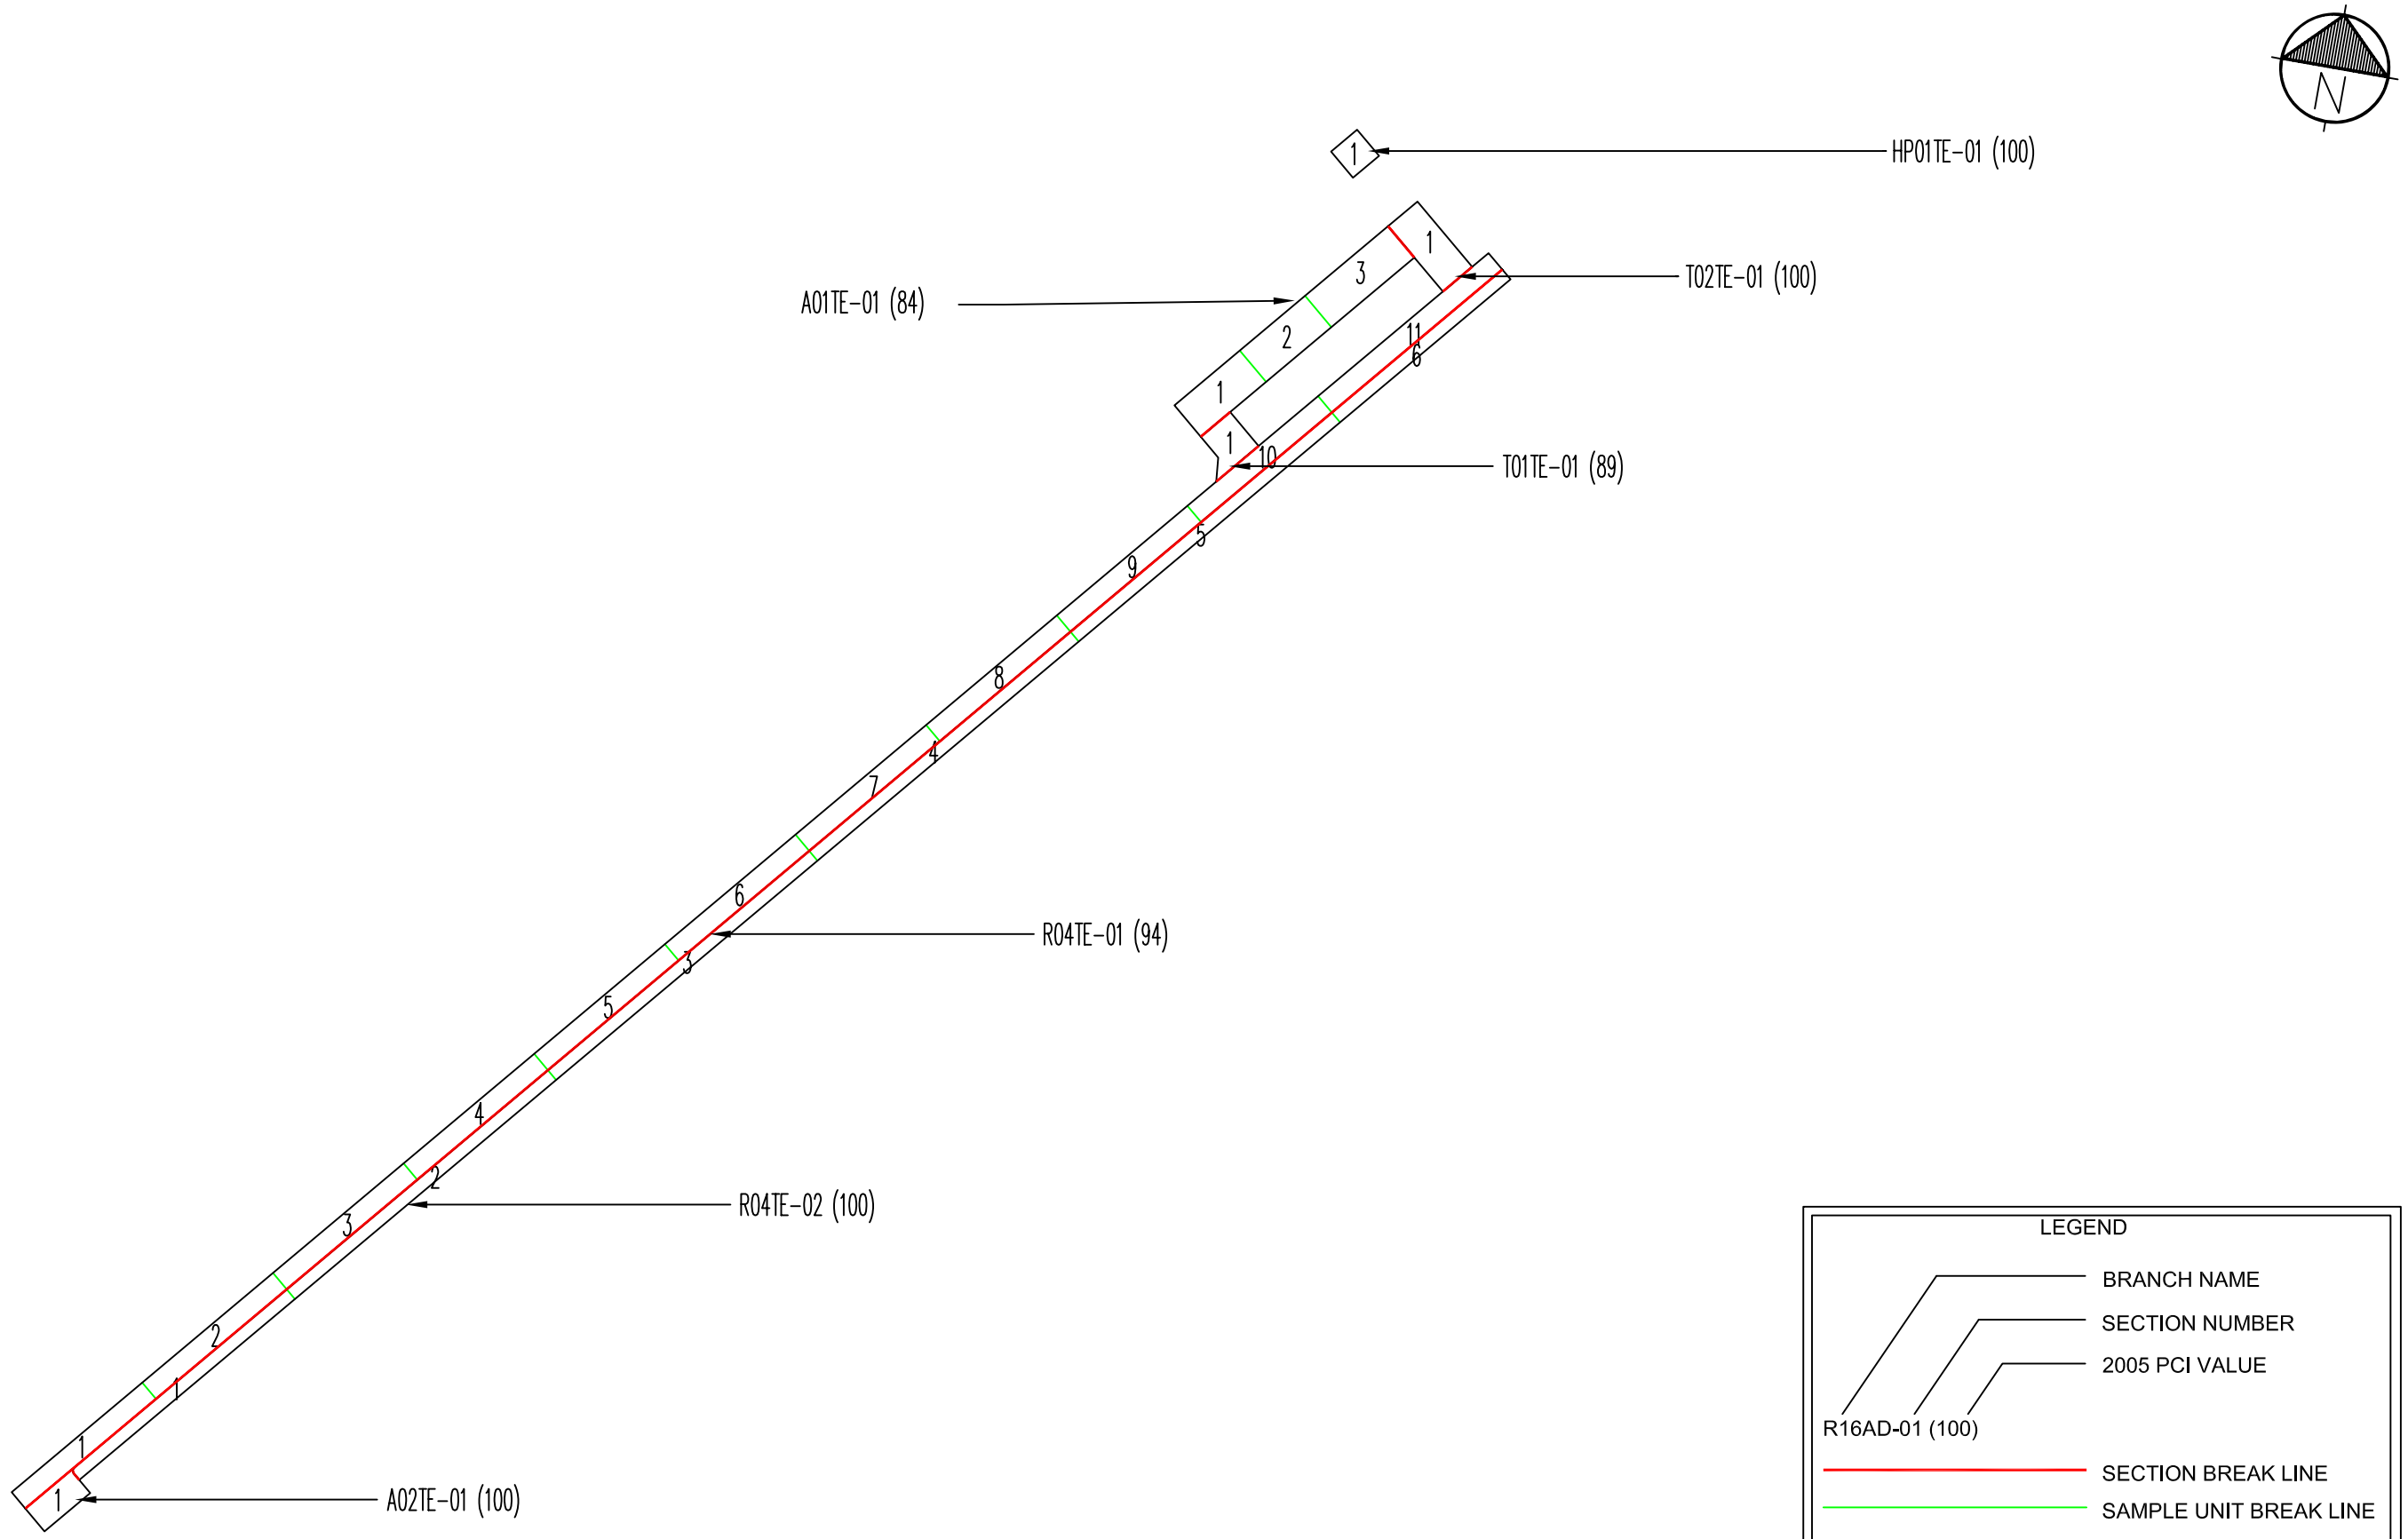
Figure 4 shows how the pavement network was divided into these units and it also shows the nomenclature used in the Micro PAVER pavement management database to identify the different pavement areas.

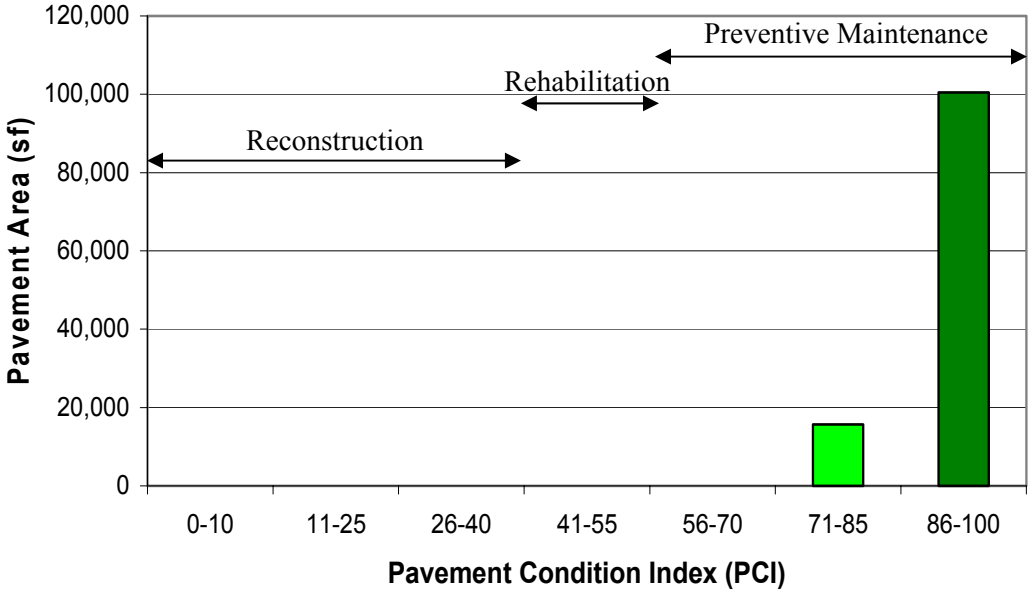
Figure 6. Willard Field Airport overall condition.

The pavements at Willard Field Airport were inspected on May 25, 2005. The 2005 area-weighted condition of Willard Field Airport is 95, with conditions ranging from 85 to 100 (on a scale of 0 [failed] to 100 [excellent]). During the previous inspection in 1999, the area-weighted condition was 78.

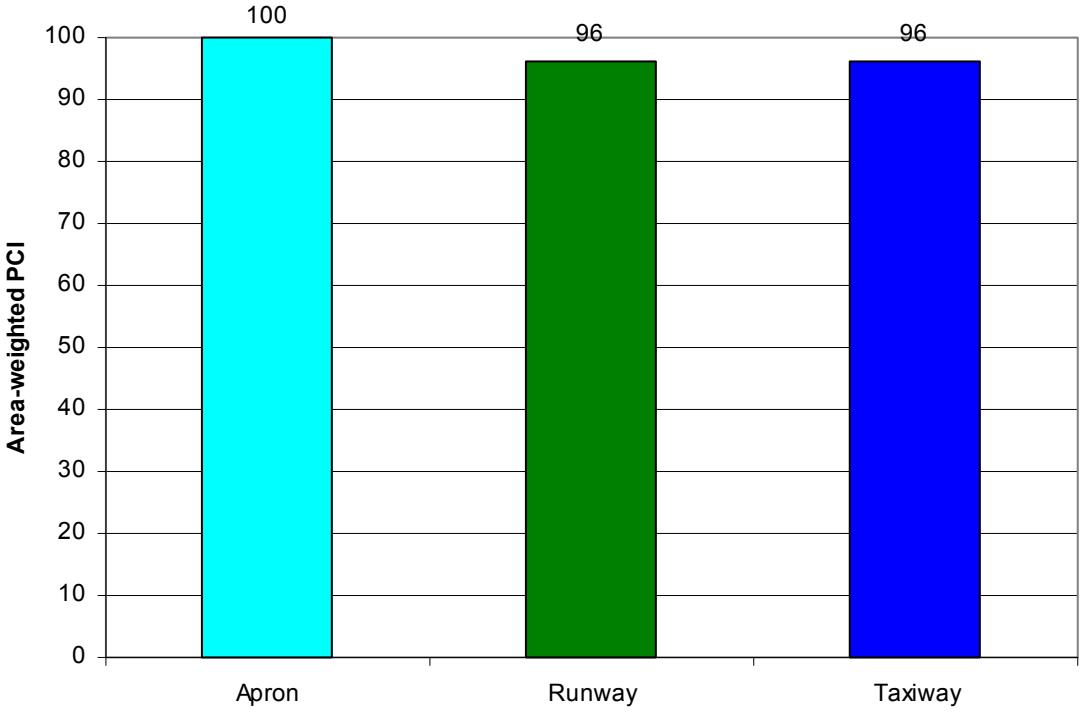
Figure 7. Willard Field Airport area-weighted PCI by use.

Figures 6 and 7 summarize the overall condition of the pavements at the Willard Field Airport. Figure 8 displays the condition of the pavements evaluated. Table 1 summarizes the results of the pavement evaluation. Appendix C presents photographs taken during the PCI inspection and Appendix D details the distresses observed during the visual survey.

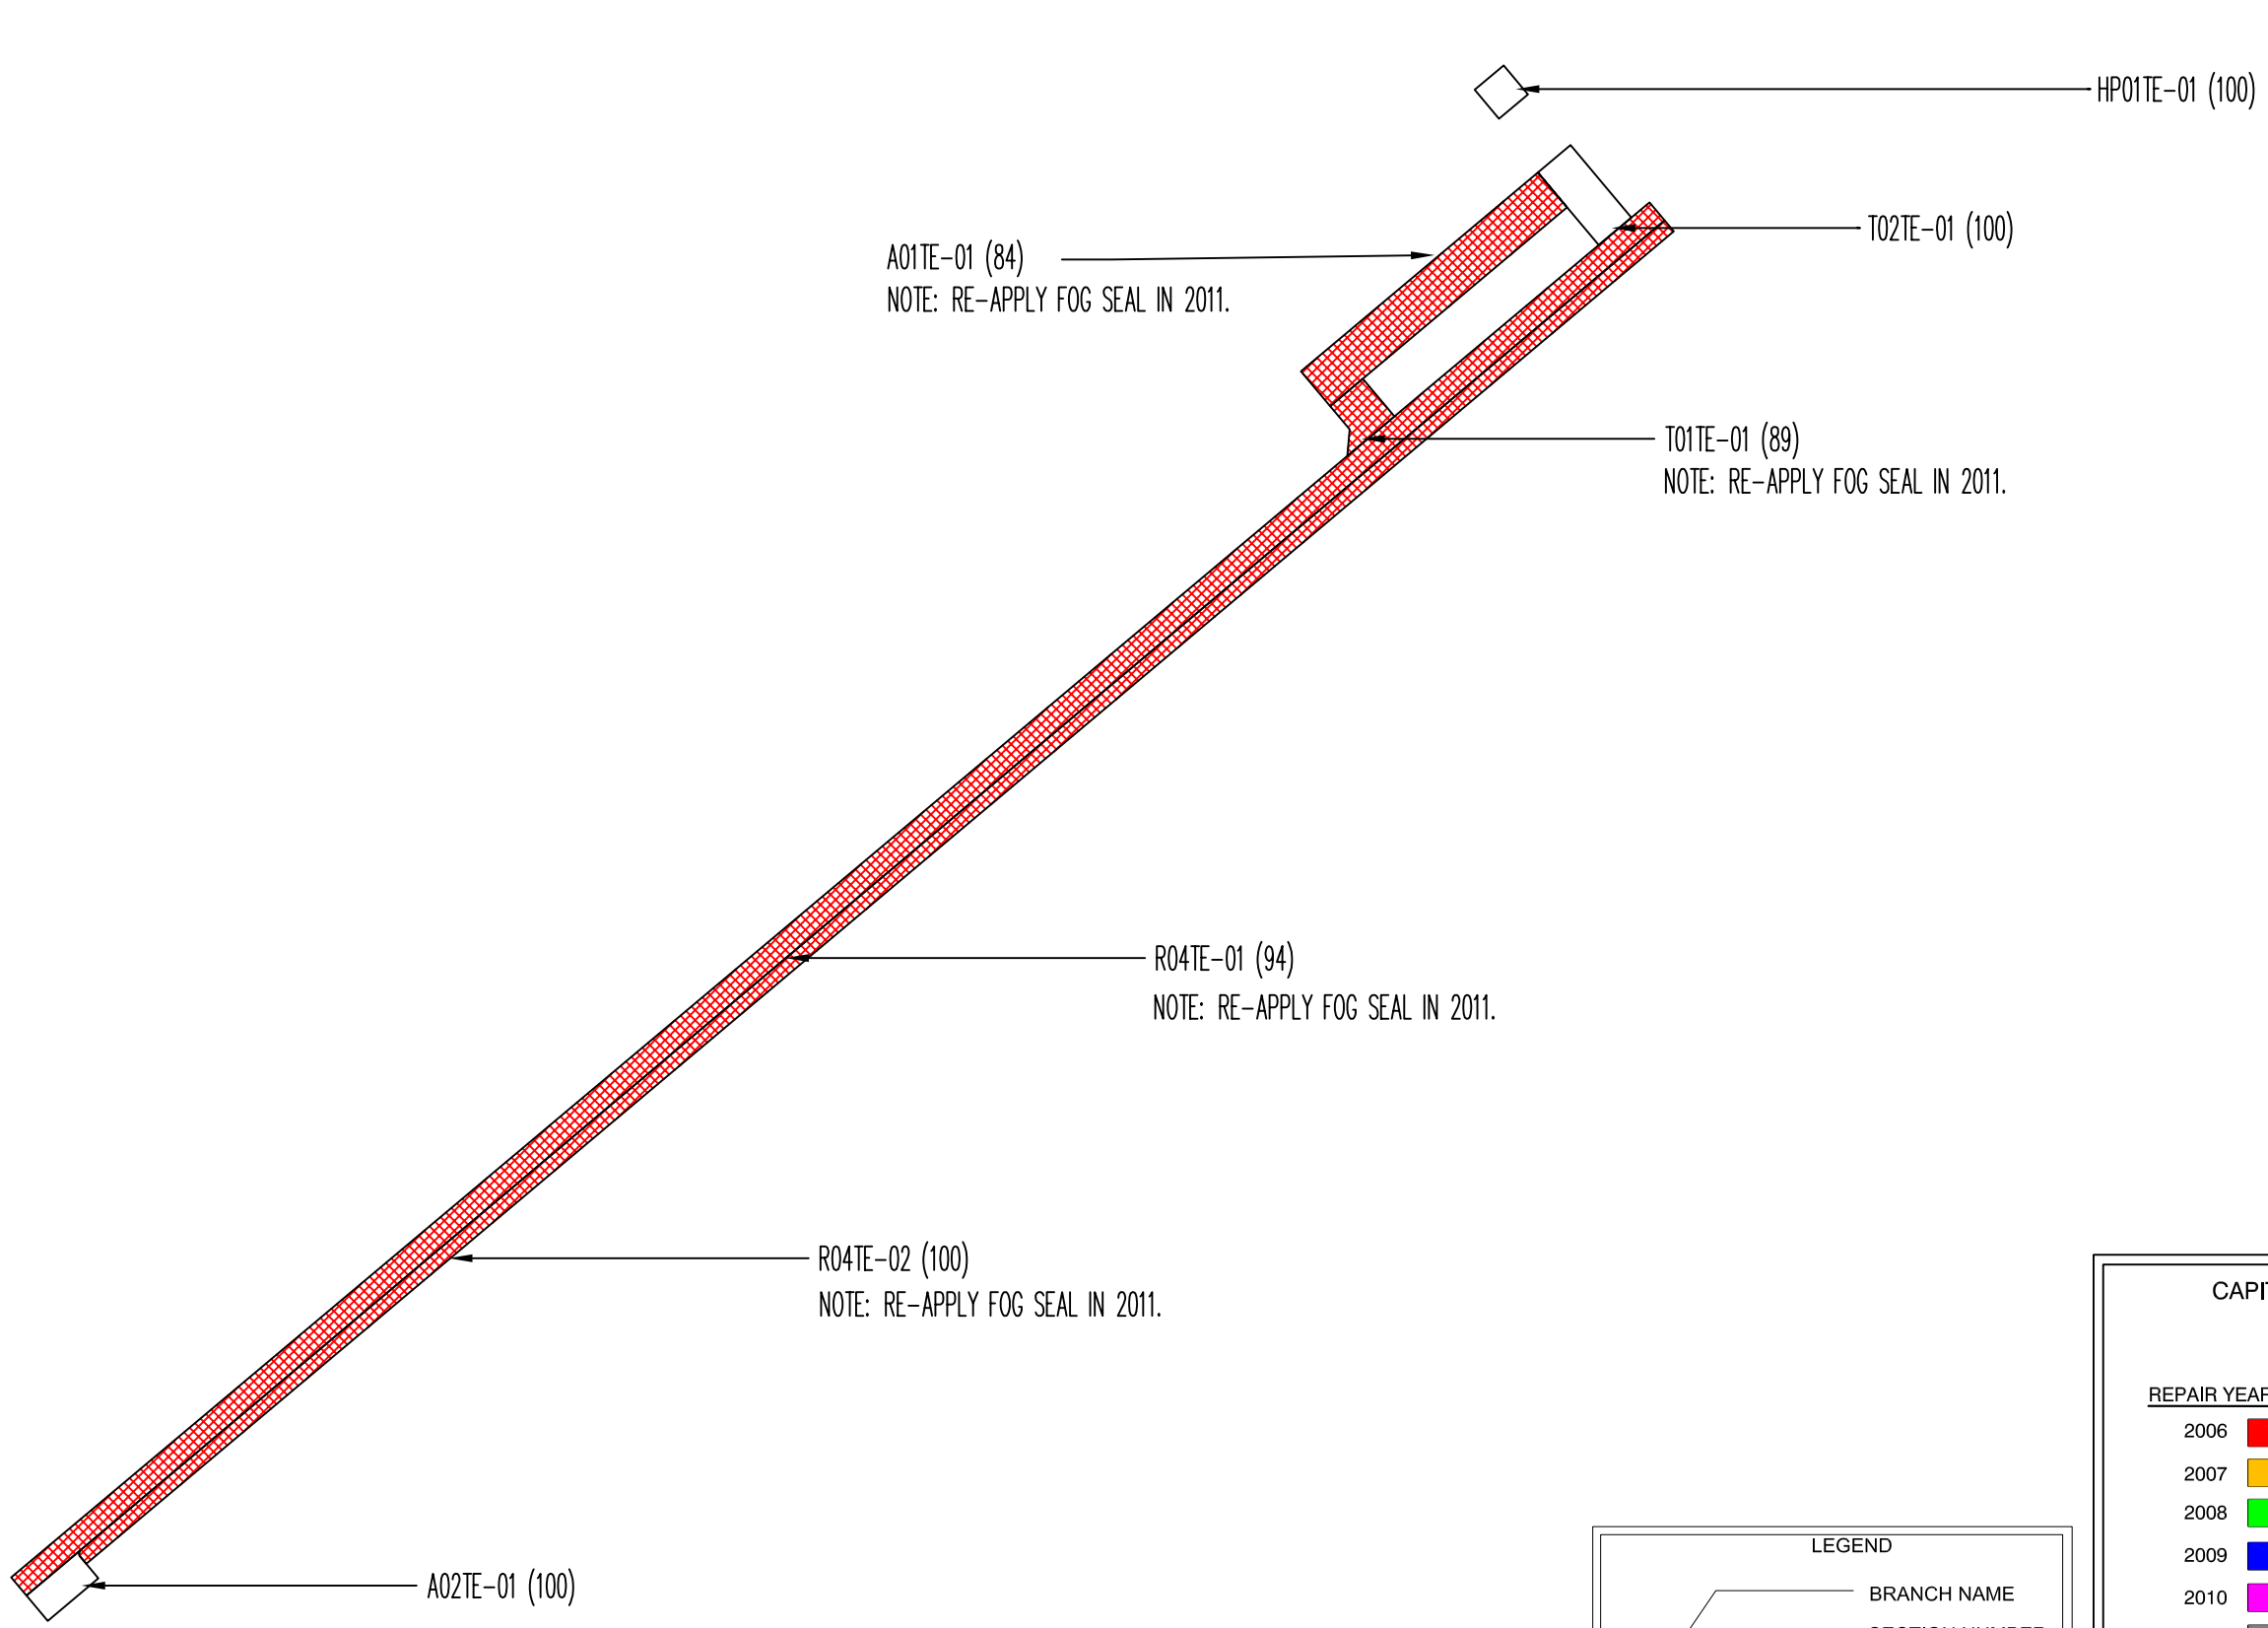
A summary of the pavement repair program for Willard Field Airport is presented in Table 4 and in Figure 9. Detailed information on the localized maintenance plan for 2006 is contained in Appendix F.

REPAIR YEAR	REPAIR TYPE
2006	FOG SEAL
2007	SLURRY SEAL
2008	REHABILITATION
2009	RECONSTRUCTION
2010	
2011	
2012
