DOROTHY SCOTT AIRPORT
2005 PAVEMENT MANAGEMENT REPORT

February 2006

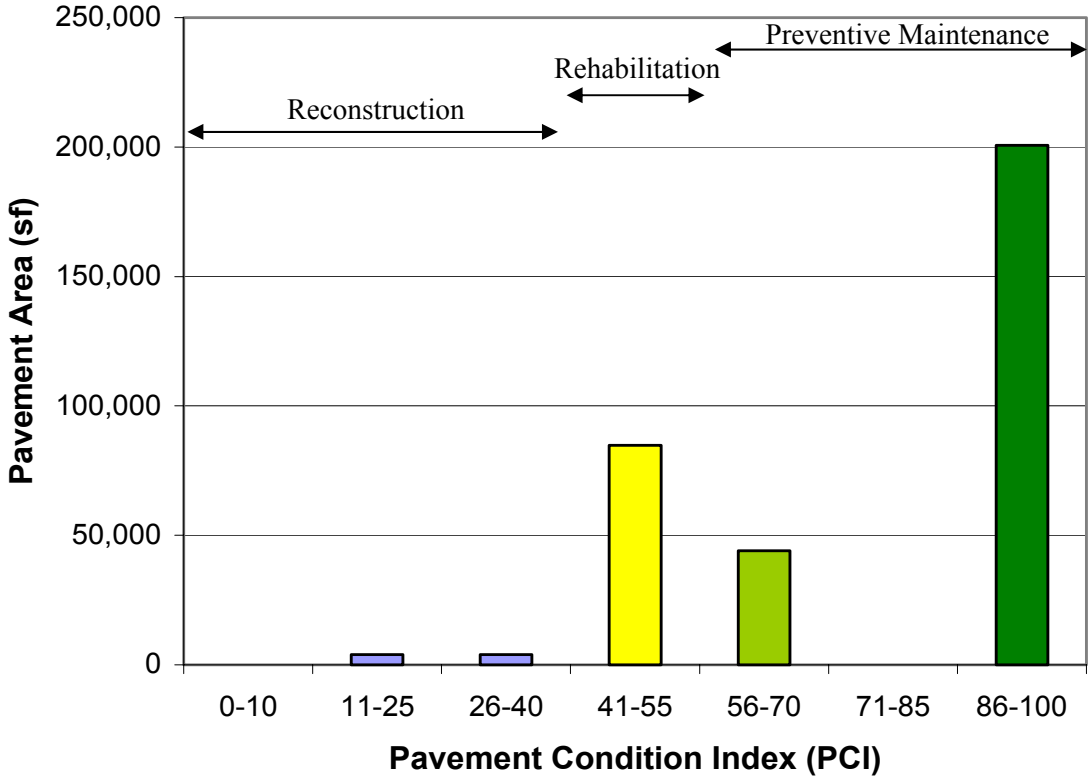
Figure 6. Dorothy Scott Airport overall condition.

The pavements at Dorothy Scott Airport were inspected on June 5, 2005. The 2005 area-weighted condition of Dorothy Scott Airport is 76, with conditions ranging from 22 to 97 (on a scale of 0 [failed] to 100 [excellent]). During the previous inspection in 1999, the area-weighted condition was 91.

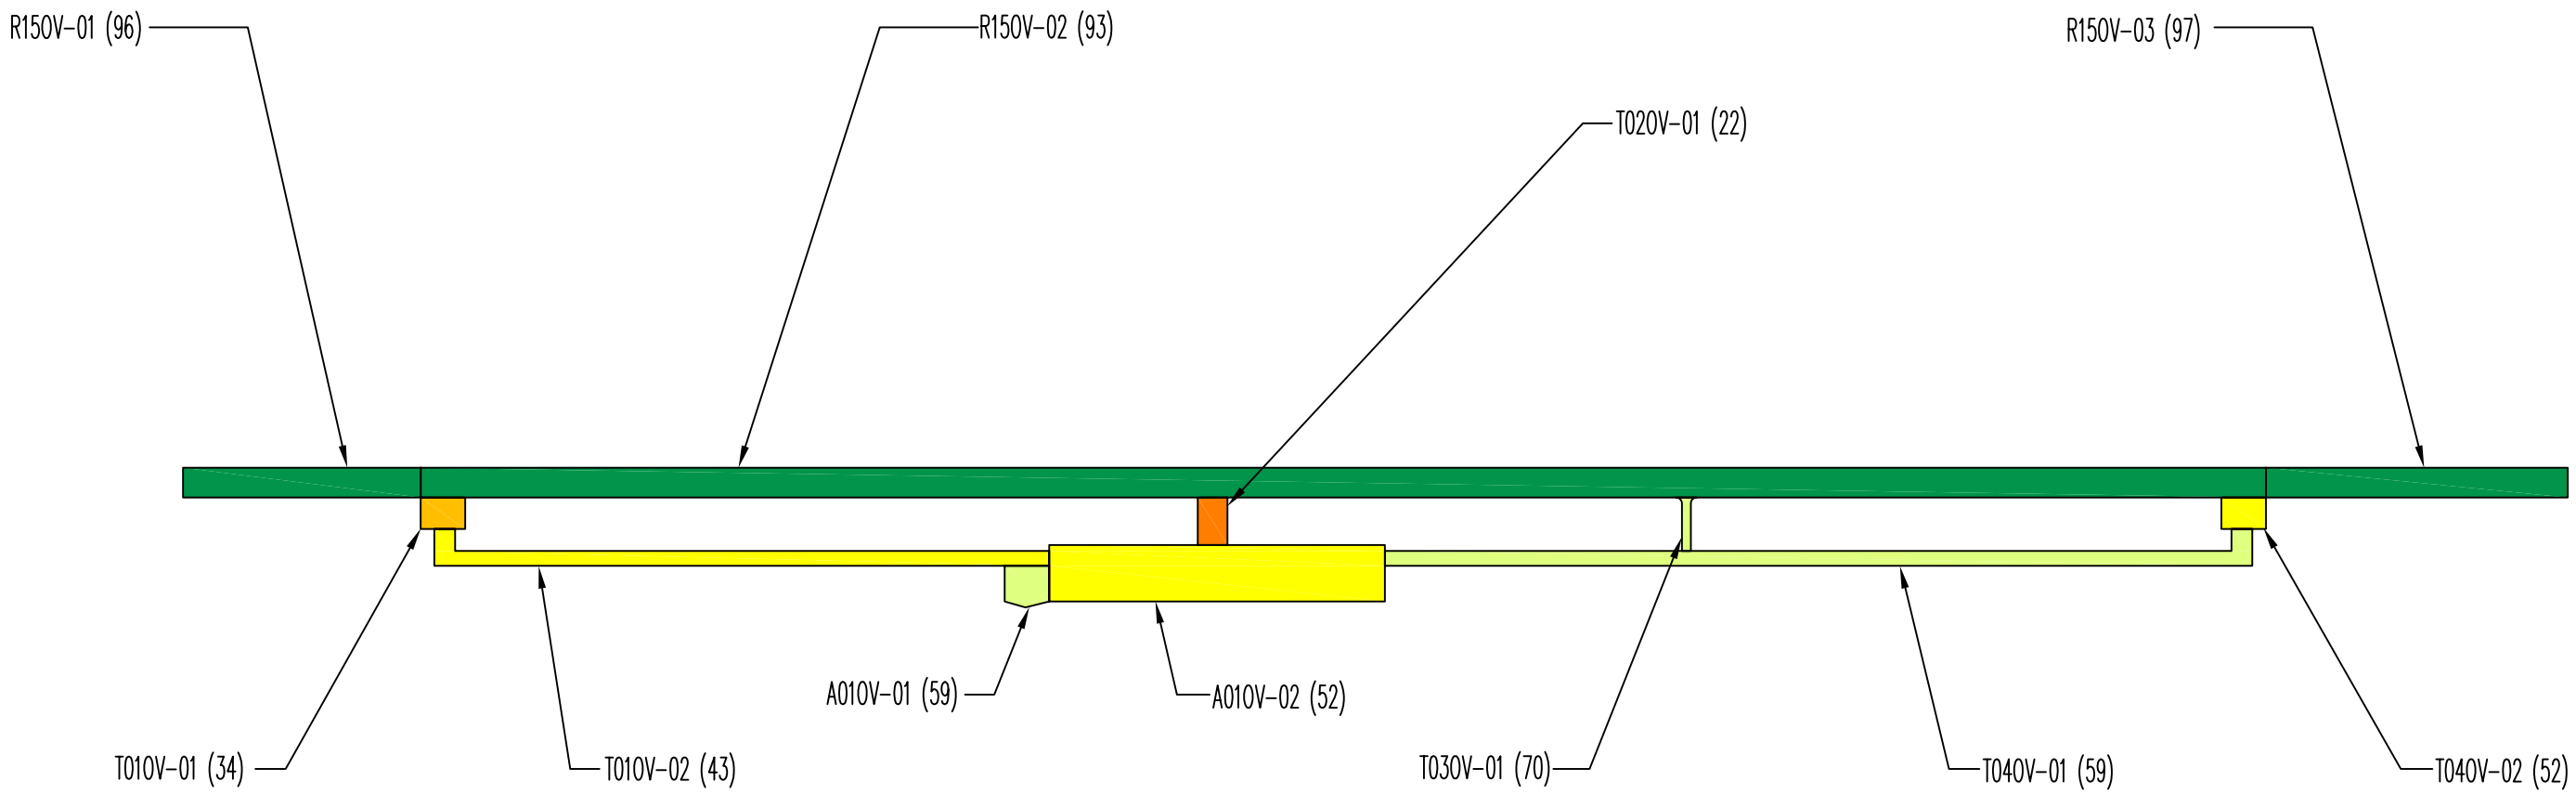
LOCATION: Dorothy Scott Airport, Oroville, Washington			
PAGE TITLE: 2005 Pavement Condition Index Map			
DRAWING SCALE: 1" = 300'	DATE: February 2006	REVISED BY: TJS	DRAWN BY: JR
FILENAME: Oroville.dwg	AIRPORT ID: OS7	LAYOUT NAME/NUMBER: Oroville (PCI)	PAGE NUMBER: 9

Figures 6 and 7 summarize the overall condition of the pavements at the Dorothy Scott Airport. Figure 8 displays the condition of the pavements evaluated. Table 1 summarizes the results of the pavement evaluation. Appendix C presents photographs taken during the PCI inspection and Appendix D details the distresses observed during the visual survey.
