MOSES LAKE MUNICIPAL AIRPORT
2005 PAVEMENT MANAGEMENT REPORT

February 2006

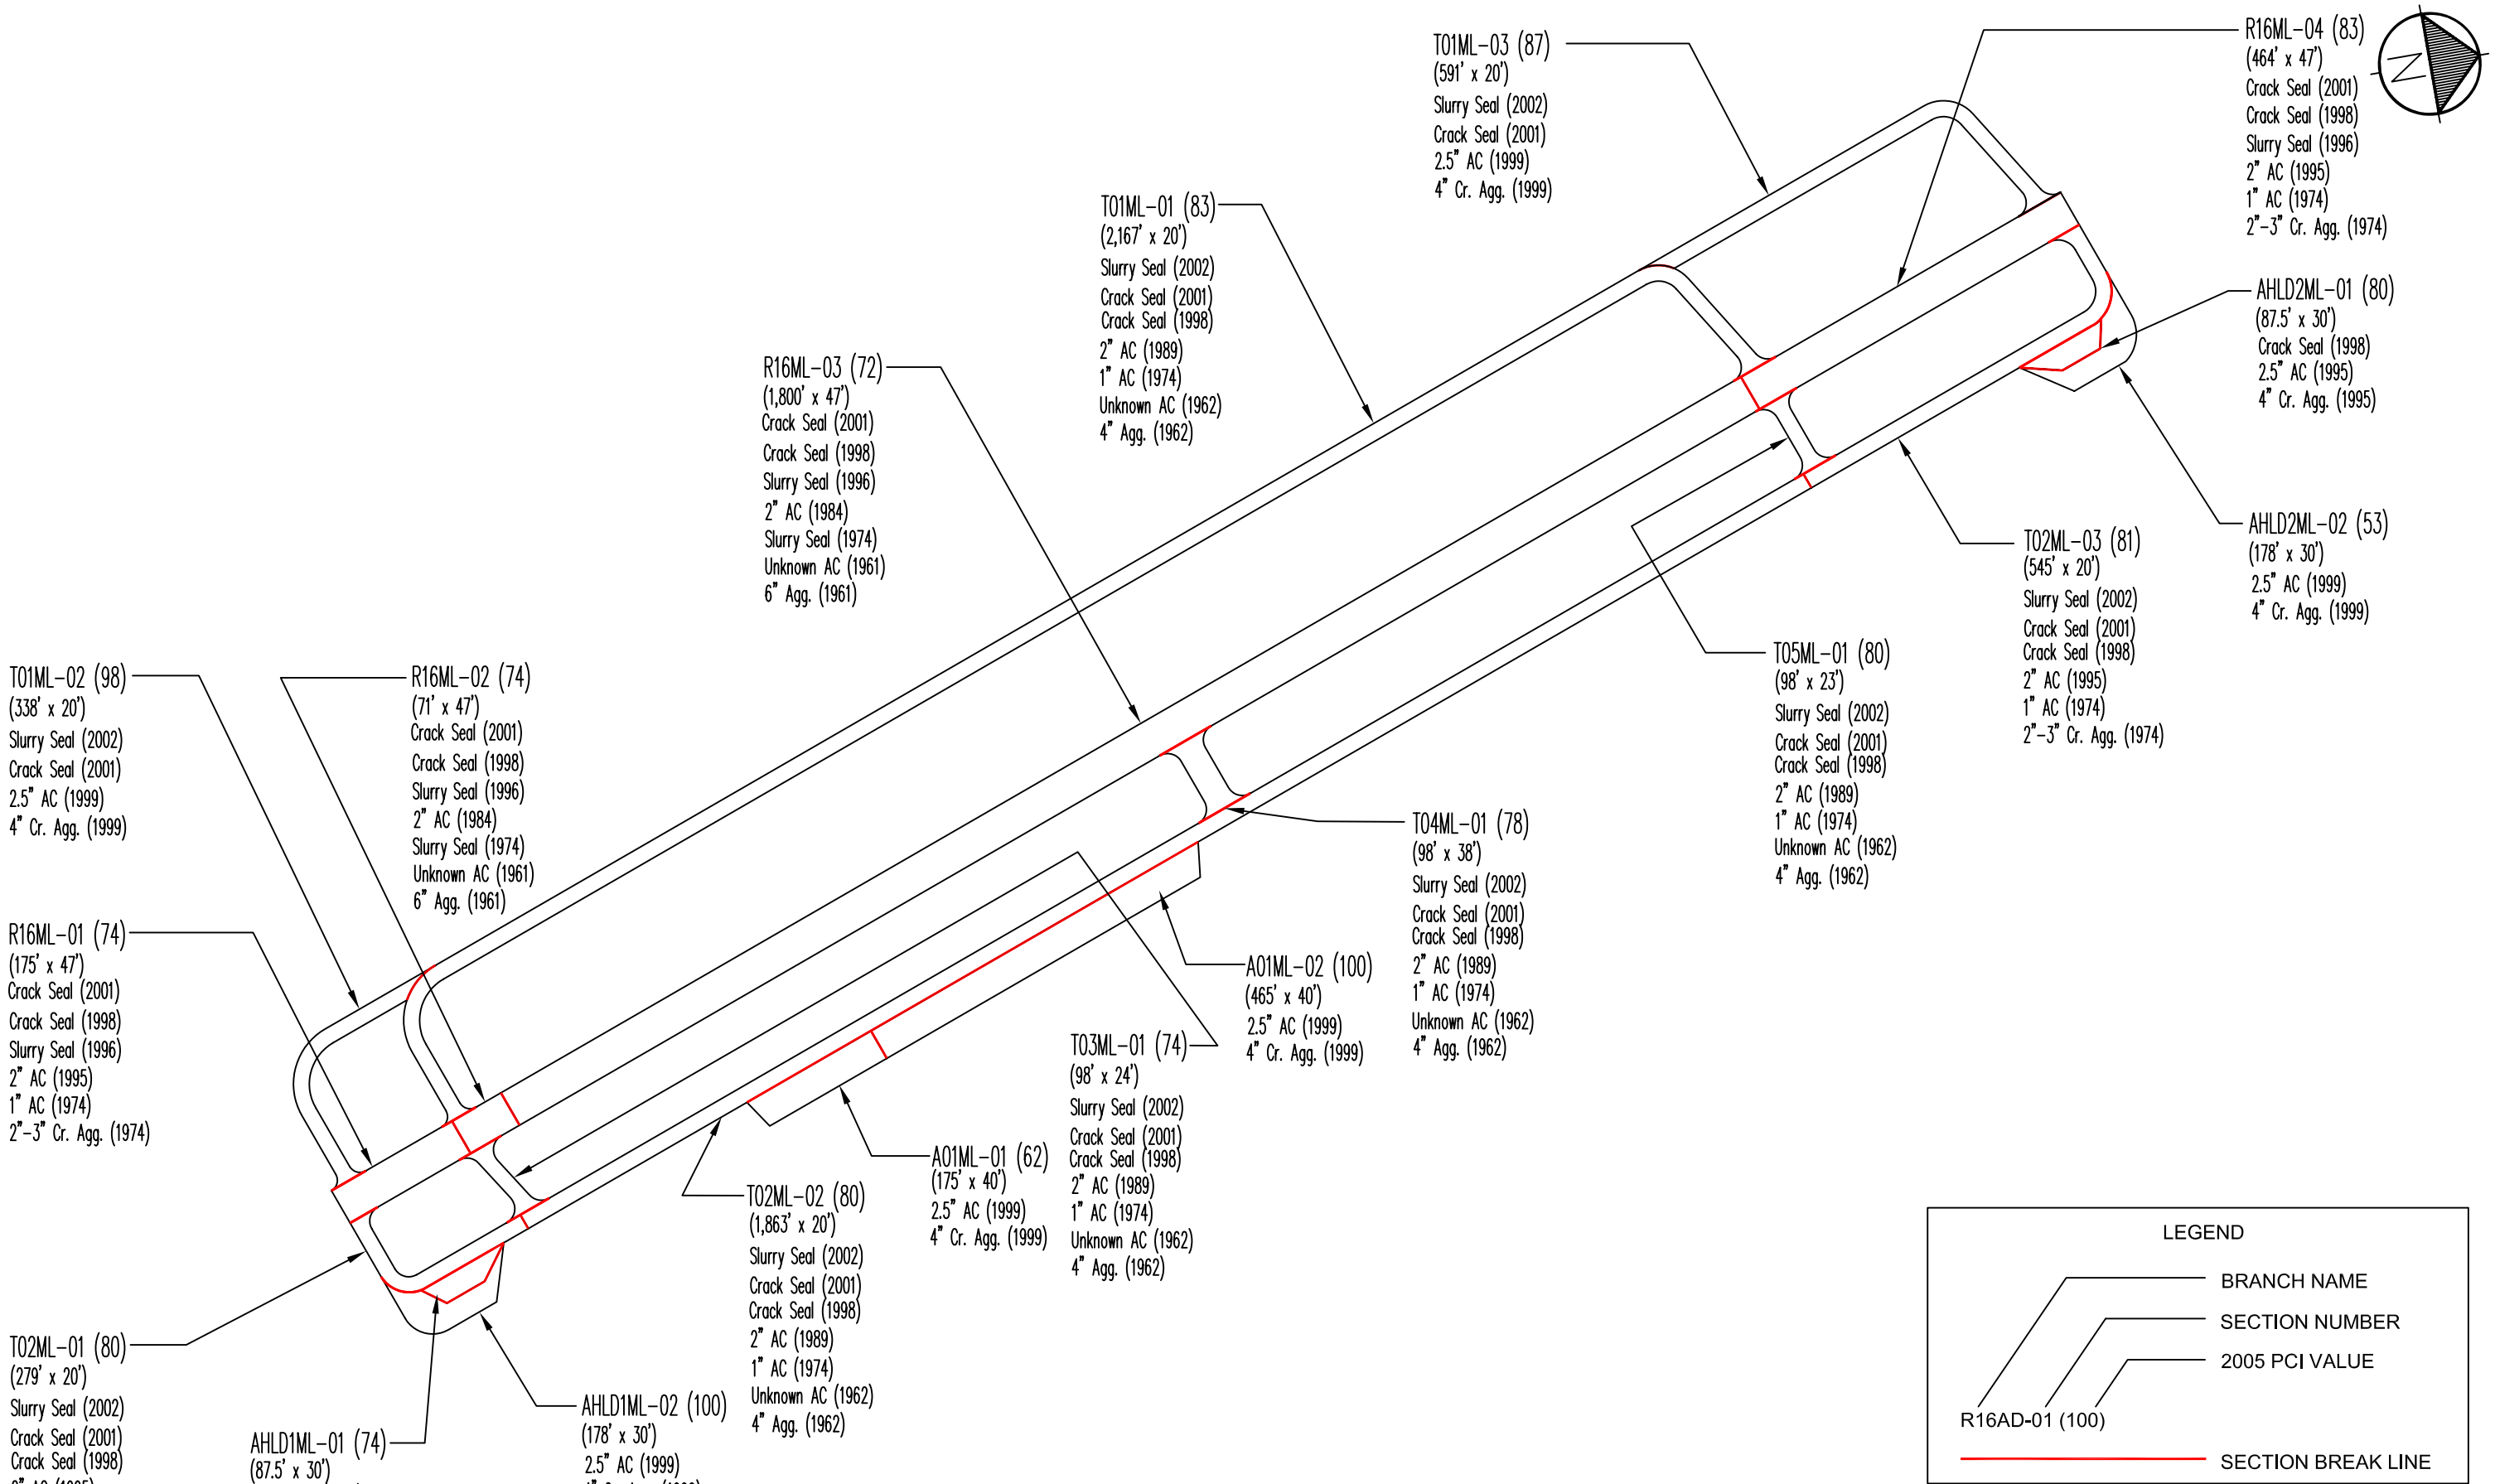
LOCATION: Moses Lake Municipal Airport, Moses Lake, Washington			
PAGE TITLE: 2005 Work History Map			
DRAWING SCALE: 1" = 200'	DATE: February 2006	REVISED BY: AM	DRAWN BY: AM
FILENAME: Moseslake.dwg	AIRPORT ID: WA40	LAYOUT NAME/NUMBER: ML (WH)	PAGE NUMBER: 4

Figure 3 presents the records review results in the form of a work history map. The Micro PAVER database (see the inside back cover of this report) contains detailed inventory information about the pavement system at the airport.

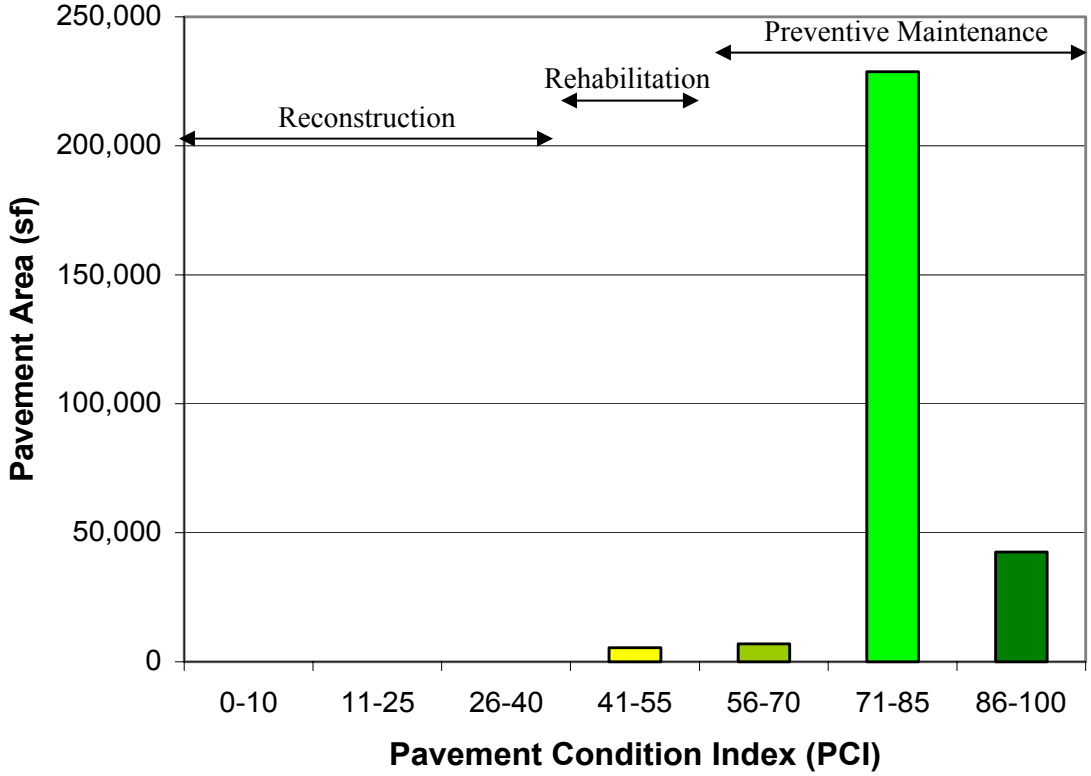
Figure 6. Moses Lake Municipal Airport overall condition.

The pavements at Moses Lake Municipal Airport were inspected on June 8, 2005. The 2005 area-weighted condition of Moses Lake Municipal Airport is 79, with conditions ranging from 53 to 100 (on a scale of 0 [failed] to 100 [excellent]). During the previous inspection in 1999, the area-weighted condition was 88.

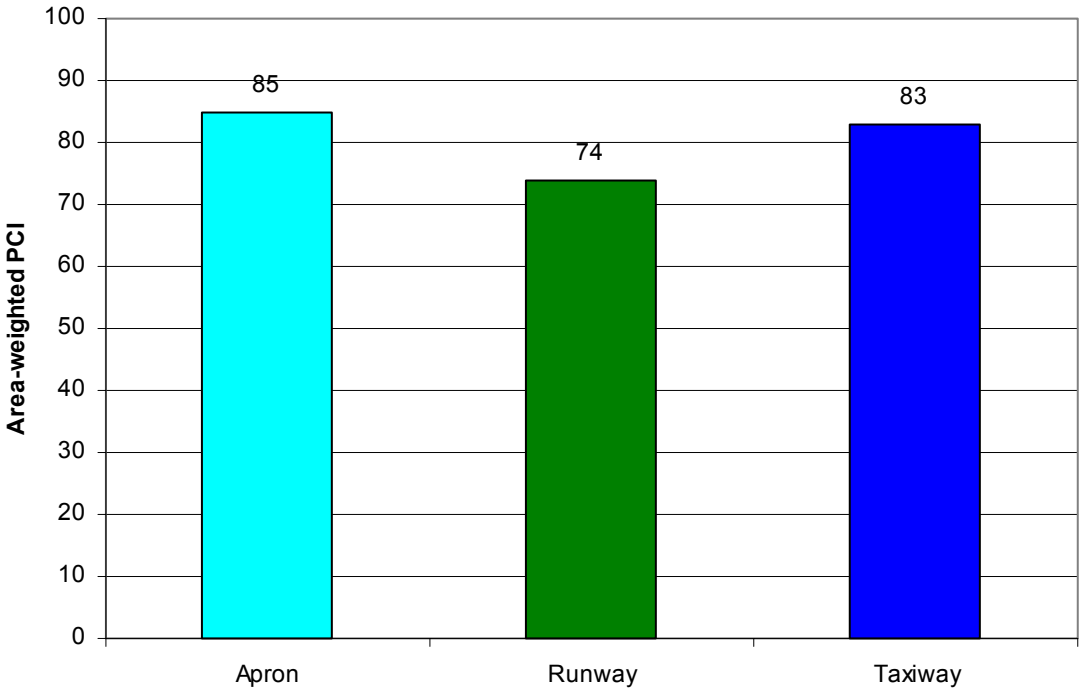
Figure 7. Moses Lake Municipal Airport area-weighted PCI by use.

Figures 6 and 7 summarize the overall condition of the pavements at the Moses Lake Municipal Airport. Figure 8 displays the condition of the pavements evaluated. Table 1 summarizes the results of the pavement evaluation. Appendix C presents photographs taken during the PCI inspection and Appendix D details the distresses observed during the visual survey.

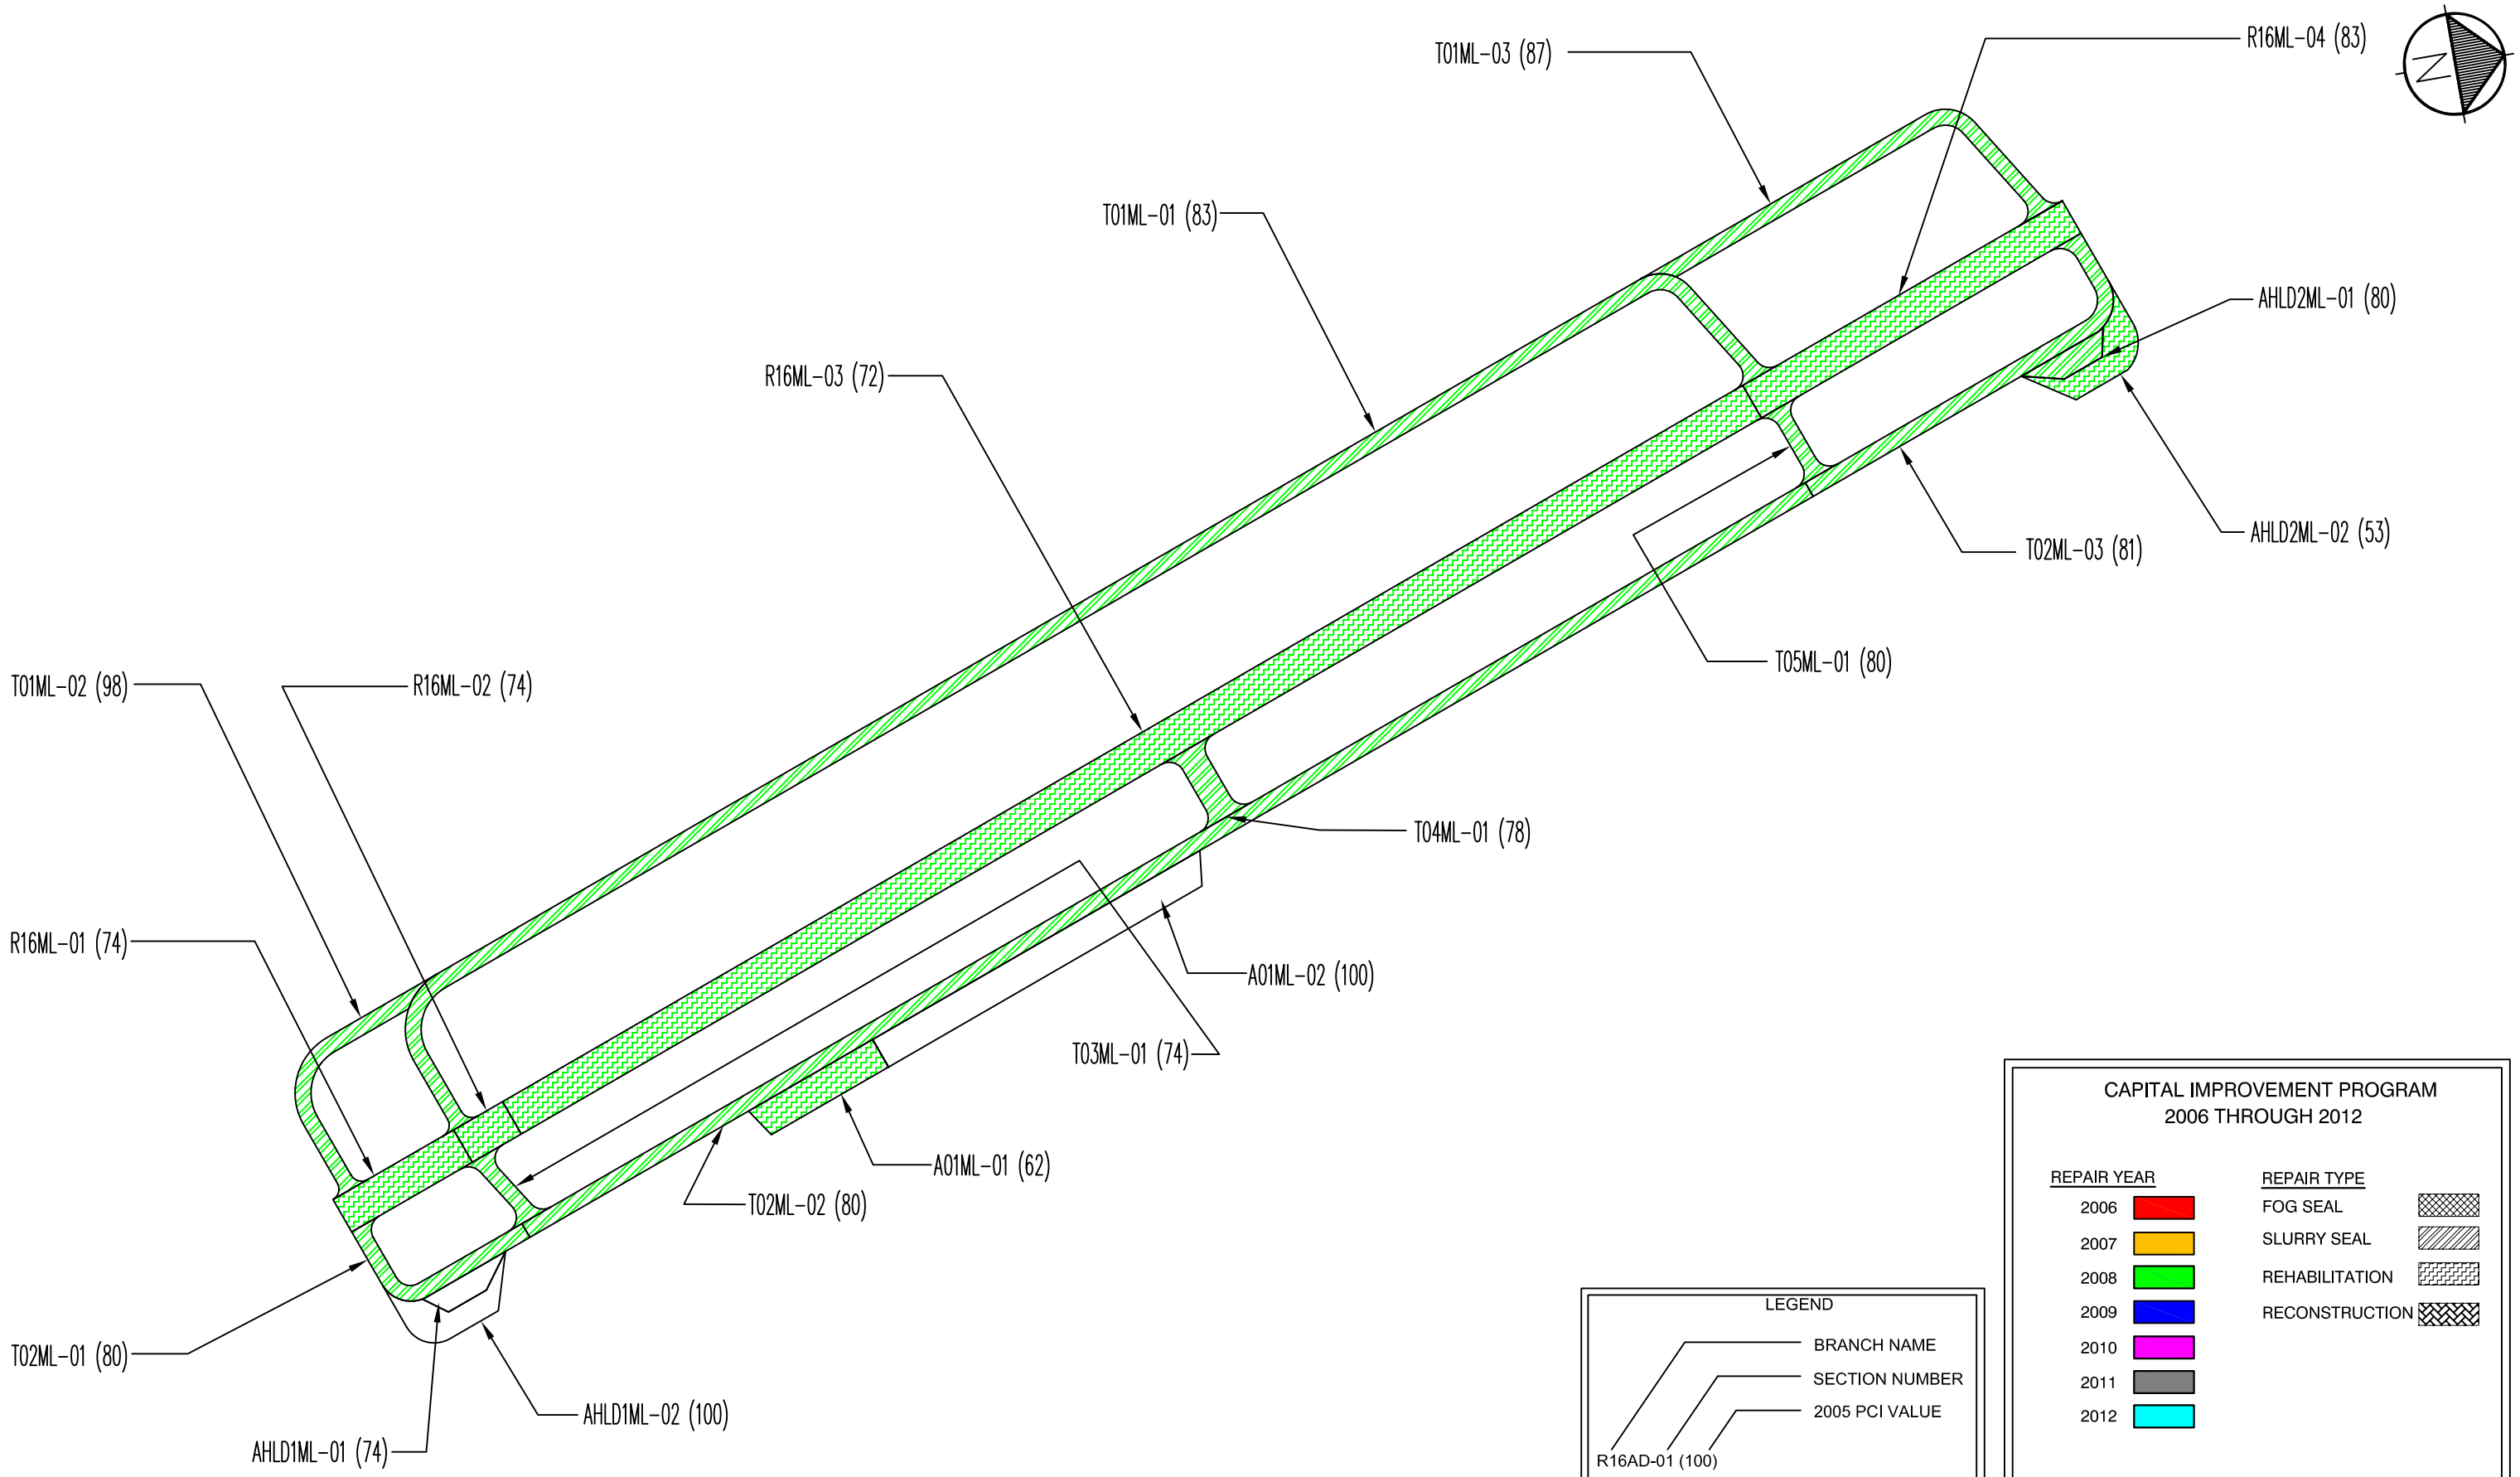
A summary of the pavement repair program for Moses Lake Municipal Airport is presented in Table 4 and in Figure 9. Detailed information on the localized maintenance plan for 2006 is contained in Appendix F.
