# SUNNYSIDE MUNICIPAL AIRPORT
# 2005 PAVEMENT MANAGEMENT REPORT

**February 2006**

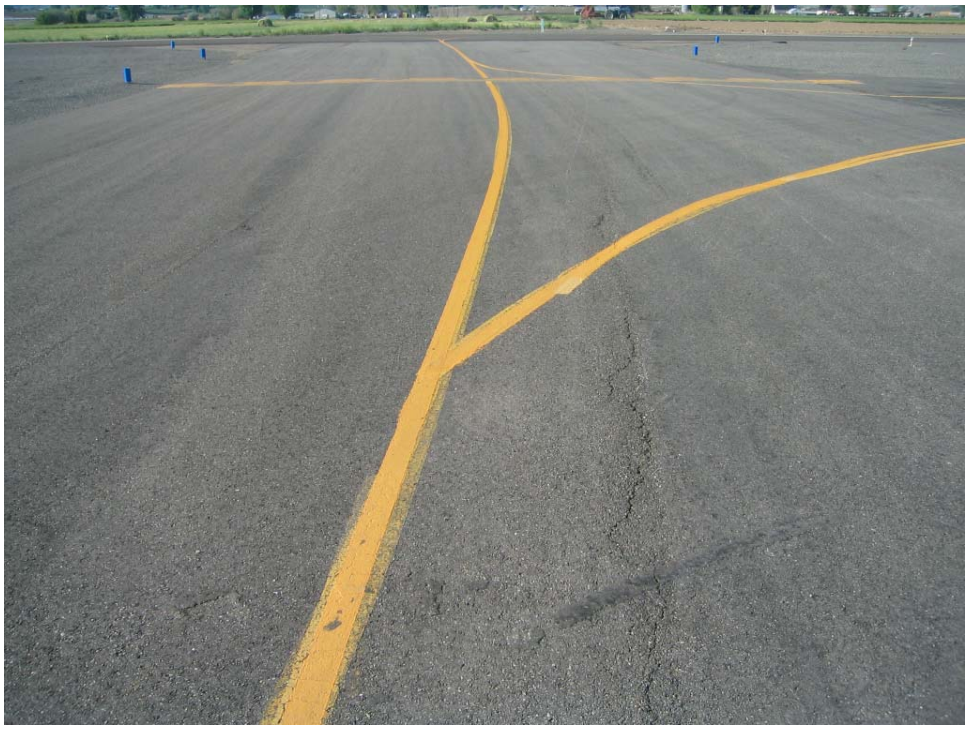
T03SU-01. Overview.

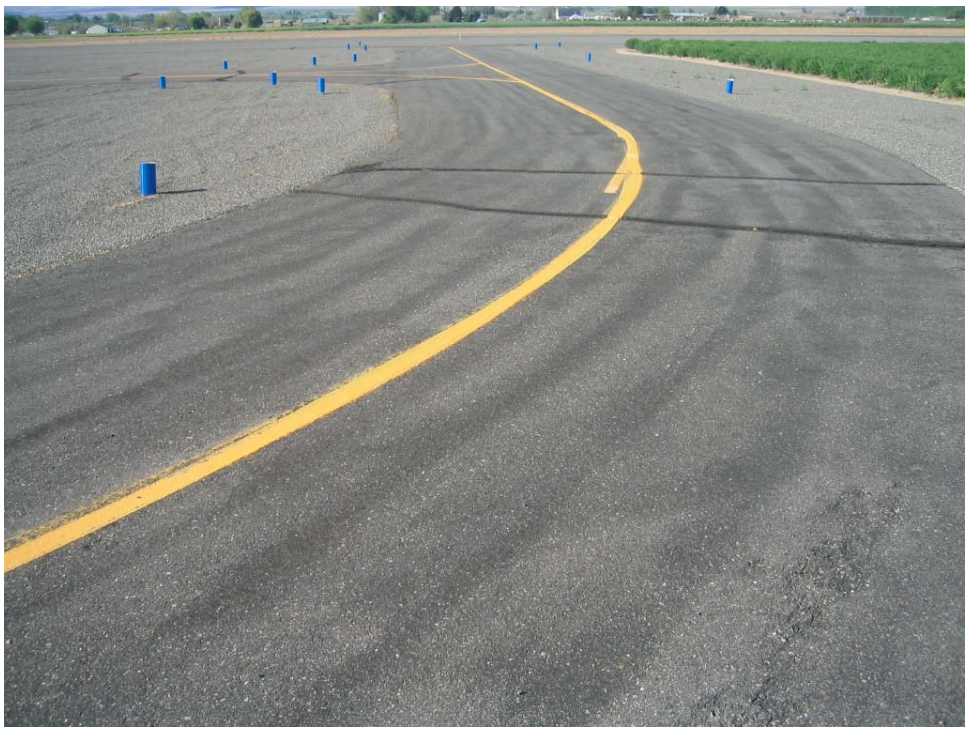
T04SU-01. Overview.

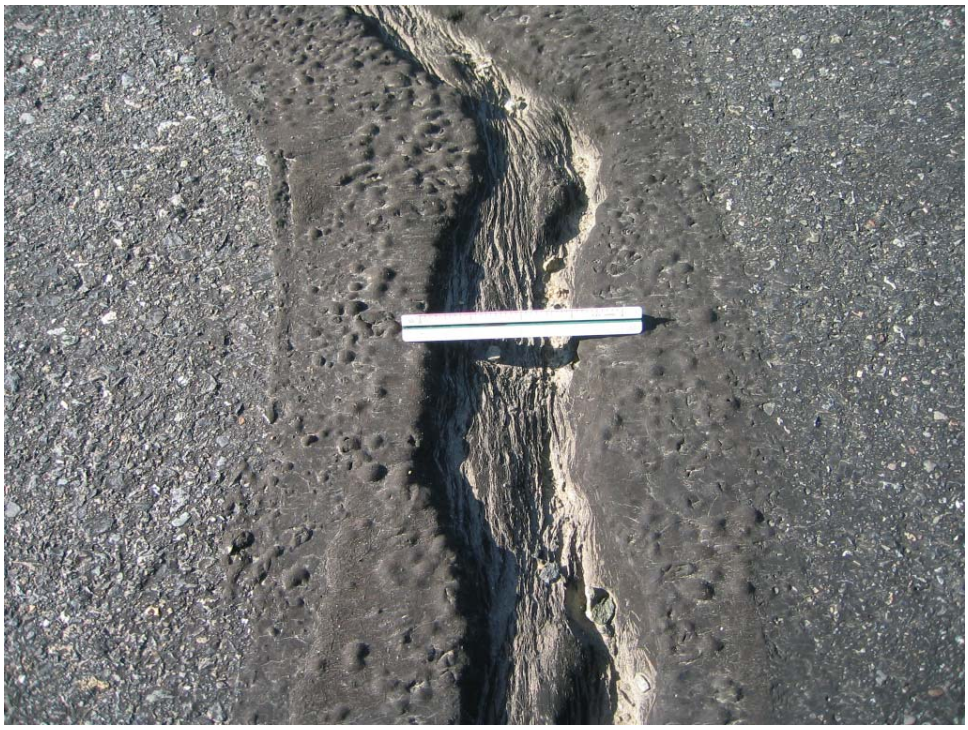
T04SU-01. Longitudinal and transverse cracking.
