HARVEY FIELD AIRPORT
2005 PAVEMENT MANAGEMENT REPORT

February 2006

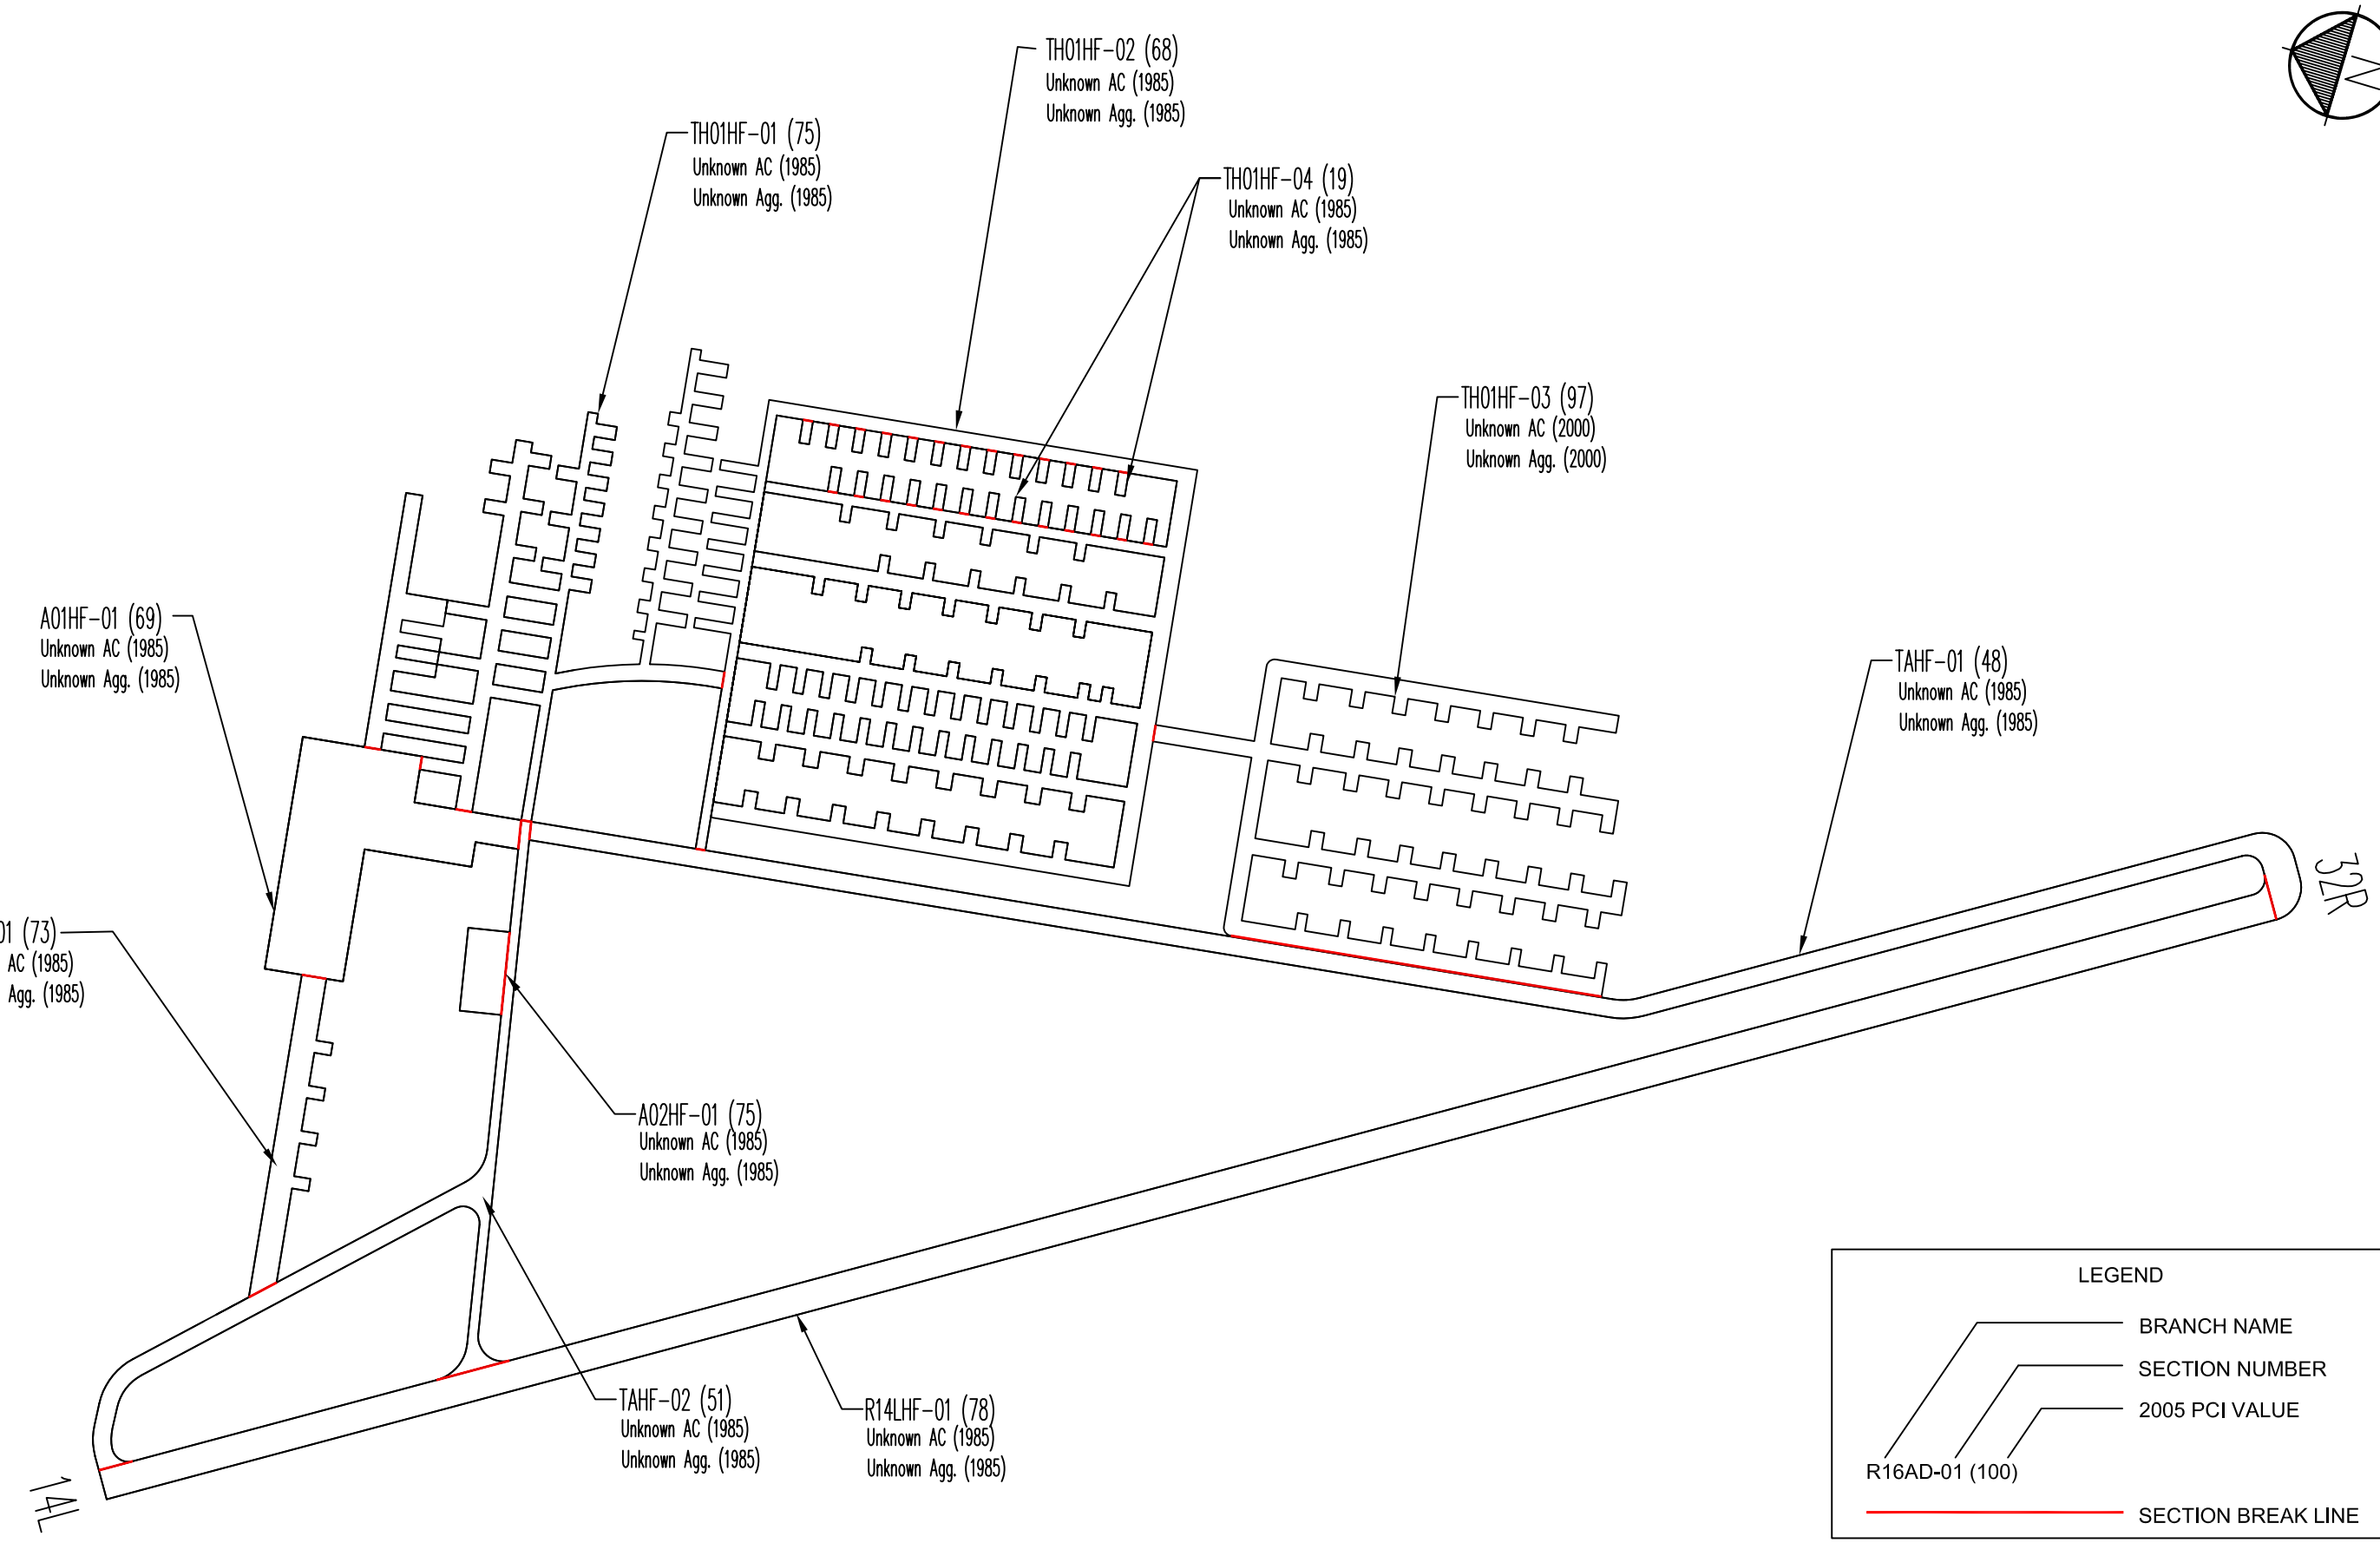
LOCATION: Harvey Field Airport, Snohomish, Washington			
PAGE TITLE: 2005 Work History Map			
DRAWING SCALE: 1" = 200'	DATE: February 2006	REVISED BY: TJS	DRAWN BY: JR
FILENAME: Snohomish.dwg	AIRPORT ID: S43	LAYOUT NAME/NUMBER: Snohomish (WH)	PAGE NUMBER: 4

Figure 3 presents the records review results in the form of a work history map. The work history information and the Micro PAVER database (see the inside back cover of this report) ensure that your airport complies with the "pavement inventory" and "record keeping and information retrieval" requirements of FAA Grant Assurance 11 (discussed later in the section of this report entitled *Public Law 103-305*).

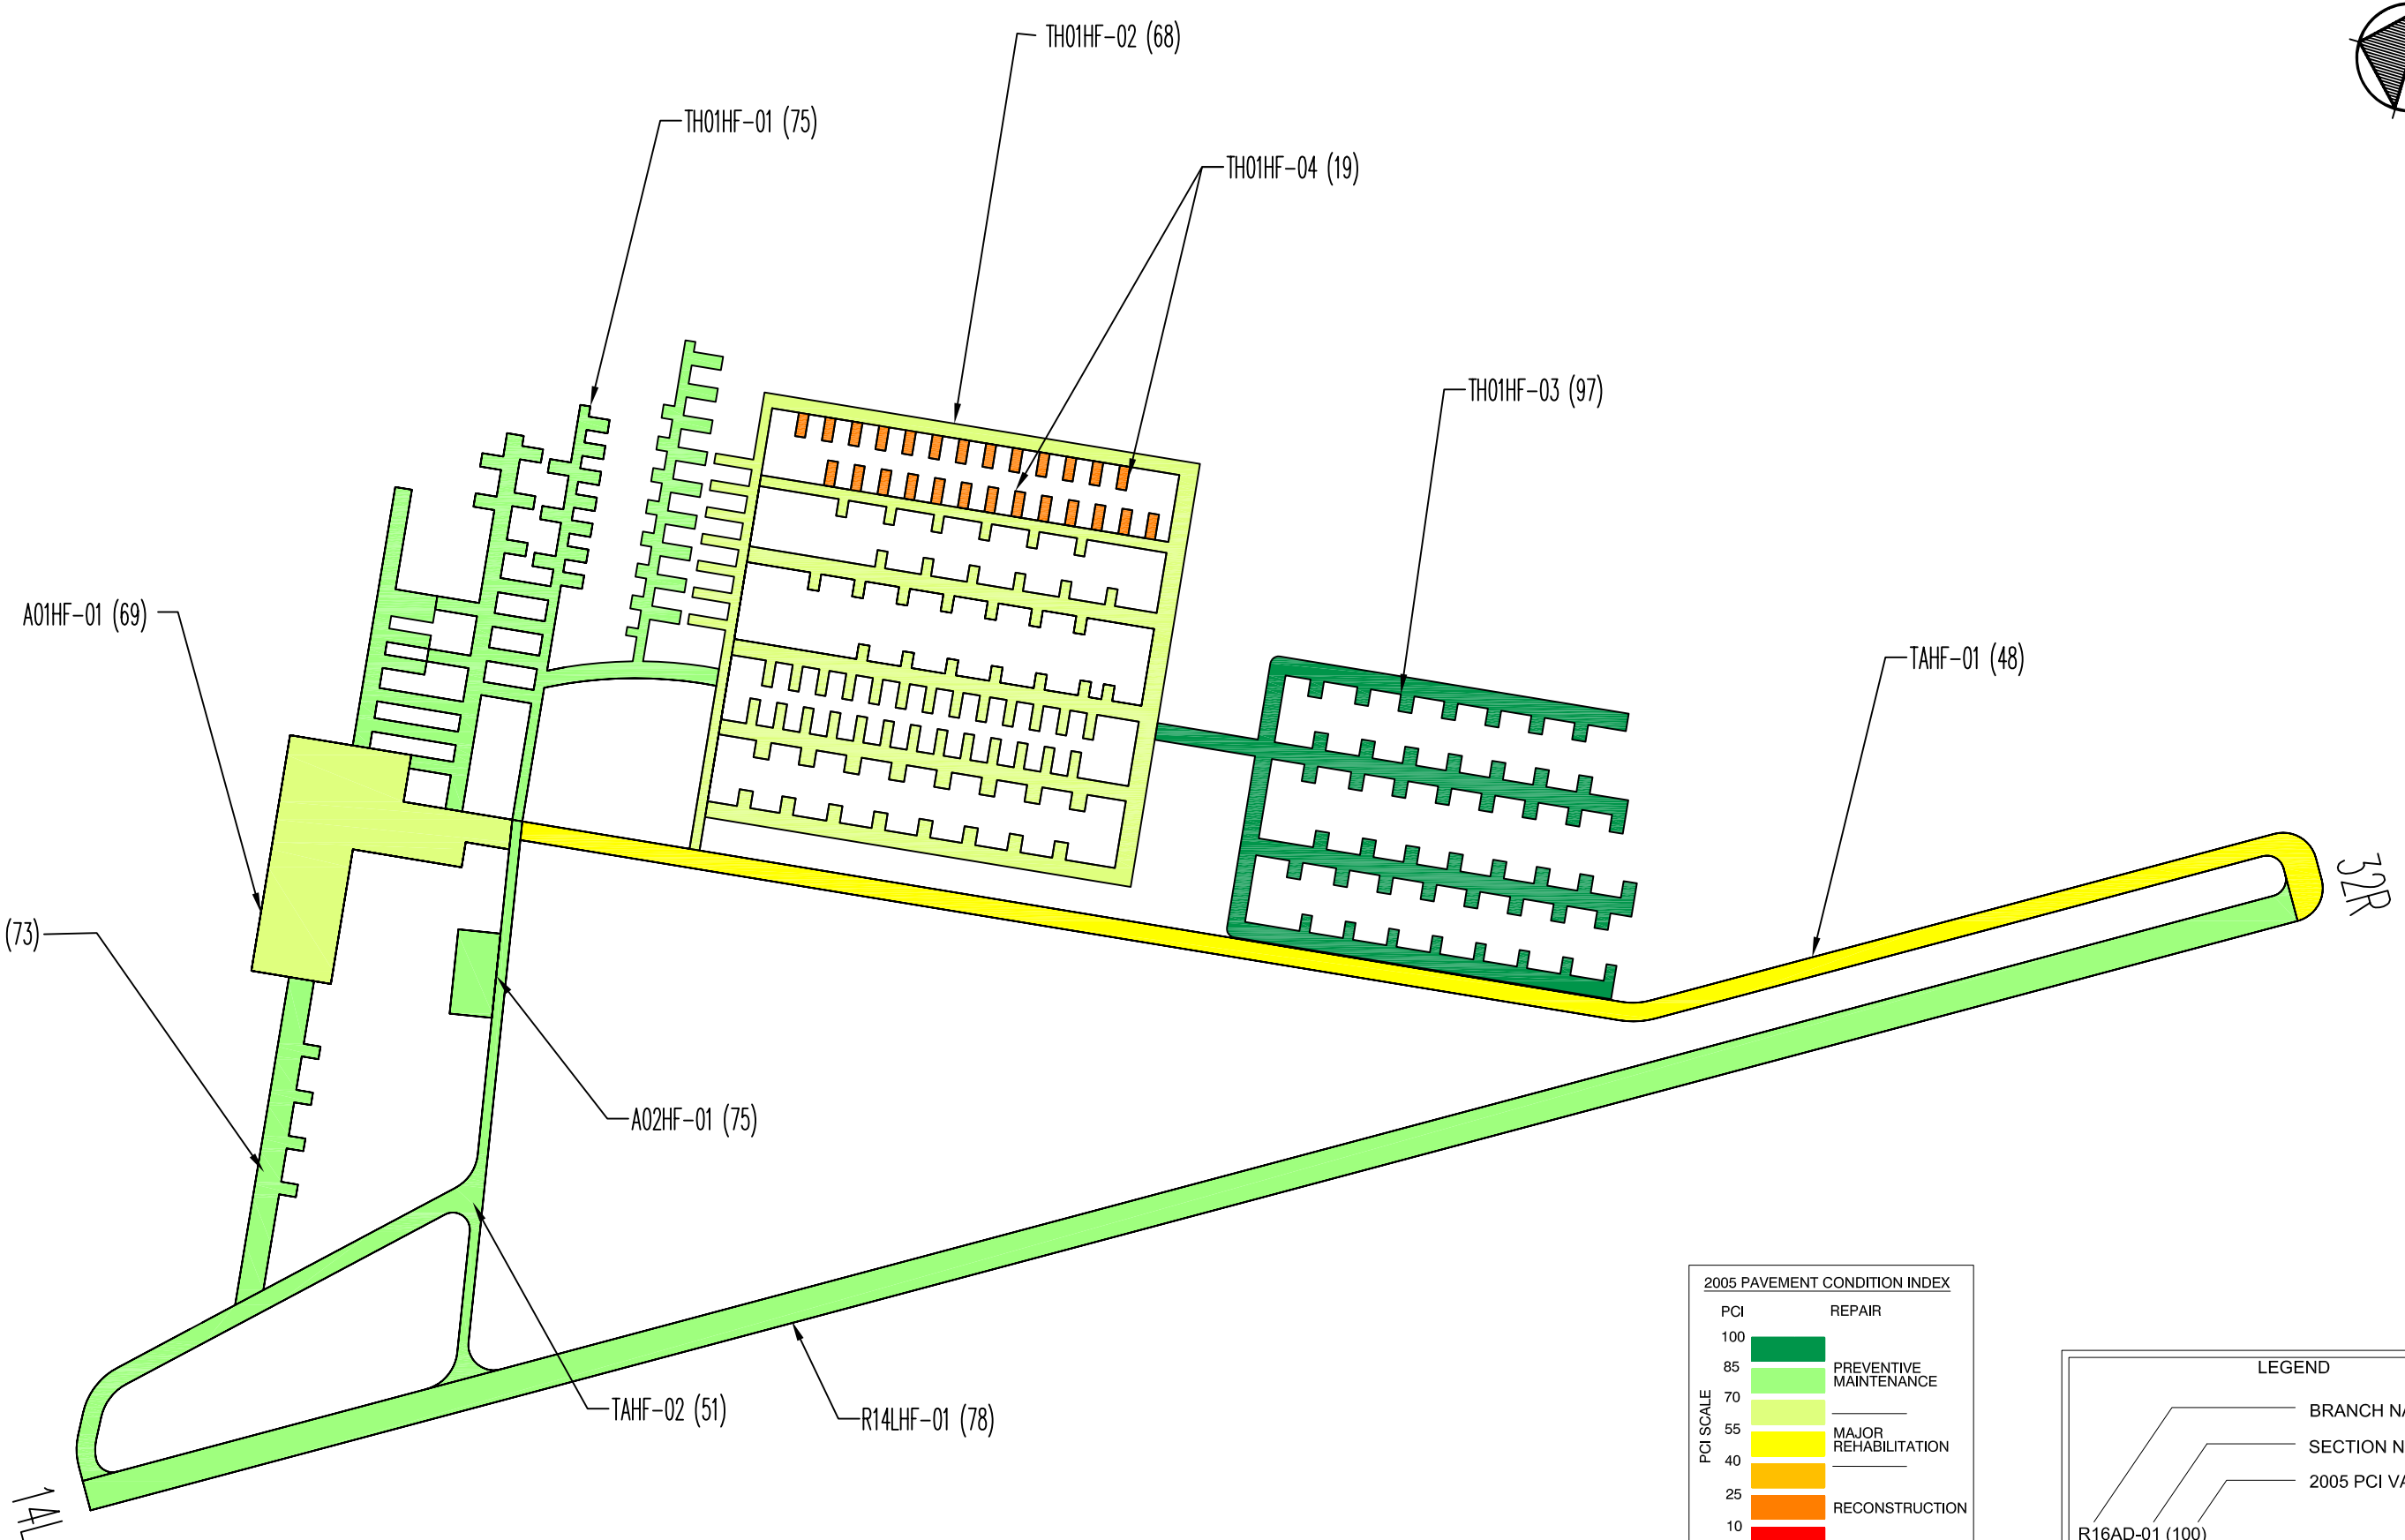
2005 PAVEMENT CONDITION INDEX

The pavements at Harvey Field Airport were inspected on June 20, 2005. The 2005 area-weighted condition of Harvey Field Airport is 69, with conditions ranging from 19 to 97 (on a scale of 0 [failed] to 100 [excellent]).

Figures 6 and 7 summarize the overall condition of the pavements at the Harvey Field Airport. Figure 8 displays the condition of the pavements evaluated. Table 1 summarizes the results of the pavement evaluation. Appendix C presents photographs taken during the PCI inspection and Appendix D details the distresses observed during the visual survey.
