WILLAPA HARBOR AIRPORT
2005 PAVEMENT MANAGEMENT REPORT

February 2006

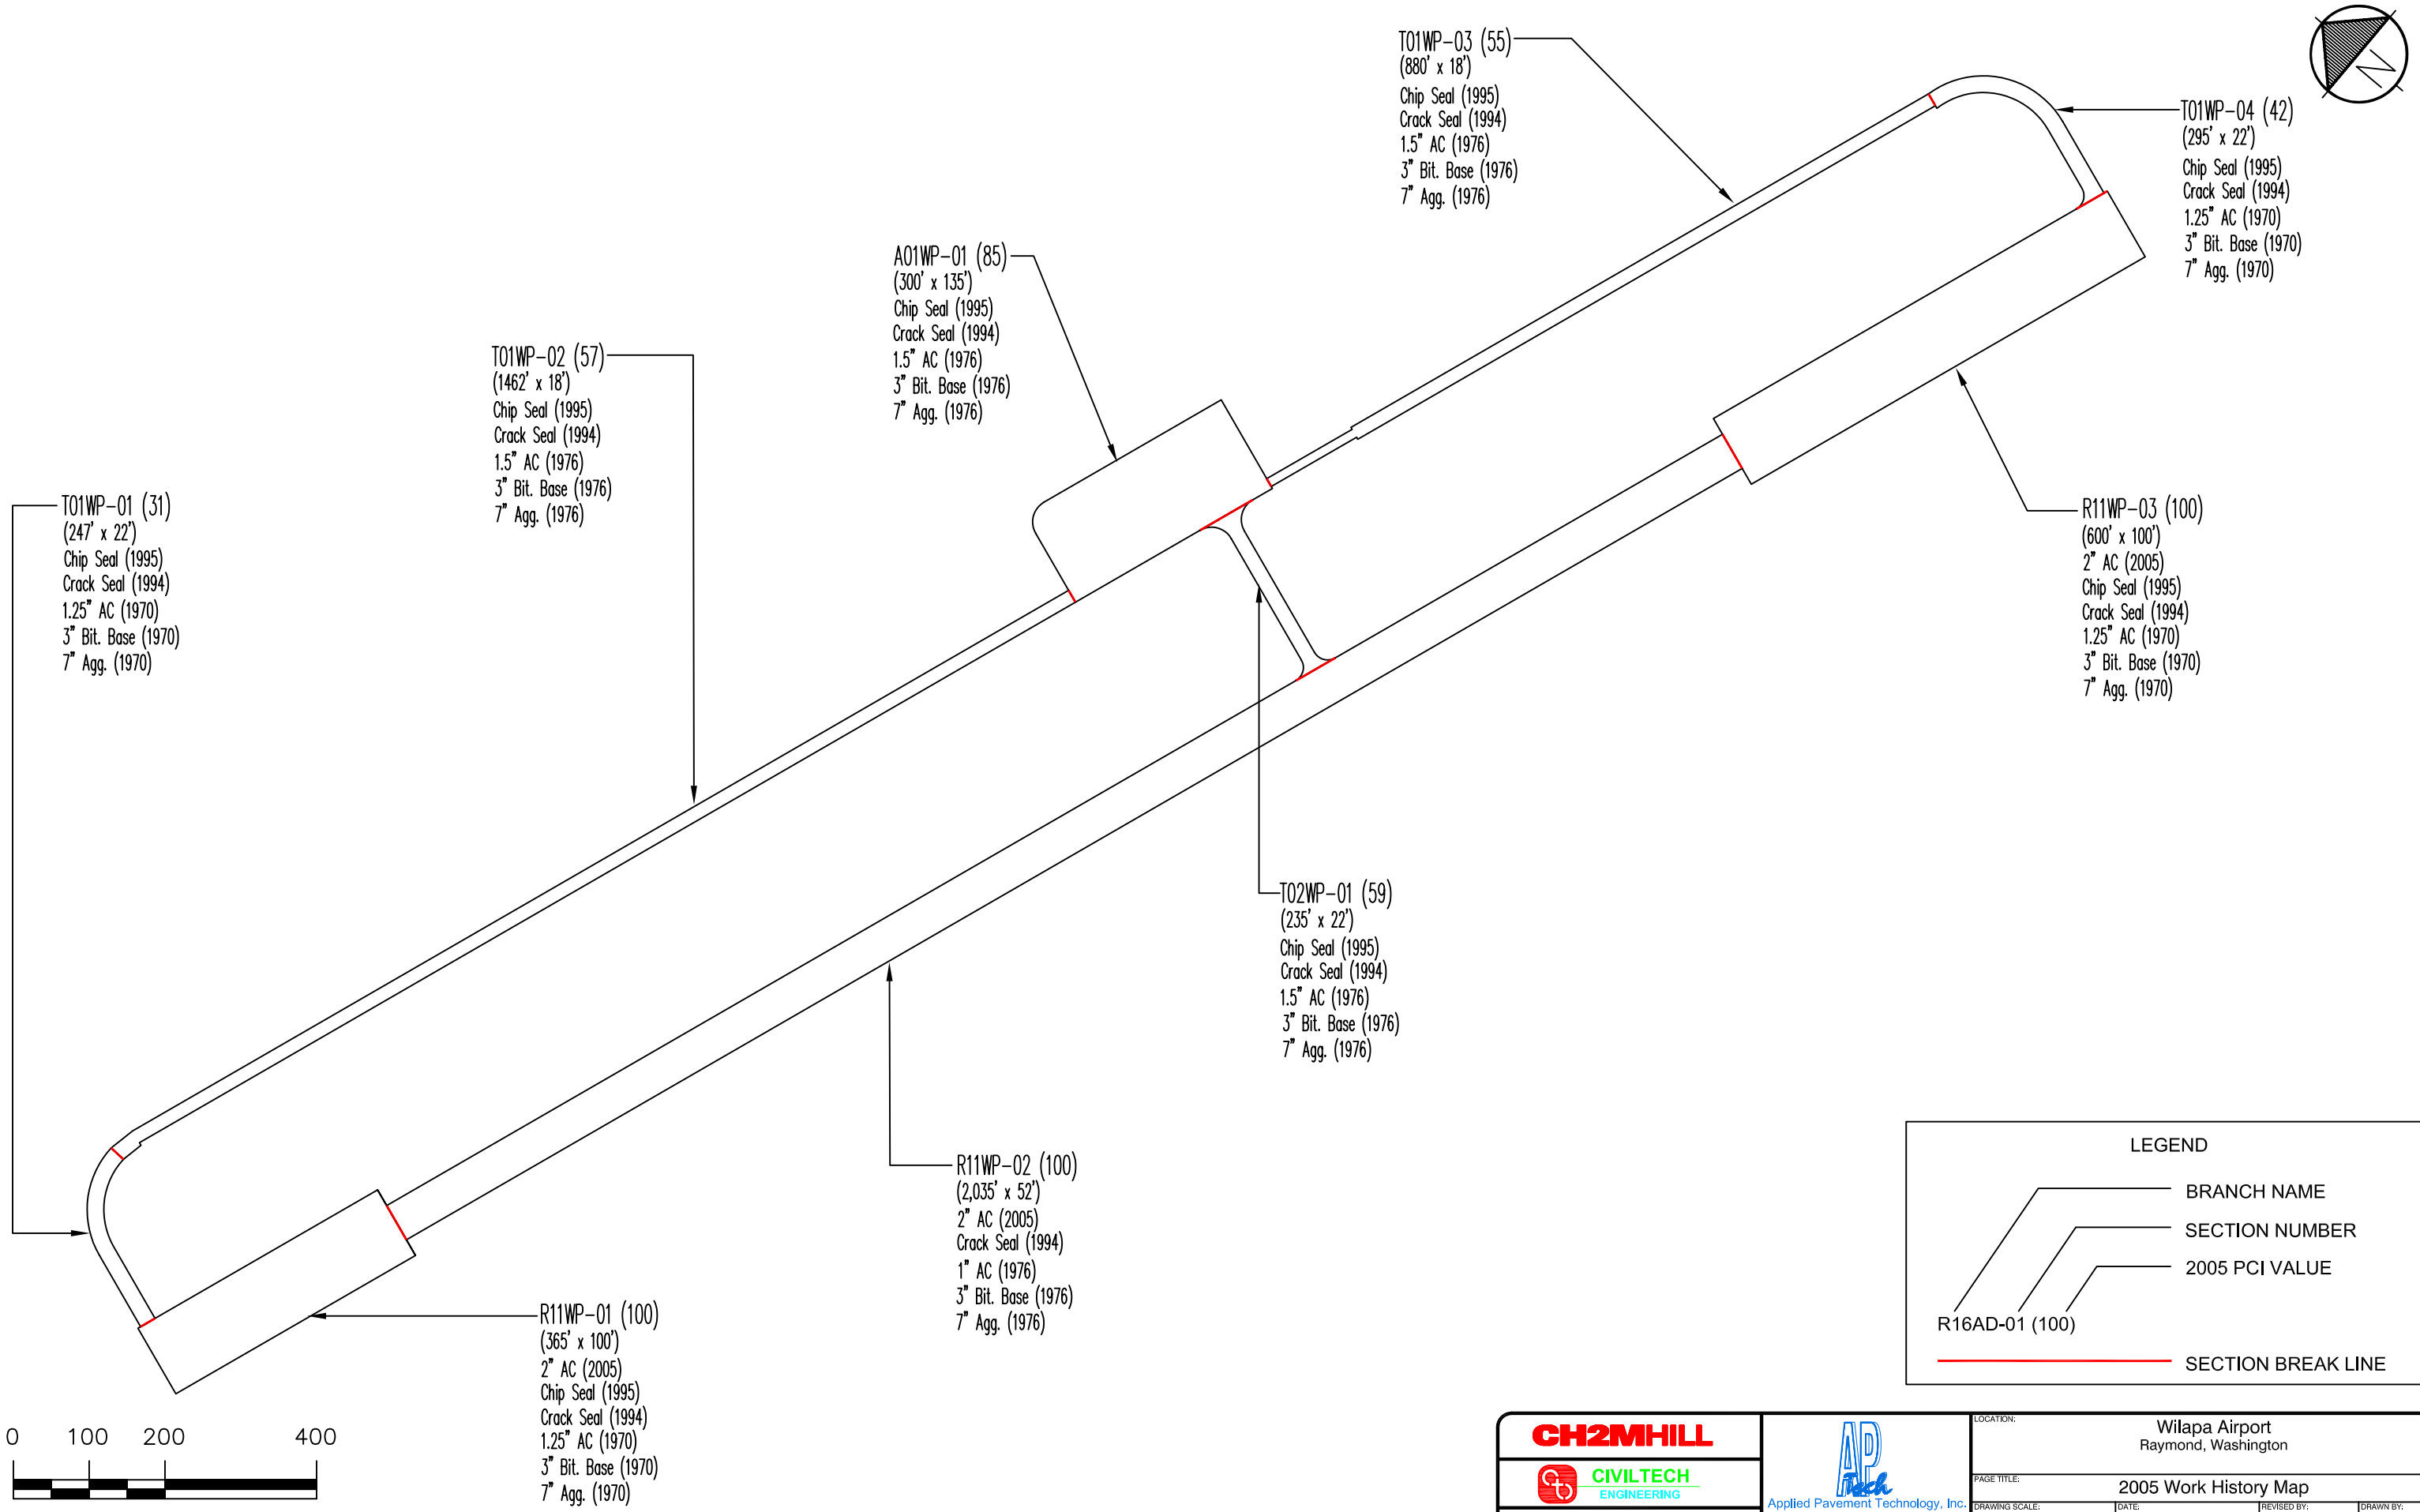
Figure 3 presents the records review results in the form of a work history map. The Micro PAVER database (see the inside back cover of this report) contains detailed inventory information about the pavement system at the airport.

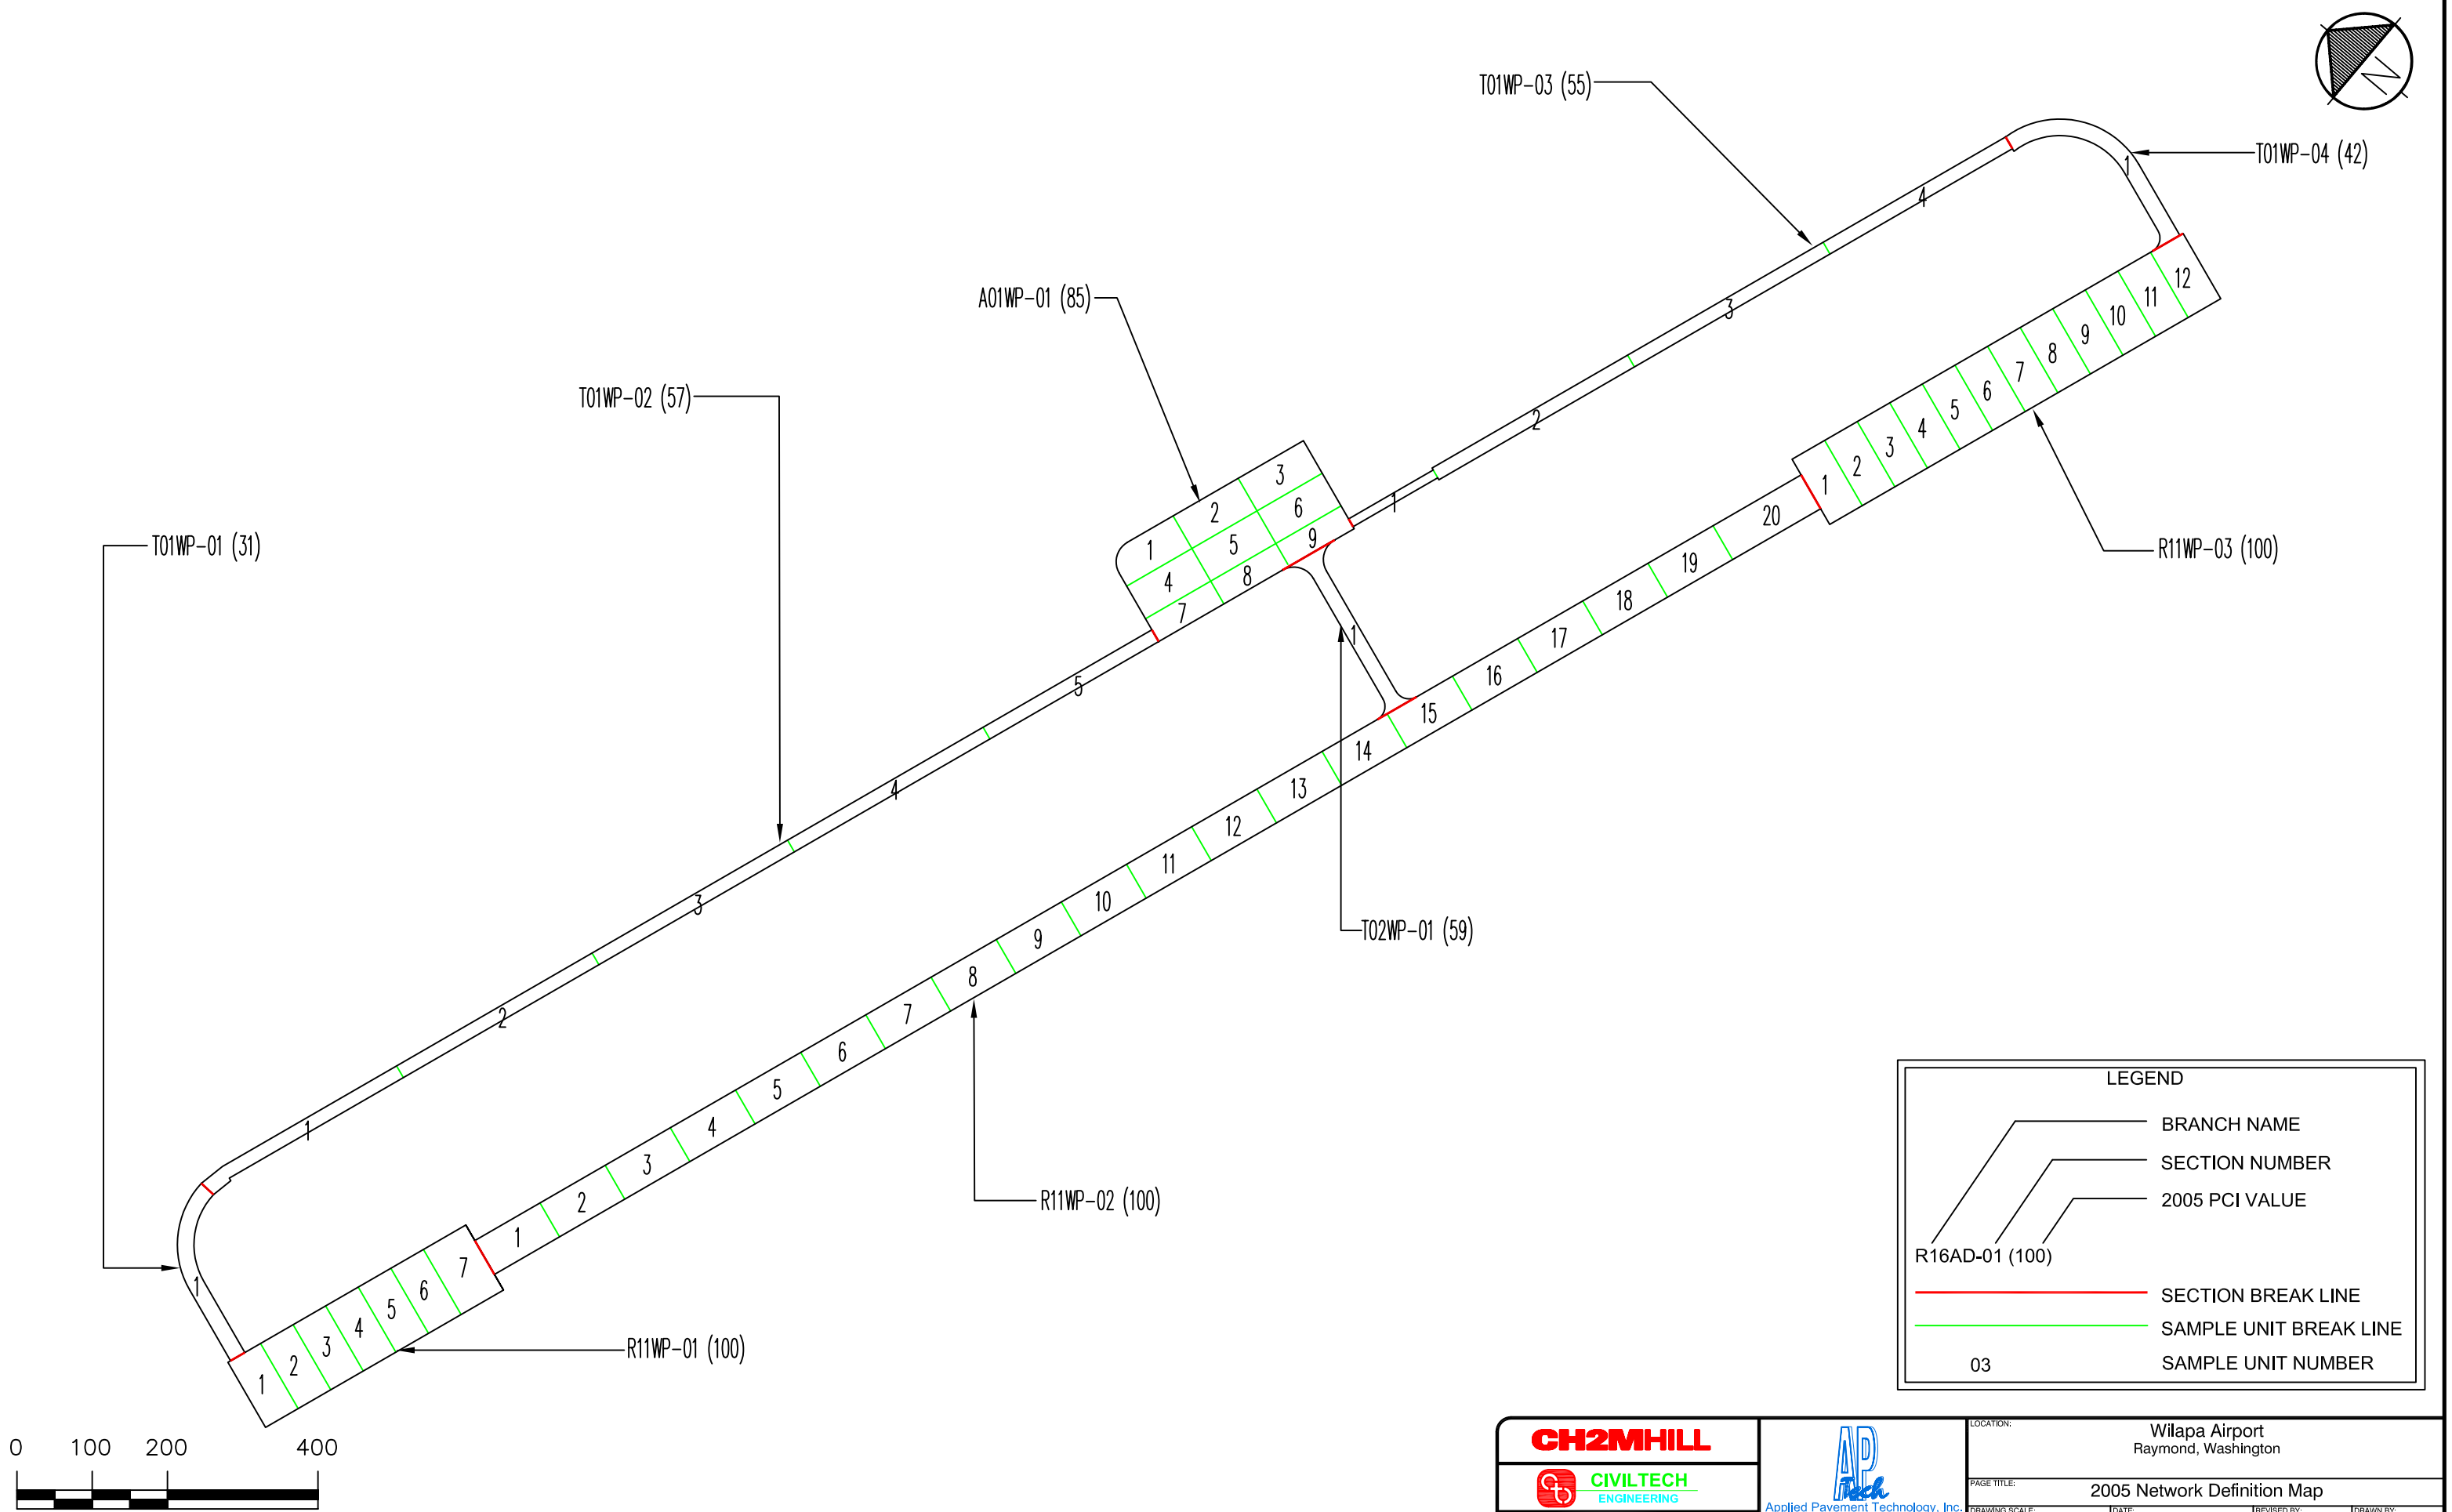
Figure 4 shows how the pavement network was divided into these units and it also shows the nomenclature used in the Micro PAVER pavement management database to identify the different pavement areas.

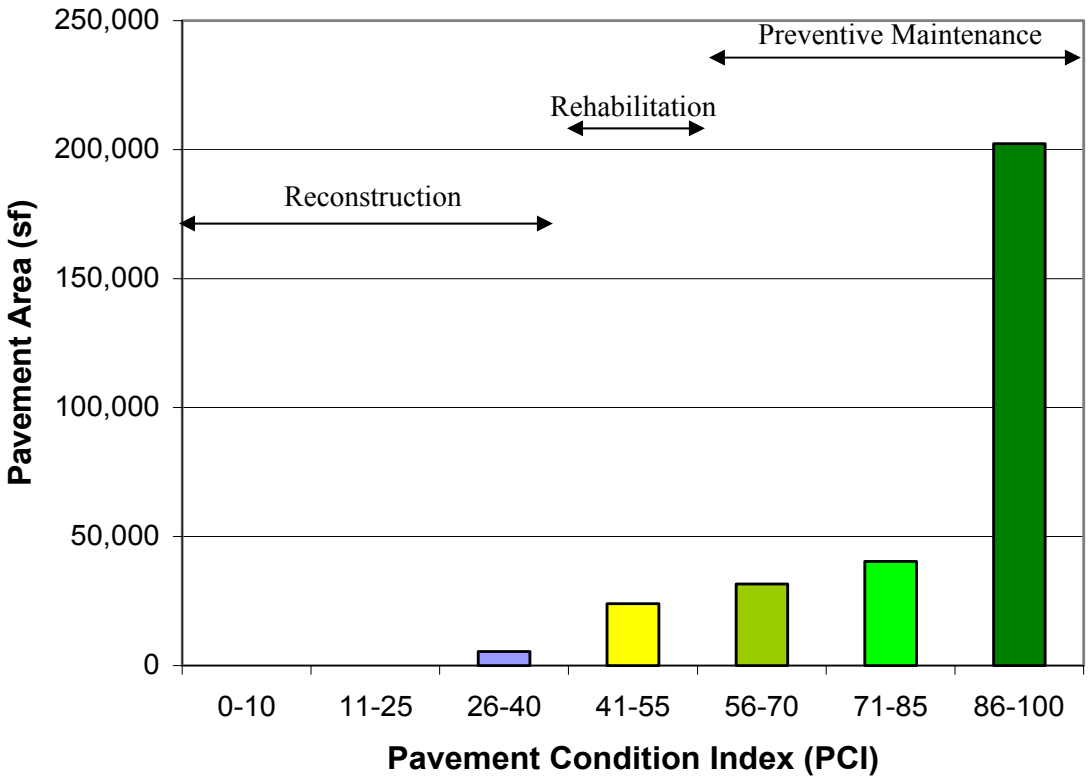
Figure 6. Willapa Harbor Airport overall condition.

During this project, the pavements at Willapa Harbor Airport were not inspected. That was because major rehabilitation work was scheduled to occur later in 2005 after the inspections were completed. However, the planned work was entered into the Micro PAVER database and it was assumed that upon completion of that work the area-weighted condition of Willapa Harbor Airport was 88. During the previous inspection in 1999, the area-weighted condition was 63.

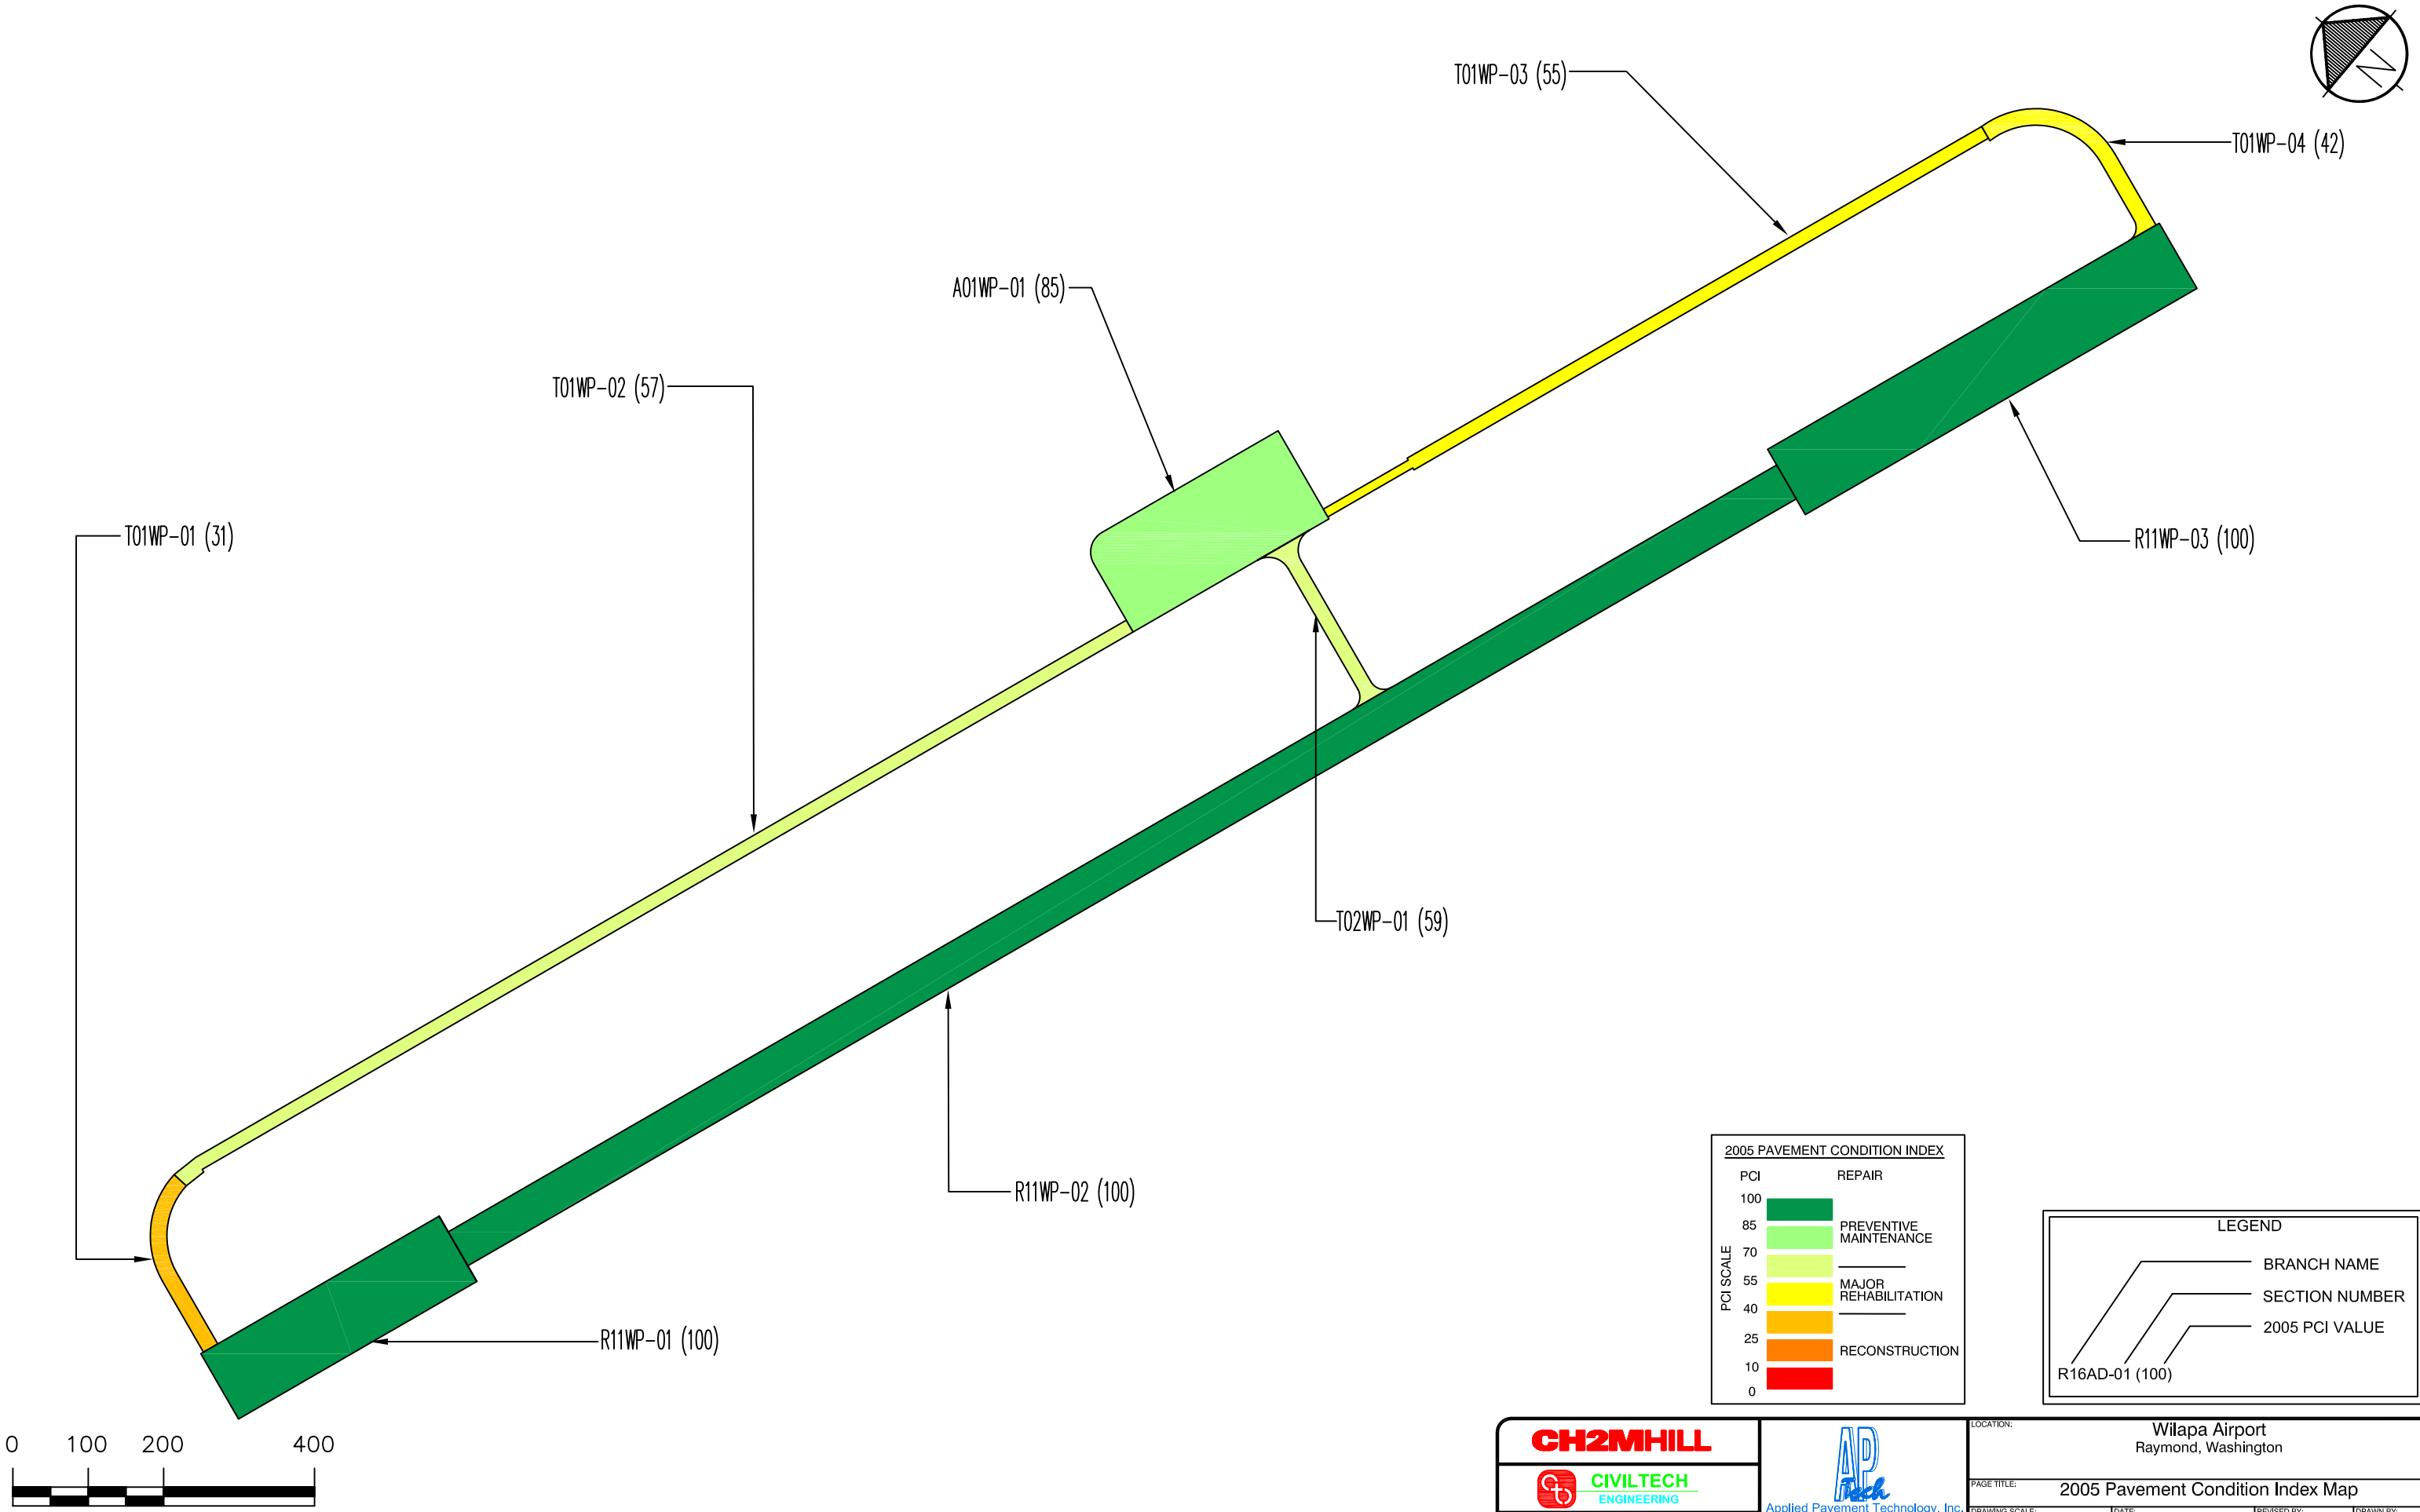
LOCATION: Wilapa Airport, Raymond, Washington			
PAGE TITLE: 2005 Pavement Condition Index Map			
DRAWING SCALE: 1" = 200'	DATE: February 2006	REVISED BY: TJS	DRAWN BY: AM
FILENAME: South Bend.dwg	AIRPORT ID: 2S9	LAYOUT NAME/NUMBER: South Bend (PCI)	PAGE NUMBER: 9

Figures 6 and 7 summarize the overall condition of the pavements at the Willapa Harbor Airport. Figure 8 displays the condition of the pavements evaluated. Table 1 summarizes the condition of the pavements, which assumes that no visible signs of deterioration were present after the rehabilitation work was completed. Appendix C would normally present photographs taken during the PCI inspection; however, since an inspection was not conducted after the rehabilitation work was completed this appendix is blank.
