MEAD FLYING SERVICE
2005 PAVEMENT MANAGEMENT REPORT

February 2006

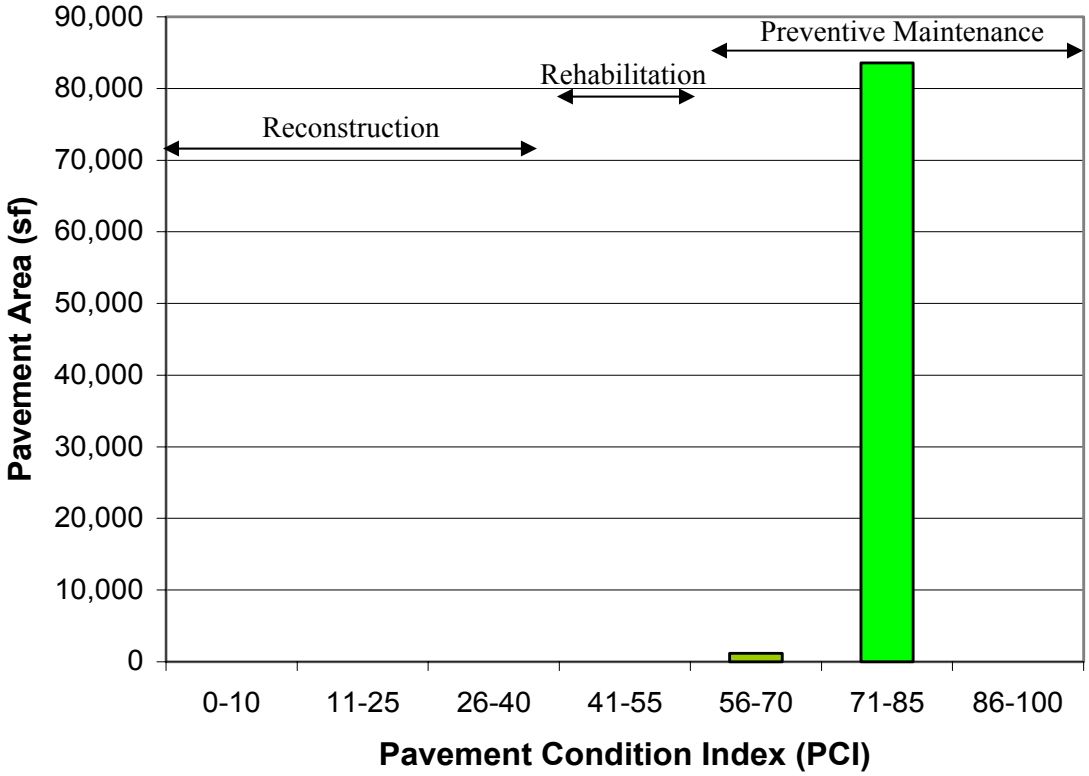
Figure 6. Mead Flying Service overall condition.

The pavements at Mead Flying Service were inspected on June 15, 2005. The 2005 area-weighted condition of Mead Flying Service is 76, with conditions ranging from 70 to 84 (on a scale of 0 [failed] to 100 [excellent]). During the previous inspection in 1999, the area-weighted condition was 67.

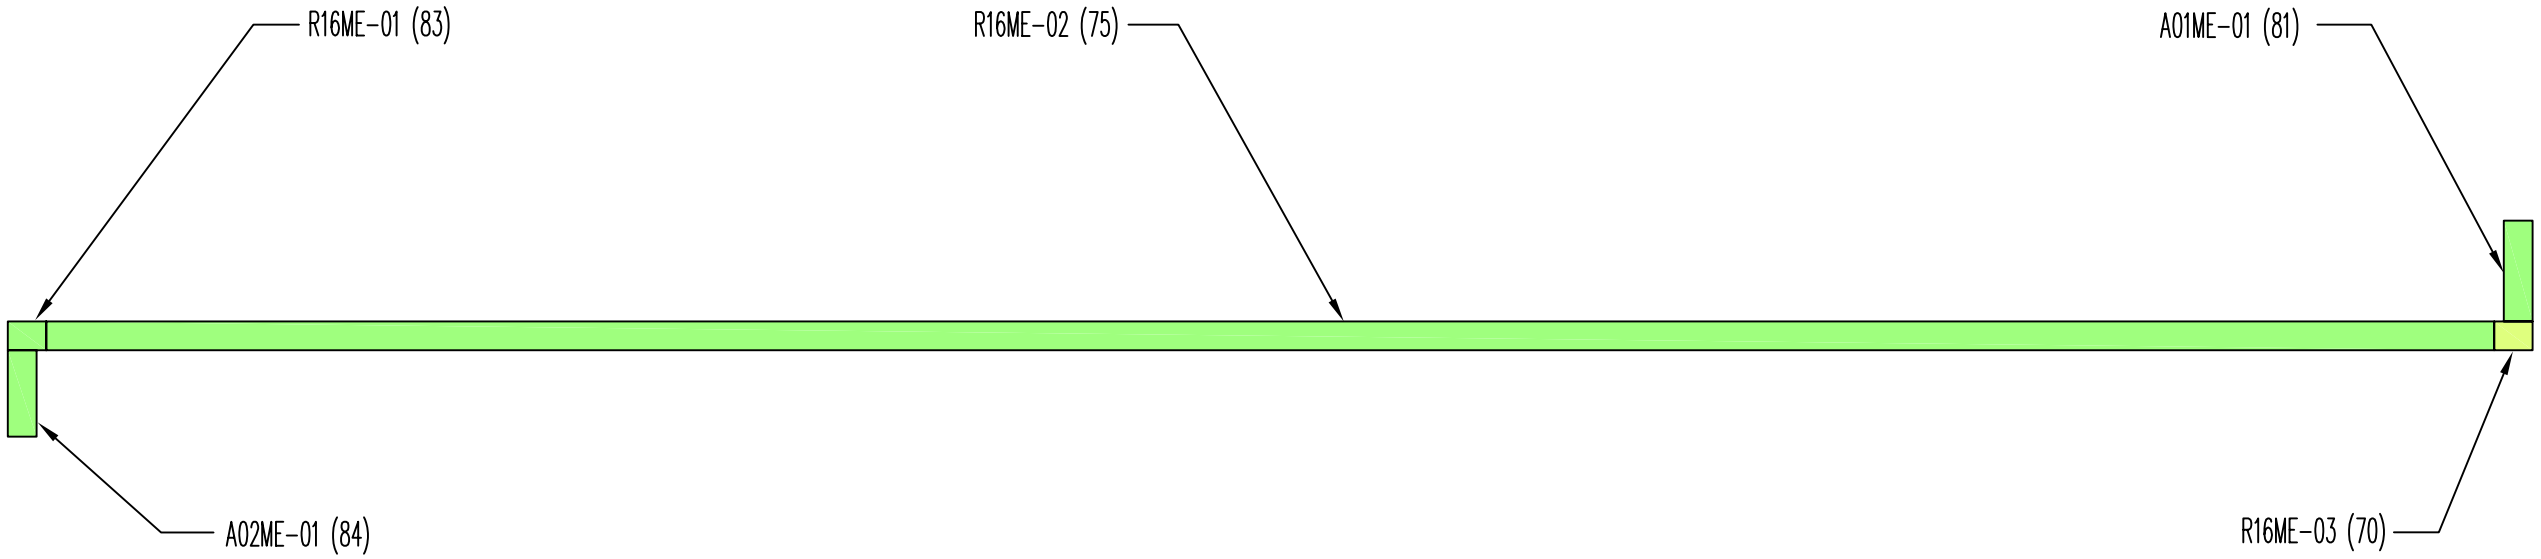
2005 PAVEMENT CONDITION INDEX

Figures 6 and 7 summarize the overall condition of the pavements at the Mead Flying Service. Figure 8 displays the condition of the pavements evaluated. Table 1 summarizes the results of the pavement evaluation. Appendix C presents photographs taken during the PCI inspection and Appendix D details the distresses observed during the visual survey.

Mead Flying Service								
Branch[1]	Section	Surface Type[2]	Section Area, sf	LCD[3]	2005 PCI	% Distress Due to:		Distress Types
						Load[4]	Climate or Durability[5]	
A01ME	01	AC	3,150	9/1/1979	81	0	100	Longitudinal and transverse cracking
A02ME	01	AC	2,700	9/1/1979	84	0	100	Longitudinal and transverse cracking
R16ME	01	AC	1,200	9/1/1979	83	0	76	Bleeding, longitudinal and transverse cracking
R16ME	02	AC	76,500	9/1/1979	75	19	42	Depression, longitudinal and transverse cracking, rutting
R16ME	03	AC	1,200	9/1/1979	70	0	100	Longitudinal and transverse cracking
