PACKWOOD AIRPORT
2005 PAVEMENT MANAGEMENT REPORT

February 2006

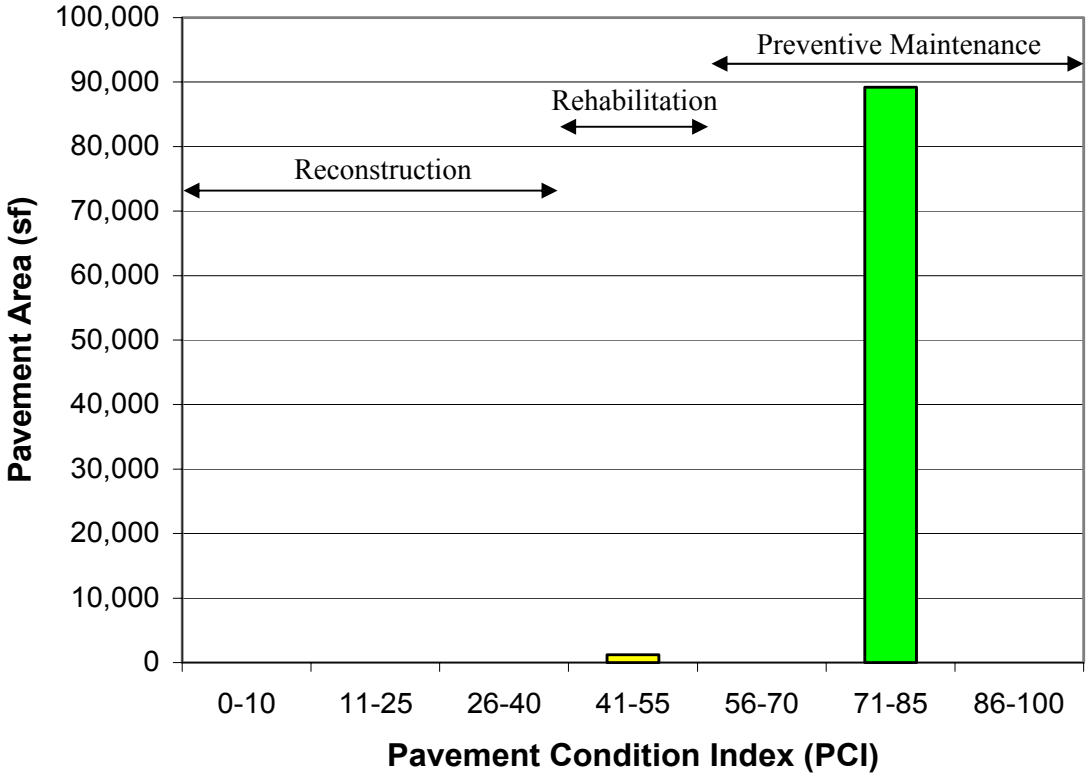
Figure 6. Packwood Airport overall condition.

The pavements at Packwood Airport were inspected on June 2, 2005. The 2005 area-weighted condition of Packwood Airport is 77, with conditions ranging from 50 to 77 (on a scale of 0 [failed] to 100 [excellent]). During the previous inspection in 1999, the area-weighted condition was 85.

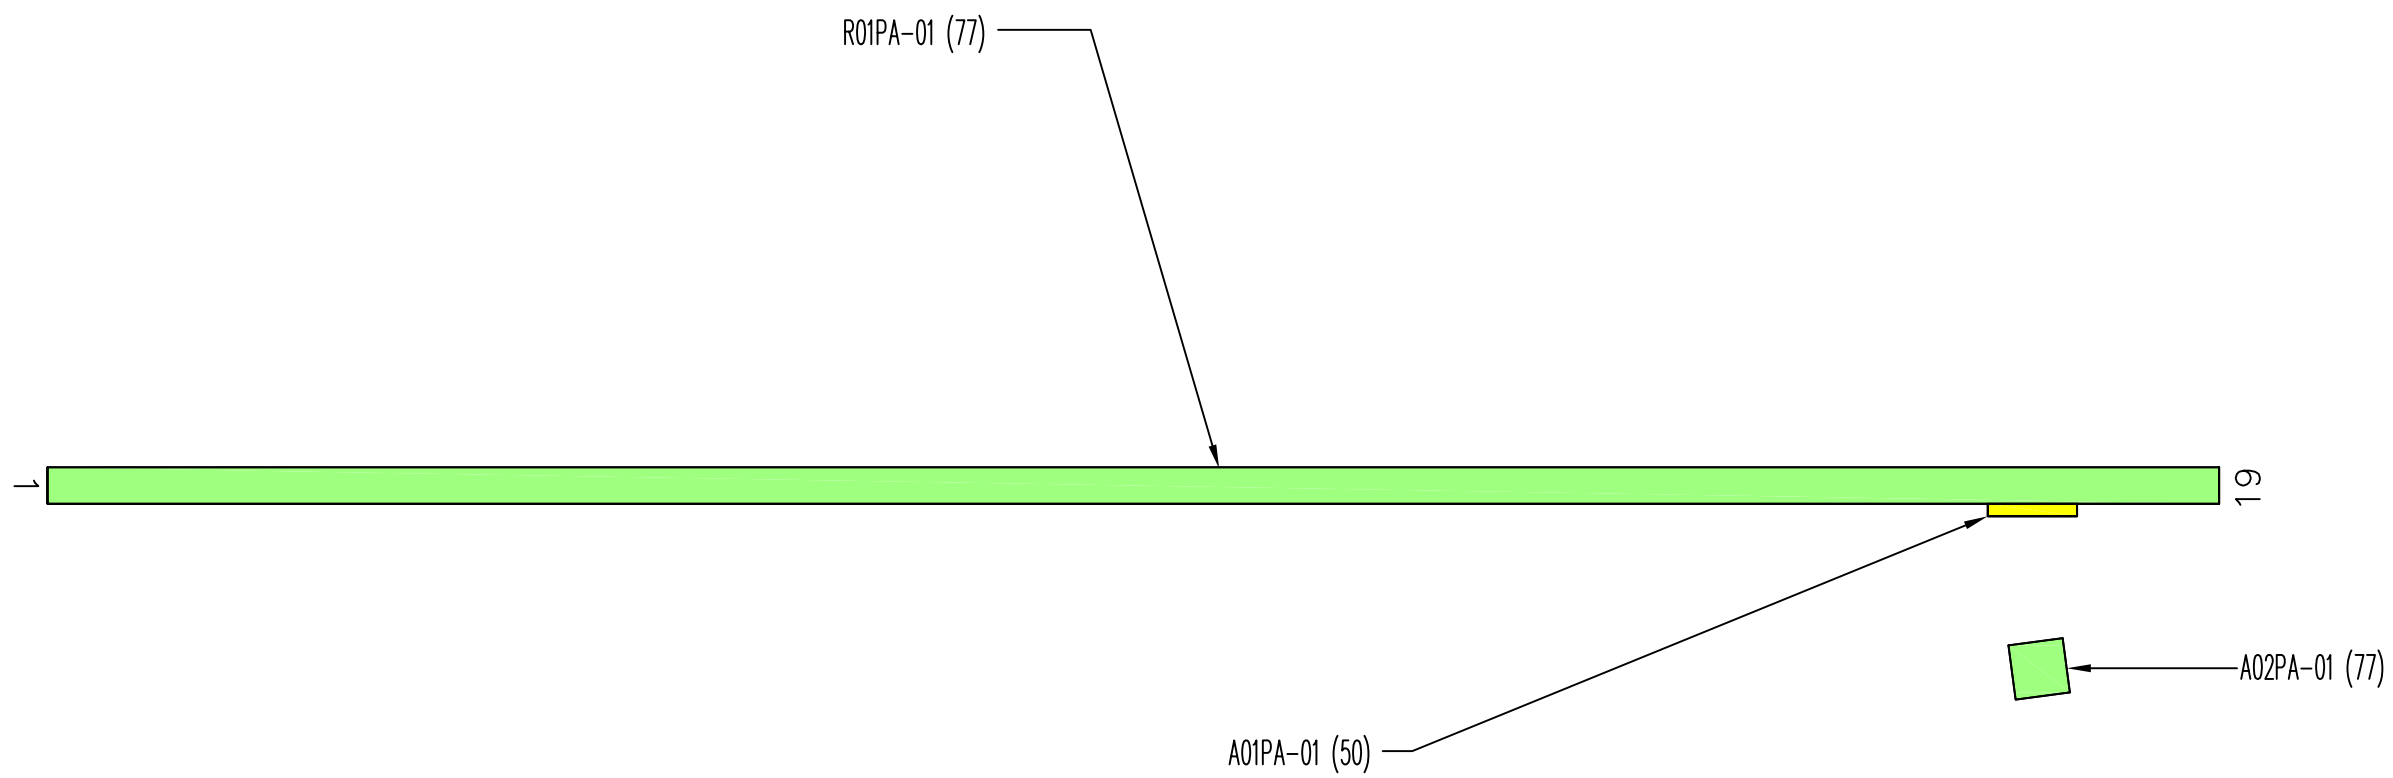
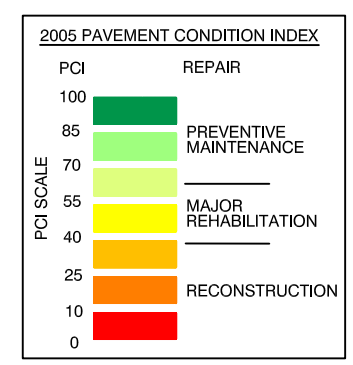
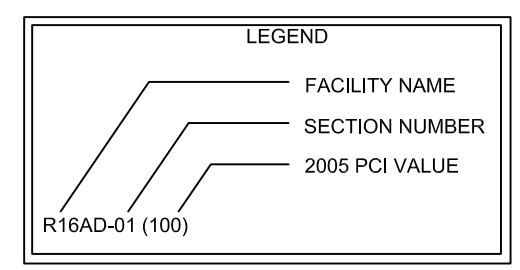
Packwood Airport								
Branch[1]	Section	Surface Type[2]	Section Area, sf	LCD[3]	2005 PCI	% Distress Due to:		Distress Types
						Load[4]	Climate or Durability[5]	
A01PA	01	AC	1,209	8/17/1985	50	55	45	Alligator cracking, longitudinal and transverse cracking
A02PA	01	AC	3,249	8/17/1985	77	0	100	Longitudinal and transverse cracking, raveling and weathering
RO1PA	01	AC	85,956	8/17/1985	77	0	100	Longitudinal and transverse cracking, patching
