NEW WARDEN AIRPORT
2005 PAVEMENT MANAGEMENT REPORT

February 2006

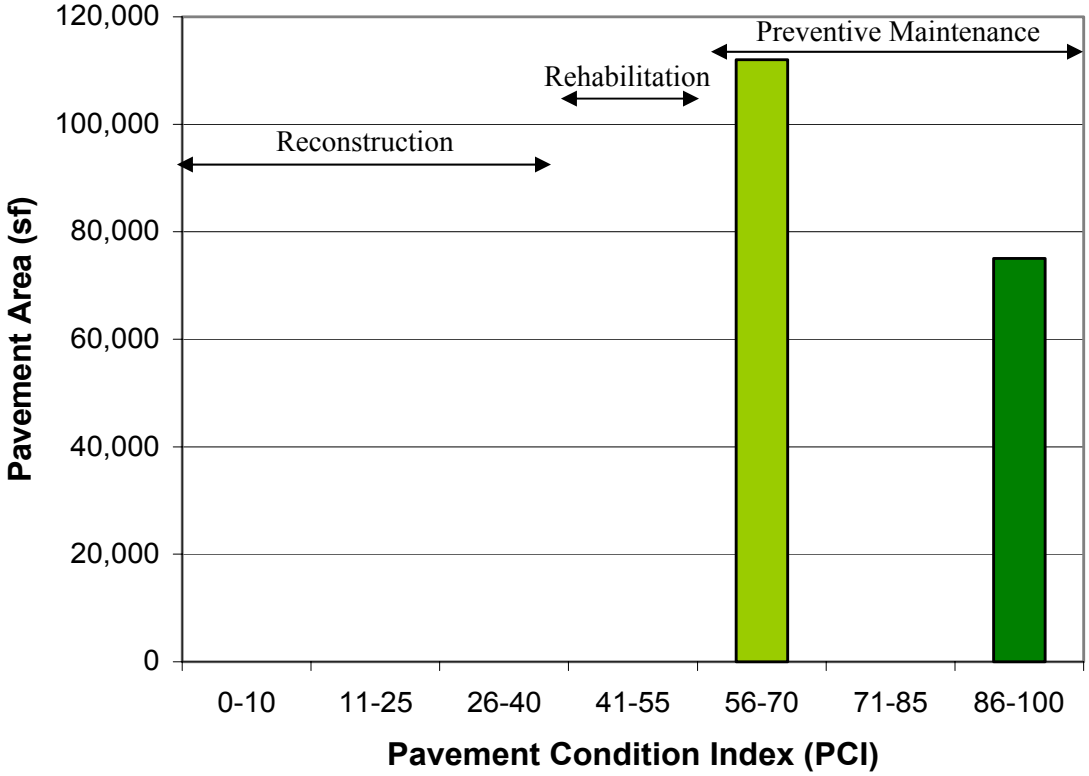
Figure 6. New Warden Airport overall condition.

The pavements at New Warden Airport were inspected on May 24, 2005. The 2005 area-weighted condition of New Warden Airport is 79, with conditions ranging from 63 to 100 (on a scale of 0 [failed] to 100 [excellent]). During the previous inspection in 1999, the area-weighted condition was 73.
