TOLEDO-WINLOCK ED CARLSON MEMORIAL AIRPORT

2005 PAVEMENT MANAGEMENT REPORT

February 2006

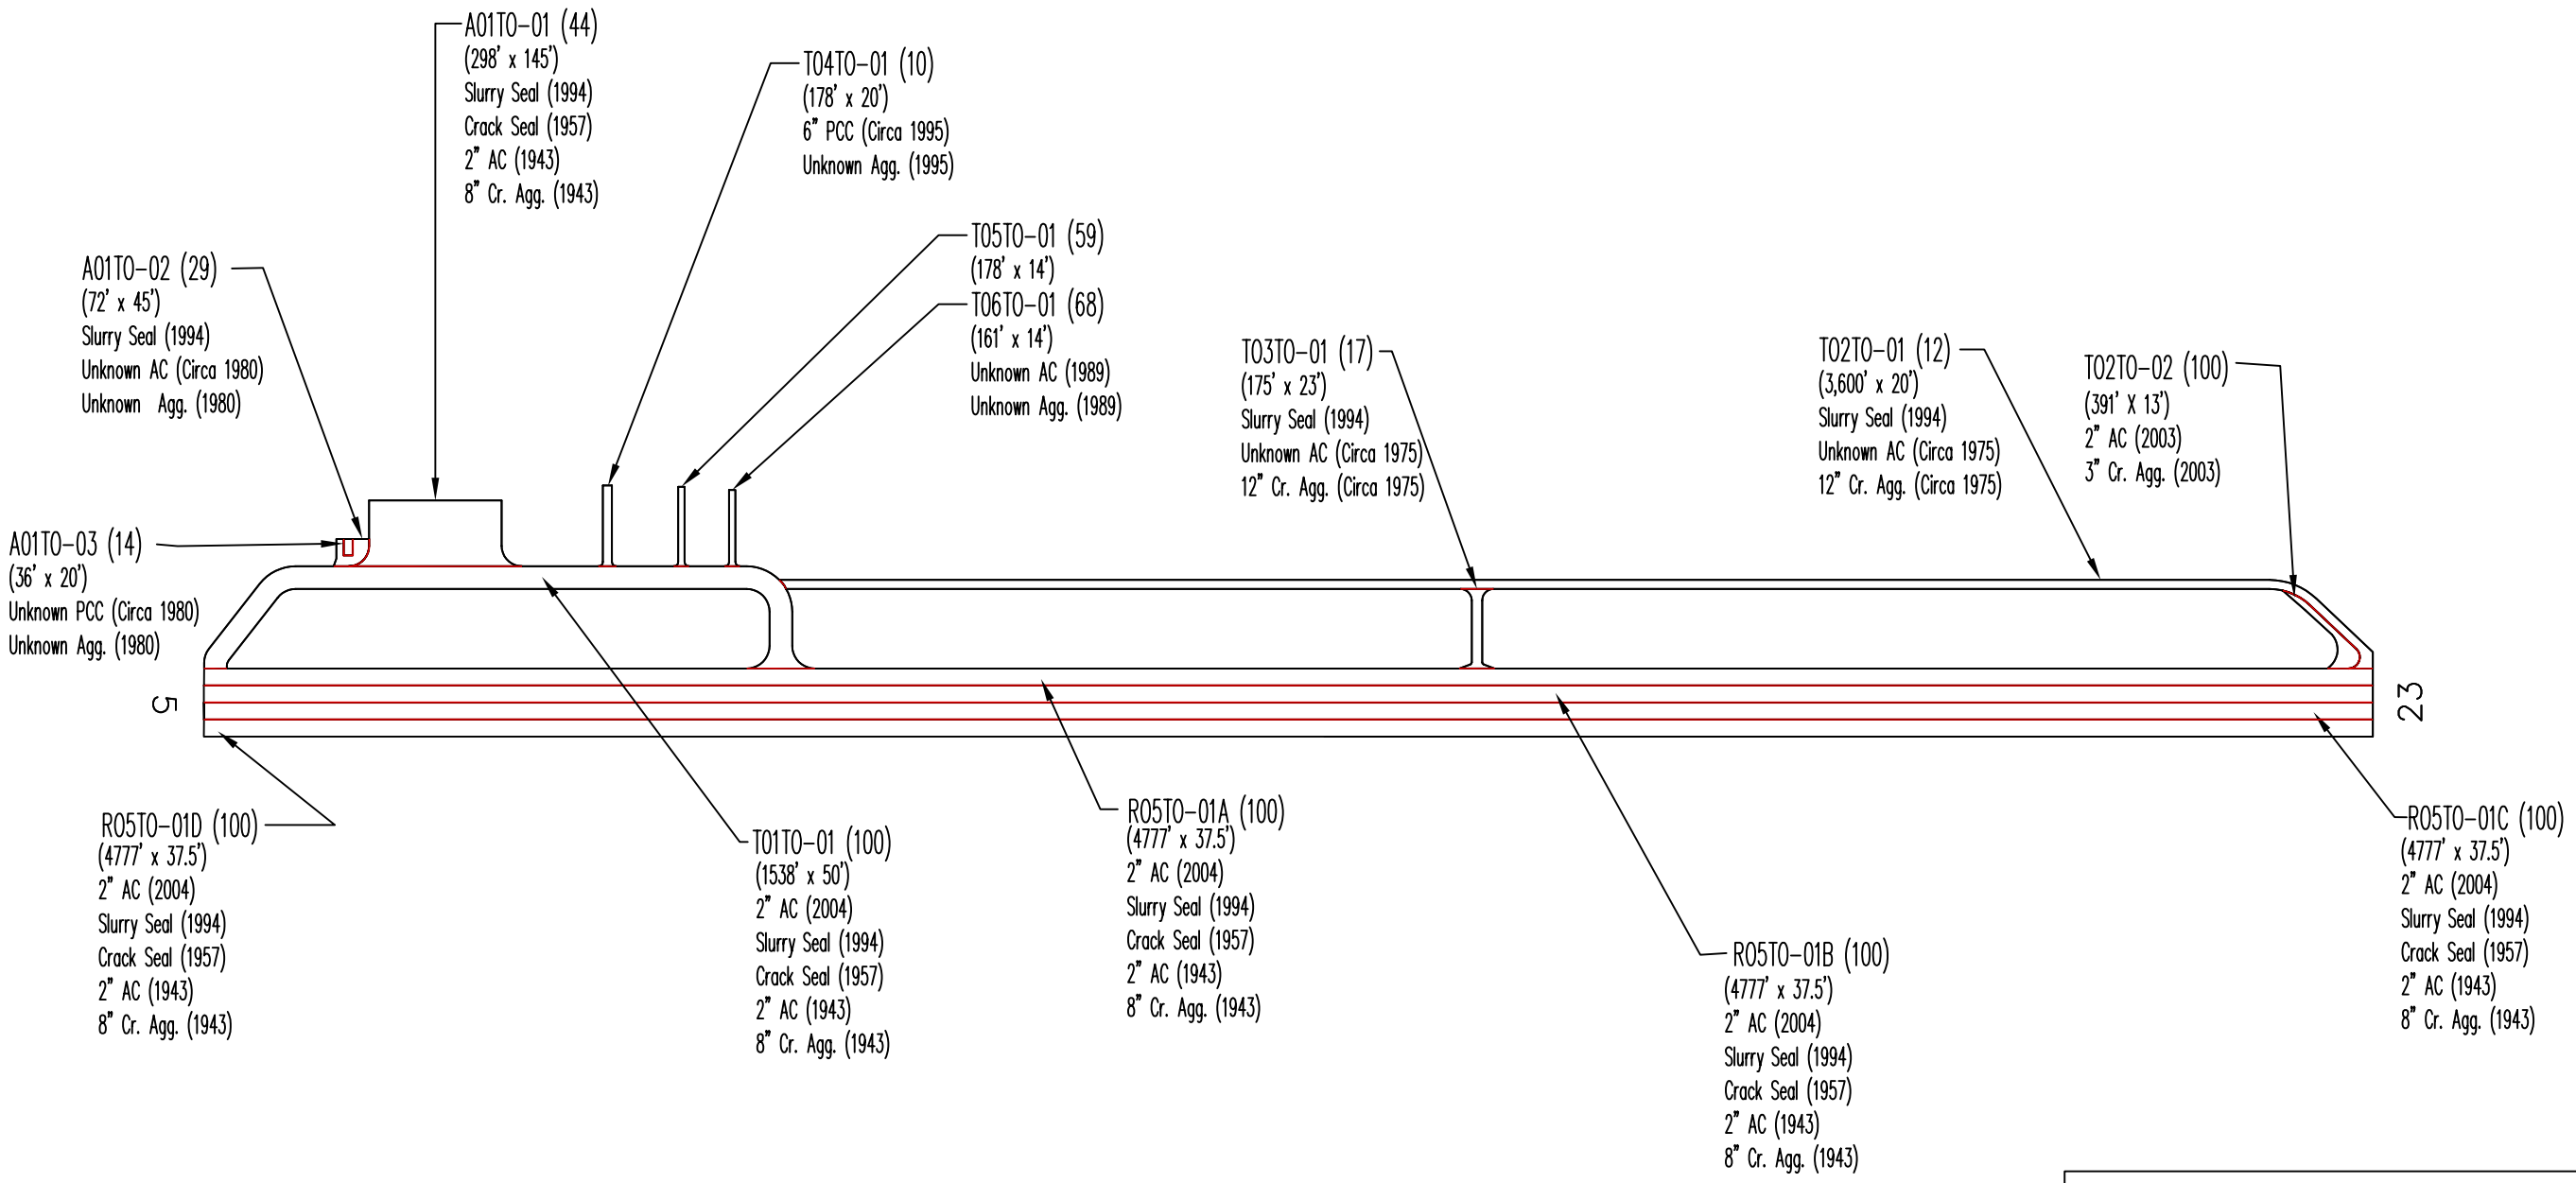
LOCATION: Toledo-Winlock Ed Carlson Memorial Field, Toledo, Washington			
PAGE TITLE: 2005 Work History Map			
DRAWING SCALE: 1" = 400'	DATE: February 2006	REVISED BY: TJS	DRAWN BY: JR
FILENAME: Toledo.dwg	AIRPORT ID: TOD	LAYOUT NAME/NUMBER: Toledo (WH)	PAGE NUMBER: 4

Figure 3 presents the records review results in the form of a work history map. The work history information and the Micro PAVER database (see the inside back cover of this report) ensure that your airport complies with the "pavement inventory" and "record keeping and information retrieval" requirements of FAA Grant Assurance 11 (discussed later in the section of this report entitled *Public Law 103-305*).

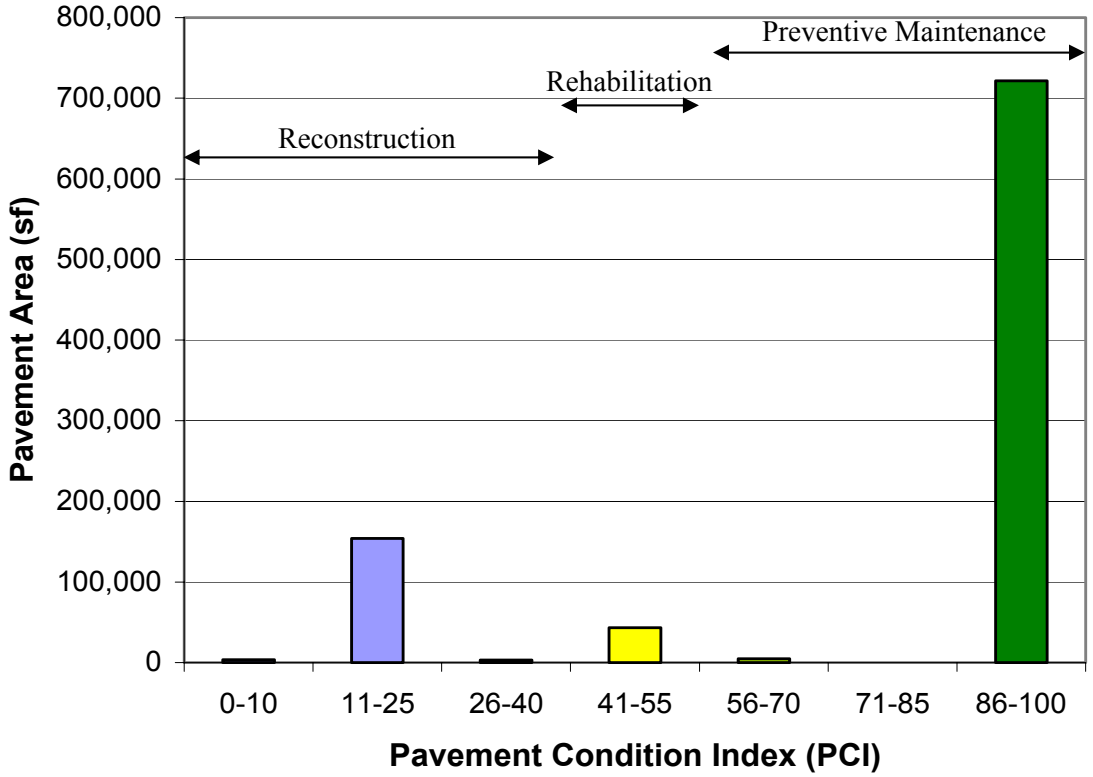
Figure 6. Toledo-Ed Carlson Memorial Airport overall condition.

The pavements at Toledo-Ed Carlson Memorial Airport were inspected on April 28, 2005. The 2005 area-weighted condition of Toledo-Ed Carlson Memorial Airport is 83, with conditions ranging from 10 to 100 (on a scale of 0 [failed] to 100 [excellent]). During the previous inspection in 1999, the area-weighted condition was 46.

Figures 6 and 7 summarize the overall condition of the pavements at the Toledo-Ed Carlson Memorial Airport. Figure 8 displays the condition of the pavements evaluated. Table 1 summarizes the results of the pavement evaluation. Appendix C presents photographs taken during the PCI inspection and Appendix D details the distresses observed during the visual survey.
