# WHIDBEY AIRPARK
# 2005 PAVEMENT MANAGEMENT REPORT

**Prepared By:**

Applied Pavement Technology, Inc.
3001 Research Road, Suite C
Champaign, Illinois 61822
217-398-3977
www.pavementsolutions.com

**February 2006**

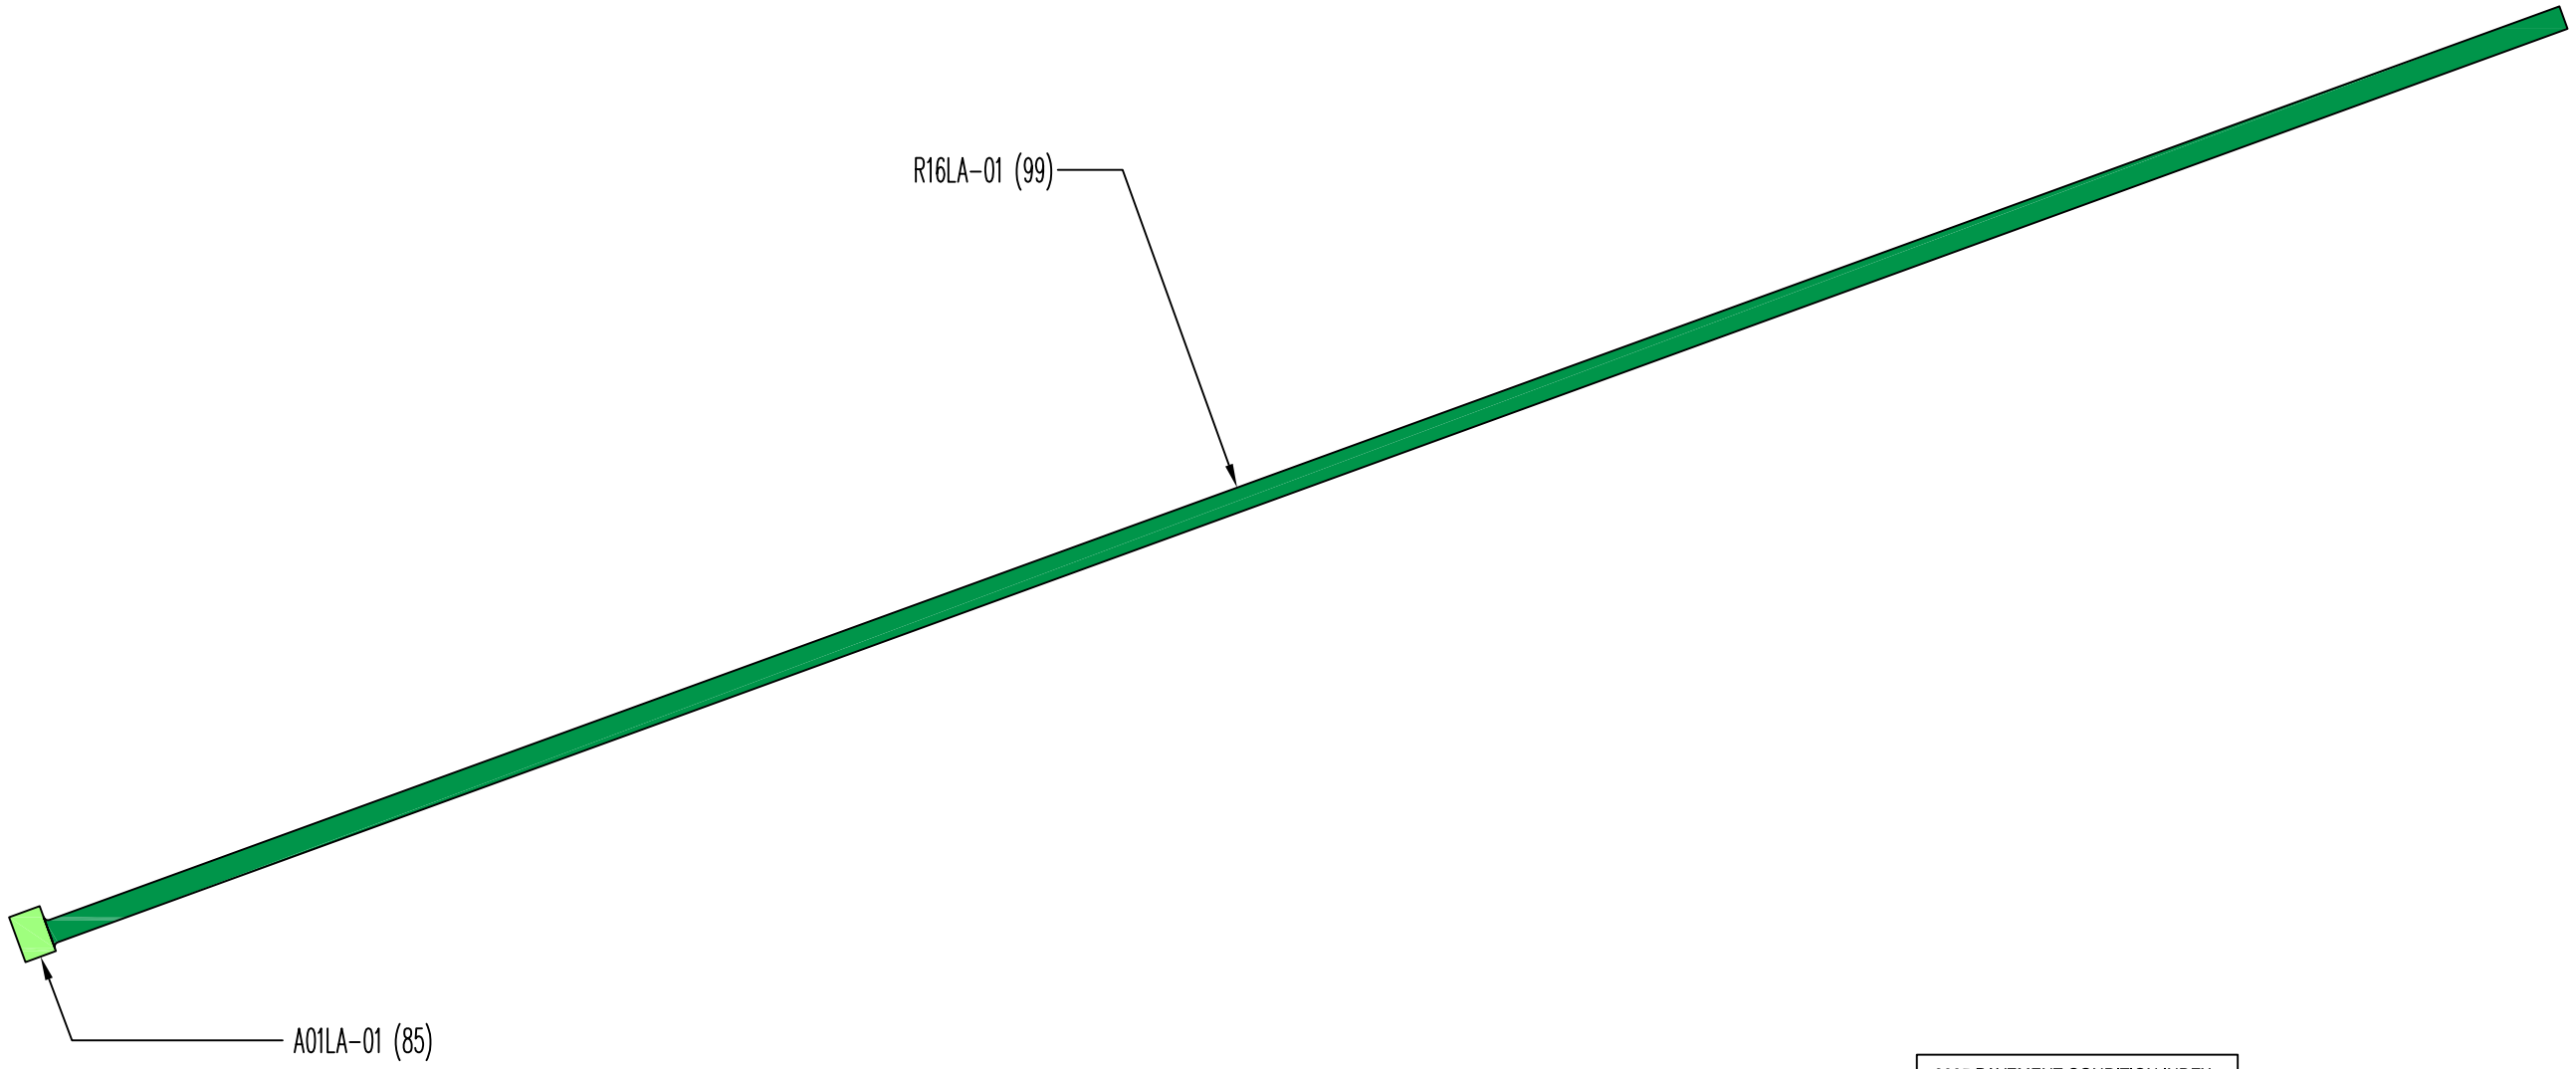
2005 PAVEMENT CONDITION INDEX

The pavements at Whidbey Airpark were inspected on April 9, 2005. The 2005 area-weighted condition of Whidbey Airpark is 99, with conditions ranging from 85 to 99 (on a scale of 0 [failed] to 100 [excellent]). During the previous inspection in 1999, the area-weighted condition was 56.

| Whidbey Airpark | | | | | | | | |
|---|---|---|---|---|---|---|---|---|
| A01LA | 01 | AC | 1,700 | 9/2/1996 | 85 | 0 | 100 | Longitudinal and transverse cracking, raveling and weathering |
| R16LA | 01 | AC | 70,010 | 7/1/2002 | 99 | 0 | 100 | Longitudinal and transverse cracking |

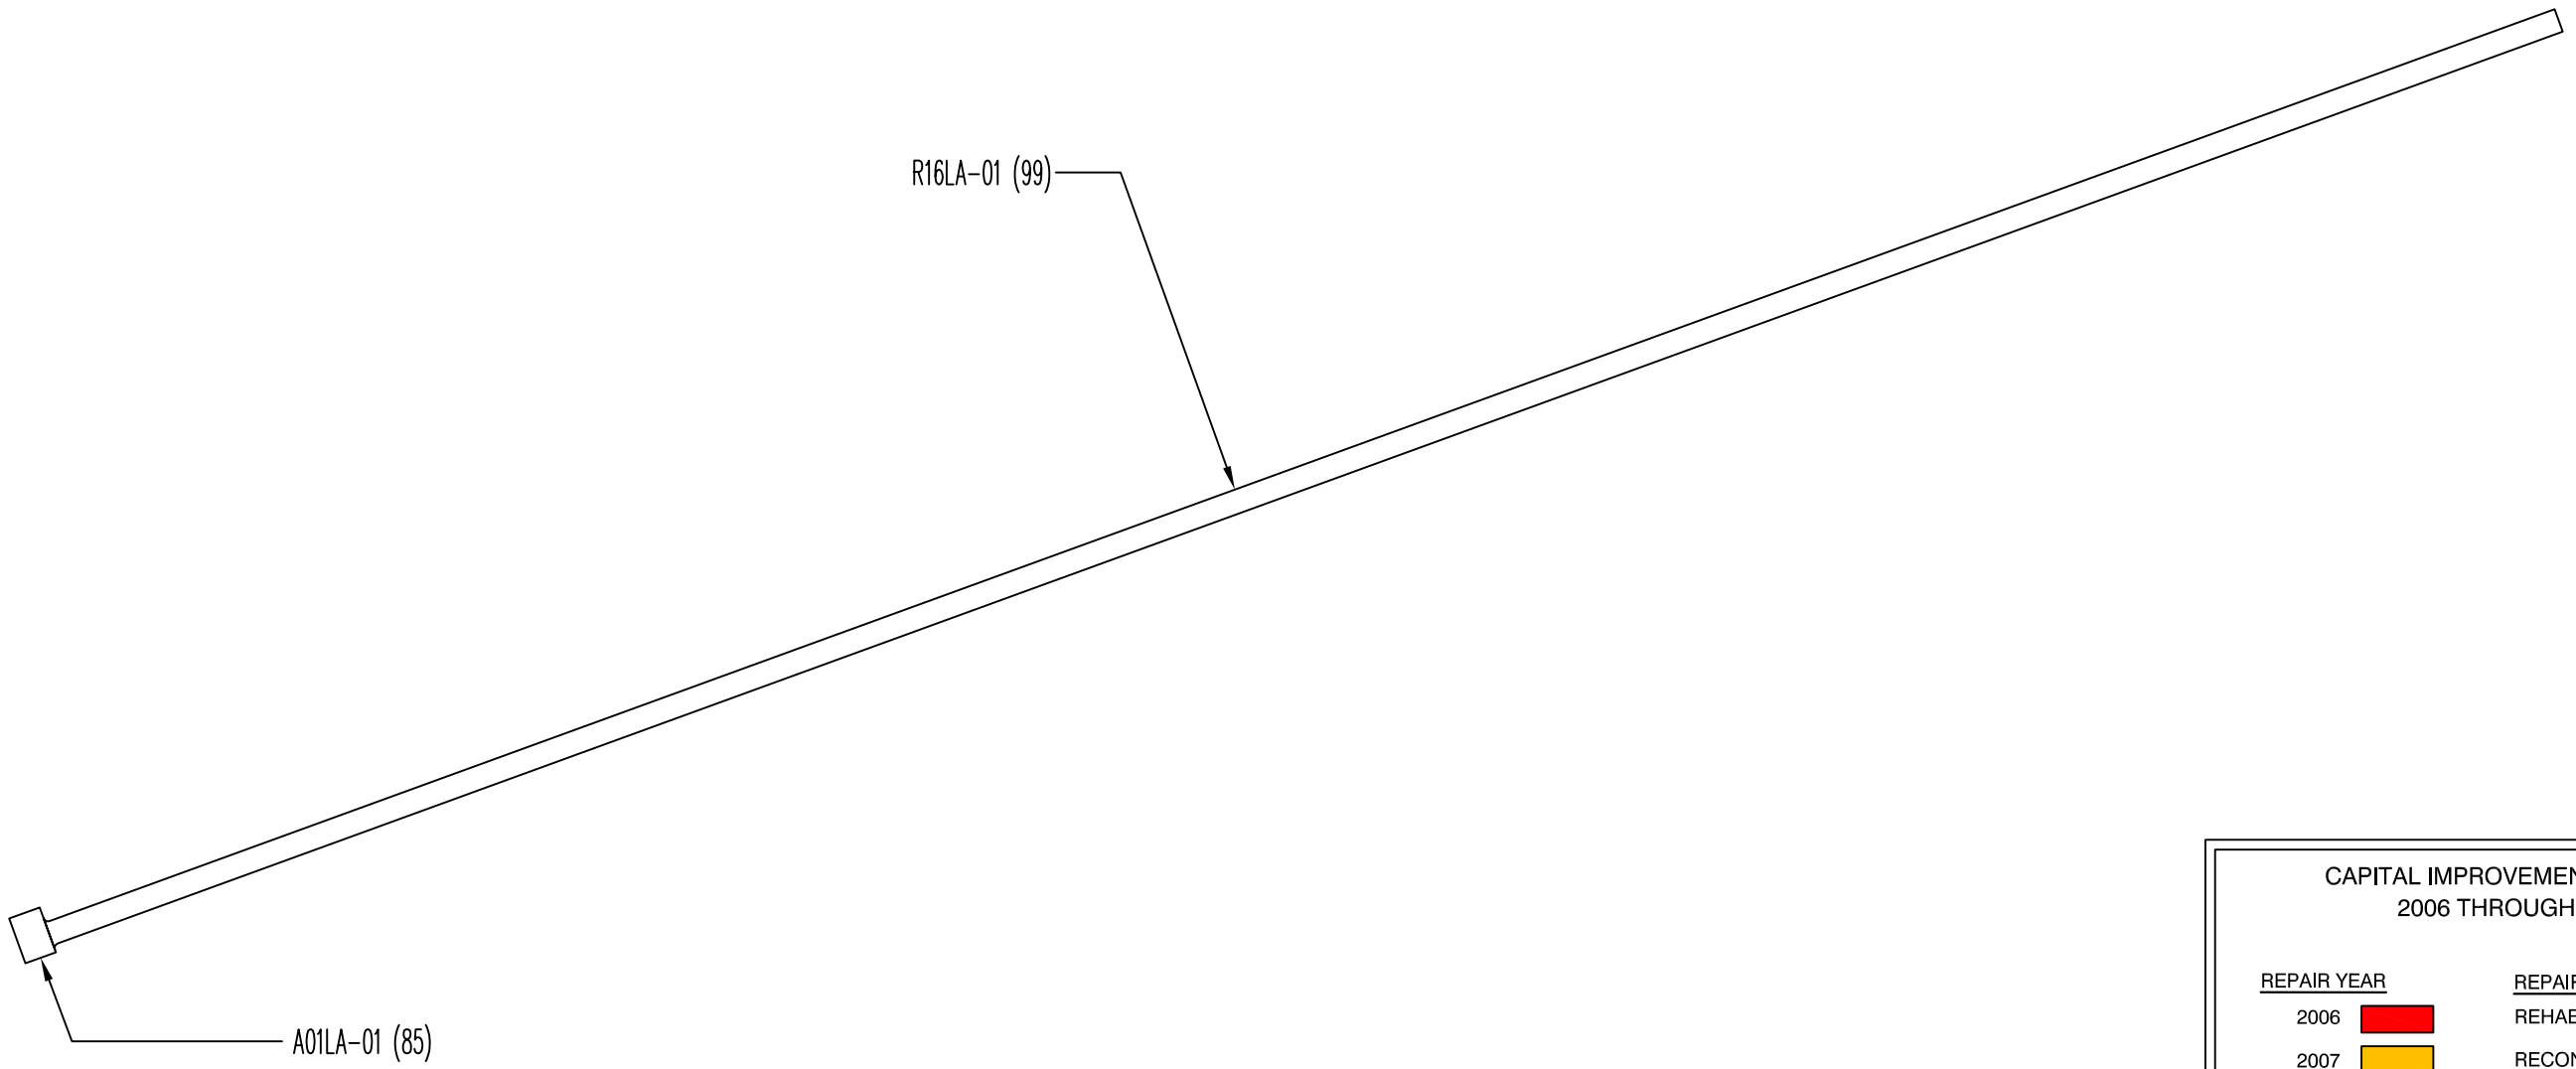
NO MAJOR REHABILITATION NEEDS HAVE BEEN IDENTIFIED FOR 2006 TO 2012. CONTINUE TO MONITOR PAVEMENT FOR CHANGES IN CONDITION.
