QUILLAYUTE STATE AIRPORT
2005 PAVEMENT MANAGEMENT REPORT

February 2006

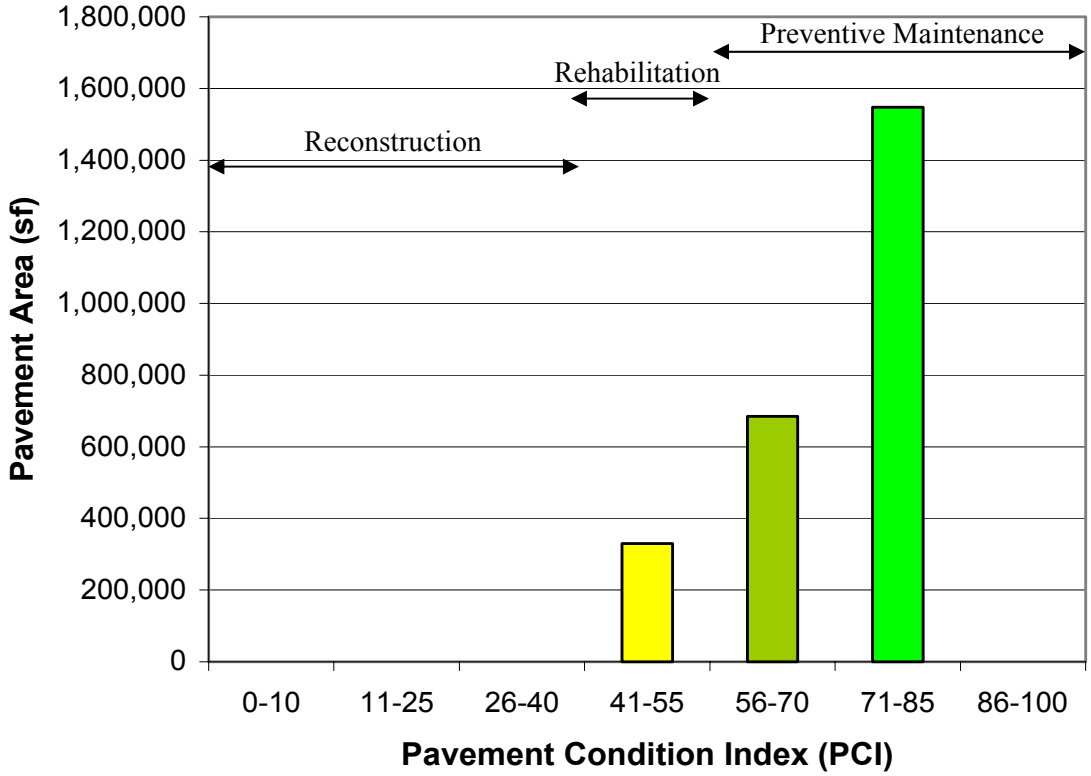
Figure 6. Quillayute State Airport overall condition.

The pavements at Quillayute State Airport were inspected on March 21, 2005. The 2005 area-weighted condition of Quillayute State Airport is 70, with conditions ranging from 62 to 82 (on a scale of 0 [failed] to 100 [excellent]). During the previous inspection in 1999, the area-weighted condition was 66.

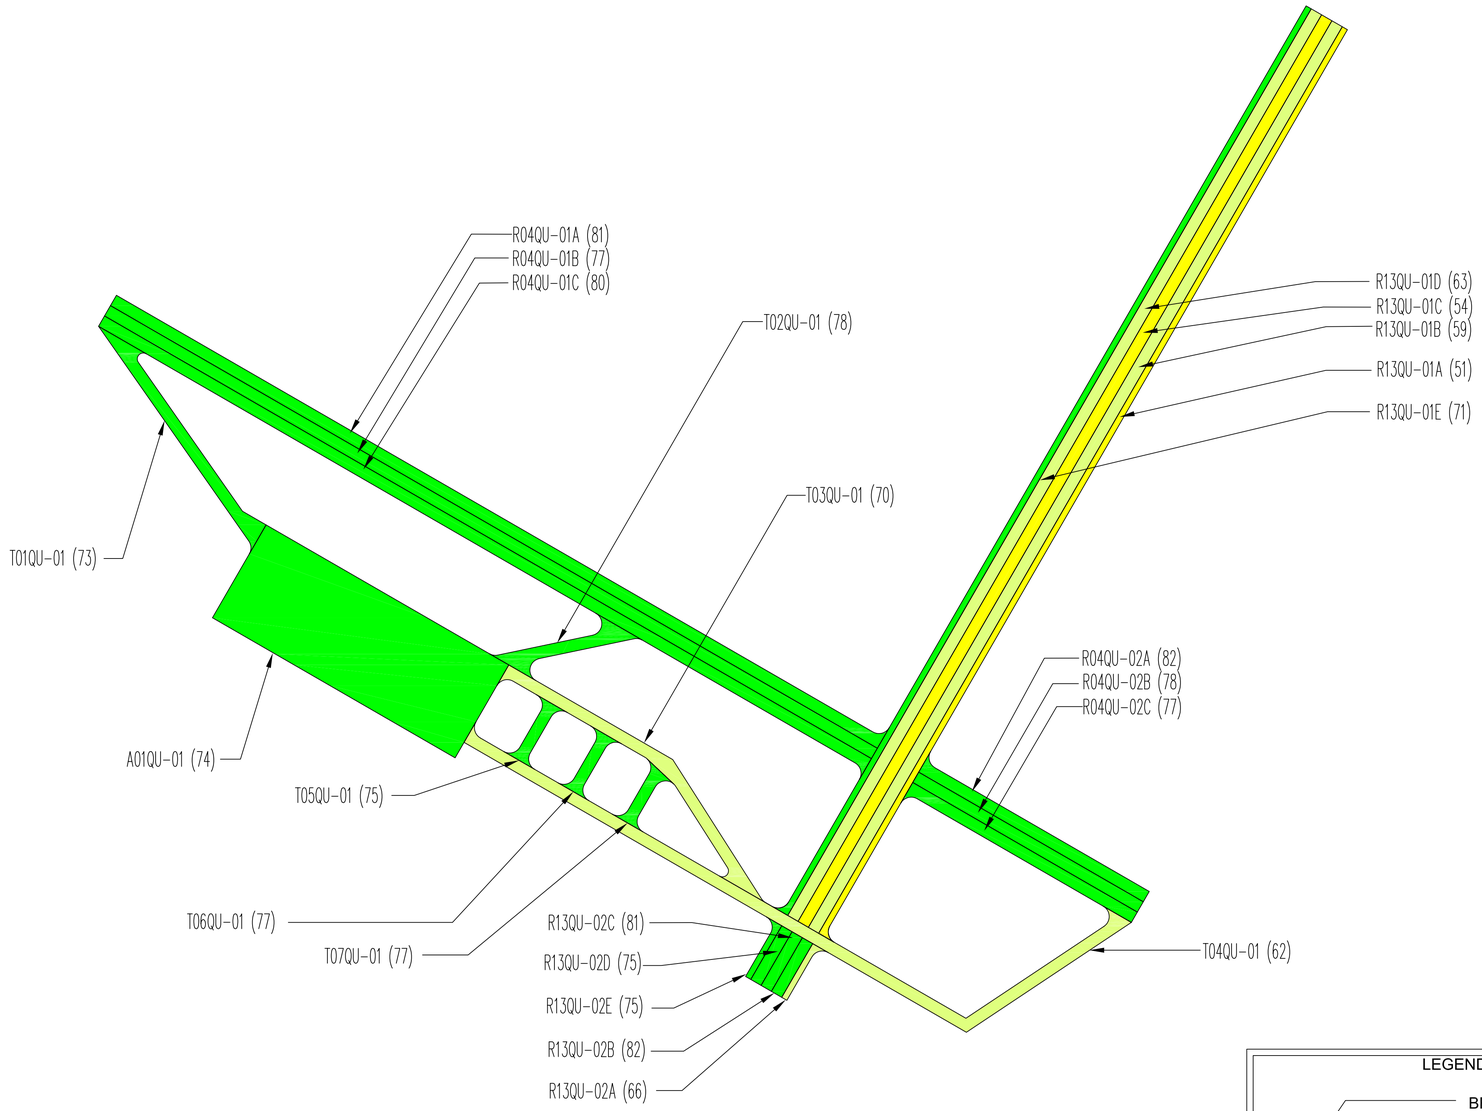
PAGE TITLE: 2005 Pavement Condition Index Map

Figures 6 and 7 summarize the overall condition of the pavements at the Quillayute State Airport. Figure 8 displays the condition of the pavements evaluated. Table 1 summarizes the results of the pavement evaluation. Appendix C presents photographs taken during the PCI inspection and Appendix D details the distresses observed during the visual survey.

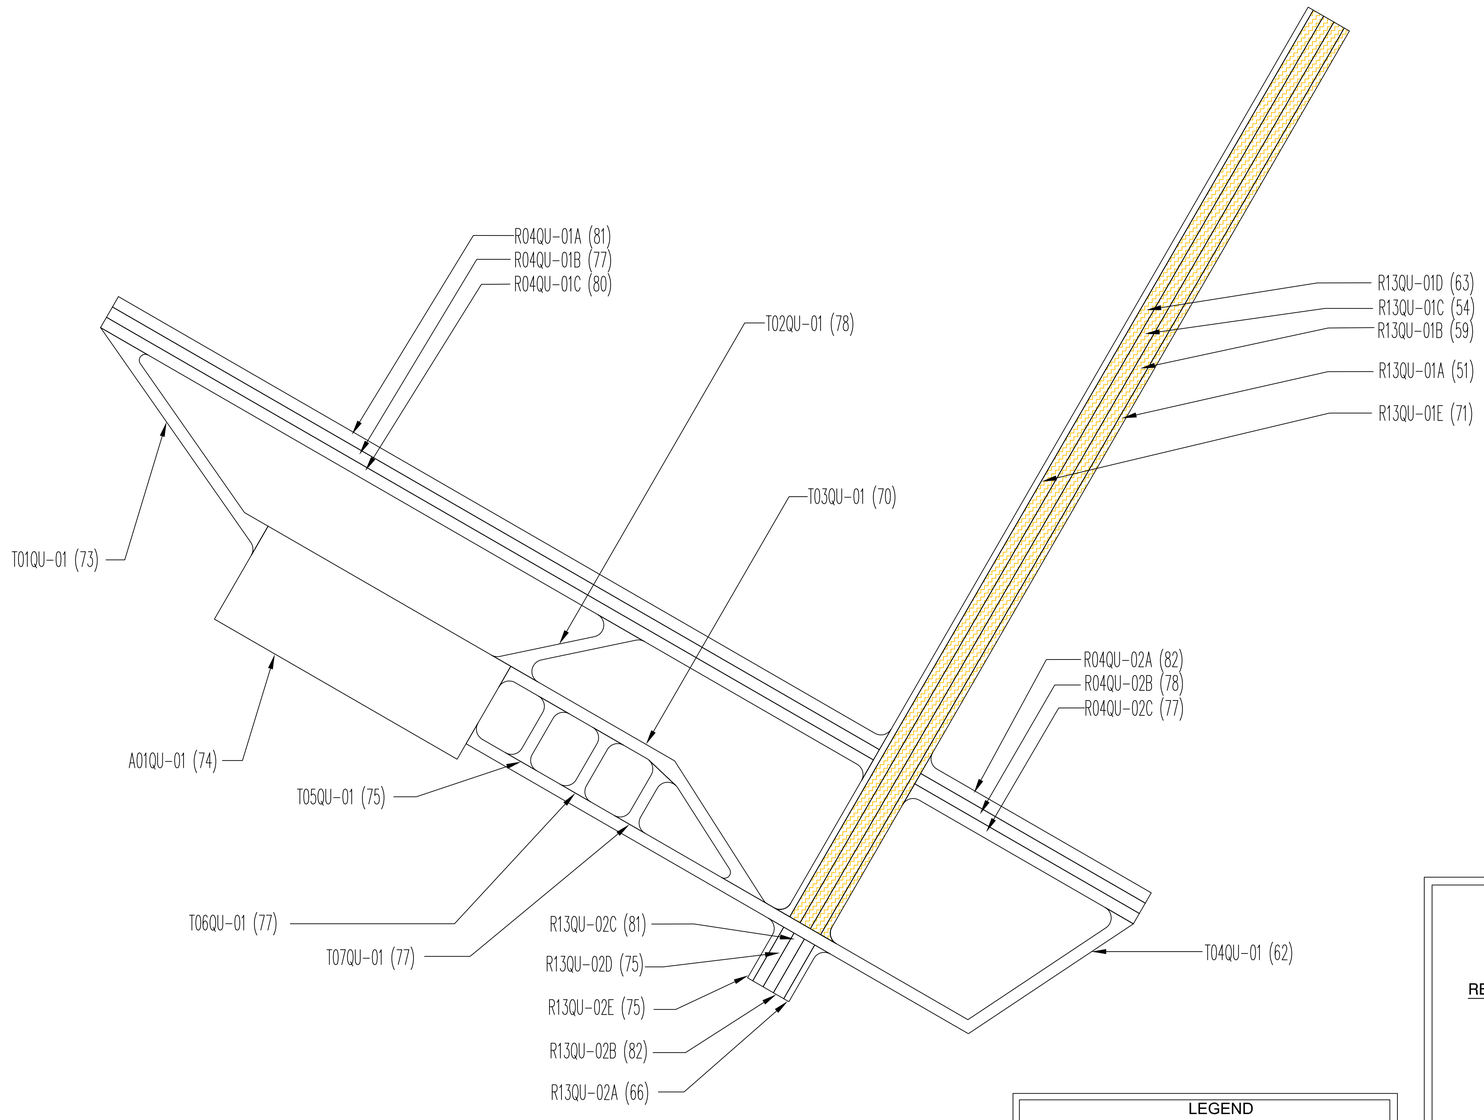
A summary of the pavement repair program for Quillayute State Airport is presented in Table 4 and in Figure 9. Detailed information on the localized maintenance plan for 2006 is contained in Appendix F.

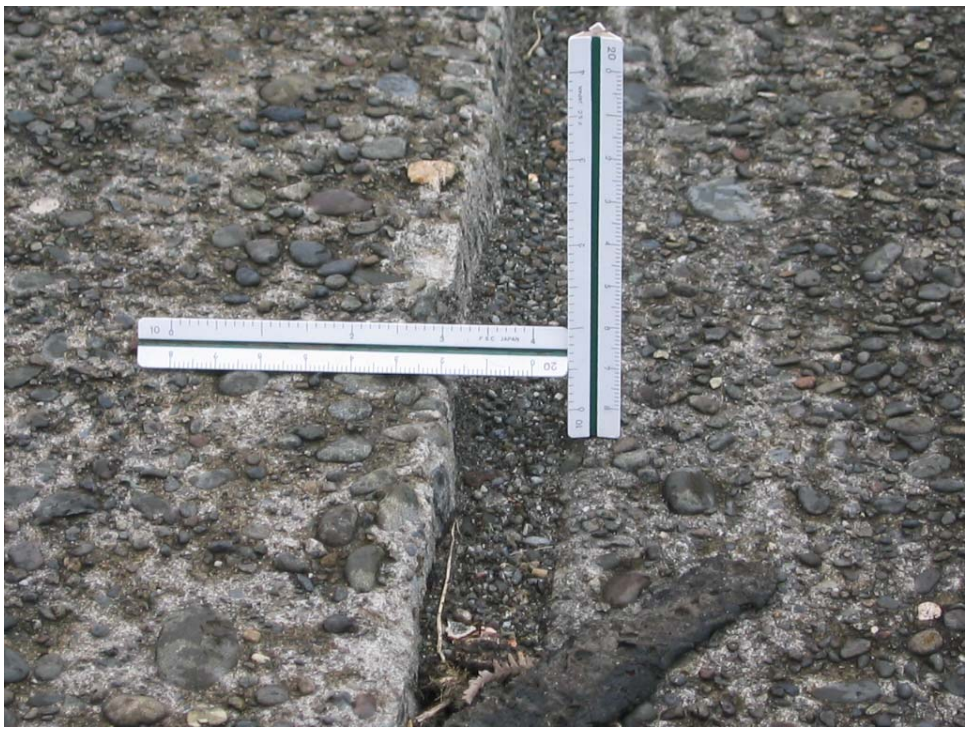
R04QU-01A. Faulting.

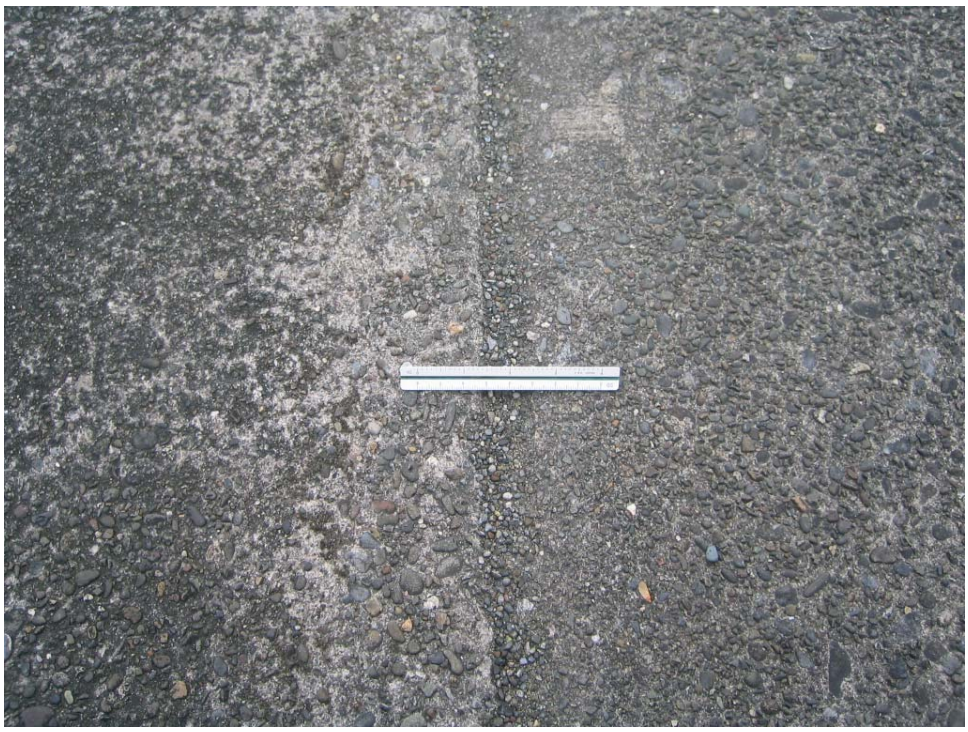
R04QU-01C. Joint sealant damage.

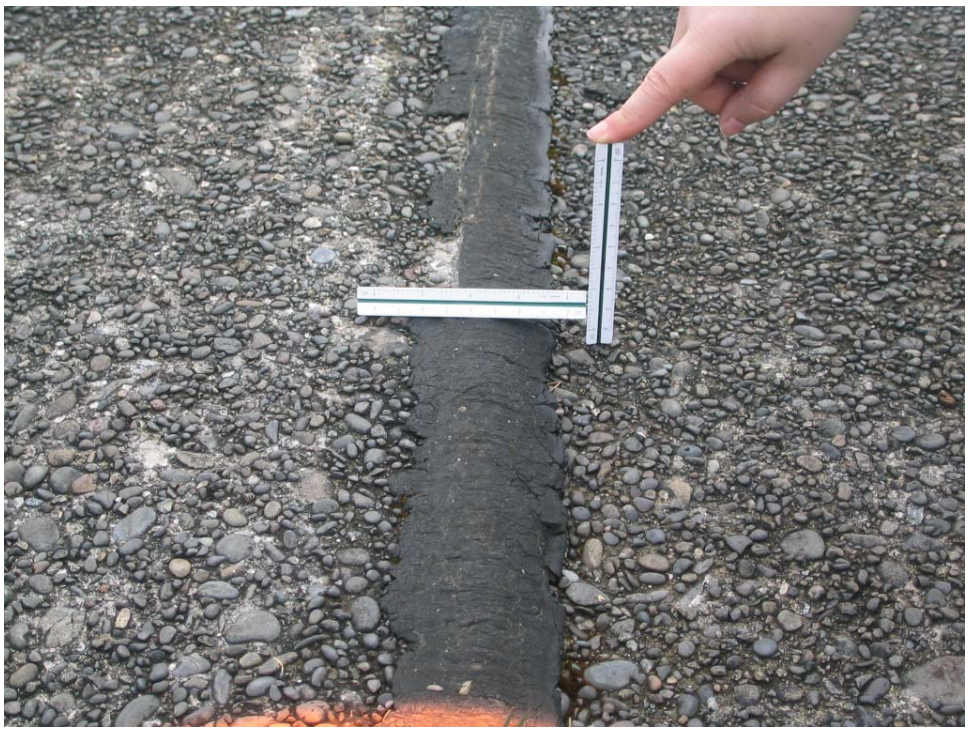
T04QU-01. Faulting.
