OTHELLO MUNICIPAL AIRPORT
2005 PAVEMENT MANAGEMENT REPORT

February 2006

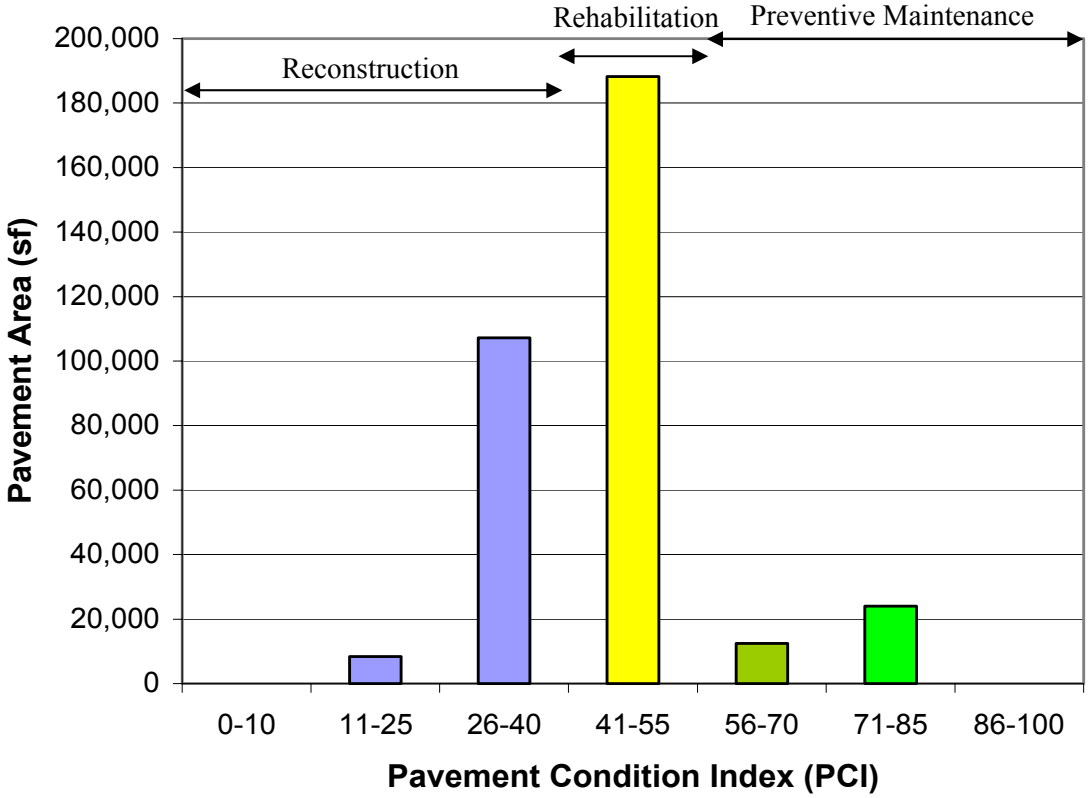
Figure 6. Othello Municipal Airport overall condition.

The pavements at Othello Municipal Airport were inspected on May 24, 2005. The 2005 area-weighted condition of Othello Municipal Airport is 48, with conditions ranging from 20 to 83 (on a scale of 0 [failed] to 100 [excellent]). During the previous inspection in 1999, the area-weighted condition was 63.

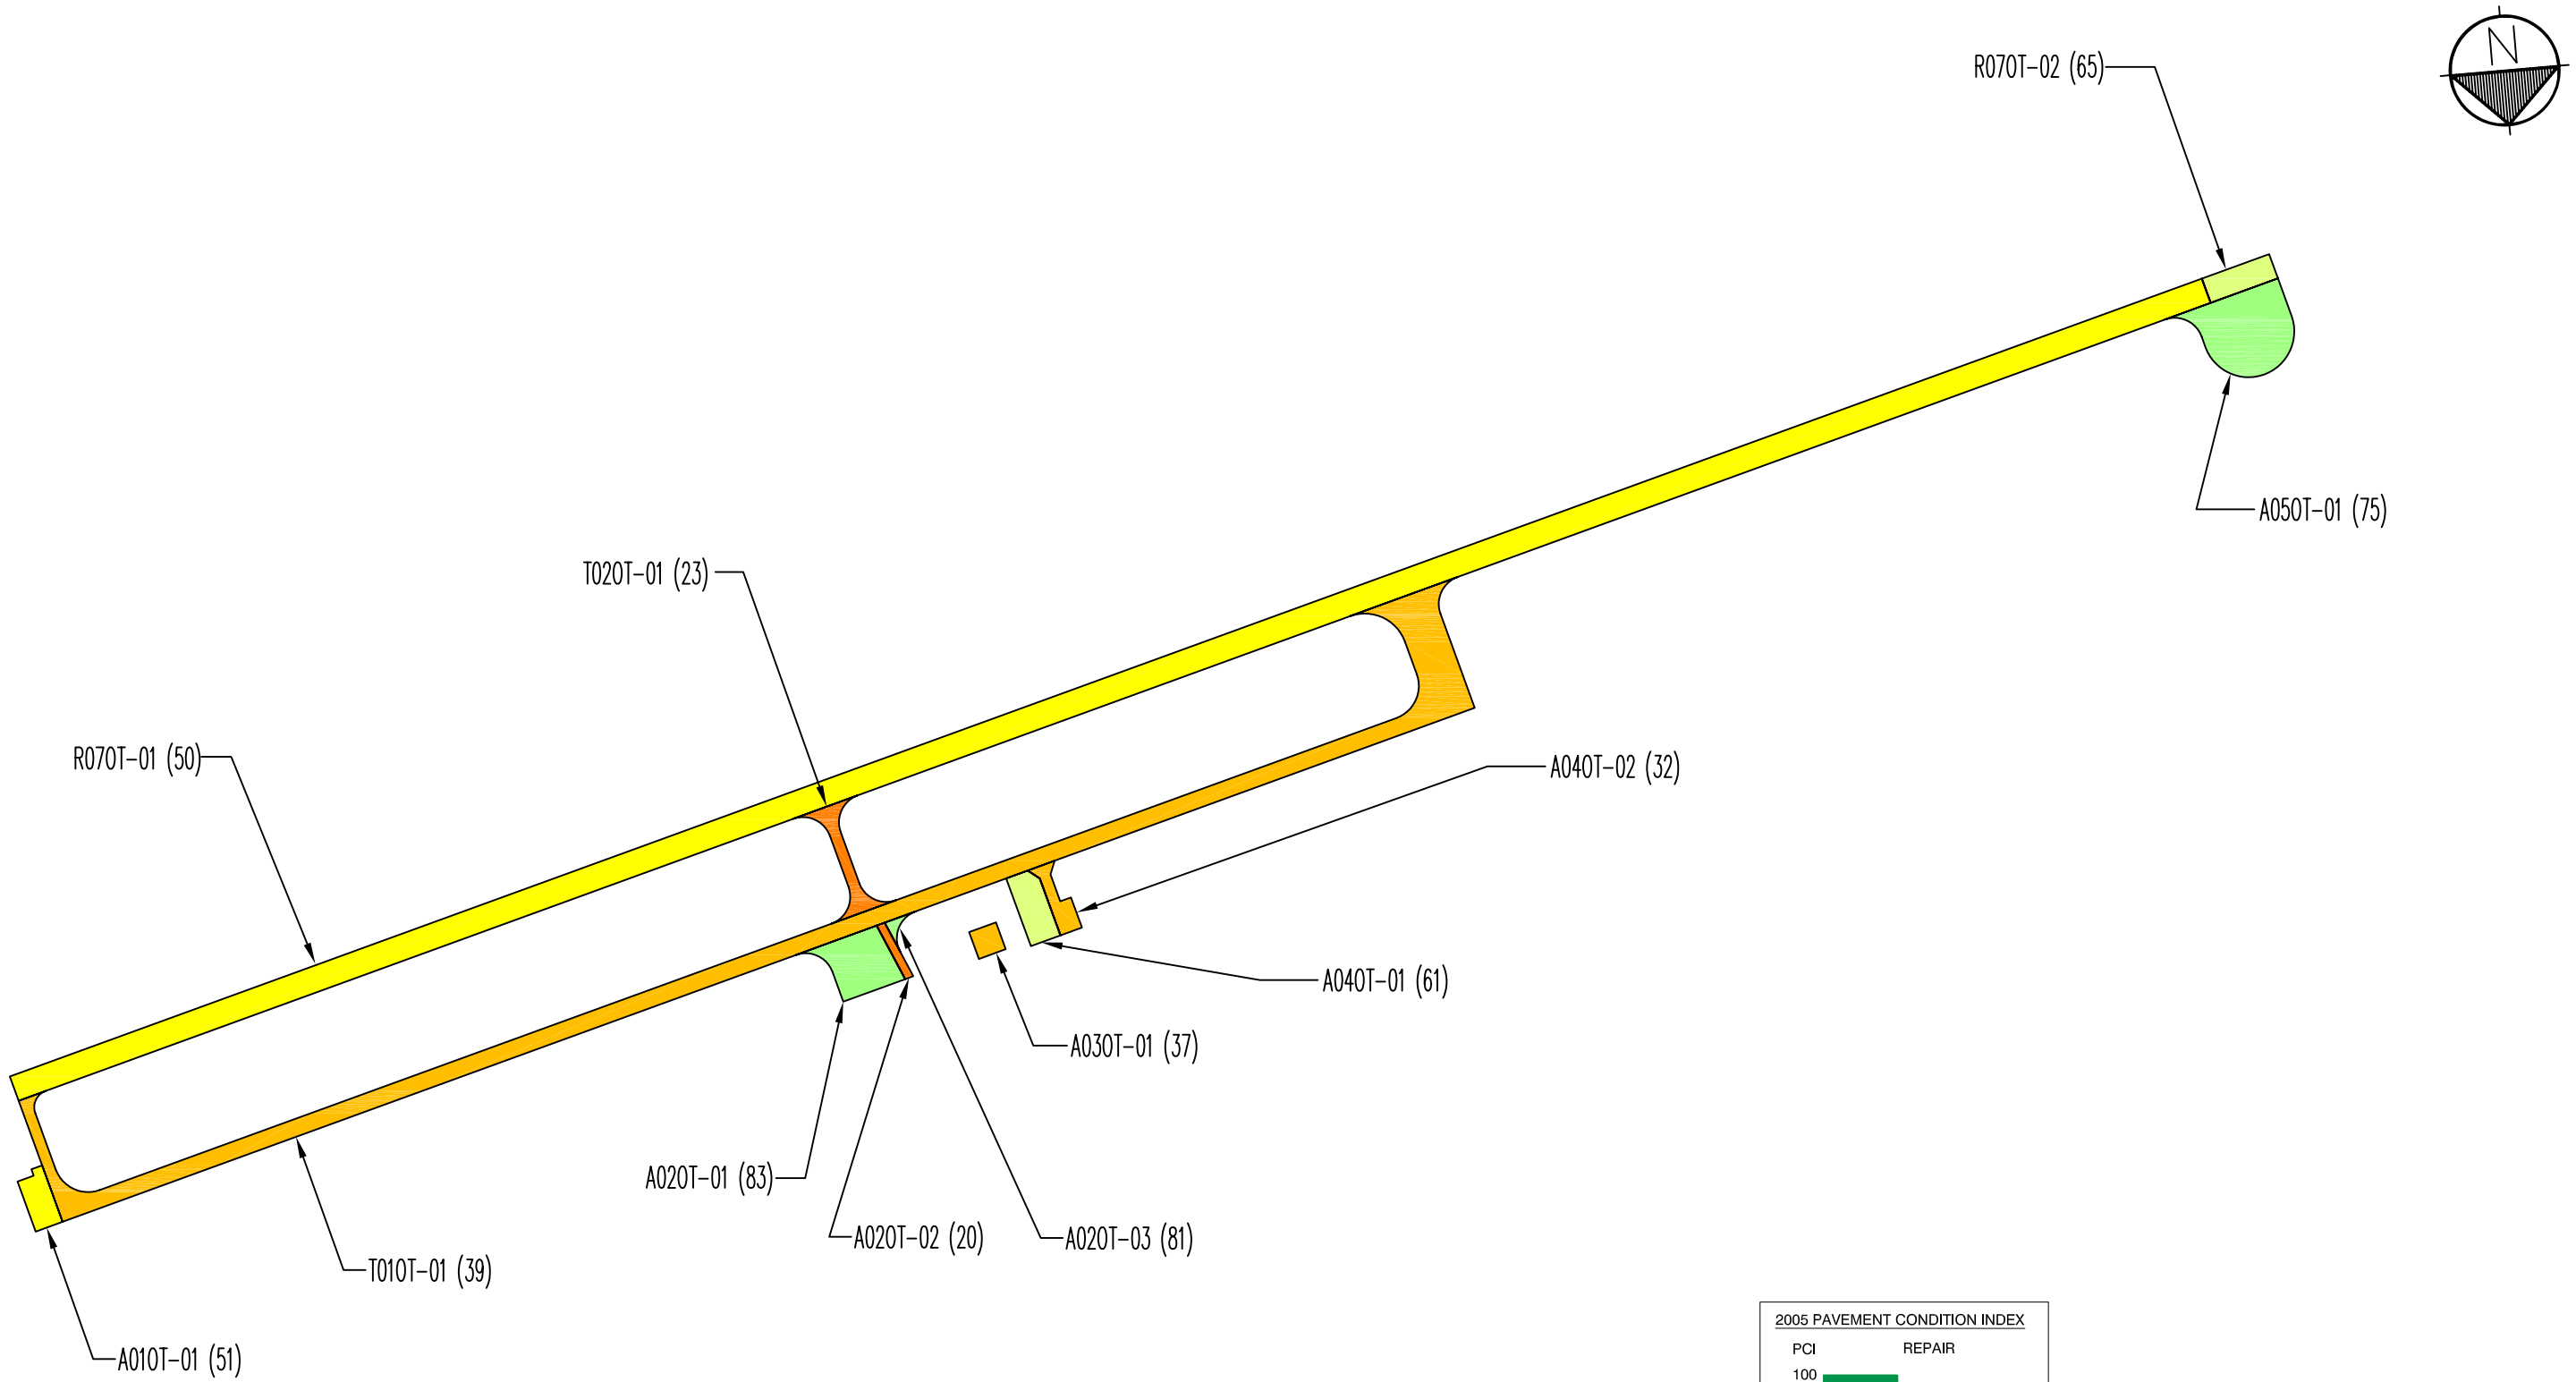
Figures 6 and 7 summarize the overall condition of the pavements at the Othello Municipal Airport. Figure 8 displays the condition of the pavements evaluated. Table 1 summarizes the results of the pavement evaluation. Appendix C presents photographs taken during the PCI inspection and Appendix D details the distresses observed during the visual survey.

Othello Municipal Airport								
Branch[1]	Section	Surface Type[2]	Section Area, sf	LCD[3]	2005 PCI	% Distress Due to:		Distress Types
						Load[4]	Climate or Durability[5]	
A01OT	01	AC	4,890	9/2/1976	52	23	76	Alligator cracking, depression, longitudinal and transverse cracking, raveling and weathering
A020T	01	AC	1,575	9/2/1989	83	0	100	Longitudinal and transverse cracking
A020T	02	AC	2,317	9/2/1976	20	0	100	Longitudinal and transverse cracking, raveling and weathering
A020T	03	AC	742	9/2/1989	81	0	100	Longitudinal and transverse cracking
A03OT	01	PCC	2,500	9/2/1989	37	83	17	Joint seal damage, shattered slab
A04OT	01	AC	6,780	9/2/1989	61	0	64	Depression, longitudinal and transverse cracking, patching
A04OT	02	AC	3,940	9/2/1990	32	49	44	Alligator cracking, depression, longitudinal and transverse cracking, patching, raveling and weathering
A05OT	01	AC	21,710	9/2/1989	74	0	100	Longitudinal and transverse cracking

R07OT	01	AC	183,375	9/2/1976	50	53	47	Alligator cracking, block cracking, longitudinal and transverse cracking, rutting
R07OT	02	AC	5,625	9/2/1989	65	55	45	Alligator cracking, longitudinal and transverse cracking
T01OT	01	AC	100,757	9/2/1976	39	58	42	Alligator cracking, longitudinal and transverse cracking, patching, rutting, raveling and weathering
T02OT	01	AC	6,046	9/2/1976	23	69	27	Alligator cracking, depression, longitudinal and transverse cracking, rutting
