DESERT AIRE AIRPORT
2005 PAVEMENT MANAGEMENT REPORT

February 2006

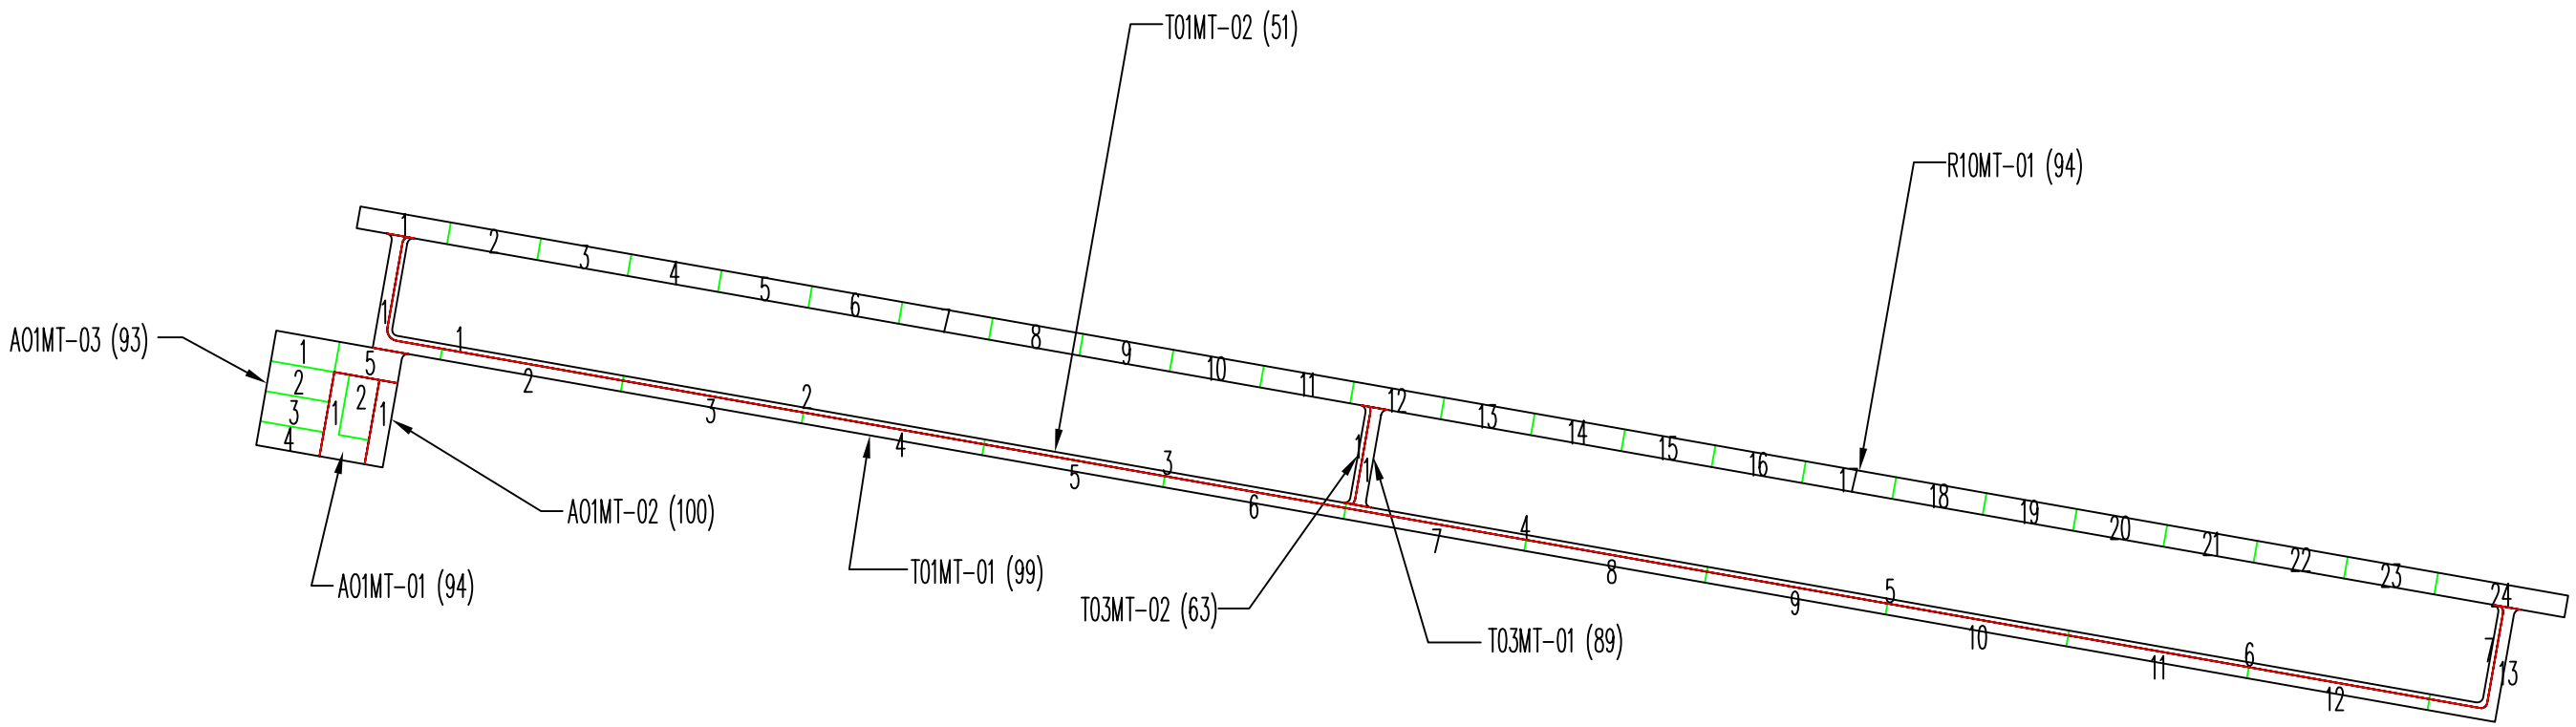
PAGE TITLE: 2005 Pavement Condition Index Map

The pavements at Desert Aire Airport were inspected on May 3, 2005. The 2005 area-weighted condition of Desert Aire Airport is 90, with conditions ranging from 50 to 100 (on a scale of 0 [failed] to 100 [excellent]). During the previous inspection in 1999, the area-weighted condition was 98.

Desert Aire Airport								
Branch[1]	Section	Surface Type[2]	Section Area, sf	LCD[3]	2005 PCI	% Distress Due to:		Distress Types
						Load[4]	Climate or Durability[5]	
A01MT	01	AC	10,500	9/1/1995	94	0	100	Longitudinal and transverse cracking
A01MT	02	AC	4,200	9/1/1995	100	0	0	No distress
A01MT	03	AC	25,256	9/1/1995	93	0	100	Longitudinal and transverse cracking
R10MT	01	AC	131,976	9/1/1995	94	0	100	Longitudinal and transverse cracking
T01MT	01	AC	69,730	9/1/1995	99	0	100	Longitudinal and transverse cracking
T01MT	02	AC	30,448	6/2/1999	50	51	47	Longitudinal and transverse cracking, rutting, swelling, raveling and weathering
T03MT	01	AC	2,978	9/1/1995	89	0	100	Longitudinal and transverse cracking
T03MT	02	AC	1,319	6/2/1999	63	0	100	Longitudinal and transverse cracking, raveling and weathering

Branch[1]	**Section**	**2005**		**2010**		**2015**	
		PCI	**Repair Level**	**PCI**	**Repair Level**[2]	**PCI**	**Repair Level**
A01MT	01	94	Prev. Mnt.	86	Prev. Mnt.	77	Prev. Mnt.
A01MT	02	100	Prev. Mnt.	93	Prev. Mnt.	84	Prev. Mnt.
A01MT	03	93	Prev. Mnt.	85	Prev. Mnt.	76	Prev. Mnt.
R10MT	01	94	Prev. Mnt.	88	Prev. Mnt.	81	Prev. Mnt.
T01MT	01	99	Prev. Mnt.	94	Prev. Mnt.	87	Prev. Mnt.
T01MT	02	50	Rehabilitation	43	Rehabilitation	36	Reconstruction
T03MT	01	89	Prev. Mnt.	82	Prev. Mnt.	75	Prev. Mnt.
T03MT	02	63	Prev. Mnt.	56	Rehabilitation	49	Rehabilitation

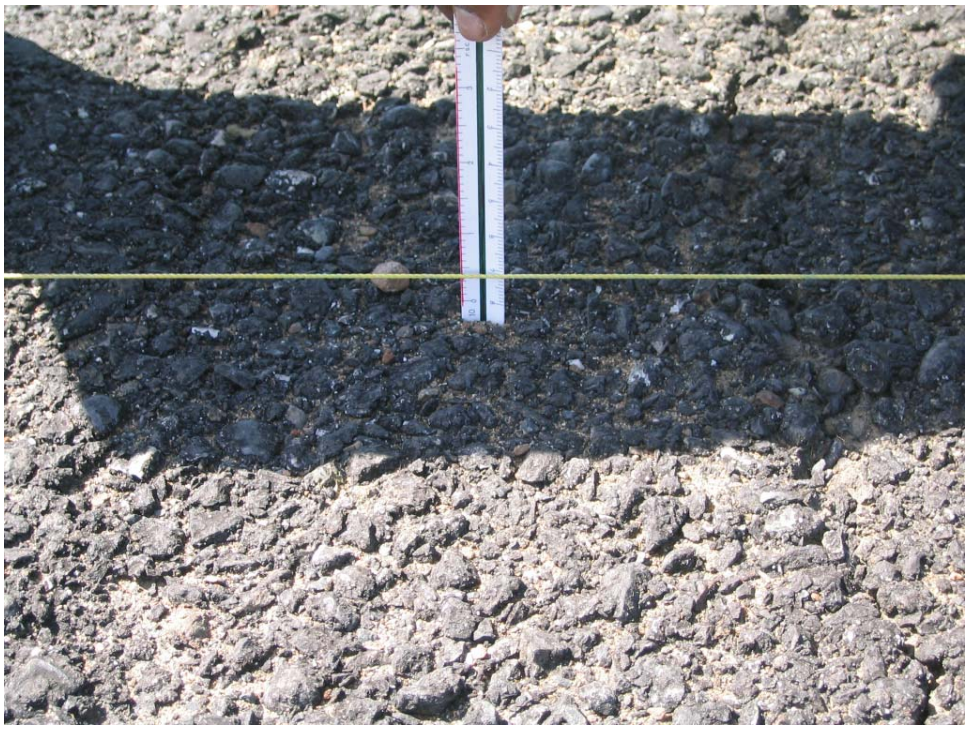
T03MT-01. Rutting.
