BOEING FIELD/KING COUNTY AIRPORT
2005 PAVEMENT MANAGEMENT REPORT

February 2006

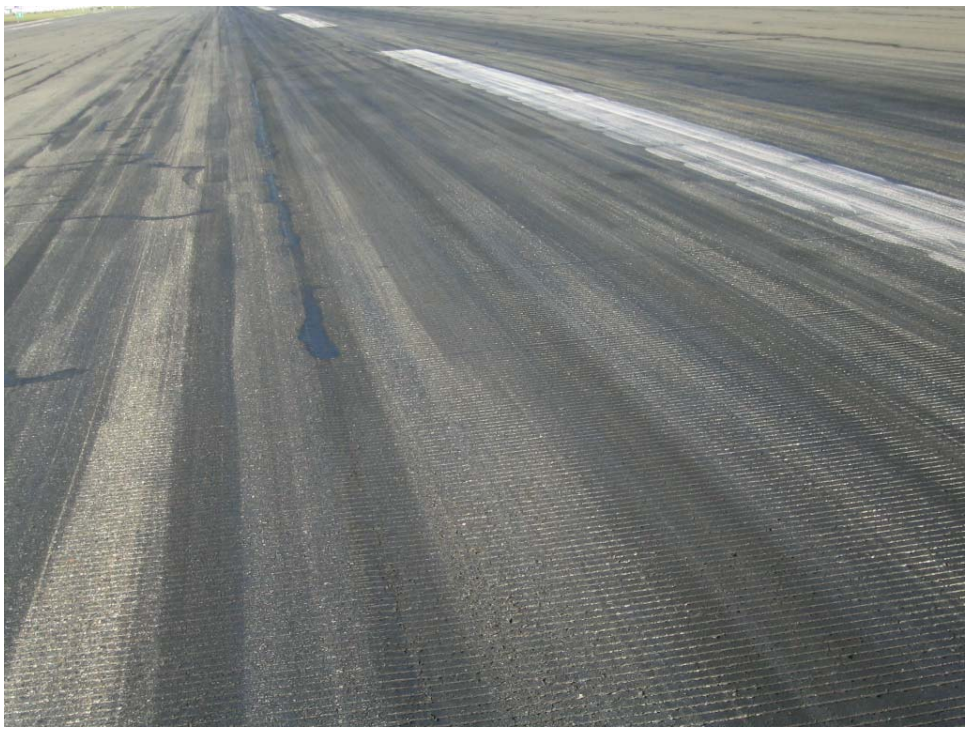
R13RBF-05A, R13RBF-05B, R13RBF-05C, R13RBF-05D, and R13RBF-05E. Overview.

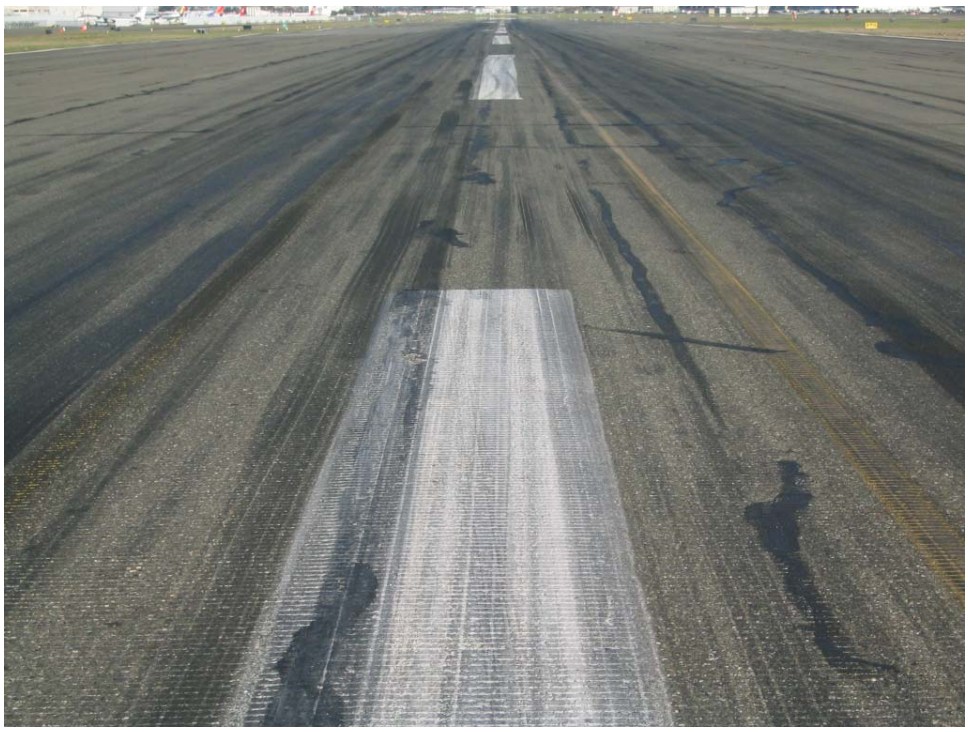
R13RBF-09A. Patching.

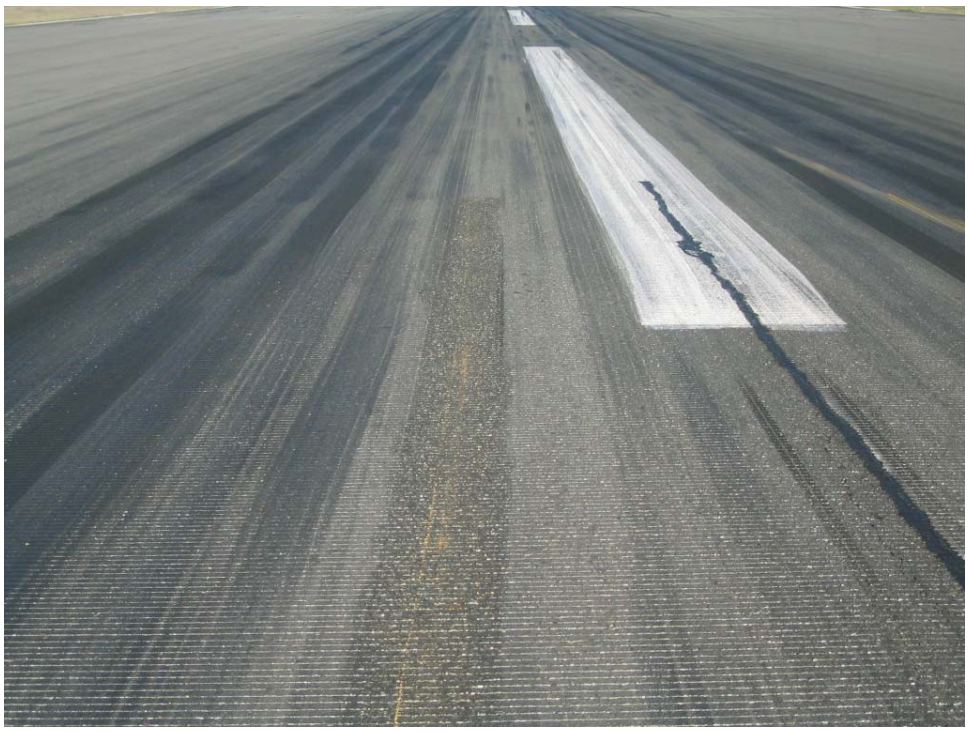
R13RBF-09C. Overview (1).

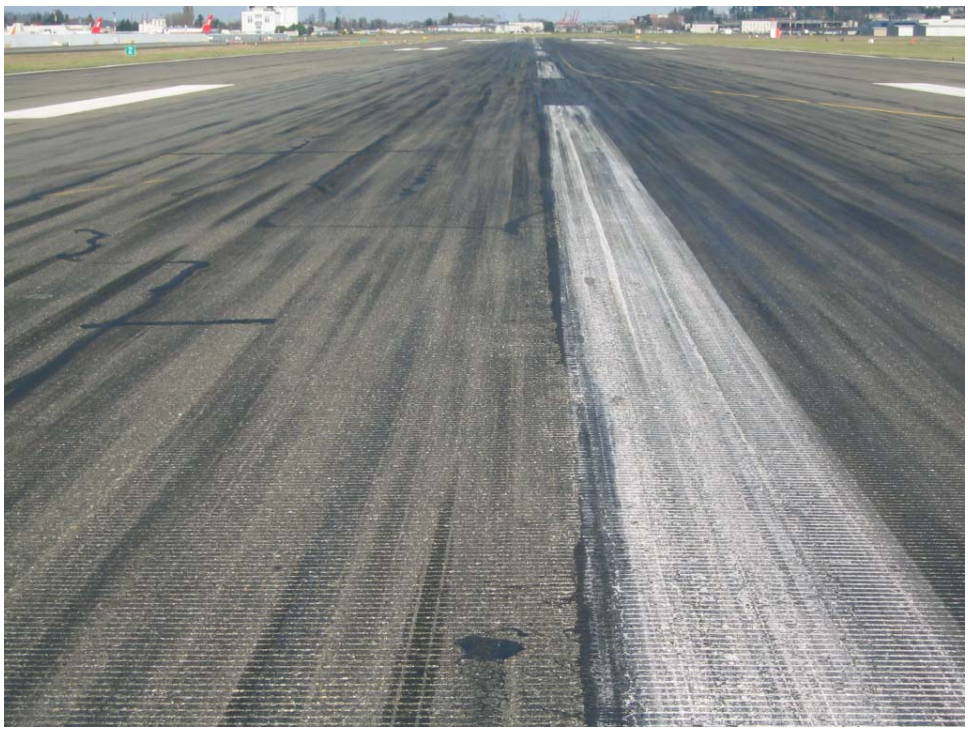
R13RBF-12A, R13RBF-12B, R13RBF-12C, R13RBF-12D, and R13RBF-12E.
Joint reflection cracking.

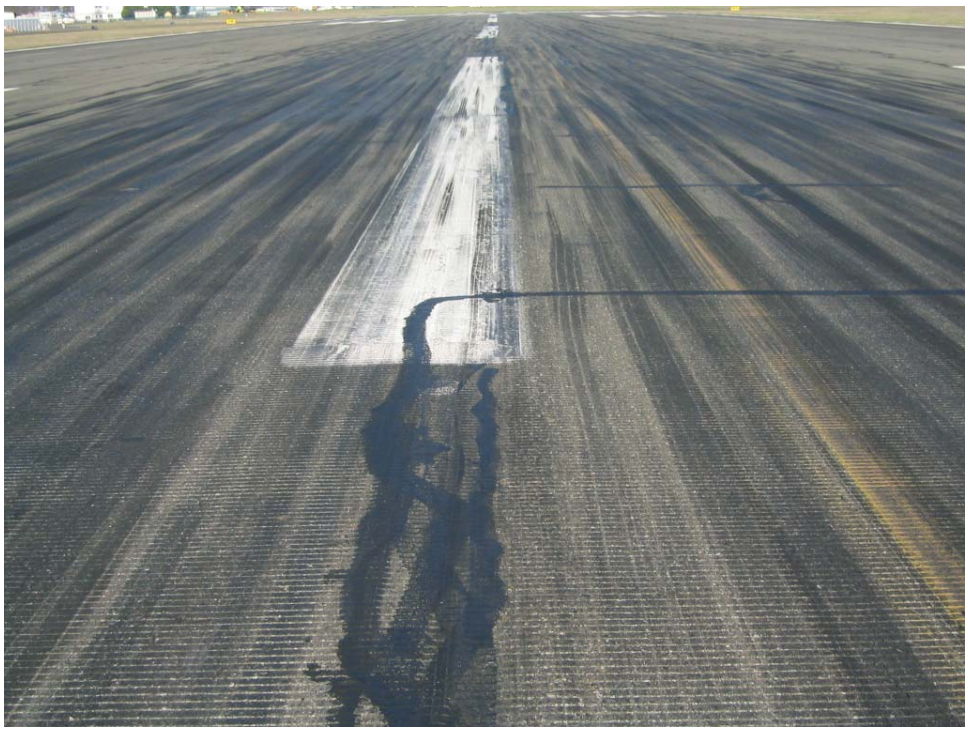
R13RBF-13C, R13RBF-13D, and R13RBF-13E. Overview.

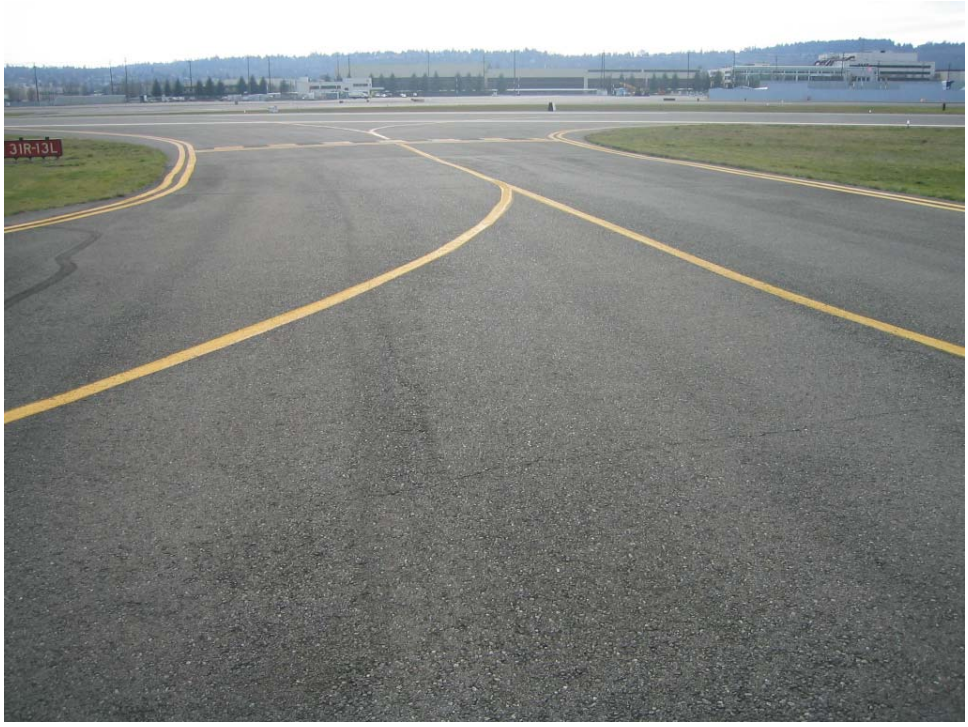
TA3BF-01. Overview.

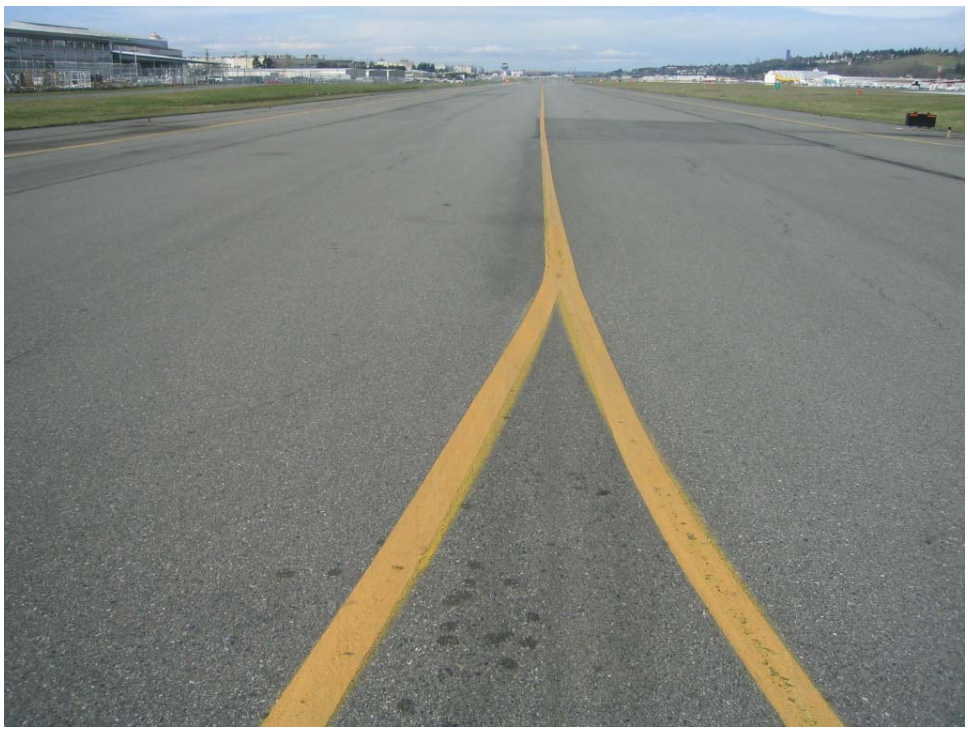
TBBF-01. Overview.
