SEKIU AIRPORT
2005 PAVEMENT MANAGEMENT REPORT

WSDOT Aviation
3704 172nd Street NE, Suite K2
Arlington, WA 98223
Phone: (360) 651-6300 or (800) 552-0666
Fax: (360) 651-6319
www.wsdot.wa.gov/aviation

February 2006

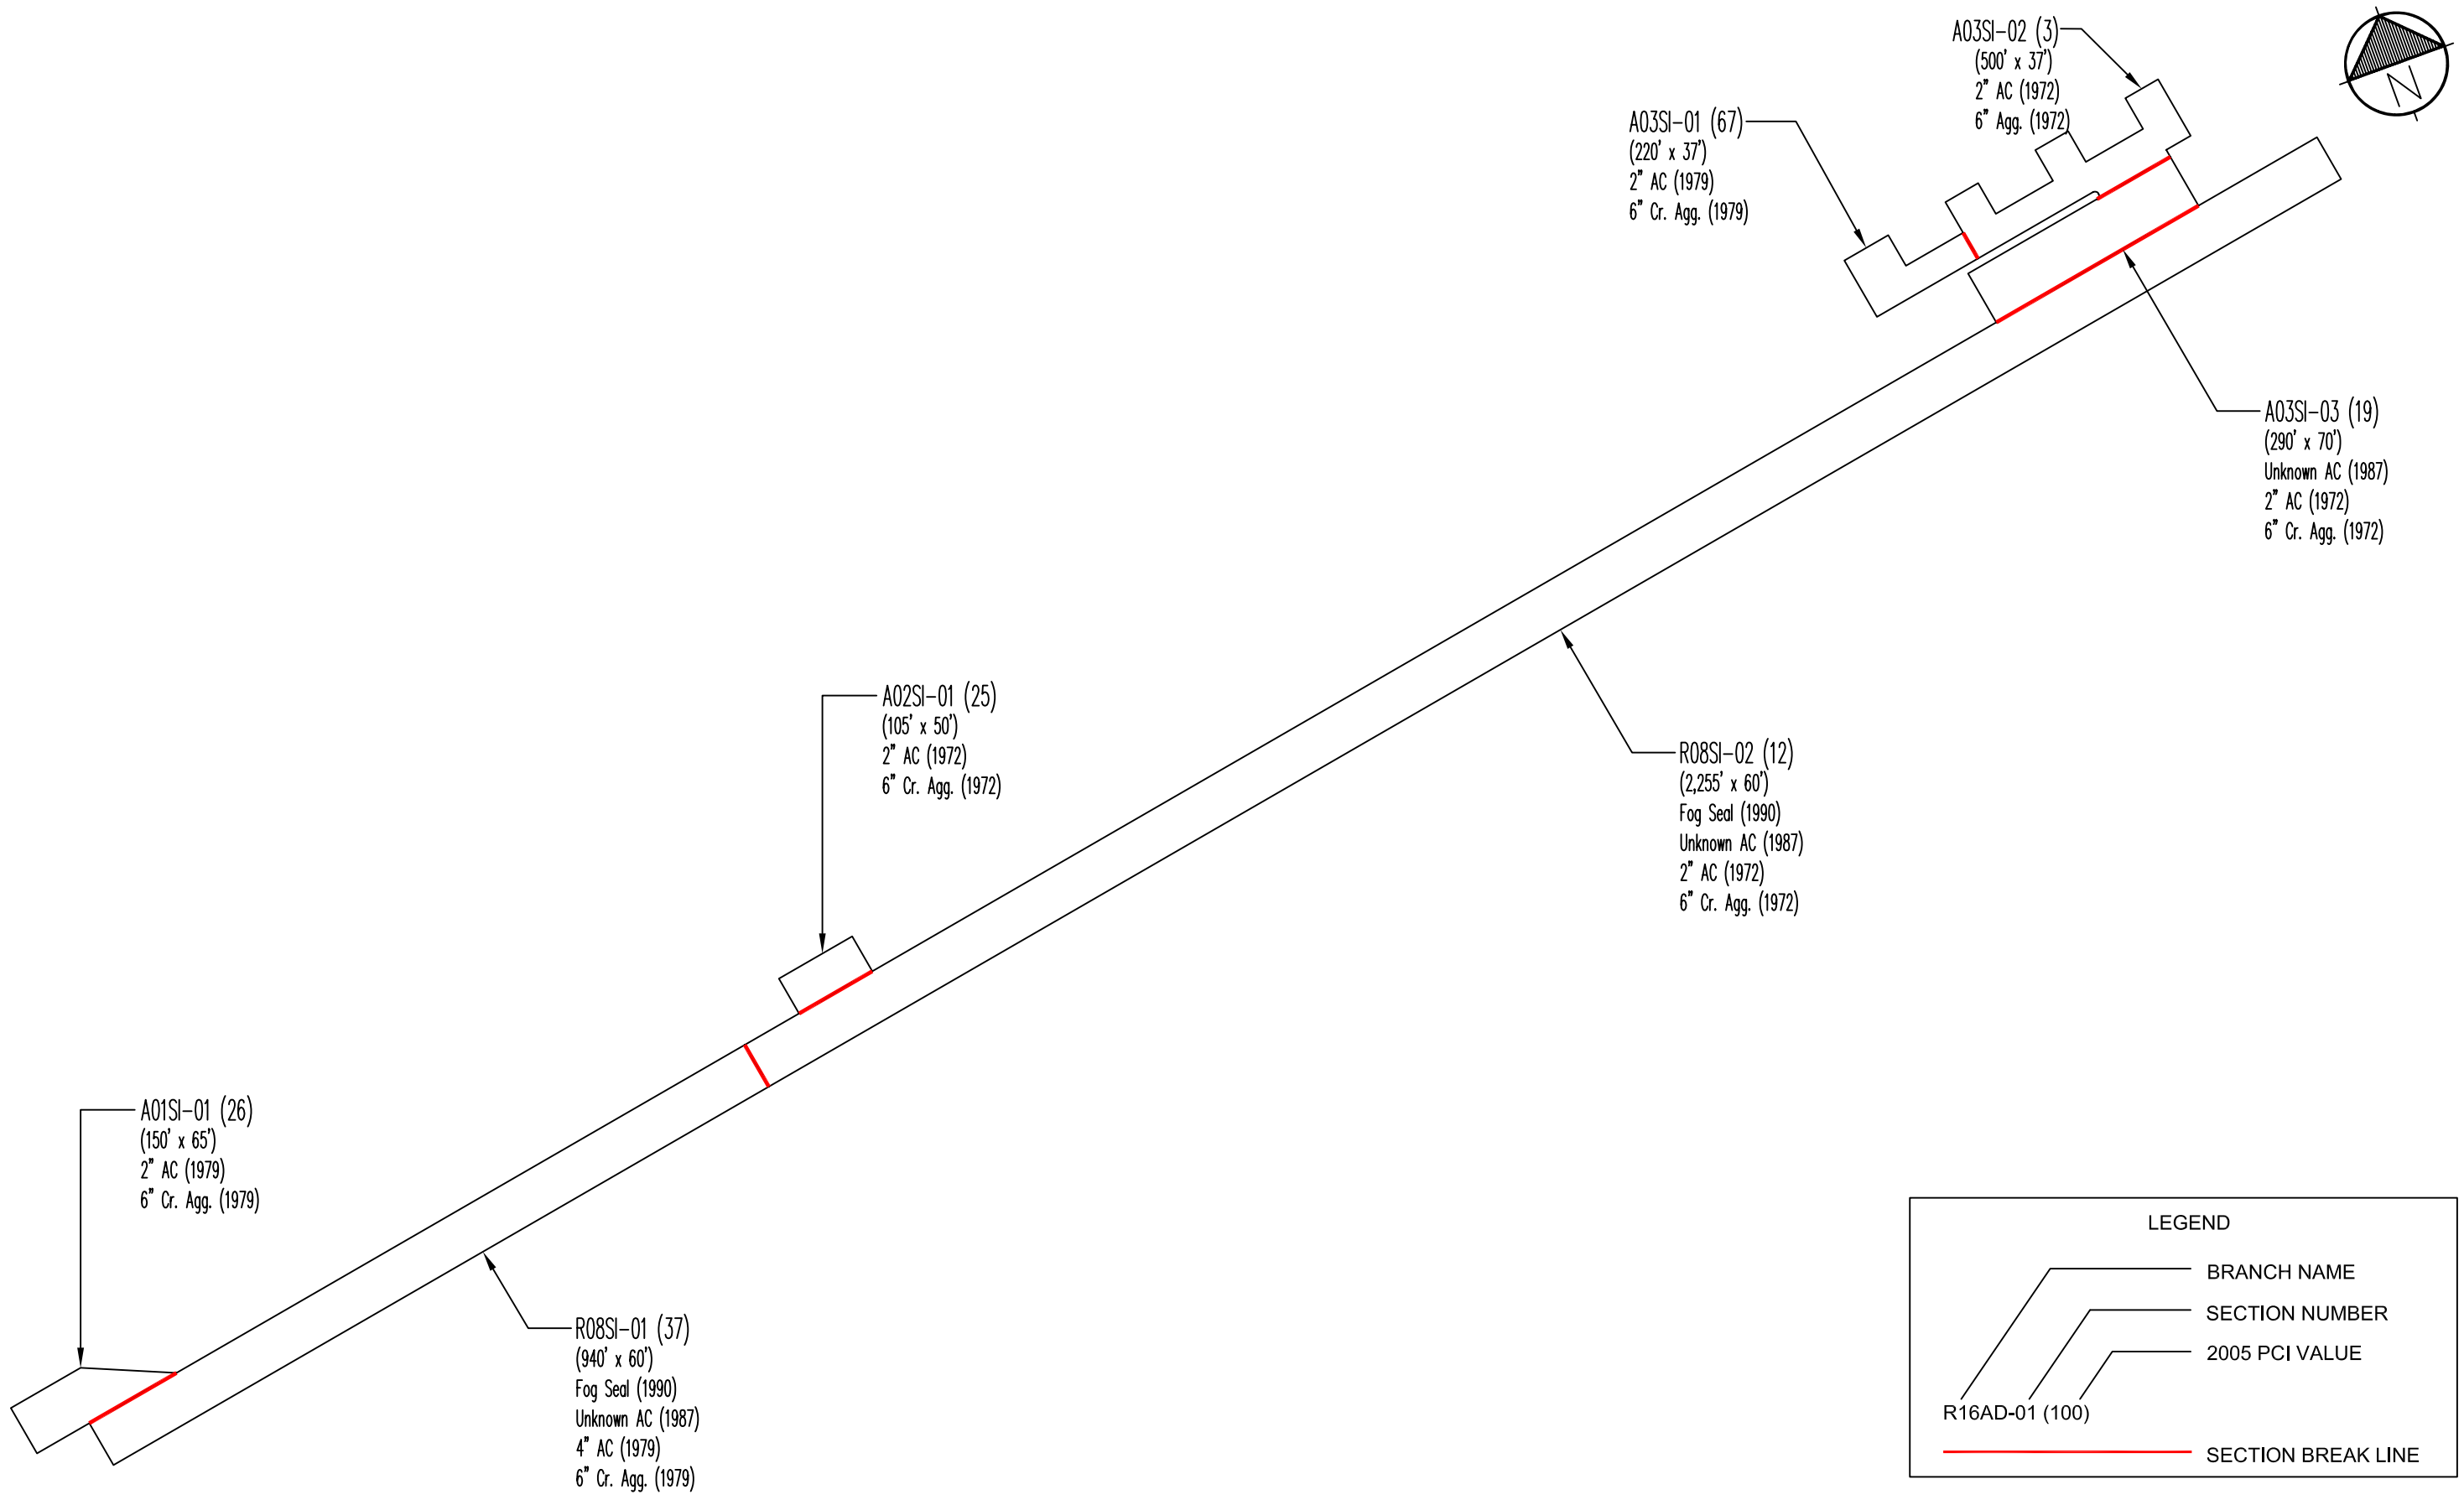
LOCATION: Sekiu Airport, Sekiu, Washington			
PAGE TITLE: 2005 Work History Map			
DRAWING SCALE: 1" = 200'	DATE: February 2006	REVISED BY: TJS	DRAWN BY: MK
FILENAME: Sekiu .dwg	AIRPORT ID: 11S	LAYOUT NAME/NUMBER: Sekiu (WH)	PAGE NUMBER: 4

Figure 3 presents the records review results in the form of a work history map. The Micro PAVER database (see the inside back cover of this report) contains detailed inventory information about the pavement system at the airport.

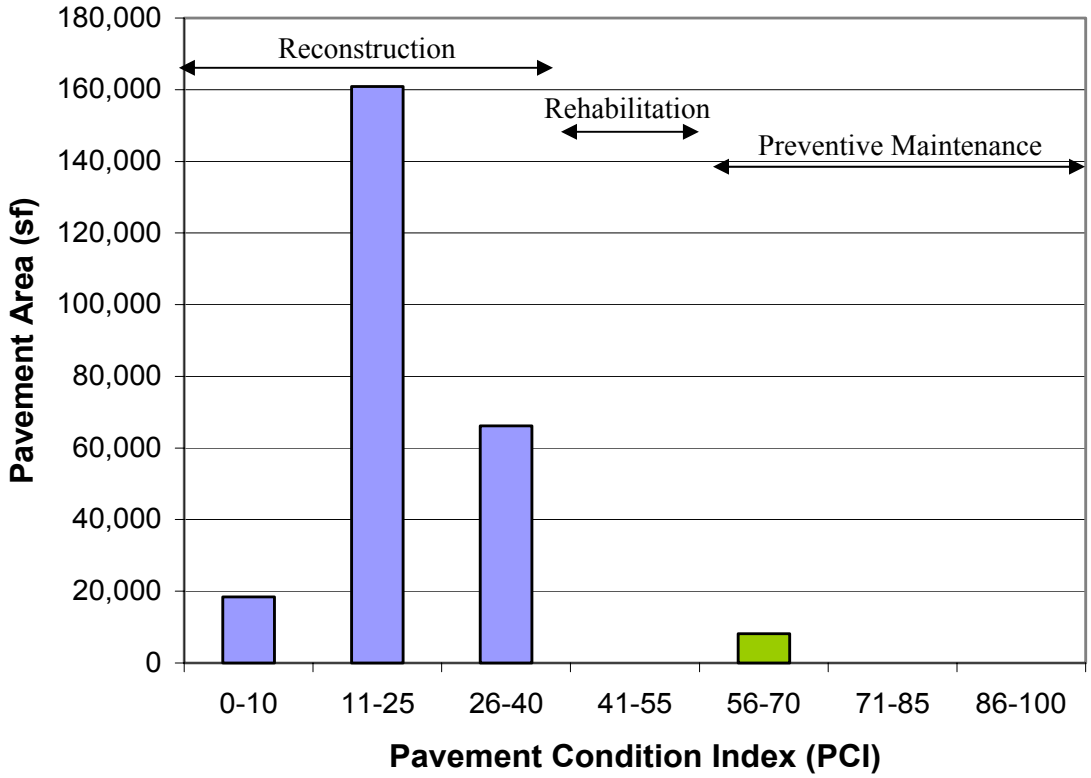
Figure 6. Sekiu Airport overall condition.

The pavements at Sekiu Airport were inspected on March 18, 2005. The 2005 area-weighted condition of Sekiu Airport is 20, with conditions ranging from 3 to 65 (on a scale of 0 [failed] to 100 [excellent]). During the previous inspection in 1999, the area-weighted condition was 35.

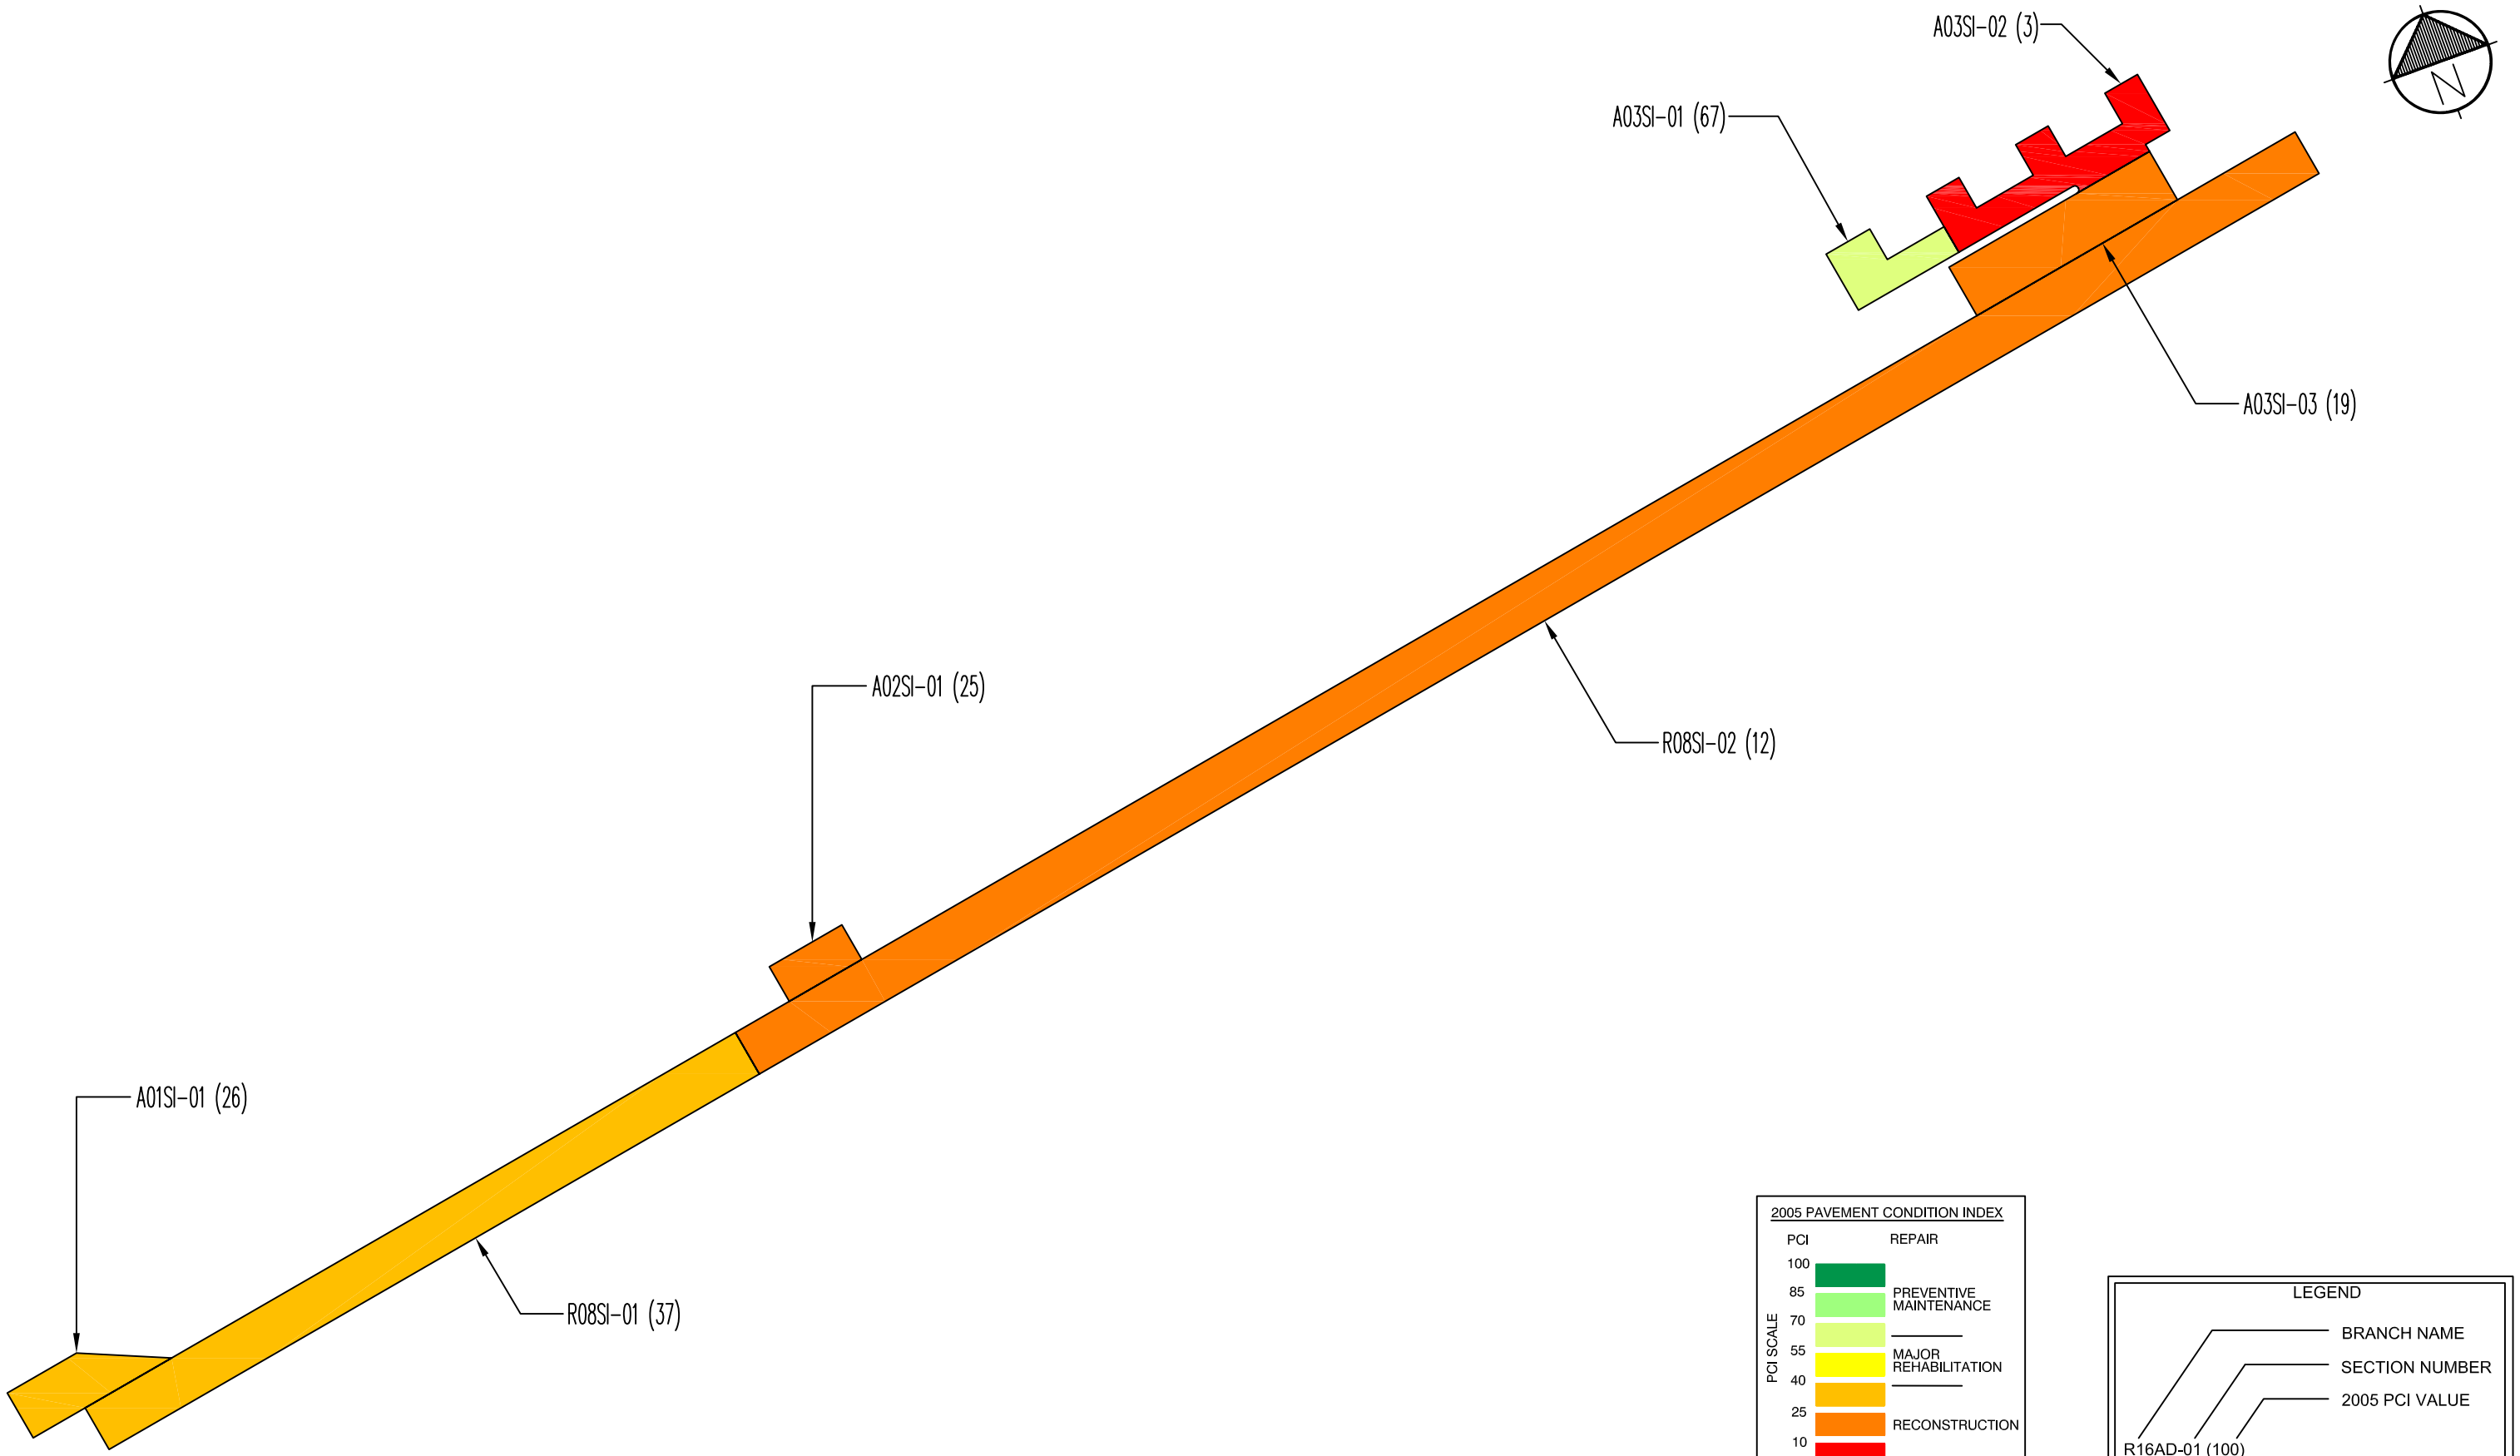
PAGE TITLE: 2005 Pavement Condition Index Map

Figures 6 and 7 summarize the overall condition of the pavements at the Sekiu Airport. Figure 8 displays the condition of the pavements evaluated. Table 1 summarizes the results of the pavement evaluation. Appendix C presents photographs taken during the PCI inspection and Appendix D details the distresses observed during the visual survey.

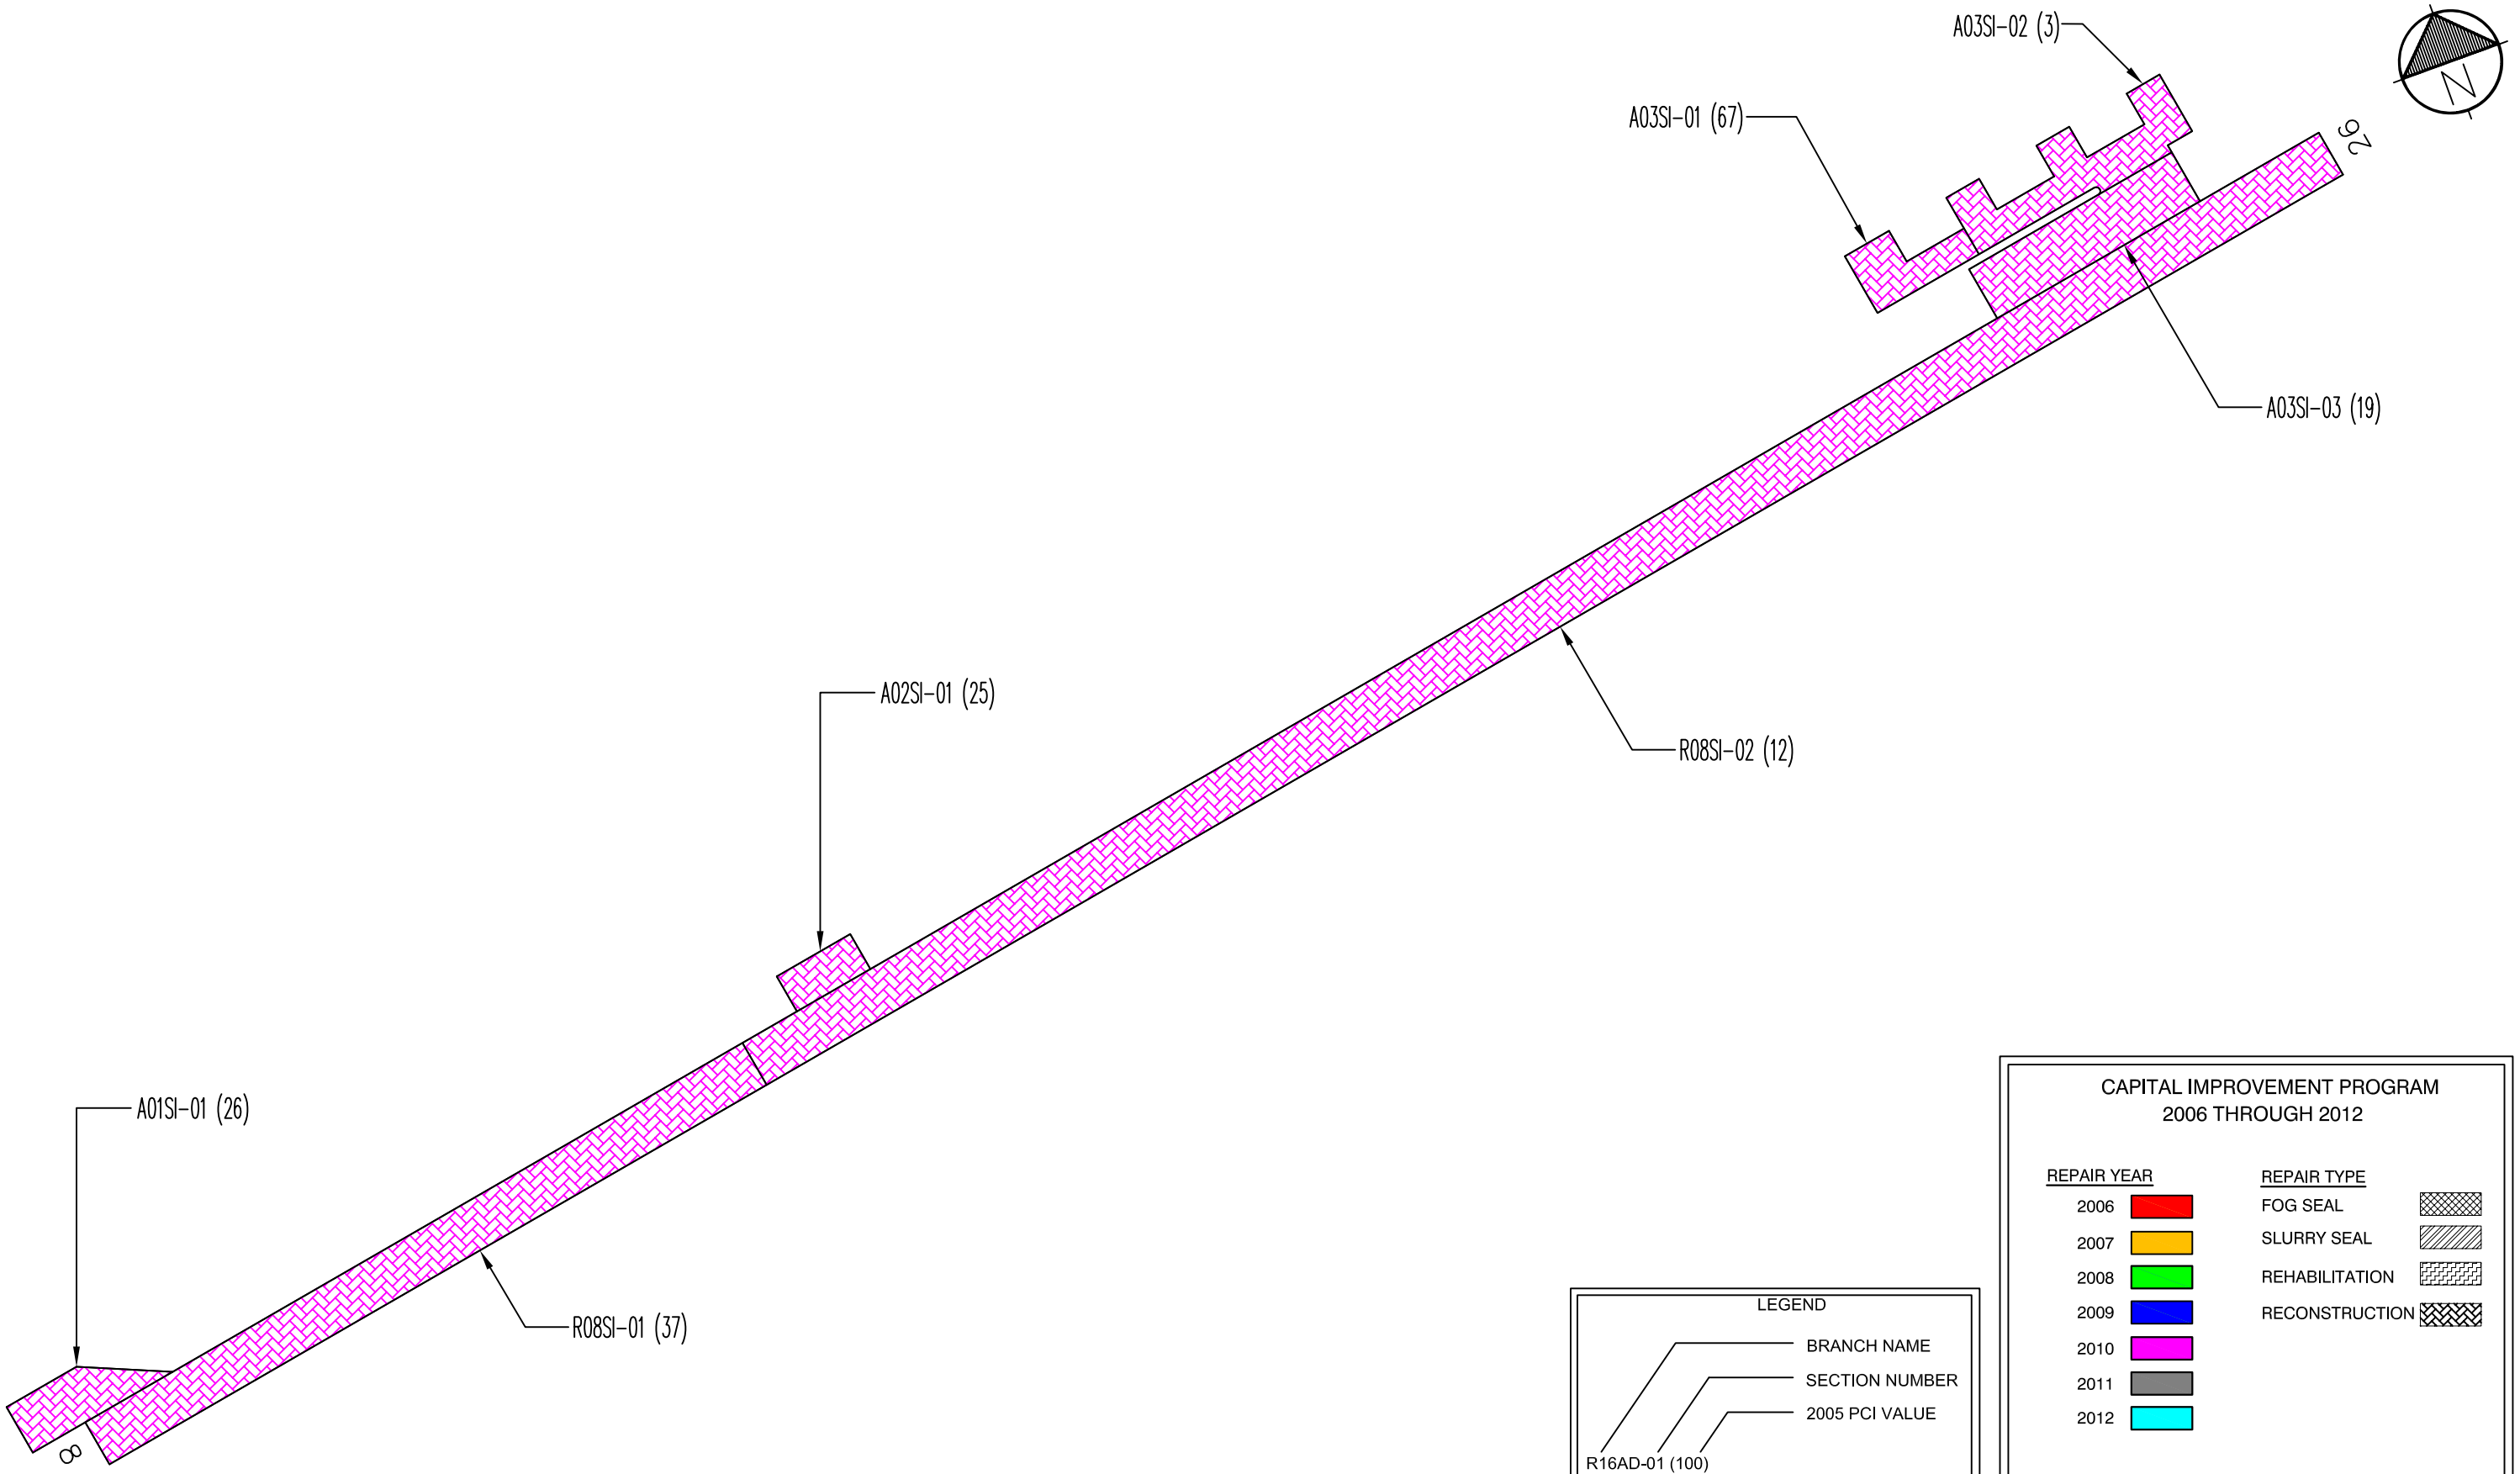
CAPITAL IMPROVEMENT PROGRAM
2006 THROUGH 2012

A summary of the pavement repair program for Sekiu Airport is presented in Table 4 and in Figure 9. Detailed information on the localized maintenance plan for 2006 is contained in Appendix F.

The recommendations presented in this report are based upon a broad network-level analysis and are meant to provide Sekiu Airport with an indication of the type of pavement-related work required during the next seven years. Further engineering investigation may be needed to identify which repair action is most appropriate. In addition, the cost estimates provided are based on a statewide policy, and Sekiu Airport should adjust the plan to reflect local costs.
