GRAND COULEE DAM AIRPORT
2005 PAVEMENT MANAGEMENT REPORT

February 2006

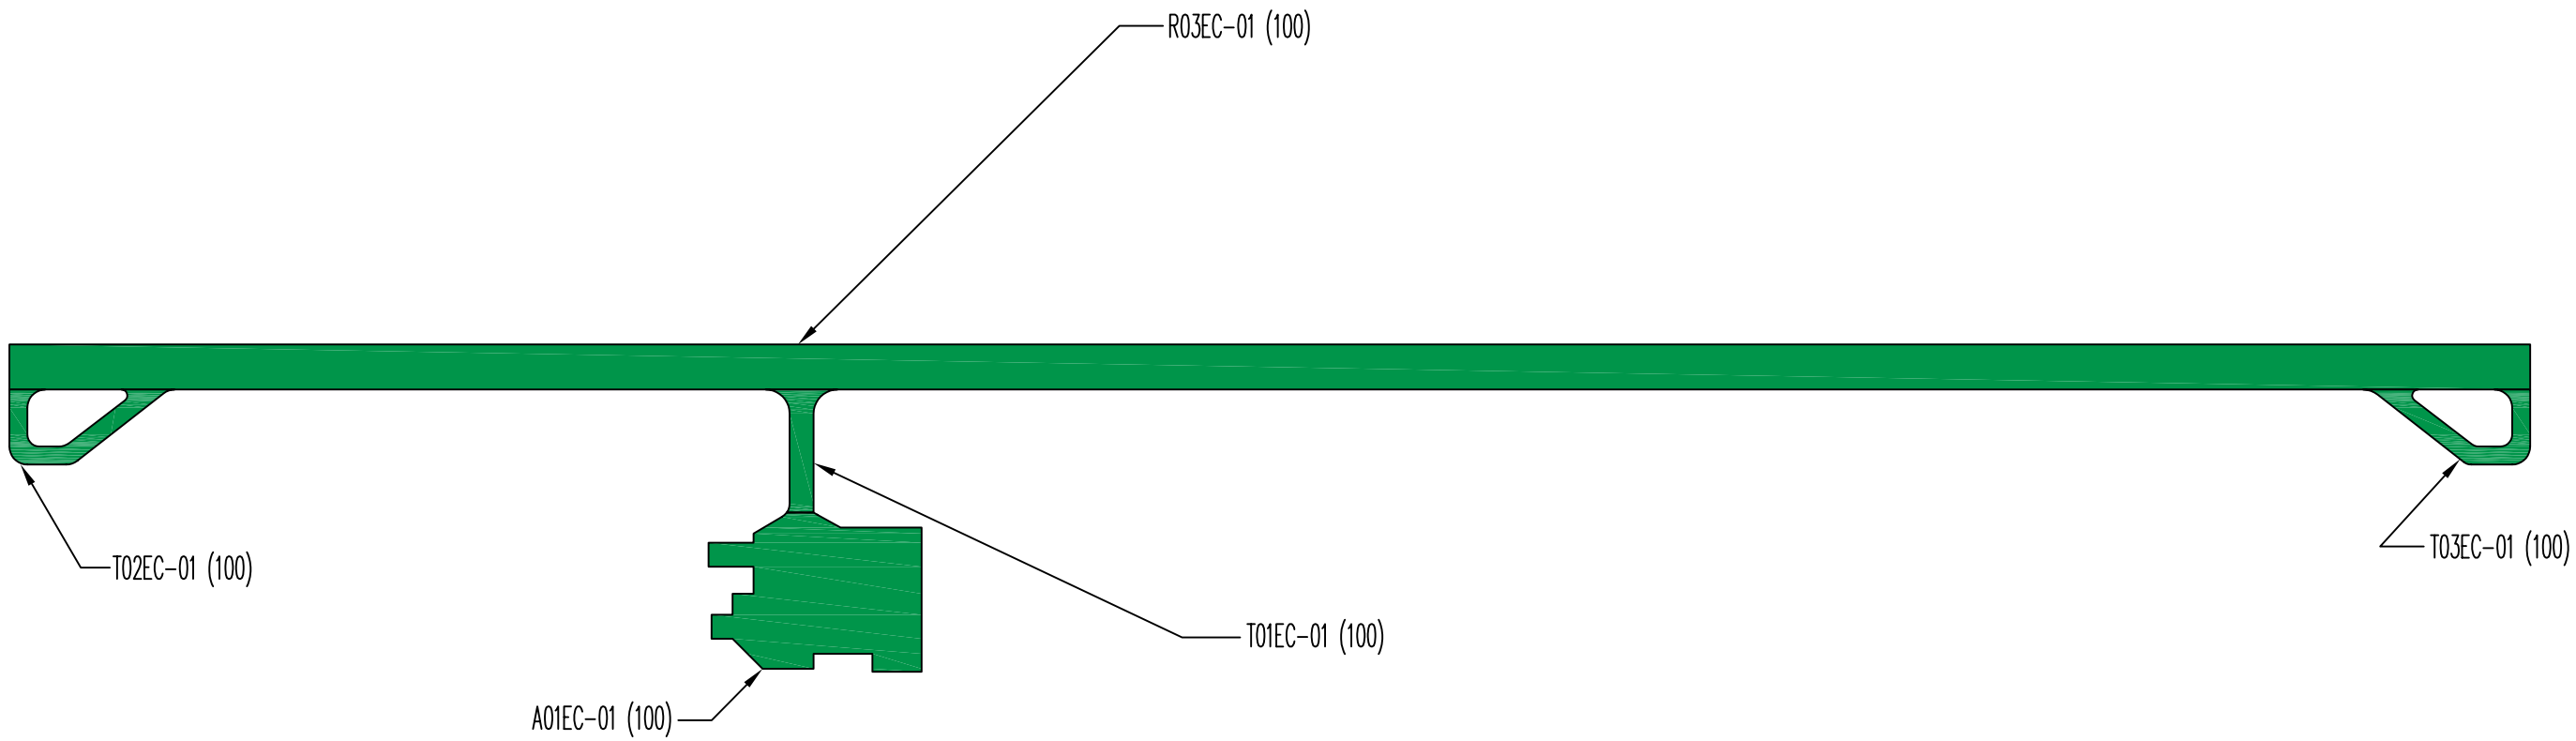
LOCATION: Grand Coulee Dam Airport, Electric City, Washington			
PAGE TITLE: 2005 Pavement Condition Index Map			
DRAWING SCALE: 1" = 300'	DATE: February 2006	REVISED BY: AM	DRAWN BY: AM
FILENAME: Electric City.dwg	AIRPORT ID: WA21	LAYOUT NAME/NUMBER: EC (PCI)	PAGE NUMBER: 9

Figures 6 and 7 summarize the overall condition of the pavements at the Grand Coulee Dam Airport. Figure 8 displays the condition of the pavements evaluated. Table 1 summarizes the condition of the pavements, which assumes that no visible signs of deterioration were present after the rehabilitation work was completed. Appendix C would normally present photographs taken during the PCI inspection and Appendix D would provide detailed information on the distresses observed during the visual survey; however, since an inspection was not conducted after the rehabilitation work was completed these two appendixes are blank.

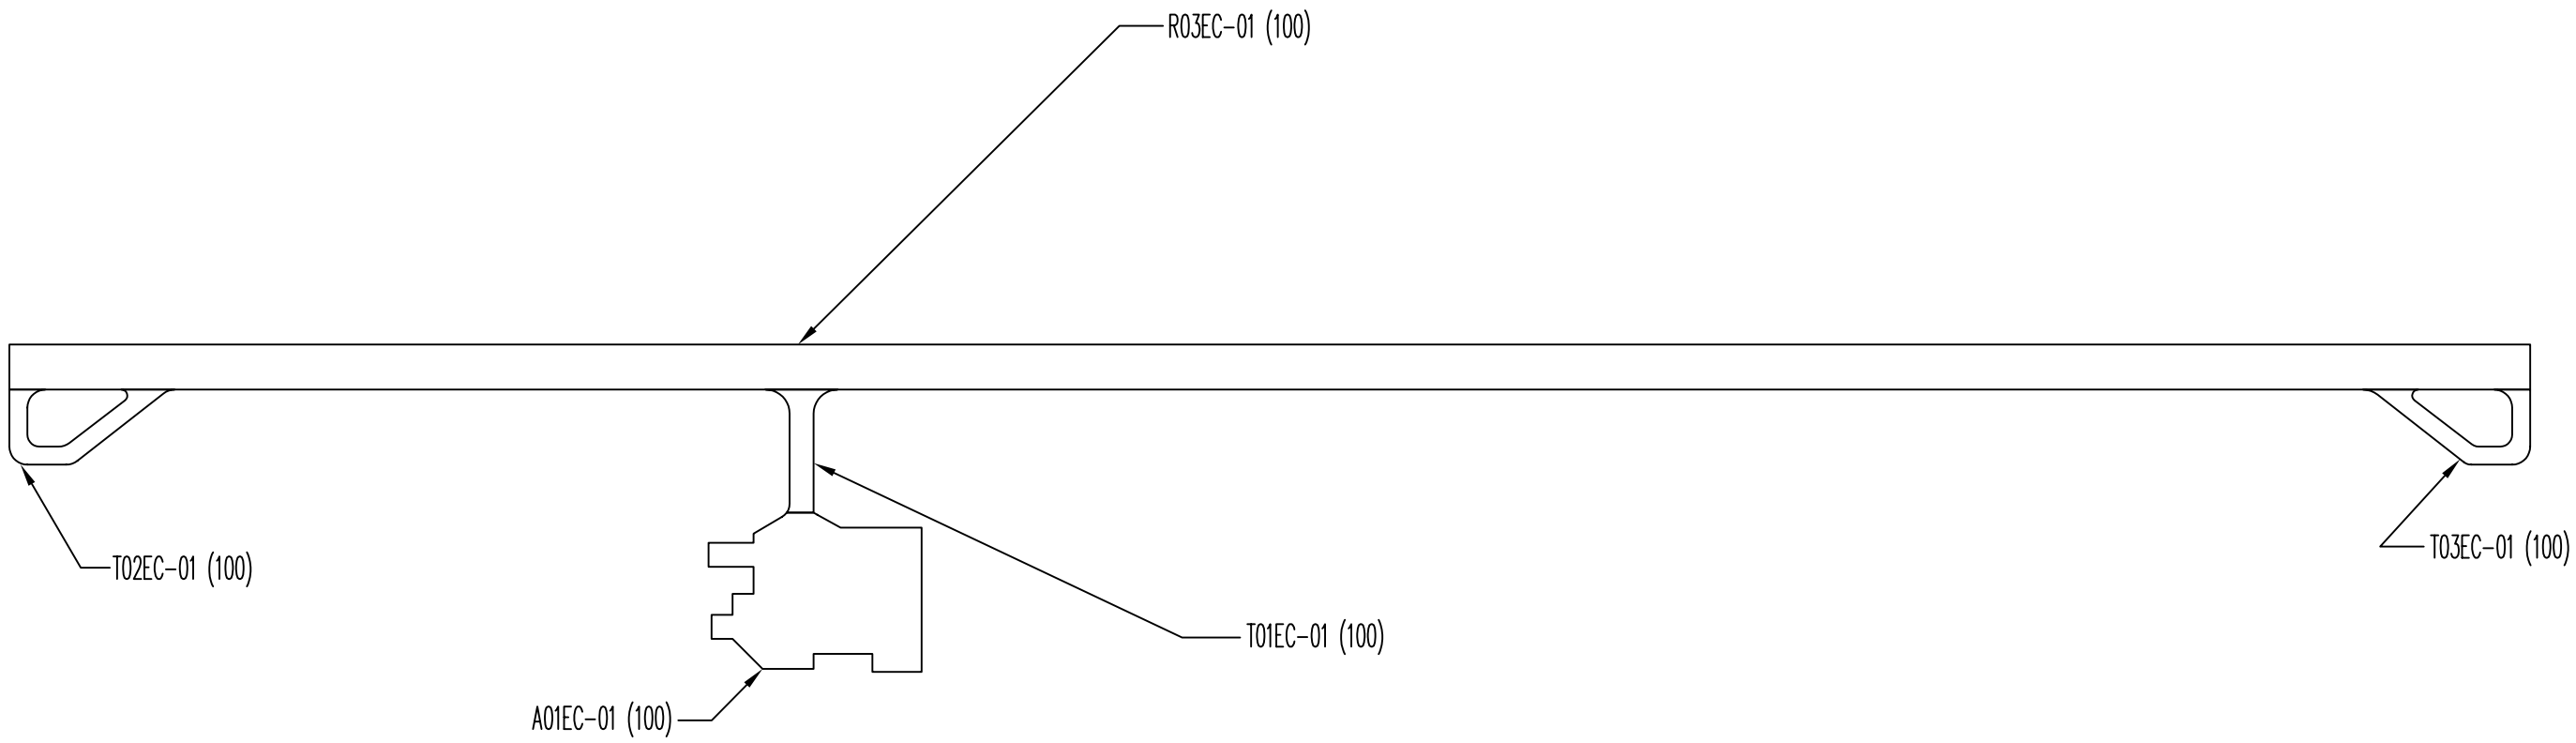
NO MAJOR REHABILITATION NEEDS HAVE BEEN IDENTIFIED FOR 2006 TO 2012.
CONTINUE TO MONITOR PAVEMENT FOR CHANGES IN CONDITION.
