4. TITLE AND SUBTITLE	5. REPORT DATE
Fatigue Cracking of Riveted Steel Tied Arch and Truss Bridges	March 1998
	6. PERFORMING ORGANIZATION CODE
7. AUTHOR(S)	8. PERFORMING ORGANIZATION REPORT NO.
Charles W. Roeder, Gregory A. MacRae, Kyoko Arima, Paul N. Crocker, Scott D. Wong	
9. PERFORMING ORGANIZATION NAME AND ADDRESS	10. WORK UNIT NO.
Washington State Transportation Center (TRAC) University of Washington, Bx 354802 University District Building; 1107 NE 45th Street, Suite 535 Seattle, Washington 98105-4631	11. CONTRACT OR GRANT NO. Contract T9903, Task 60
12. SPONSORING AGENCY NAME AND ADDRESS	13. TYPE OF REPORT AND PERIOD COVERED
Washington State Department of Transportation Transportation Building, MS 7370 Olympia, Washington 98504-7370	Research Report
	14. SPONSORING AGENCY CODE

Research Report
Research Project T9903, Task 60
Steel Bridge Cracking

FATIGUE CRACKING OF RIVETED STEEL TIED ARCH AND TRUSS BRIDGES

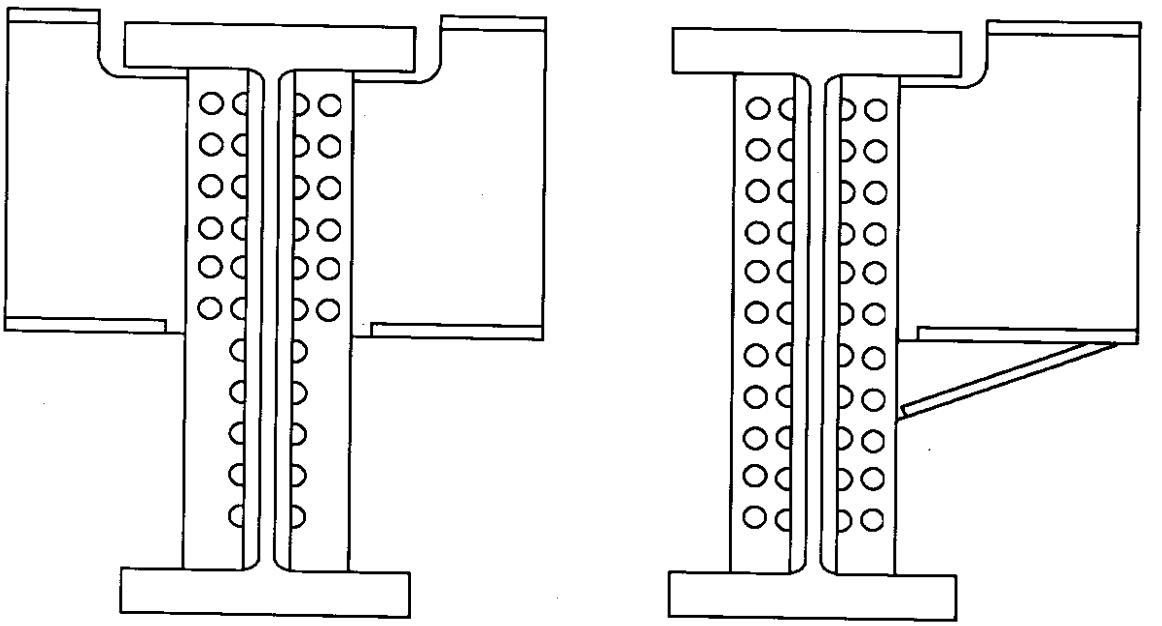
a) Coped Web Angle Connection

b) Stiffened Seat Connection

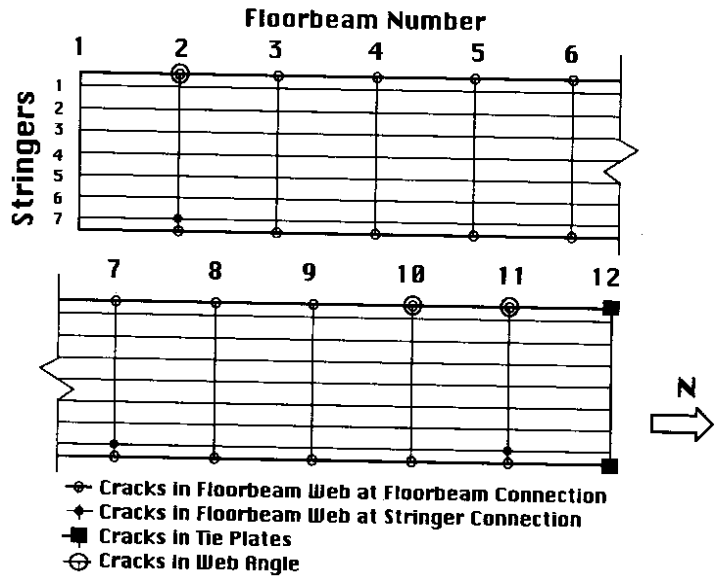
center. There is no skew in the structure, and the arch and deck system are symmetric. The north end is pinned, and the south end is movable. The bridge is known to be flexible and lively under truck traffic, and fatigue cracking of the floorbeam web at the floorbeam-to-chord connection has occurred at all interior floorbeam connections. This type of cracking is illustrated in Figure 5. In addition, three of the web angles at these same floorbeam-to-chord connections have exhibited cracking. In 1989, these floorbeam to chord connections were repaired. The top flanges of the floorbeams were connected to the top flange of the chord by a flange plate to eliminate distortion of the connection. Since that date, crack initiation has moved down the web of the floorbeam at the stringer-to-floorbeam connection.

In the abutment floorbeams of the Toutle River Bridge, the abutment floorbeam was directly connected to the chord from the original construction with a flange plate. Two of these riveted flange plates have experienced serious fatigue cracking and have required replacement. Figure 9 illustrates the locations of cracking noted in the Toutle River Bridge.

Figure 9. Locations of Cracking Noted for the Toutle River Bridge

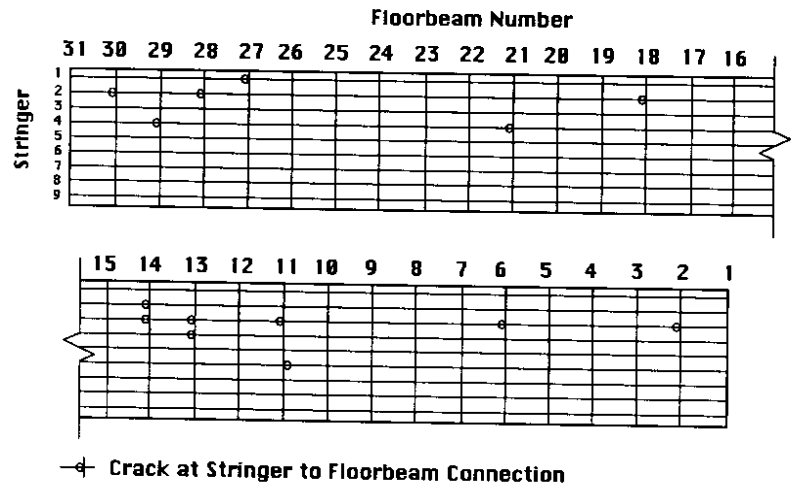
The Lewis River Bridge is 246.9 m long, with 30 bays in the truss and floor system. Each bay of floor framing has nine stringers, which are 1.777 m on center. The trusses are 15.55 m apart center to center, and the bridge deck has no skew with respect to the abutments and the longitudinal axis. However, the two interior piers are sharply skewed at a skew angle of approximately 43.4° between the longitudinal axis of the bridge and the axis of the internal piers. The result of this internal skew means that the deck system is symmetric, but there is a substantial asymmetry in the truss system. The south end of the bridge is pinned, and the interior piers and north abutment are movable. Fatigue cracking, as illustrated in Figure 3, has been noted at the stringer to floor beam connections at 14 locations of the bridge deck. Most of these locations are in the second or third stringers from the west side of the bridge under the right hand driving lane. Figure 10 illustrates the locations of cracking noted for the Lewis River Bridge.

Figure 10. Locations of Cracking on the Lewis River Bridge

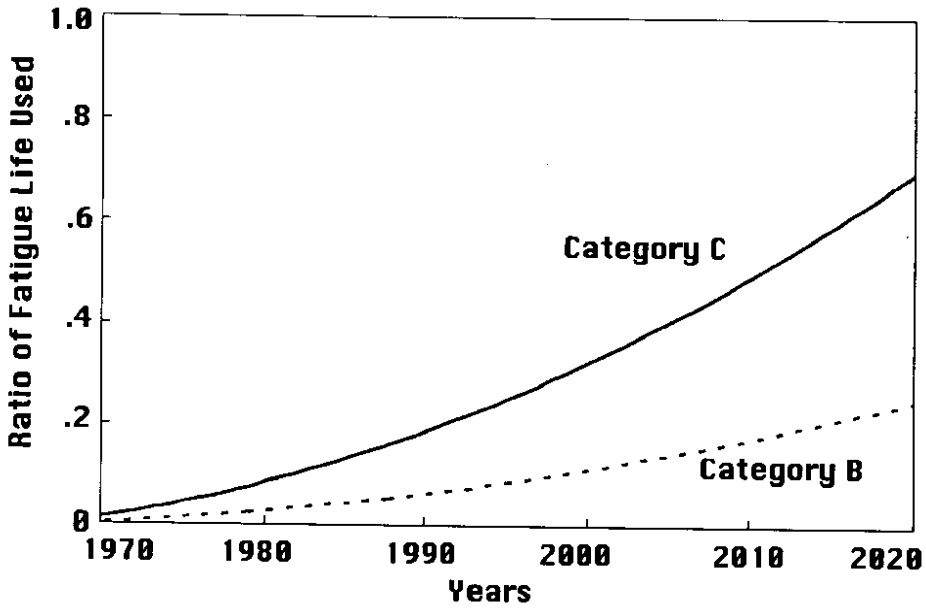
Figure 41. Estimated Fatigue Life for Stringer Cope Detail on the Toutle River Bridge

Figure 41 suggests that the Toutle River bridge will have used less than 70 percent of its fatigue life by the year 2020 AD. This suggests that fatigue cracking at this location is not a serious problem for the Toutle River bridge. Note that no cracks have been observed at this connection at the Toutle River site. Figure 42 suggests that cracking should be noted at these connections for the Lewis River bridge starting in the mid-1980s and full fracture of these connections should be expected by approximately 2005 AD. In evaluating these observations, it must be recognized that the AASHTO S-N curves are selected to be approximately 2 standard deviations from the mean. Thus, fracture would be expected only on a small portion of these elements at the times noted. Furthermore, the stress range will have achieved the largest number of cycles only for the stringers under the right hand lane. This again appears to be consistent with observed behavior on the Lewis River bridge, since a number of cracks have been noted primarily in the stringers under the right lane. The S-N curves used in this analysis were the S-N curves for non-redundant stress conditions. Non-redundant S-N curves have an allowable stress range that is 80 percent of that for the normal redundant curves. When this decrease in the stress range is

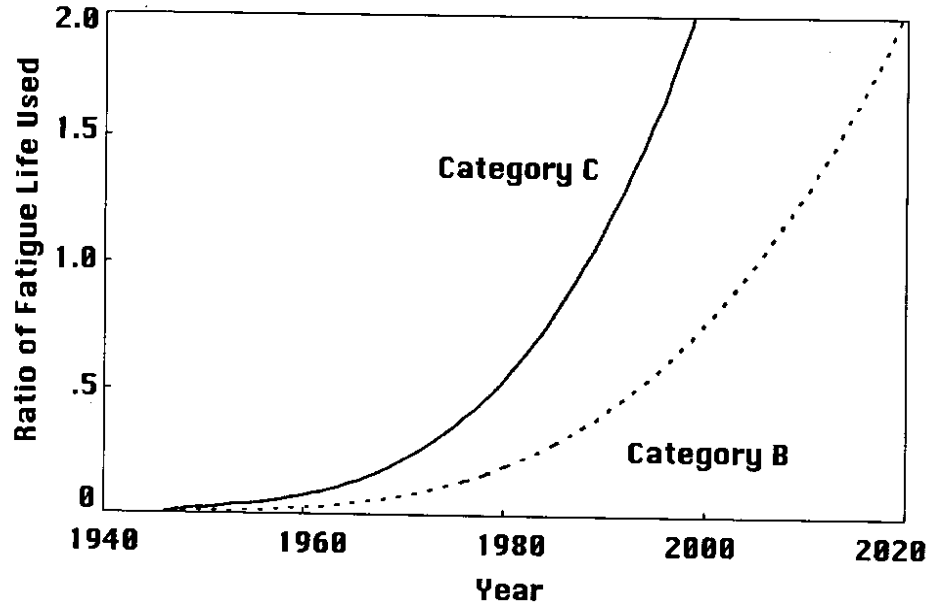
Figure 42. Estimated Fatigue Life for Stringer Cope Detail on the Lewis River Bridge

applied in Equation 4, the fatigue life ratio is reduced to approximately 51 percent of that expected with redundant S-N curves. The issue of redundancy is important because the stringers are closely spaced in parallel, and some load sharing clearly occurs. The net effect of these factors is that the curves in Figure 42 and 43 must be treated as lower bound estimates of the true fatigue life. The use of redundant fatigue S-N curves would mean that fatigue fracture should not occur until a fatigue life ratio of nearly 2.0 has been achieved. However, the good agreement between these Lewis River predictions and the actual cracking noted on that bridge suggest that this lower bound is not too far from the true solution.

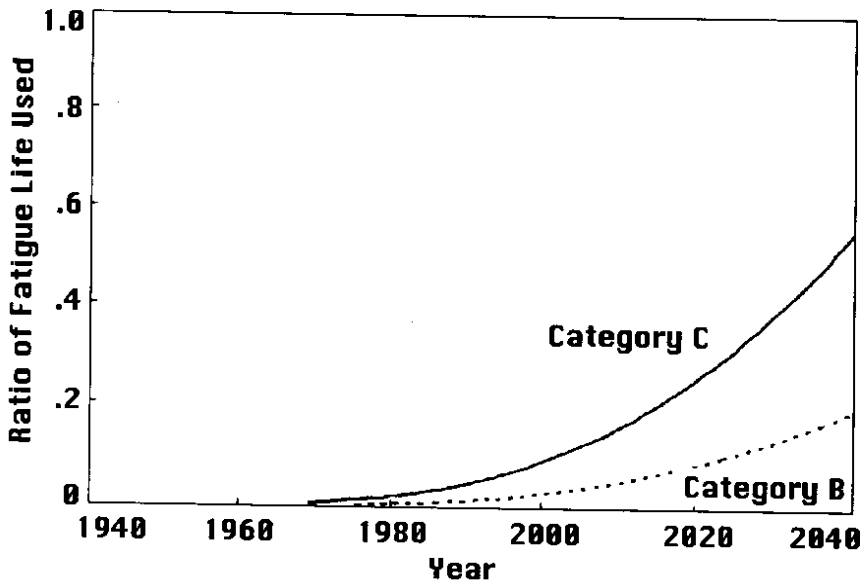
Figure 43. Maximum Upper Bound Fatigue Life Estimate for the Stringers on the Lewis River Bridge

The large difference in the fatigue life expected for the stringers for the Lewis River and Toutle River bridge was somewhat unexpected because the Toutle River bridge stringers are smaller, with larger spacing, than the Lewis River bridge stringers. The primary factors that contribute to this reduced fatigue life are the greater number of truck cycles and the greater end restraint measured for the Lewis River Bridge stringers. One may question whether the end restraint is maintained after cracking occurs. Ductile behavior would reduce this end restraint, and this ductility could extend the fatigue life of the elements, but fracture is not a particularly ductile mode of behavior. Furthermore, the previous discussion showed that Figures 41 and 42 are lower bound estimates of the fatigue life. As a result, the fatigue life calculation was modified to evaluate the maximum fatigue life that could be expected under the most favorable circumstances. This modified calculation is a clear upper bound and can be achieved only if significant ductility is retained in the cracked connection. It assumes no rotational restraint at the stringer-to-floorbeam connection and employs redundant S-N curves. Figure 43 illustrates this upper bound estimate for the Lewis River bridge. This figure shows that if this ductility is achieved, fatigue fracture is a far less serious problem at this location. This figure also shows that elimination of the end rotational restraint of the stringer-to-floorbeam connections could

significantly increase the fatigue life of these connections. These analyses provide no information regarding the repairs made to these connections, and this remains a question of further consideration.

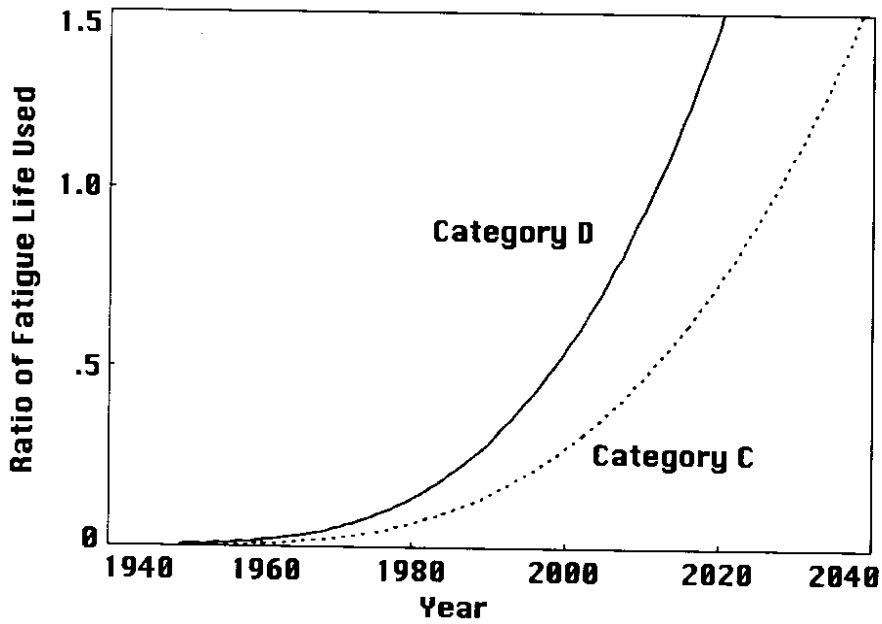
Figure 45. Estimated Fatigue Life of the Floorbeam at the Second Coverplate Termination.

The floorbeams and floorbeam connections of the Lewis River bridge required additional consideration. The connection between the floorbeam and the truss hangers develops very little rotational restraint, and so the connection appears to be less susceptible to fatigue than the floorbeam member. The floorbeams for the Lewis River bridge are riveted, built-up members with multiple riveted coverplate terminations, as illustrated in the sketch of Figure 44. There is limited information for selecting S-N curves for elements of this type, but research by Fisher suggests that the elements may initiate visible cracking when the stress range history reaches the Category D S-N curve, and fatigue fracture may conservatively be estimated with Category C S-N curve. There is no redundancy for these floorbeams, so the more conservative non-redundant S-N curves were employed. The members were checked at maximum moment and other critical locations. Ultimately the second cover plate termination was found to be the most critical location, and Figure 45 shows the fatigue life predictions for this coverplate termination. This critical termination point is well within its fatigue life, but cracking may be expected in the coming years. Because Category C is probably a conservative estimate of fatigue life, the figure suggests that cracking at these locations can be anticipated during the years 2005 to 2025 AD. Beyond this critical location, it appears that the floorbeams of both bridges are less sensitive to fatigue cracking than other parts of the structure.

It is surprising that the floorbeams of the Lewis River bridge are more sensitive to fatigue cracking than the floorbeams of the Toutle River bridge, since numerous cracks have been noted on the Toutle River floorbeams but none have been noted for the Lewis River floorbeams. Later discussion will elaborate on this issue and show the causes of this apparent discrepancy.

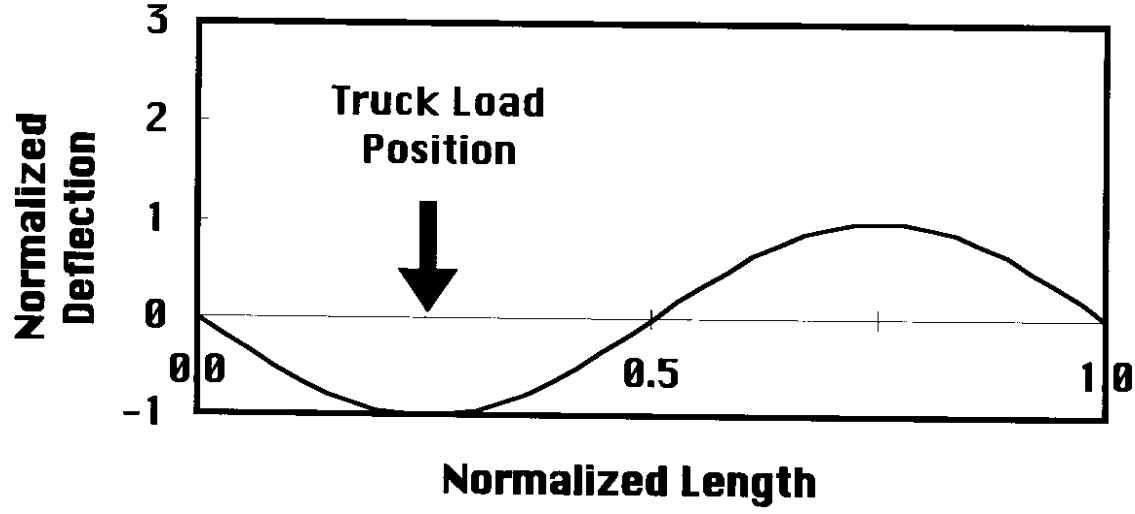
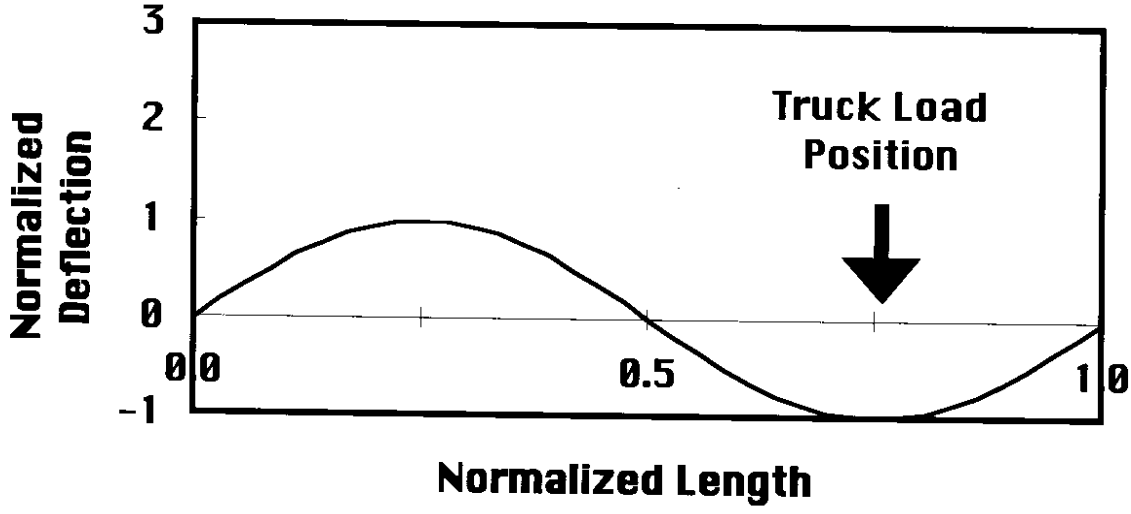
Figure 48. Deflected Shape of Chord of Toutle River Bridge with Relationship to Truck Position

The measured response of the bridge showed that the chord deflects approximately as a full sine wave when a truck crosses the Toutle River bridge. This sine wave deflection is a manifestation of the first mode of vibration. It is excited by the movement of the truck across the bridge, as illustrated in Figure 48.

These large deflections cause time dependent rotations of the chord and the end of the floorbeam because the ends of the floorbeams are attached to the chord. The bridge deck lies on the top flanges of the stringers and floor beams, which are at the same level as the top of the chord. Figure 48a shows that the deflected shape of the bridge induces tensile stress in the right hand portion of the bridge deck and compressive stress in the other half of the deck slab. Figure 48b shows that these stresses are reversed when the truck moves to the 3/4 span portion of the bridge deck. Although the deflected shape attempts to axially deform the deck, it is unable to do this effectively. The floorbeams are

not stiff enough or strong enough in torsion or weak axis bending to develop these forces and moments needed to deform the deck. As a result, significant twisting of the floorbeam occurs over the short length between the tie chord and the first one or two stringers.

Some shortening or lengthening of the top of the chord occurs because of limited compressive or tensile stress developing in the slab, as noted earlier. However, there must be relative movement between the deck and the top of the chord because the floorbeams are unable to transmit the large forces and moments necessary to fully stress the slab. This twisting and differential rotation was measured (Crocker 1997) in the experiments. At the same time, relative movement between the deck slab and the steel framing was measured. This differential slip and differential rotation and twist are the main contributing factors to the deformation driven fatigue in the Toutle River floorbeams.

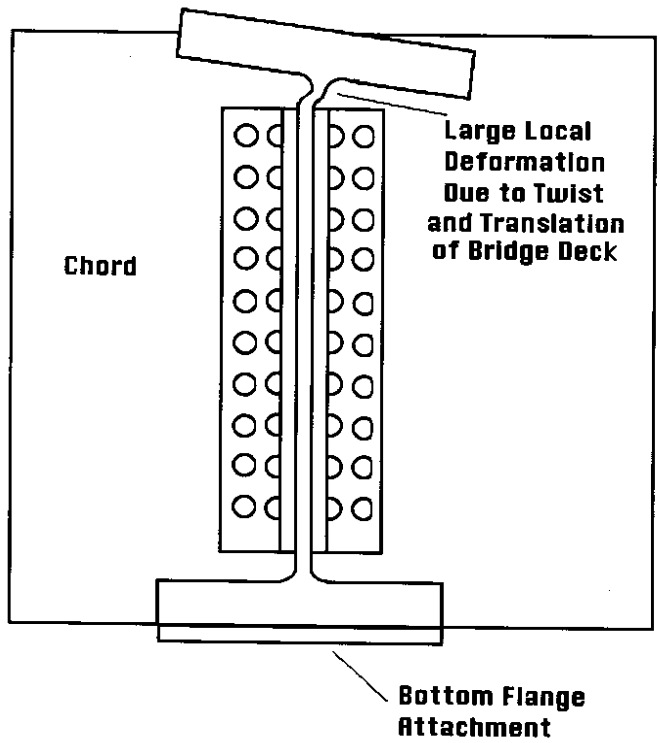
Figure 49. Local Deformation in Floorbeam Web at Floorbeam to Chord Connection
