Final Research Report
Research Project T2695, Task 35
Bucoda Phase III

LONG-TERM PERFORMANCE OF GEOTEXTILE SEPARATORS BUCODA TEST SITE—PHASE III

October 2005

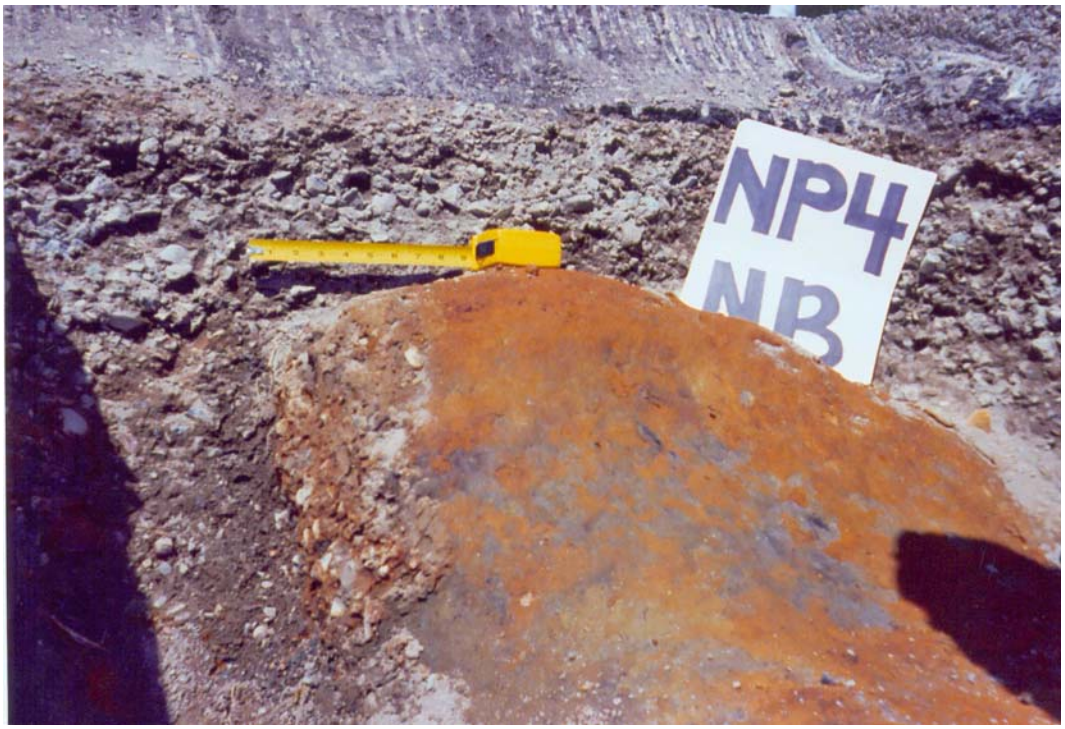
Figure 3.36. Photo of wave in NP4-NB subgrade. Tear was below end of tape measure.
