Research Project WA-RD 491.1
Soil Bioengineering for Slopes

SOIL BIOENGINEERING FOR UPLAND SLOPE STABILIZATION

February 2001

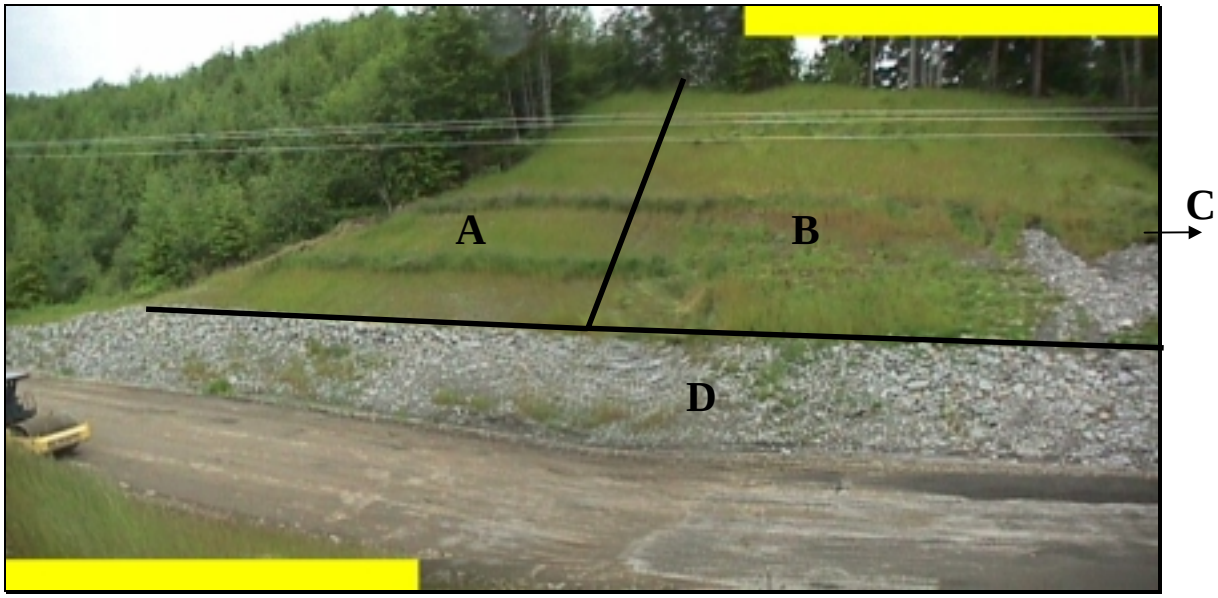
Figure 11. Site 3

<u>Site 3 - Section A</u>
Grasses were effective in stabilizing surface erosion. To maintain surface stability and to prevent shallow rapid landsliding:

Grasses were effective in stabilizing surface erosion of upper B section. Below this upper section, however, grasses had minimal effect in preventing erosion. Within Site 1, Section C experienced the highest level of surface erosion (rills and gullies). This erosion was caused by overland flow and insufficient plant cover and root development. To maintain stability, inhibit additional surface erosion, and prevent shallow rapid landsliding:

Starting above rock apron, construct continuous row of *willow fence.*
Dimensions: continuous length and 2 foot height. Use 3 foot to 4 foot long willows for stakes to support fencing. Additional instructions can be found in the soil bioengineering technical manual. Once constructed, fill behind *willow fence* with soil (preferably a silt loam).

Construct “live gully repairs” in all gullies, except the one already filled with rock. Use willow stems 1 inch to 2 inch diameter and length determined by depth of gully. Additional instructions can be found in the soil bioengineering technical manual.

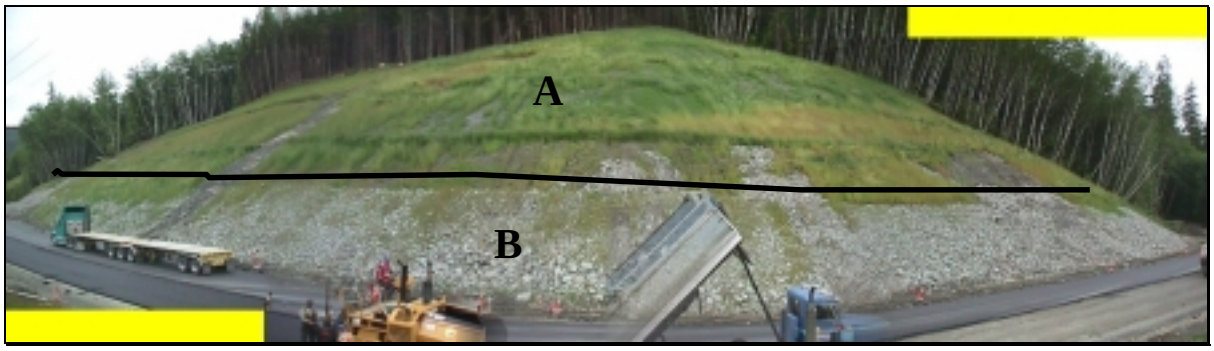
Figure 12. Site 5 before treatment

Grass minimized surface erosion. Within Site 5, Section A experienced the highest level of surface erosion. This erosion was caused by high rainfall and subsequent saturated soils. This condition led to excess overland flow and draining hay bales. There was insufficient plant cover and root development to maintain slope stability. To inhibit additional surface erosion and shallow rapid landsliding:

Concurrent with this decision, the head scarp on Site 5 began rapidly moving, this rotational failure moved 10-15 feet within a week. A WSDOT geotechnical engineer was brought in, and upon field review, placed this site on WSDOT's list of major erosion sites to be considered for engineering solutions. This confirmed the PI's decision to discontinue soil bioengineering on Site 5.

Install "branchpacking" in shallow rapid landslide. Use willow stems ½ inch to 2 inch diameter. Additional instructions can be found in the soil bioengineering technical manual.

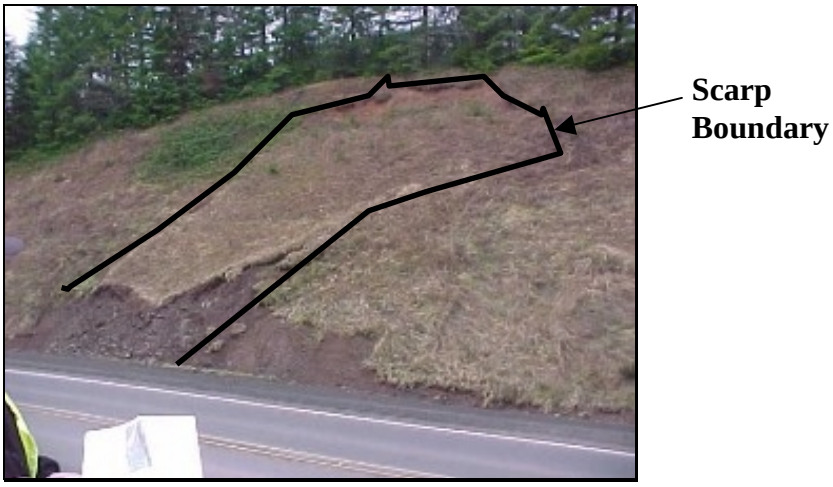
Figure 17. Area of Instability

Soils on this 591 feet long by 112 feet high east-facing slope are composed of marine sedimentary rocks that are weathered. Small shallow rapid landslides have occurred where these weathered clay layers have left slope sections exposed to water movement. With excess surface and subsurface moisture, these layers slipped and moved downhill into the ditch. To manage stormwater runoff, maintenance activities required clearing of these plugged ditch lines. In doing so, the base of the shallow rapid landslide was undercut, leaving a portion of the area with an exposed vertical face. During the year, the slope would "adjust," move again into the ditch line, leaving a larger head scarp exposed to surface and subsurface water movement.
