**Final Research Report**
Research Project T9903, Task 72
Advanced Technology Branch Support

# AN EVALUATION OF MOTORIST AID CALL BOXES IN WASHINGTON

WA-RD 420.1

November, 1996

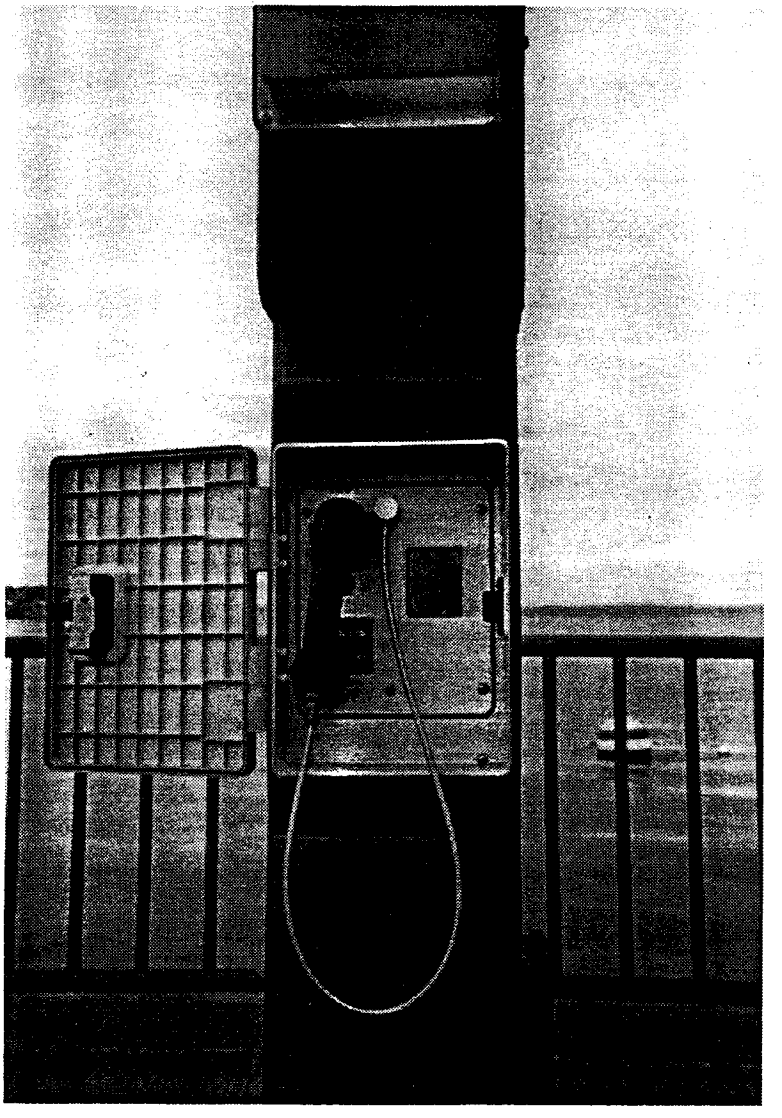
Figure 2. Design Problems with Wireline Call Boxes

- corrosion build-up on the internal circuit board inside the call box; the phone may quit working or will make false 911 calls
- doors left open and cords hanging out; the door does not have spring action to allow automatic closure and the long phone cord must be coiled to fit inside (see Figure 2)
- no central control is available; maintenance personnel have to check system operation by attending each phone to test its ability to call 911.
