**Site and Reach Assessment  
Evaluation of Treatment Alternatives**

**SR 530/Sauk River Chronic Environmental Deficiency Site**

**April 21, 2004**

**Washington State Department of Transportation**  
Environmental and Engineering Service Center  
Environmental Services Office

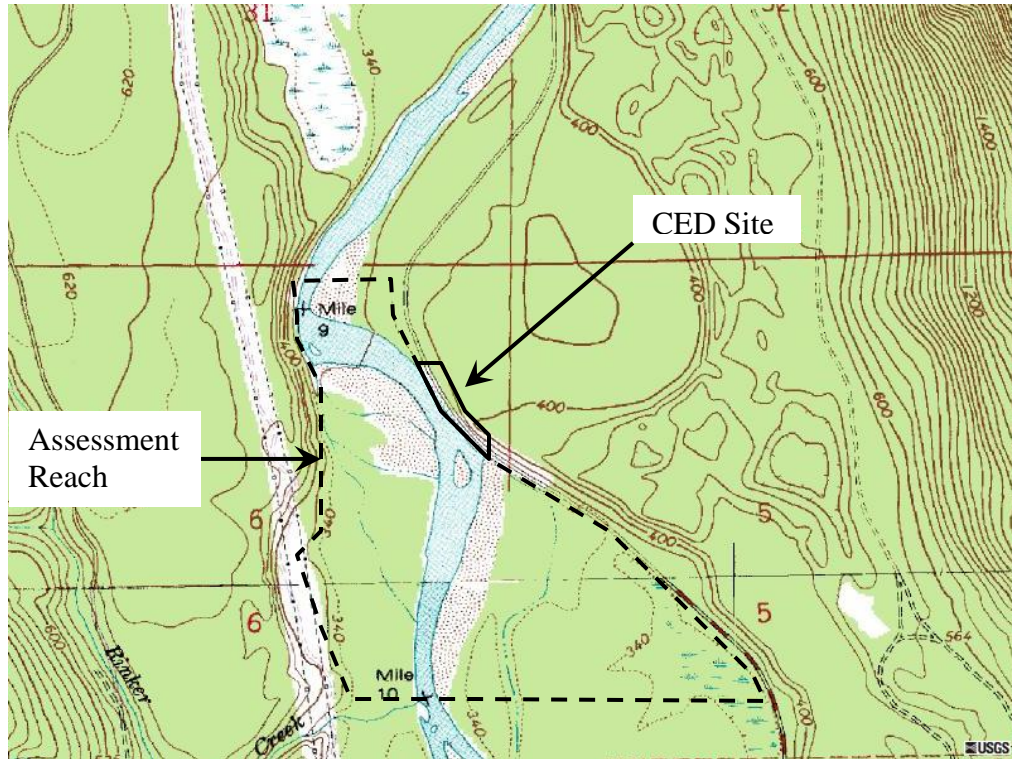
**Figure 5.** SR 530 CED assessment reach.

A shift in the channel alignment induced by last fall's event has caused the main thread of the river to impinge on the bank at a 45° angle of attack (the previous channel alignment had been nearly parallel to the bank) along the outside of a meander bend (Figure 5). This particular configuration guarantees that the largest erosional forces (shear stress and fluid momentum) in this reach will be exerted on the site. Two potential adverse outcomes for the streambank and roadway prism may be foreseen:

The project reach for geomorphic analysis (Figure 5) extends from the confluence of Rinker Creek and the Sauk River at approximately RM 10, downstream to the next meander bend below the project site (approx. RM 9). This reach encompasses approximately one meander cycle.

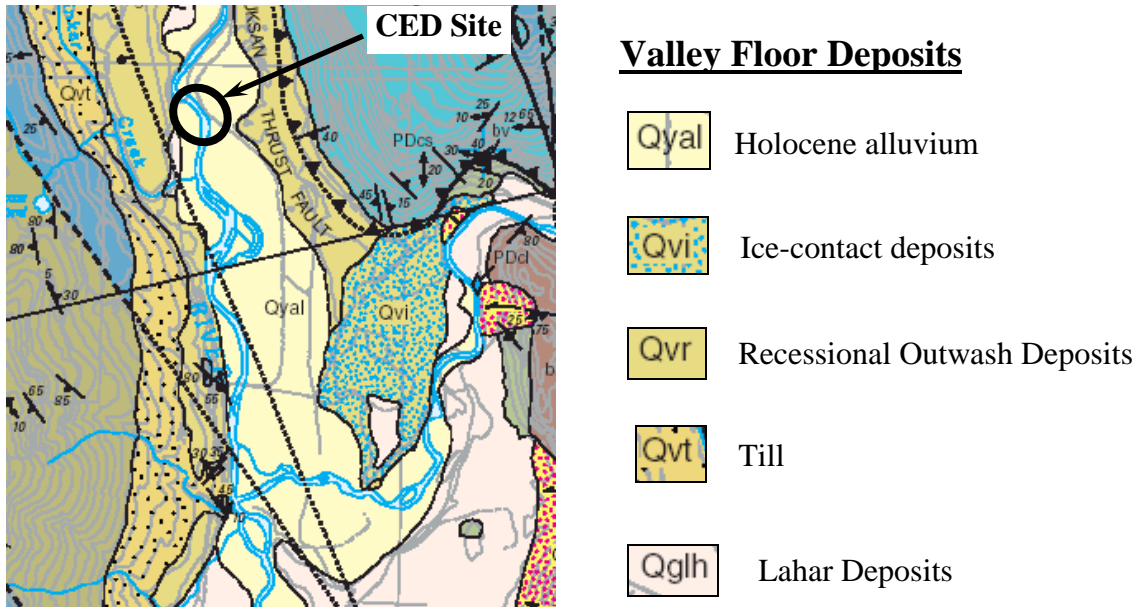
**Figure 7.** Valley floor geology in the vicinity of the SR 530 CED site.

The Sauk River basin is made up of steep, mountainous terrain underlain by a complex mélange of metamorphic, marine sedimentary, and volcanic rocks. The valley floor for the Sauk River is comprised of recessional outwash deposits from the most recent continental glaciation, and lahar (mudflow) deposits from past eruptions of Glacier Peak; these deposits occur as high terraces, or have been reworked since the last glaciation into the alluvium which constitutes the lower terraces and active floodplain (Figure 7). Lateral migration of the channel has exposed terrace deposits immediately above and below the site to form “feeder” bluffs 40 to 60 feet high; these are capable of contributing large quantities of sediment to the river as they are eroded. Erosion of one such bluff on the left bank just upstream of the site caused the loss of a Seattle City Light power line tower during the 1990 event, and may put one or more an additional towers at risk unless measures are taken soon to stabilize the bluff or shore up the tower foundation.
