**Technical Memorandum:  
River Bank Erosion at SR 7, Milepost 4.75,  
Tilton River, Lewis County, WA**

**Work Order MT0265**

**Ed Molash, Hydrologist  
WSDOT Environmental Services  
Hydrology Program**

**July 2010**

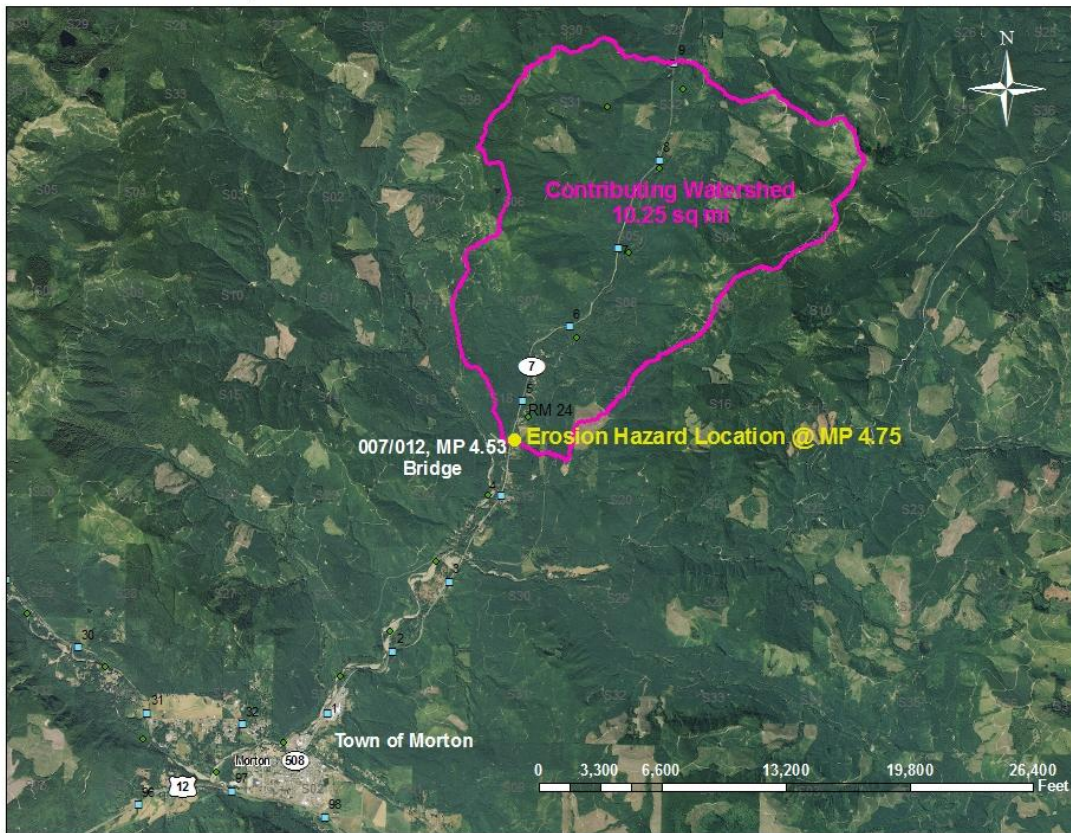
**Figure 1. Location of Bridge 07/012 and the erosion hazard area along the Tilton River.**

This technical memorandum analyzes hydrologic and geomorphic conditions that contribute to an erosional scour problem at milepost 4.75 on SR 7. At this location, a riprap blanket formerly covered the right embankment of the Tilton River next to the northbound lanes of SR 7. This protective blanket has been eroded to the point where the pavement and guard rail are nearly undermined. A utility line, likely for fiber optics, has also been exposed by the erosional scarp. At this location, the Tilton River's thalweg transitions from left bank to the right bank, creating cross flows that collide with the right bank at an angle of approximately 55 degrees. The cross flows impart shear stresses on the bank during high flows and flood flows. The shear stress contributes to undermining the road prism and subsequent failure of the road prism and stream embankment.

There is little documentation of the history of erosion problems at this location. However, the previous erosion problems and repairs are visually apparent. Evidence of previous erosion at this site includes the remnants of a rock blanket that still exists directly downstream of the current erosional scarp and two vertical wood piles that were apparently used to anchor some type of retaining or crib wall. Within the approximately 420 feet between the MP 4.75 erosion site and the (functionally obsolete) 007/012 bridge there are three other erosional scarps that have formed on the right bank, although none currently threaten the highway.

- 1) Very large 4 to 5-man rock revetment, stacked from the toe of the slope up to (at least) the ordinary high water mark.
- 2) Several root wads anchored by the 4 to 5-man rock, projecting three to six feet into the bed of the river at an angle of approximately 55 degrees from perpendicular. The root wads will deflect the river's thalweg away from the bank.
- 3) Quarry spall backfill from the top of the revetment up to the pavement and guardrail.
