**Site and Reach Assessment
Middle Fork Wildcat Creek
At SR 8, MP 5.01
Bridge No. 8/13**

Work Order MS 5454

**Rob Schanz, Hydrologist
WSDOT Environmental Services
Watershed Management Program**

October 2007

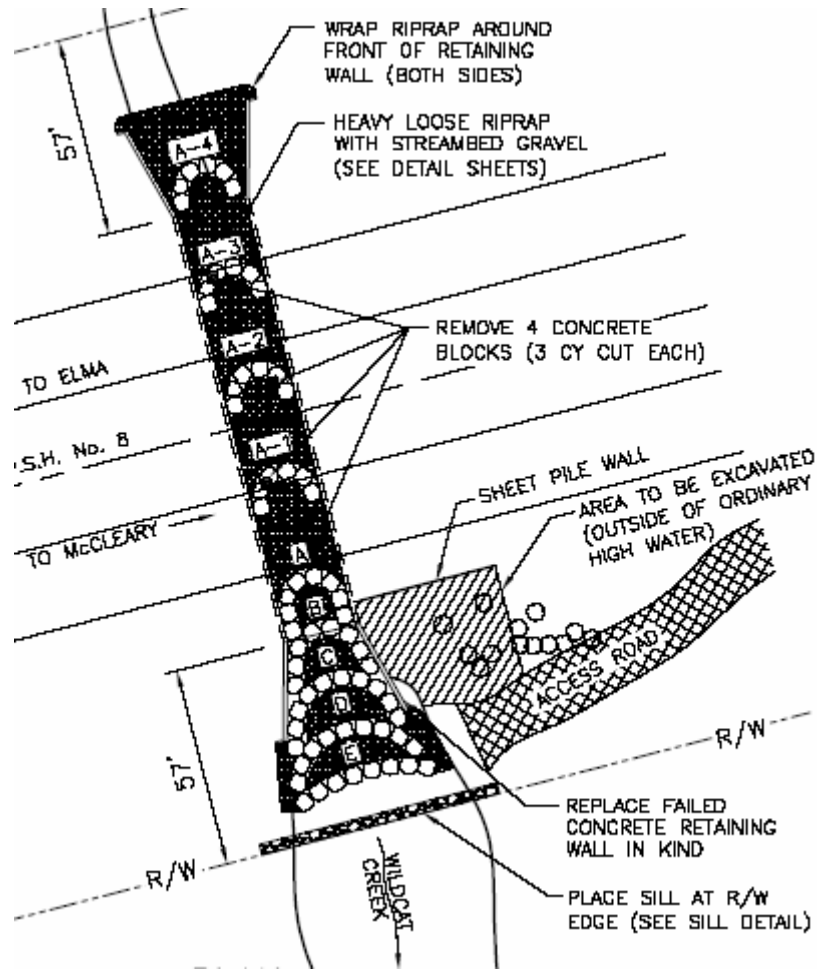
An emergency repair was completed in September 2005 to replace the failed wing wall. The southeast wingwall is now on deeper footings, but the other wingwall foundations are still shallow and vulnerable to undermining. During this repair WSDOT covered all footings with heavy loose riprap, and installed nine boulder drop structures in the culvert and at the exit to control erosion and maintain fish passage (Figure 3). These boulder drop structures were designed to create a series of pools, with a maximum drop of about one foot between pools. The first structure (A-4) is located just upstream of the inlet, and was not visible in April 2007. The next four structures (A-3, A-2, A-1, and A) control the gradient within the culvert. The last four structures step flow down from the outlet to a deep pool near the WSDOT right-of-way boundary. Two rootwads are anchored into heavy loose riprap on each bank at the bottom drop structure (Figure 4).

Figure 3. Design of the Wildcat Creek Drop Structures

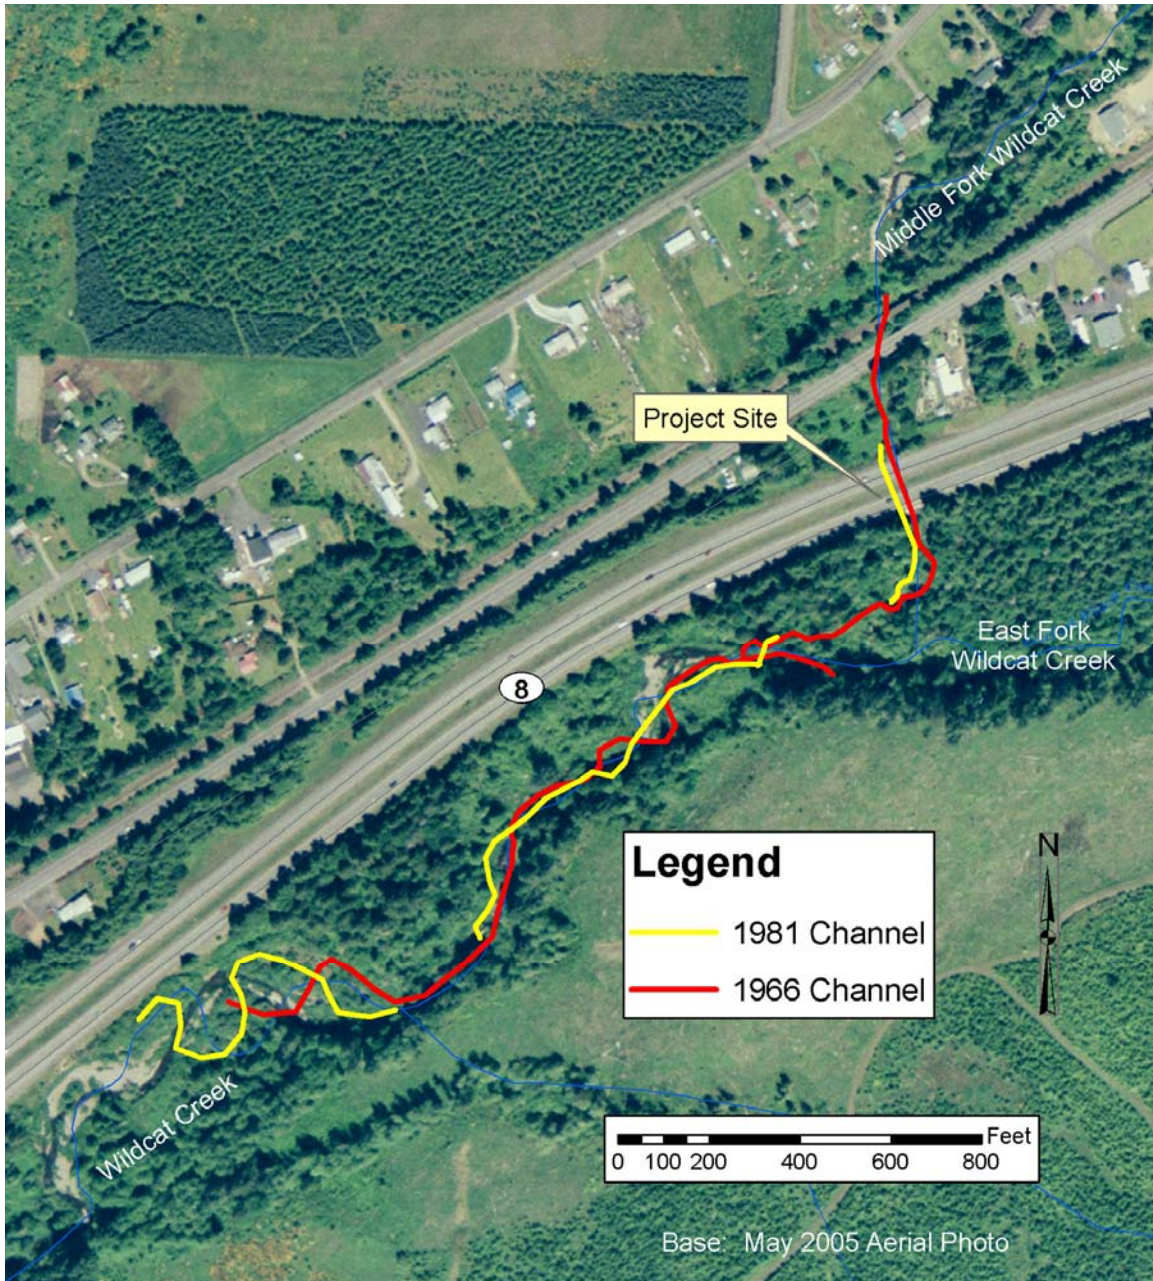
Figure 11 compares channel alignments shown in aerial photos from 1966, 1981, and 2005. In 1966 the creek corridor still showed the impacts of highway construction, when most riparian areas below SR 8 were cleared of mature vegetation. Tree cover in later photos obscures much of the channel, but there is no evidence that the Middle Fork has migrated substantially from its 1966 alignment. Similarly, the East Fork upstream of the confluence is completely obscured by trees and shows little active channel movement or gravel bar growth. This indicates that both forks upstream of the confluence are incised into glacial deposits.

Figure 11. Channel Alignments shown in Historical Aerial Photos

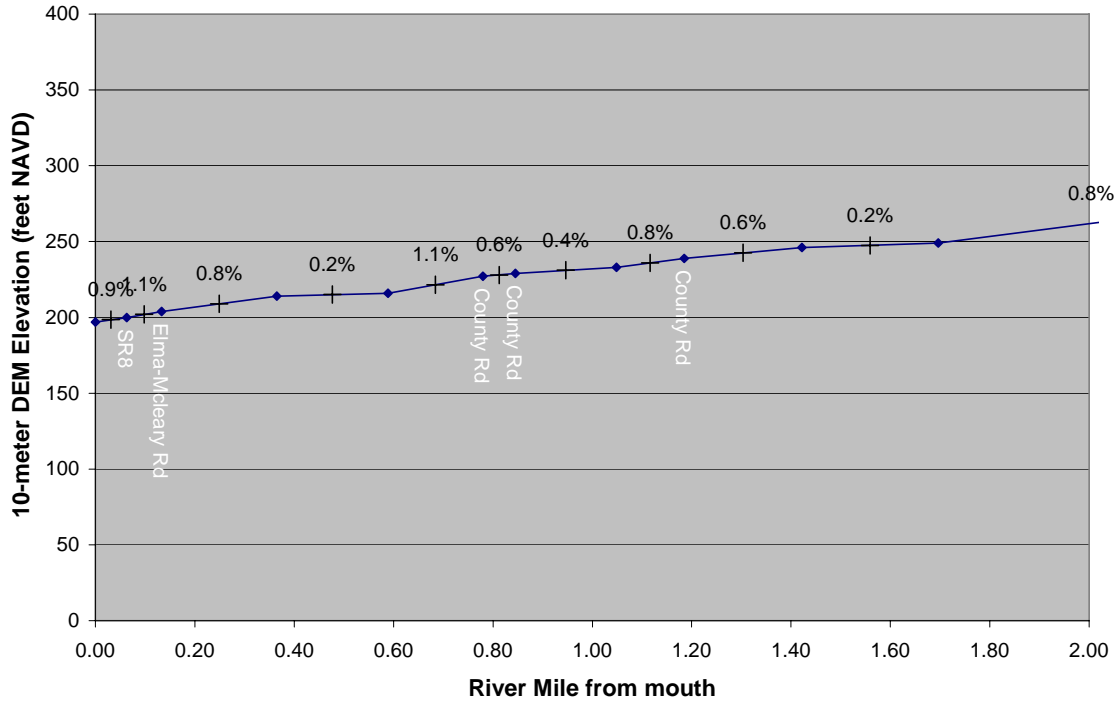
The Middle Fork begins in steep hills about 6 miles upstream of its mouth, and flows steeply for about one mile before emerging onto a plain of glacial deposits. The creek flows across this plain at an overall gradient of about 0.6 to 0.7 percent. The lower valley profile generally consists of a series of flatter steps (0.2 to 0.4 percent gradient) connected by steeper segments flowing at about one percent gradient (Figure 12). The project reach is located in a steeper segment that begins about 1200 feet above Elma -McCleary Road and approaches the SR 8 culvert at a slope of about 1.1 percent. This gradient creates a plane-bed channel with rapid, shallow flow over gravels and cobbles.

Figure 12. Profile of the Lower Middle Fork Wildcat Creek Valley

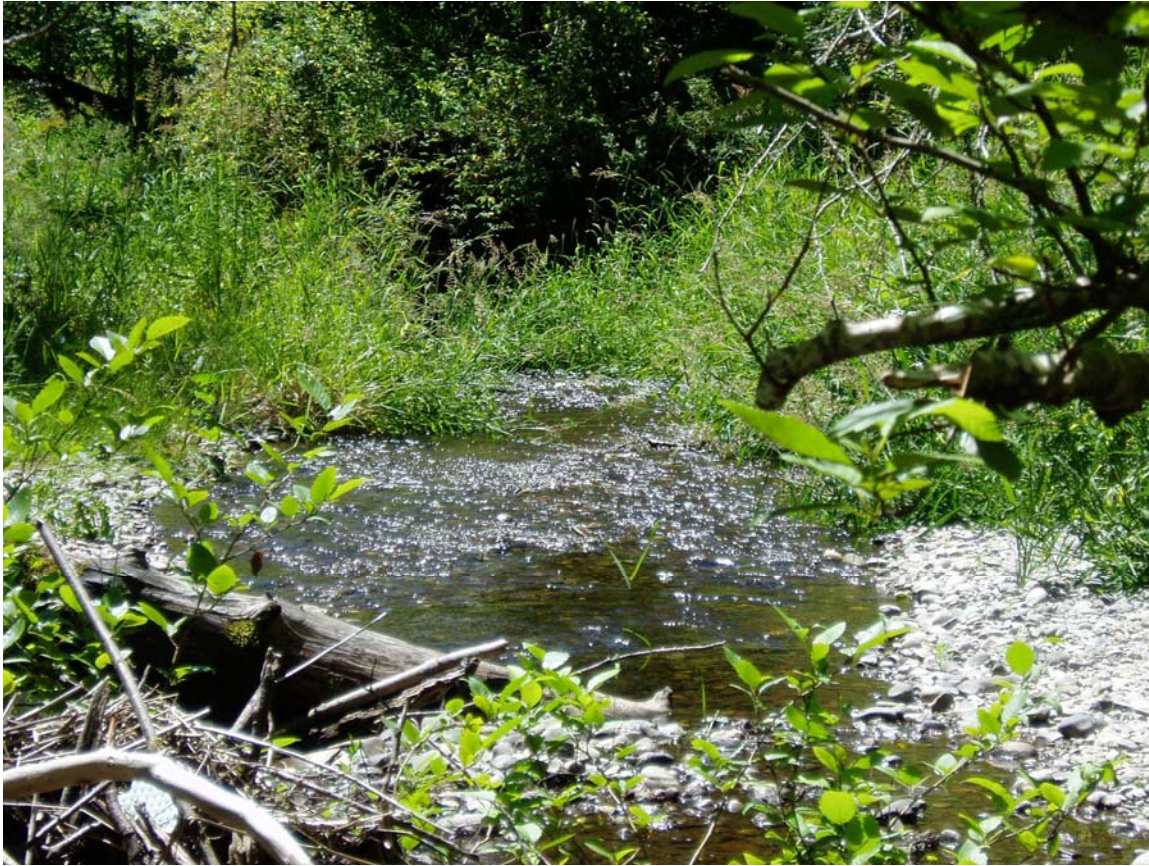
Immediately downstream is a large, approximately four foot deep scour pool which transitions into a long riffle composed of cobble, gravel and a large amount of fines, which is not preferred spawning habitat for chum, steelhead, coho or cutthroat. During a site visit on June 25, 2007 with WDFW, there were coho fry rearing in this pond. The WDFW biologist also noted the pool creates ideal conditions for poaching chum that can't negotiate the fish barrier. Immediately downstream of the tailout were some scour holes with woody debris above them that would serve as cutthroat holding and rearing areas. Mid-stream in this area, 50 feet downstream of pool could serve as chum and steelhead spawning areas after a good winter flush, there are currently too many fines in the substrate; the eggs would be suffocated. About 100 feet downstream is a natural logjam, immediately downstream of that is ideal chum spawning habitat.

Figure 17. Chum Spawning Habitat in the Downstream Riffle
