YAKIMA AIR TERMINAL 2005 PAVEMENT MANAGEMENT REPORT

2005 PAVEMENT MANAGEMENT REPORT

February 2006

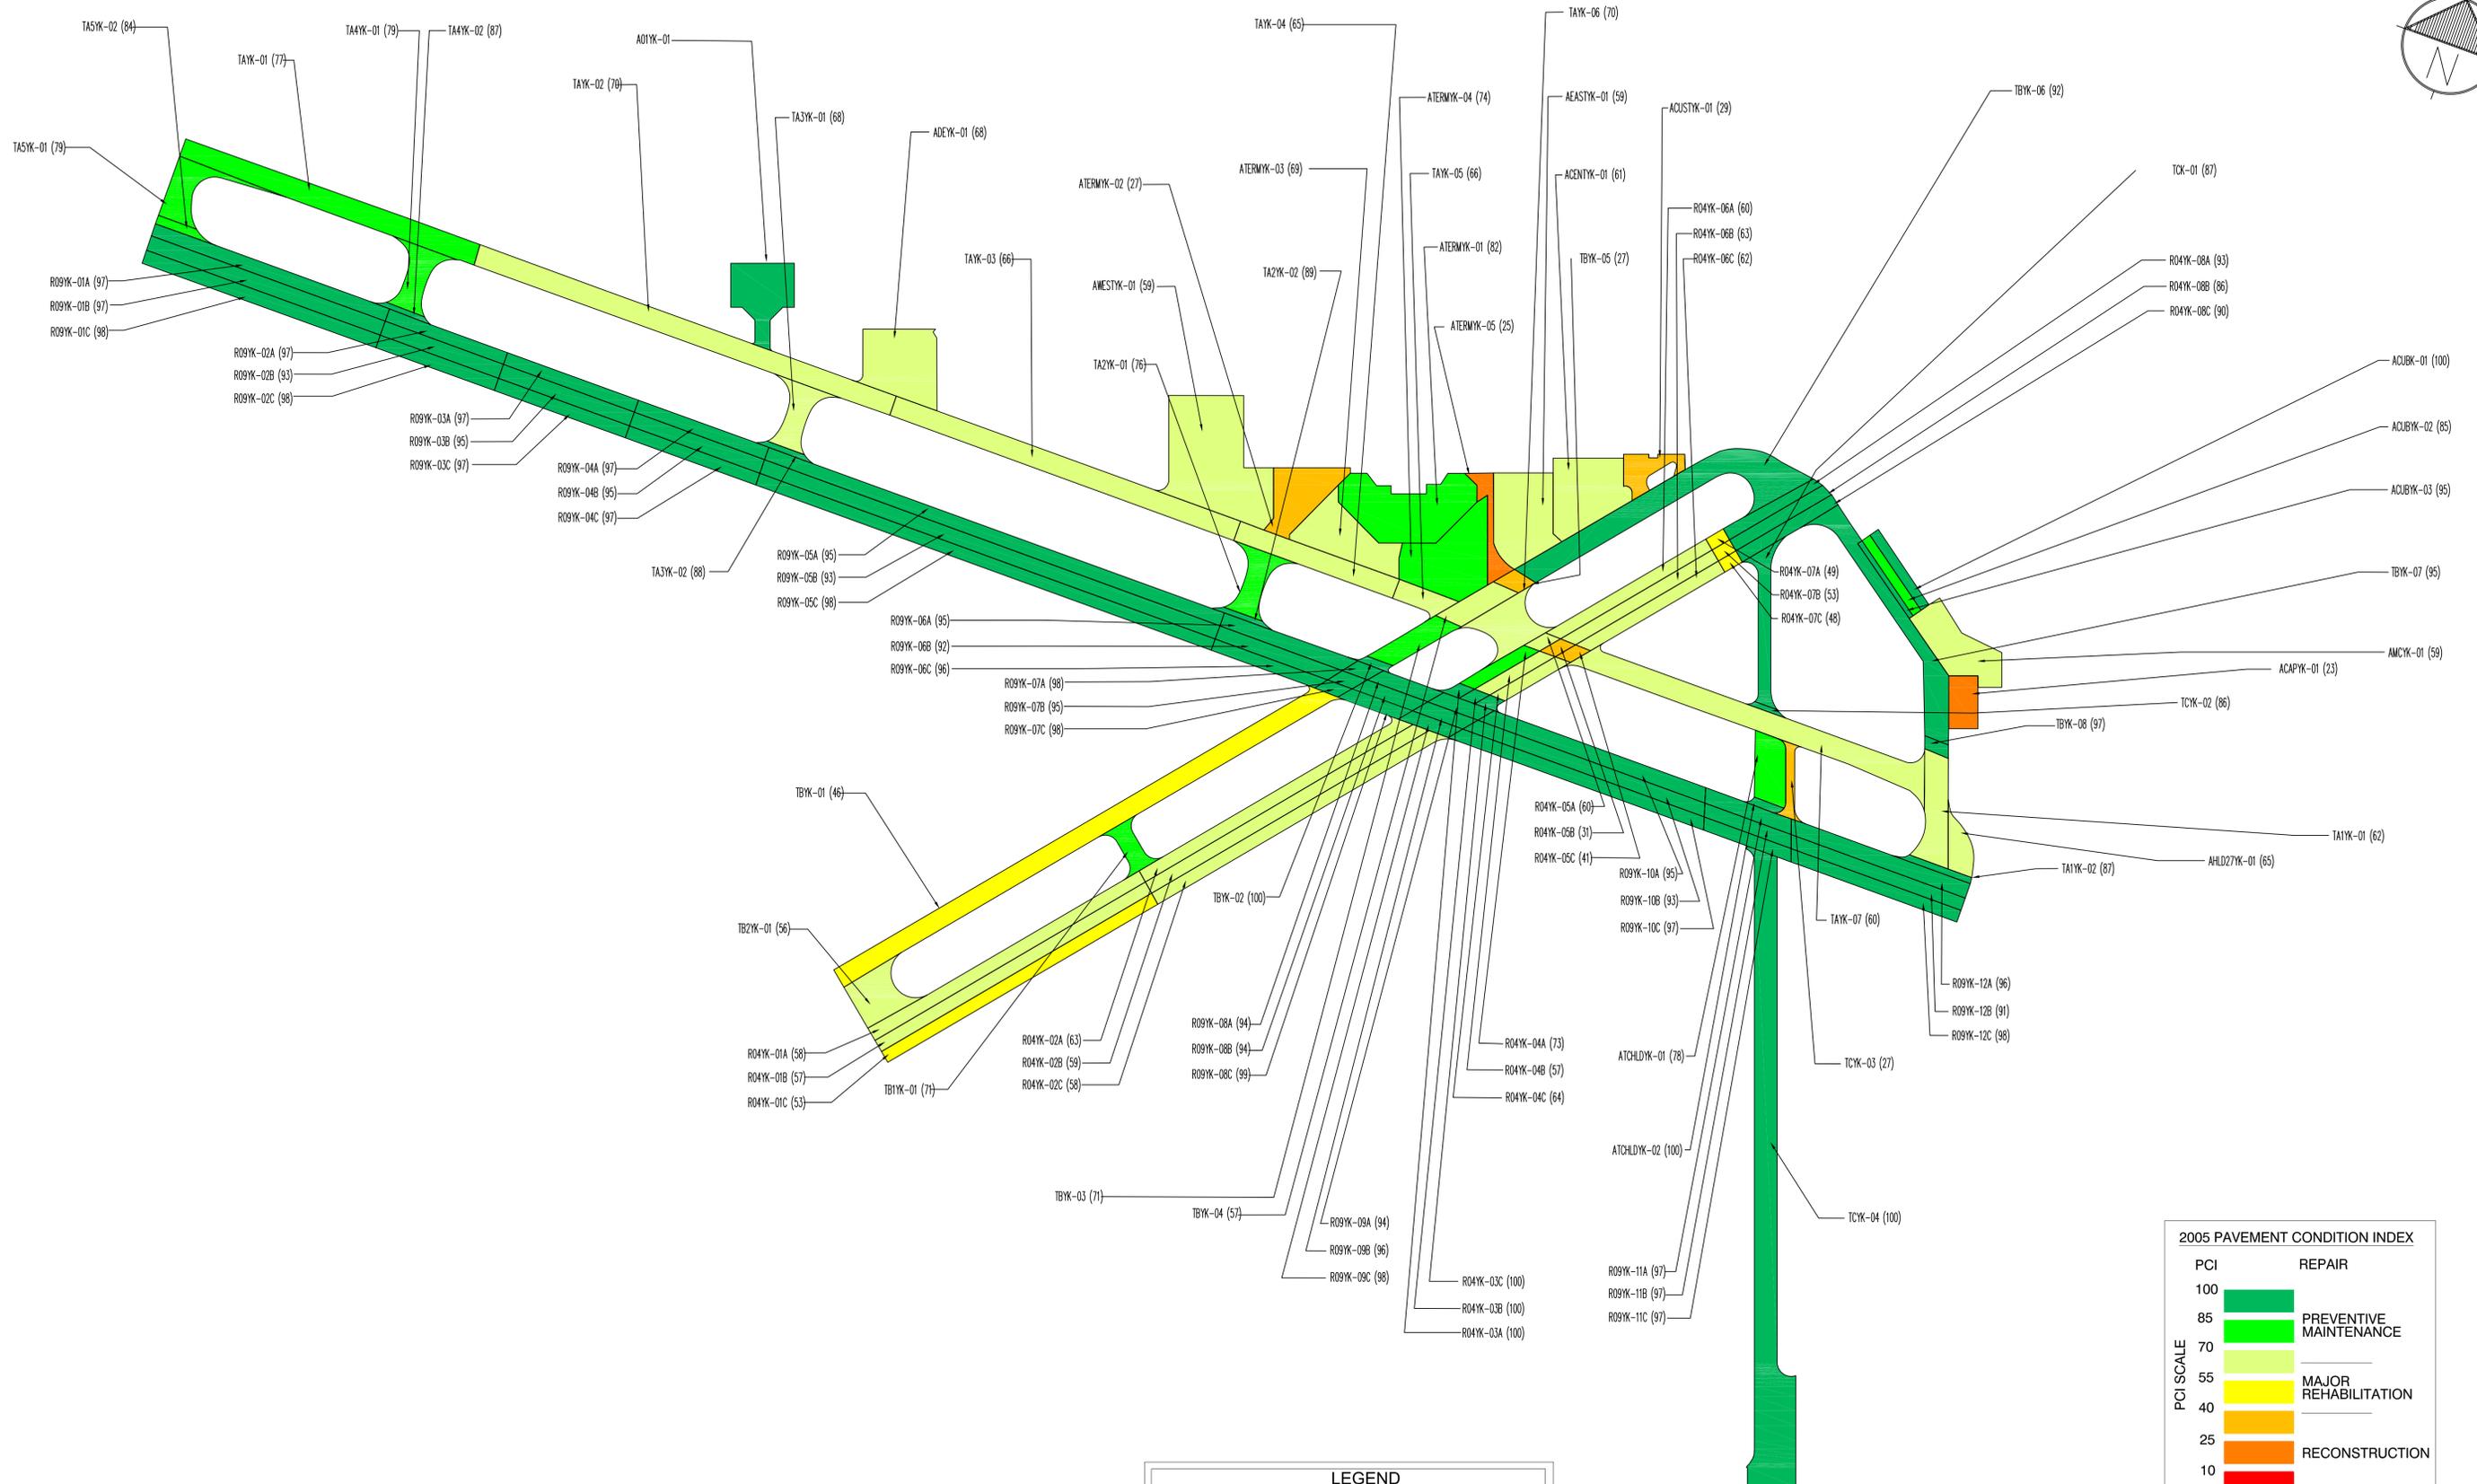
The pavements at Yakima Air Terminal were inspected on May 5, 2005. The 2005 area-weighted condition of Yakima Air Terminal is 74, with conditions ranging from 23 to 100 (on a scale of 0 [failed] to 100 [excellent]).

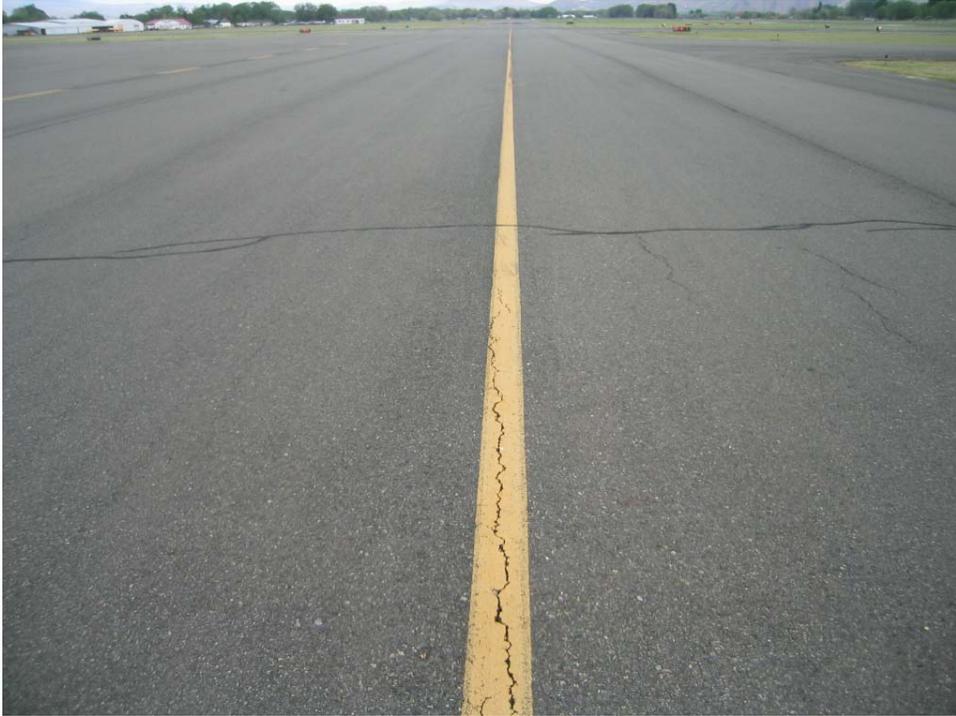
TAYK-05. Overview.

TAYK	05	AC	17,686	9/3/1988	66	40	60	Alligator cracking, bleeding, longitudinal and transverse cracking, raveling and weathering
TAYK	06	AAC	39,260	9/1/1988	70	32	68	Bleeding, longitudinal and transverse cracking, rutting, raveling and weathering
TAYK	07	AAC	128,452	9/1/1988	60	20	80	Bleeding, longitudinal and transverse cracking, rutting, raveling and weathering
TB1YK	01	AC	16,727	9/2/1984	70	0	100	Longitudinal and transverse cracking

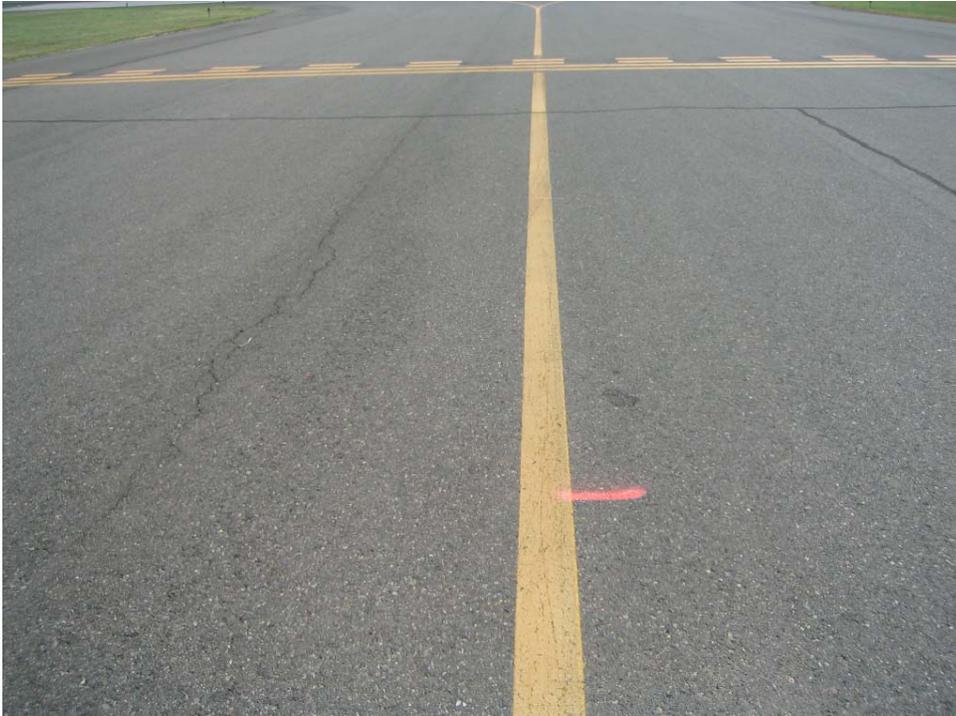
TA4YK-01. Overview.

TA4YK	01	AC	28,260	9/3/1988	79	0	93	Bleeding, longitudinal and transverse cracking, polished aggregate, raveling and weathering
TA4YK	02	AAC	3,893	9/1/1995	87	0	100	Longitudinal and transverse cracking
TA5YK	01	AC	6,615	9/3/1988	79	0	98	Bleeding, longitudinal and transverse cracking, raveling and weathering
TA5YK	02	AAC	6,615	9/1/1995	84	0	100	Longitudinal and transverse cracking, raveling and weathering
TAYK	01	AAC	101,114	9/1/1988	77	0	99	Bleeding, depression, longitudinal and transverse cracking, raveling and weathering
TAYK	02	AAC	141,834	9/1/1988	70	18	69	Bleeding, longitudinal and transverse cracking, rutting, raveling and weathering
TAYK	03	AAC	115,359	9/1/1988	66	47	53	Alligator cracking, longitudinal and transverse cracking, rutting, raveling and weathering
TAYK	04	AAC	52,230	9/1/1988	65	38	62	Alligator cracking, bleeding, block cracking, depression, longitudinal and transverse cracking
