APPENDIX A

Site Photographs

Reach Analysis—Hoko, Clallam, Pysht Rivers Photographic Log

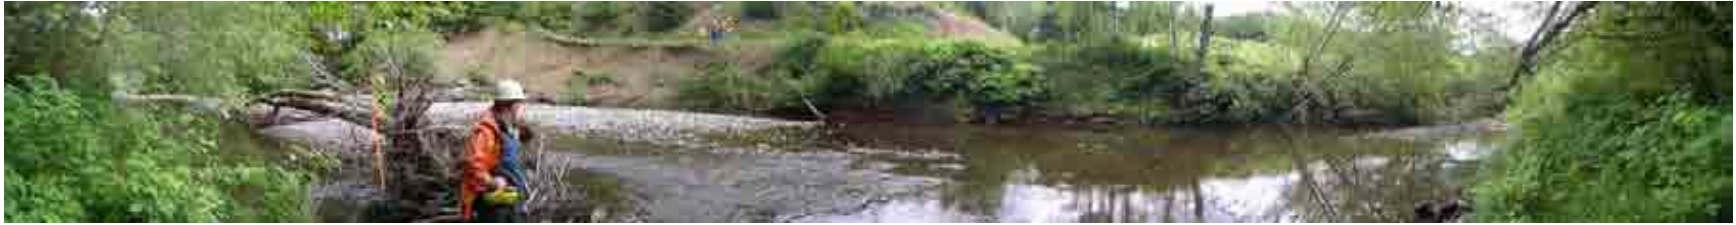
Photo A-16. Clallam River Site ID C-2 (May 11, 2005). Looking at the right bank. Erosion. Toe of slope erosion. (Photo Pan 2388-2394)

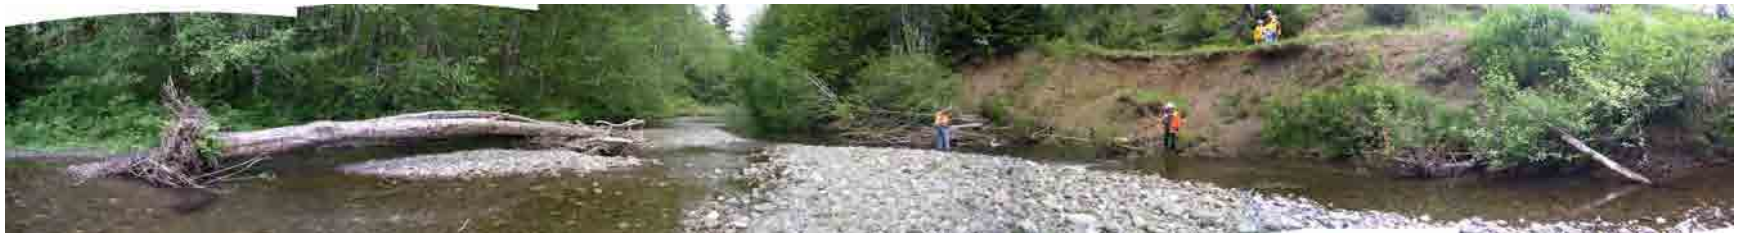
Photo A-17. Clallam River Site ID C-2 (May 11, 2005). Looking at right bank erosion – 220 feet of erosion. (Photo Pan 2395-2401)

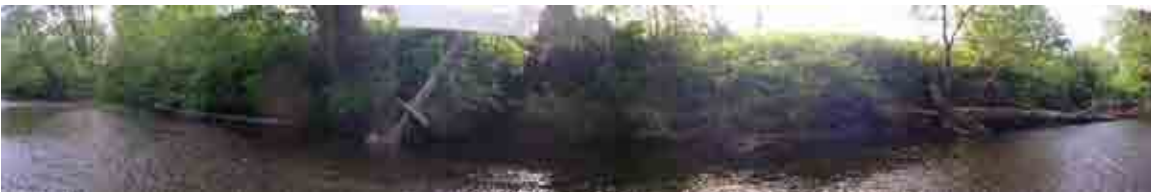
Photo A-27. Pysht River Site ID P-2 (May 11, 2005) Bank Erosion (Photo Pan 2516-2521)

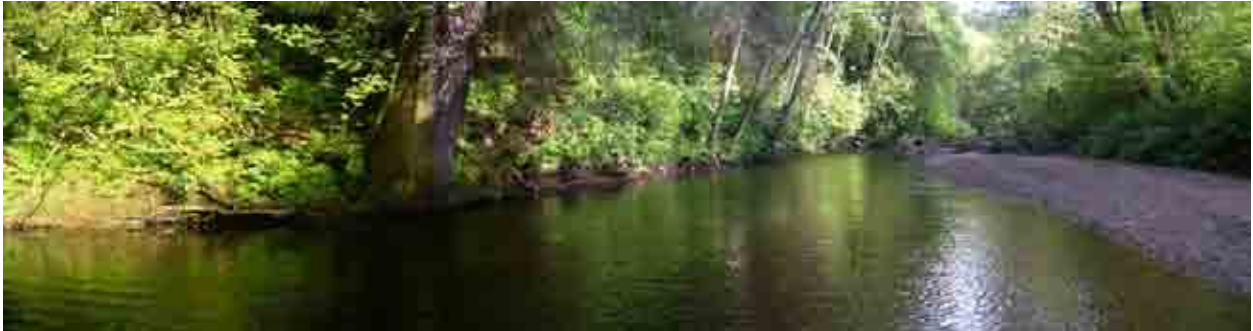
Photo A-35. Pysht River Site ID P-3 (May 11, 2005). Looking upstream from same location. (Photo Pan 2505-2507)

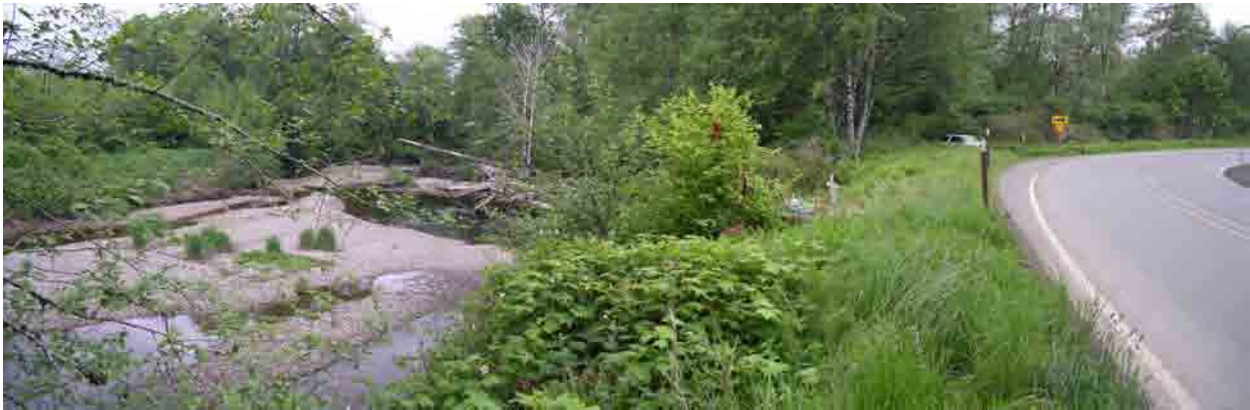
Photo A-36. Pysht River Site ID P-4 (May 10, 2005) MVA memorial site. (Photo Pan 2282-2284)

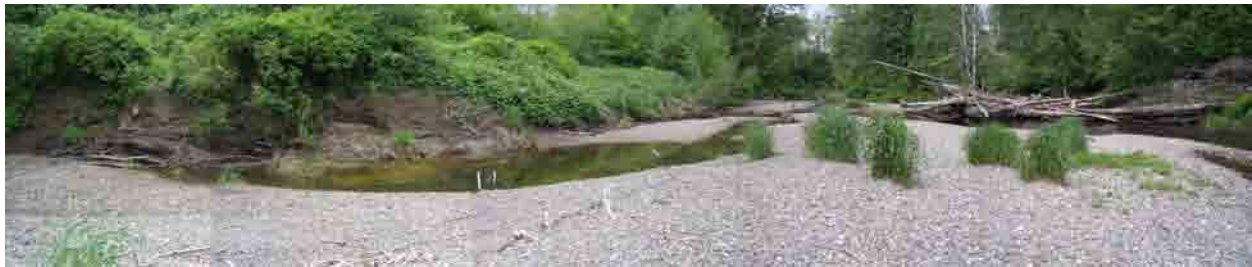
Photo A-38. Pysht River Site ID P-4 (May 10, 2005). Channel adjacent to memorial site. (Photo Pan 2291-2295)

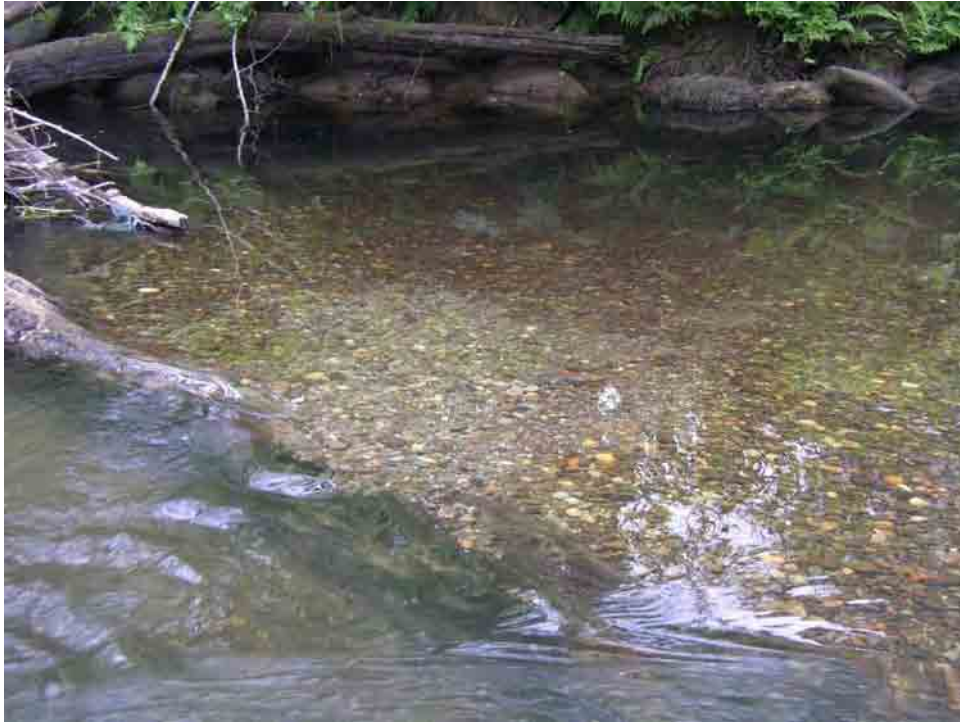
Photo A-41. Pysht River Site ID P-4 (May 10, 2005) Two of three noted spawning redds, spawning starts about 1 mile downstream from this location at “Fridge” Creek (Recter Creek). (Photo 2299)

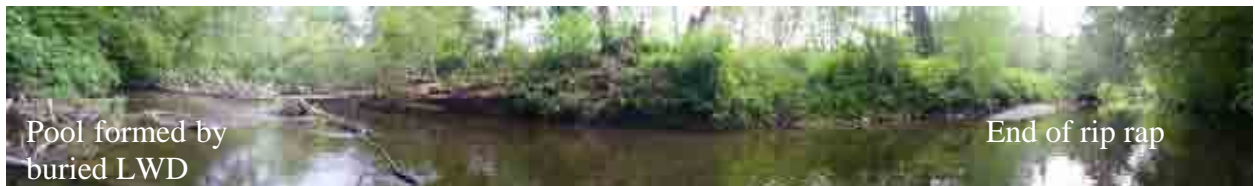
Photo A-43. Pysht River Site ID P-4 (May 10, 2005). Just downstream of MP 27. downstream of rip rap is an unprotected bank ~18 feet high. (Photo Pan 2437-2443)

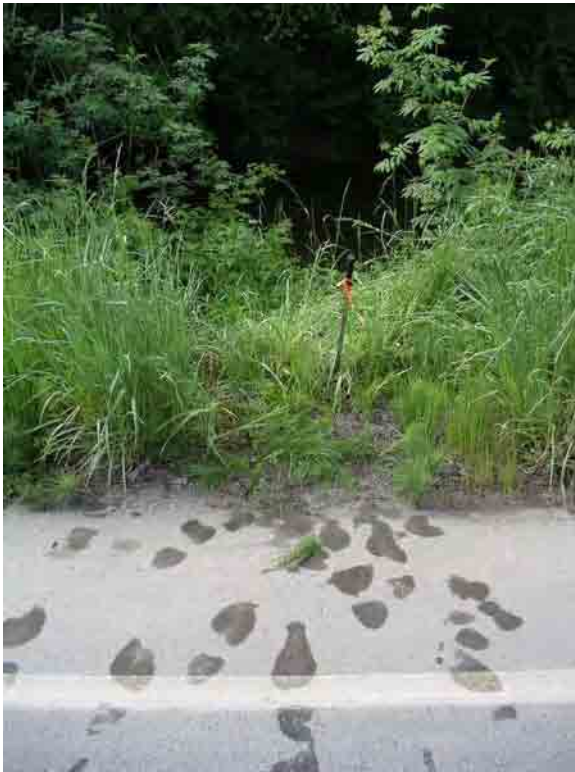
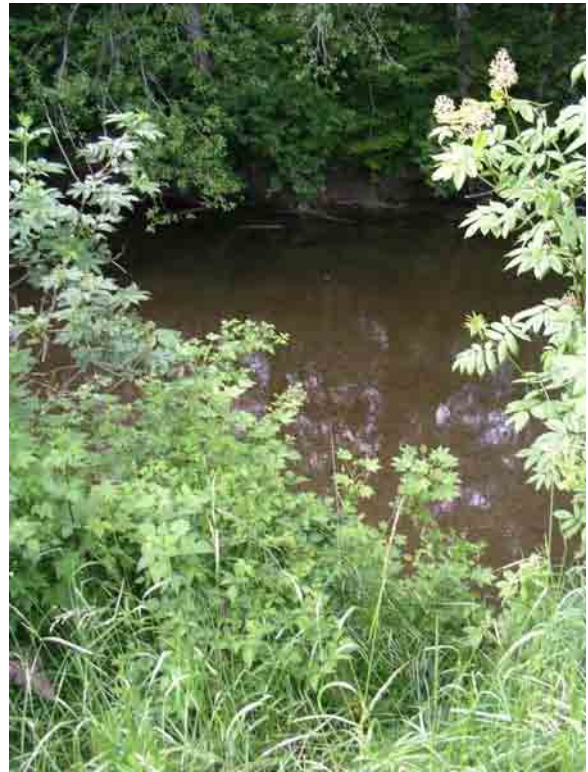
Photo A-44. Pysht River Site ID P-4 (May 10, 2005). Looking at right back from road at P105. (Photos P2444 and P2445)

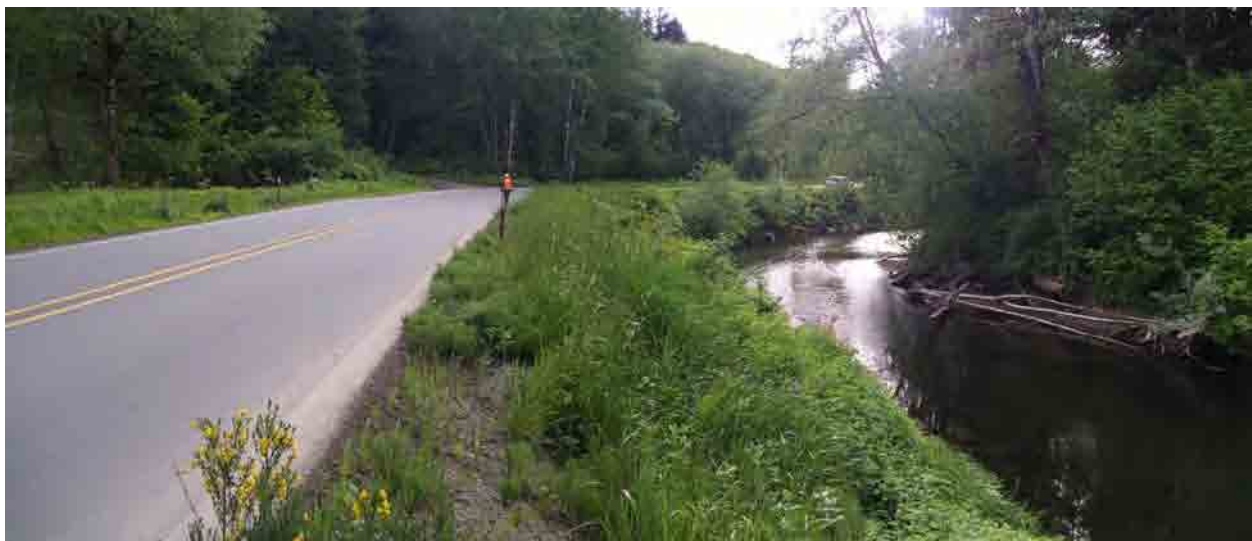
Photo A-46. Pysht River Site ID P-4 (May 11, 2005). Looking downstream on the Pysht River at milepost 28. (Photo 2449-2450)

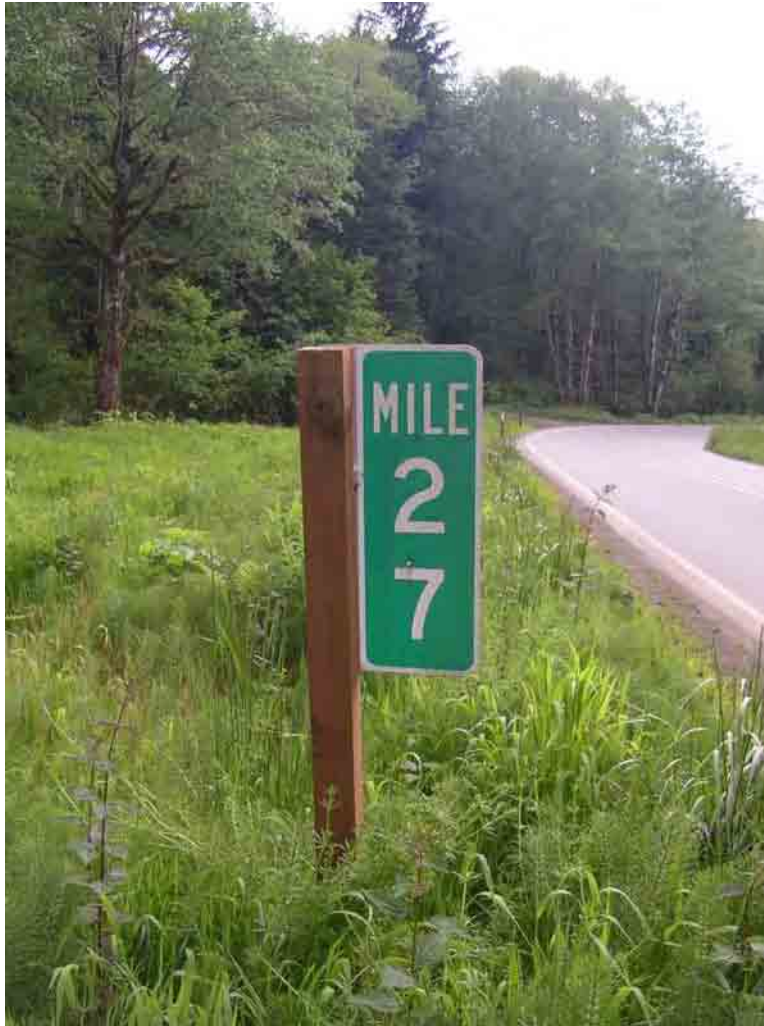
Photo A-47. Pysht River Site ID P-4 (May 11, 2005). Mile post 27 marker (Photo 2451)

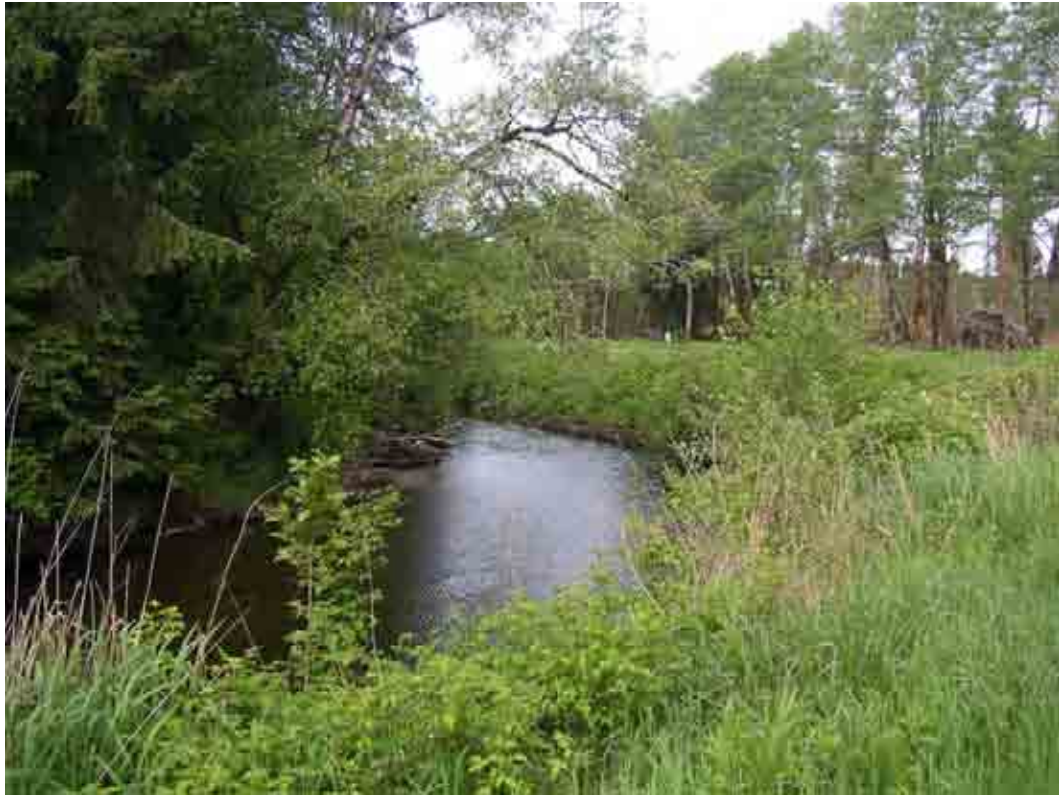
Photo A-48. Pysht River Site ID P-4 (May 11, 2005). Looking downstream of the Pysht River towards the MP 27 sign. (Photo 2452)

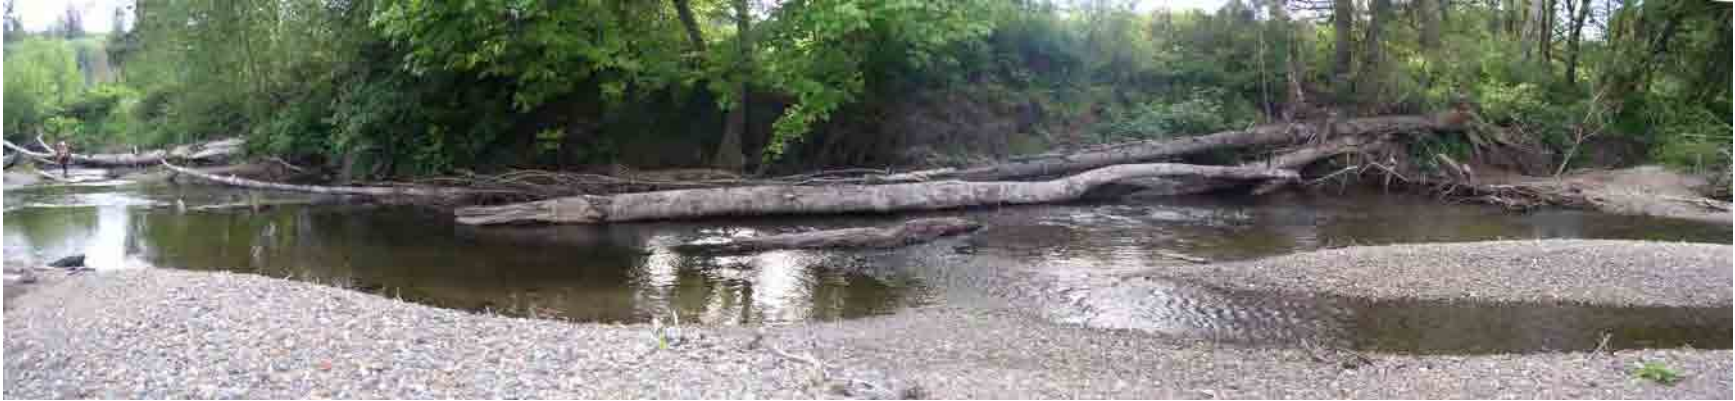
Photo A-52. Pysht River Site ID P-4 (May 11, 2005). Panoramic of right bank. (Photo Pan 2476-2479)

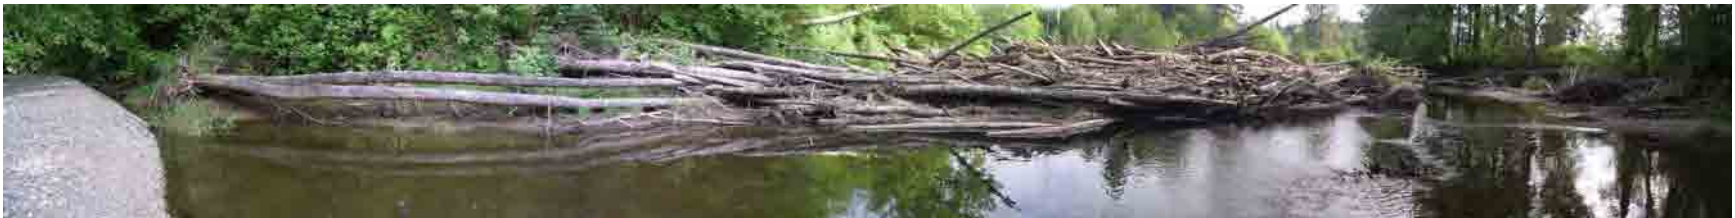
Photo A-53. Pysht River Site ID P-4 (May 11, 2005). Channel spanning logjam (Photo Pan 2487-2493)

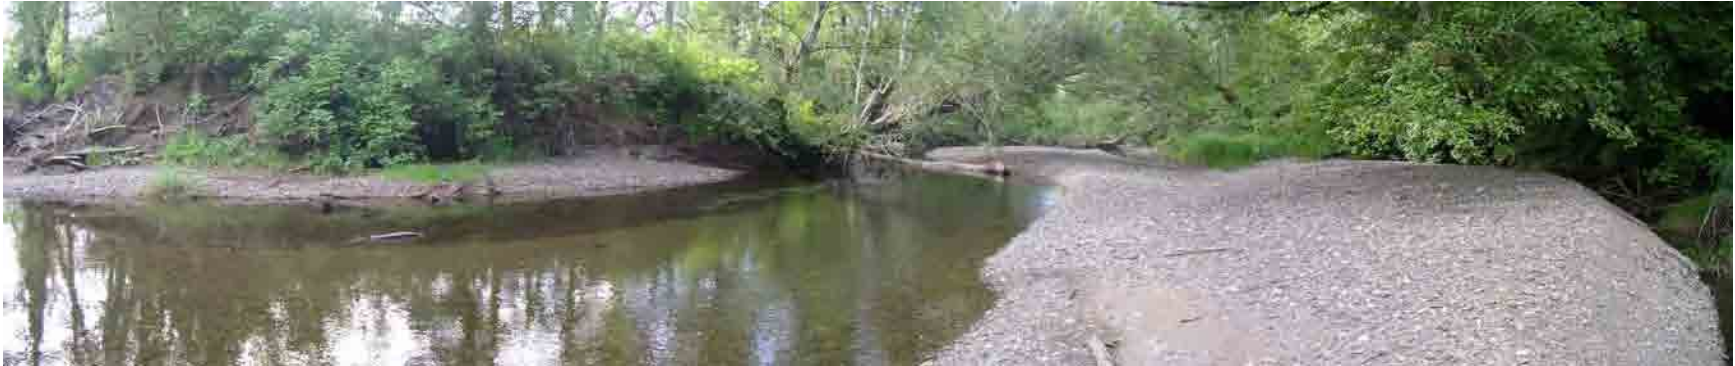
Photo A-54. Pysht River Site ID P-4 (May 11, 2005). Directly downstream of channel spanning logjam. (Photo Pan 2483-2486)

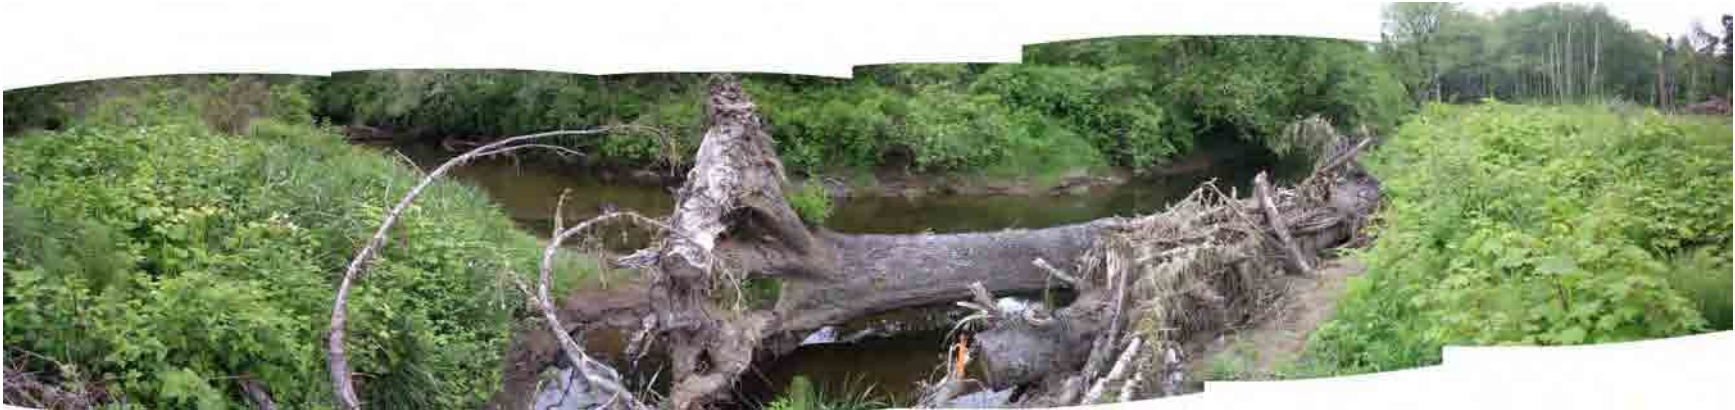
Photo A-56. Pysht River Site ID P-5 Right bank cabled LWD. (Photo Pan2302-2307)

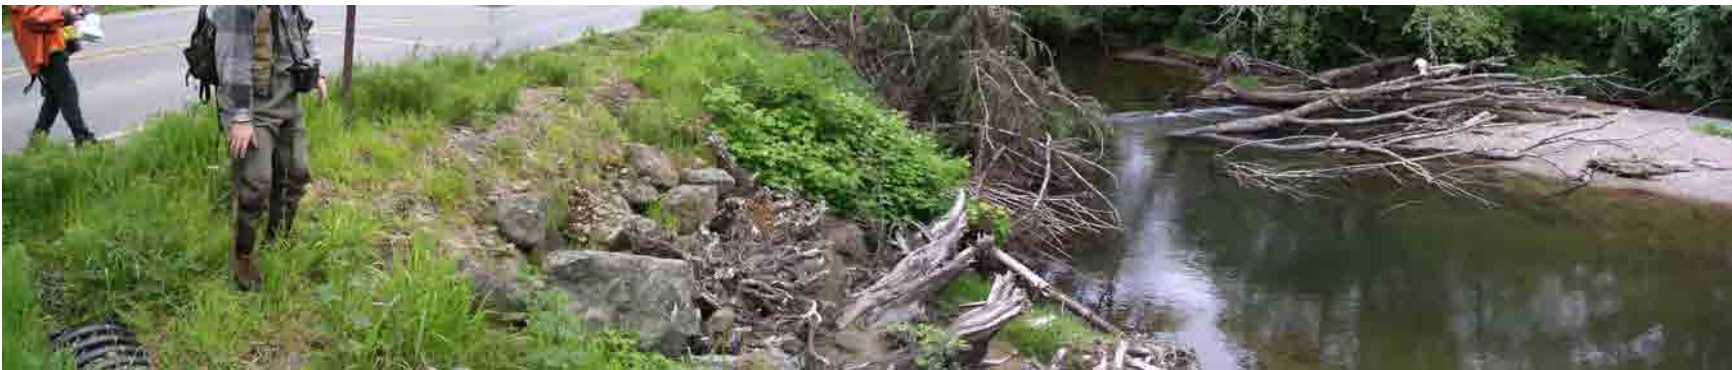
Photo A-57 Pysht River Site ID P-5 Rip rap by corrugated plastic drain pipe standing on tip of bank looking at log step across channel. Saw 3 adult steelhead in river at this site. Deep pool below log step (22mx13mx24m) (Photo Pan 2308-2310)

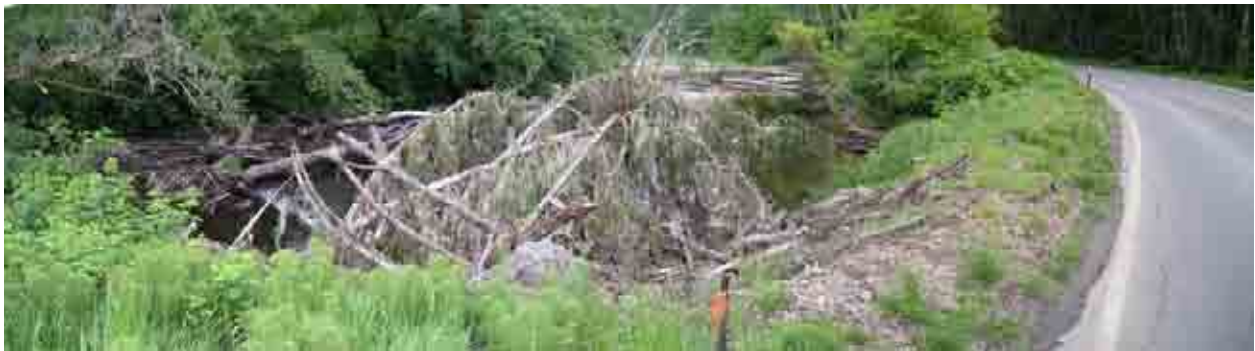
Photo A-60. Pysht River Site ID P-5 (May 10, 2005) Looking downstream – note Alders across channel 85 yards from photo point. (Photo Pan 2315-2317)

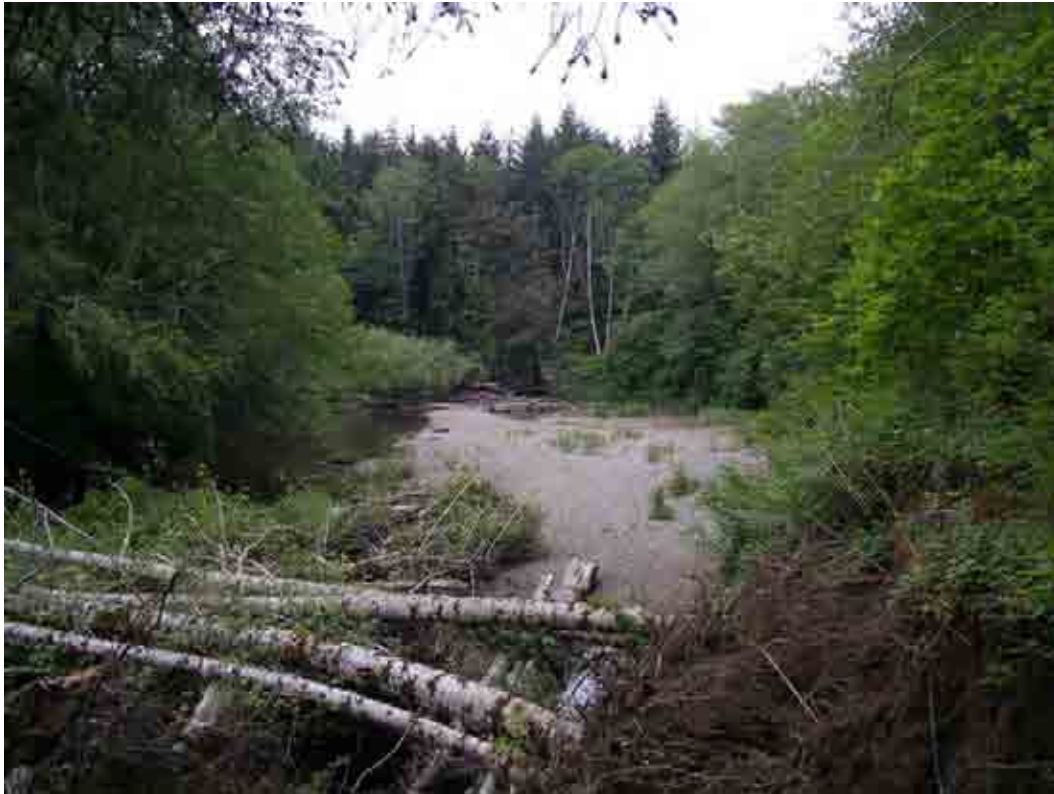
Photo A-63 Pysht River Site ID P-5 (May 10, 2005). Looking downstream to spruce 132m away. Channel wide directly upstream of alder logjam is 39m. (Photo 2322)

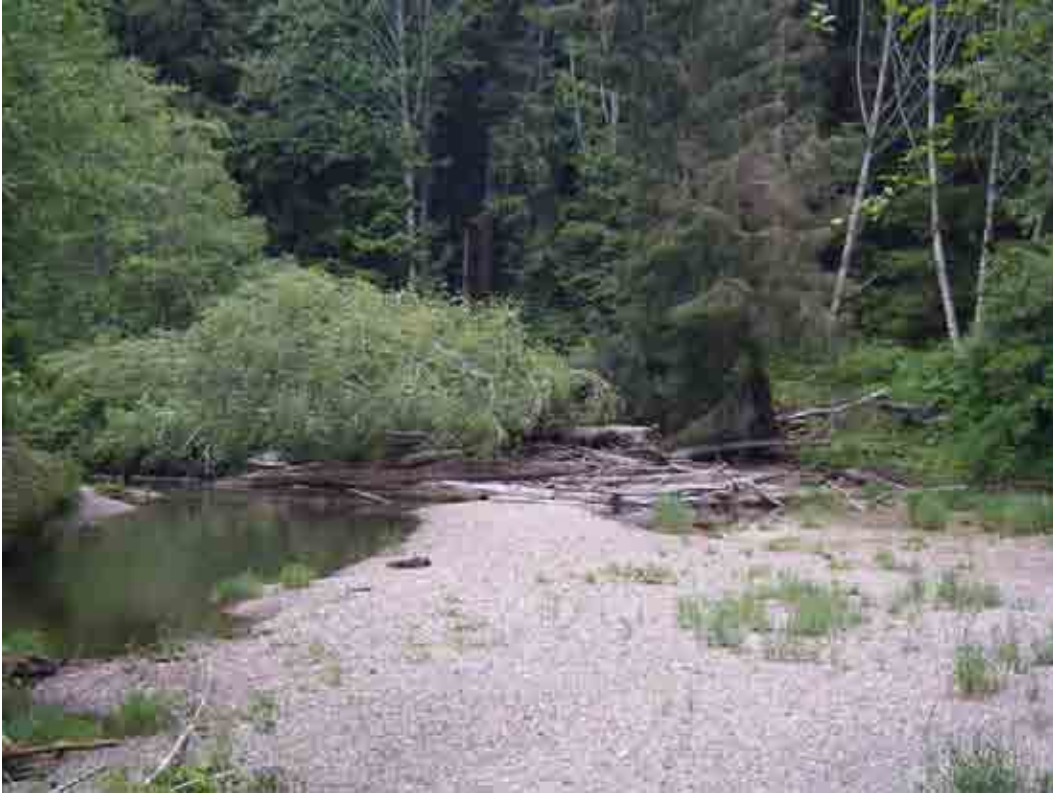
**Photo A-65. Pysht River Site ID P-5 (May 10, 2205). Close up of downstream logjam.
(Photo 2329)**

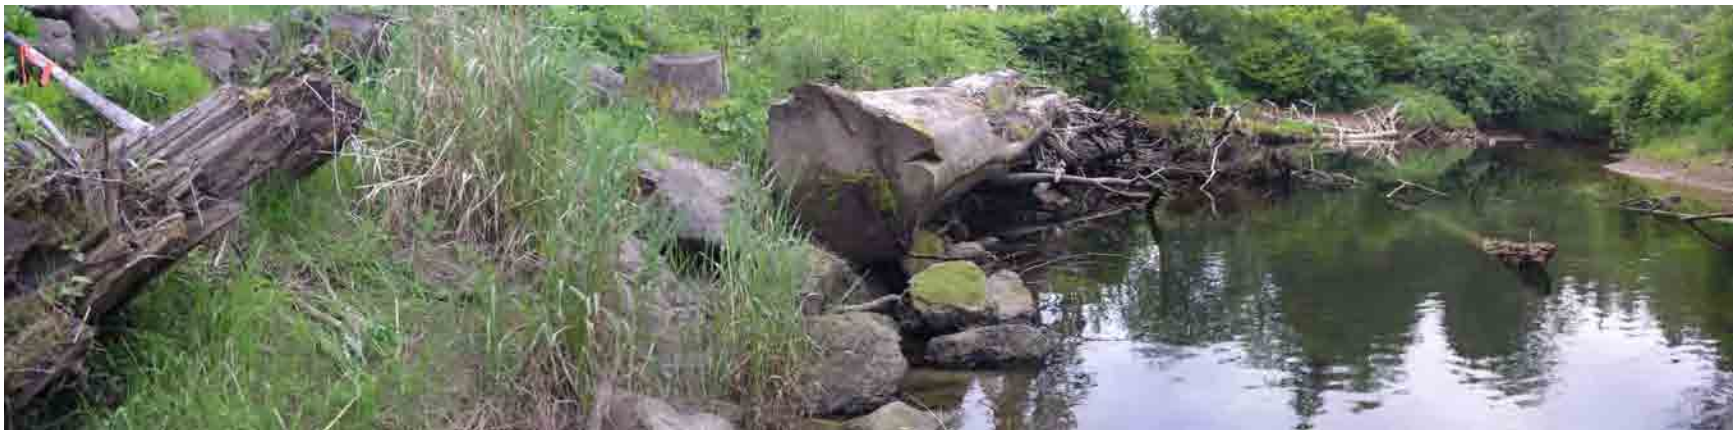
Photo A-71. Pysht River Site ID P-8 (May 10, 2005). Looking upstream. (Photo Pan 2279-81)

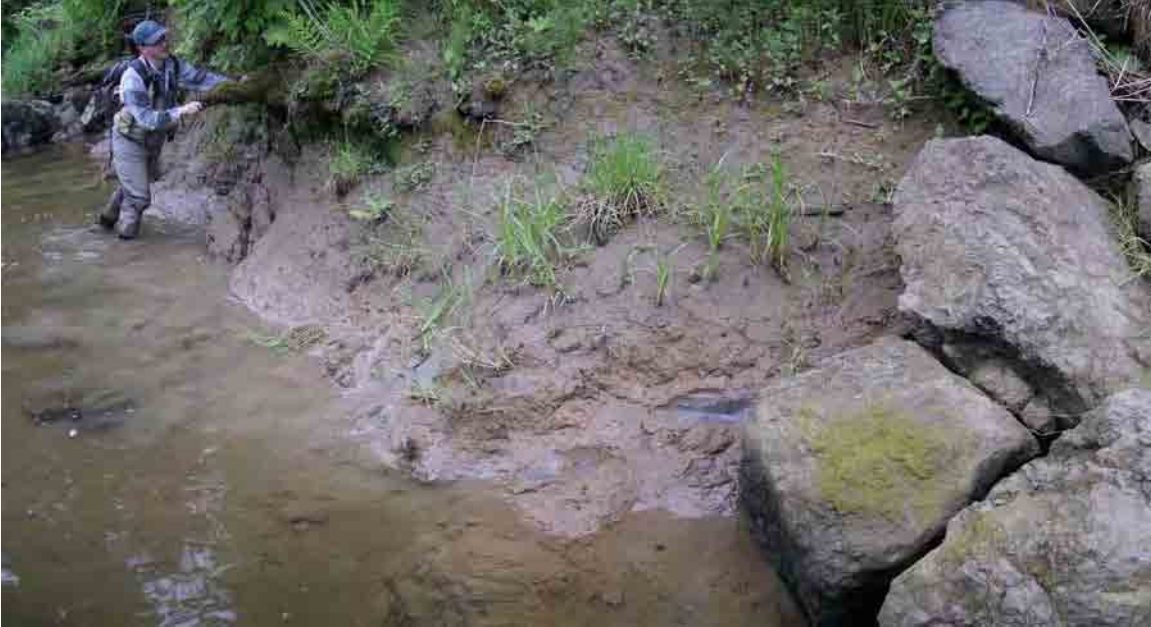
**Photo A-72. Site ID P-8. Taken at the toe of bank (~6ft from edge of water on rock).
(Photo 2275-77)**

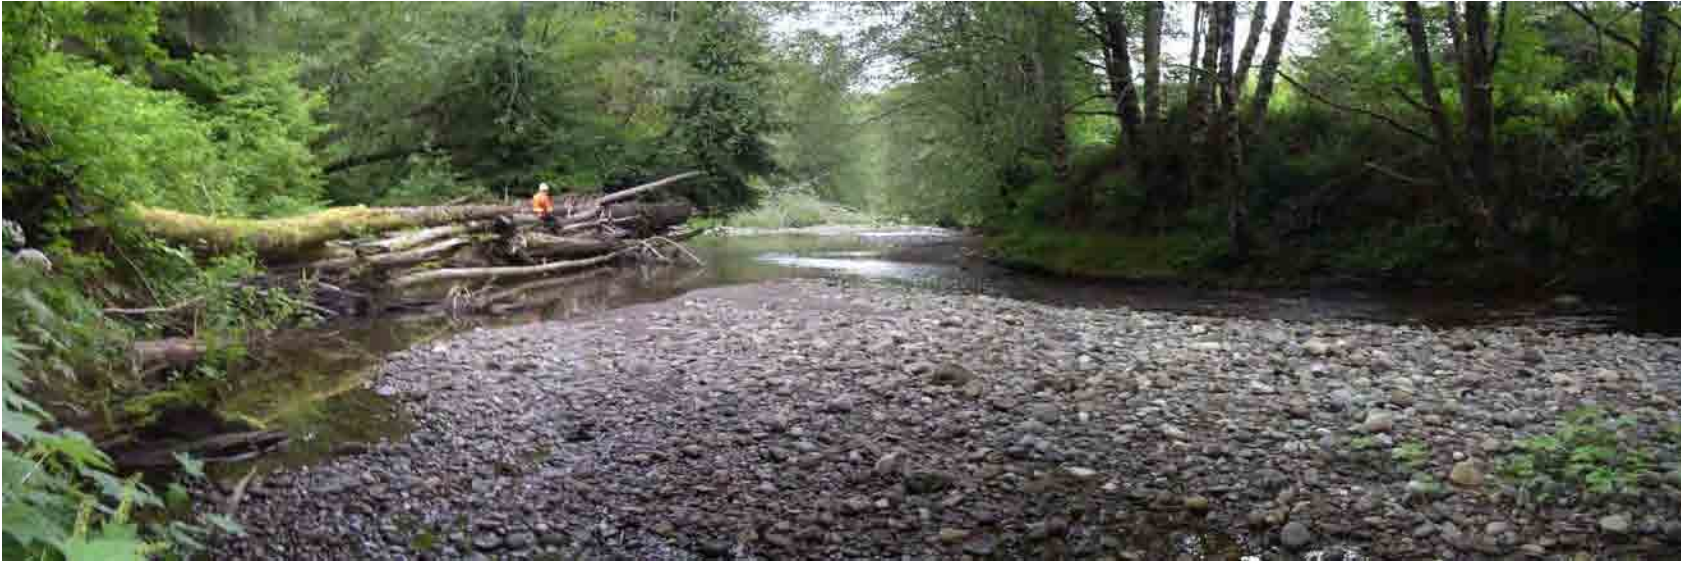
Photo A-74 The logjam at the left bank indicates the head of a side-channel at RM 5.9 on the Clallam River (May 11, 2005). LWD in this survey reach largely consists of locally recruited alder. A narrow riparian buffer exists at the right bank between the channel and the historical alignment of State Route 112. Side channel substrate sediment was observed to consist primarily of gravel and sand which was considerably finer than the cobble that dominates the main stem alignment and is evident in the bar at photo center. The flow direction is away from the camera. (Photo Pan 2346-2348)

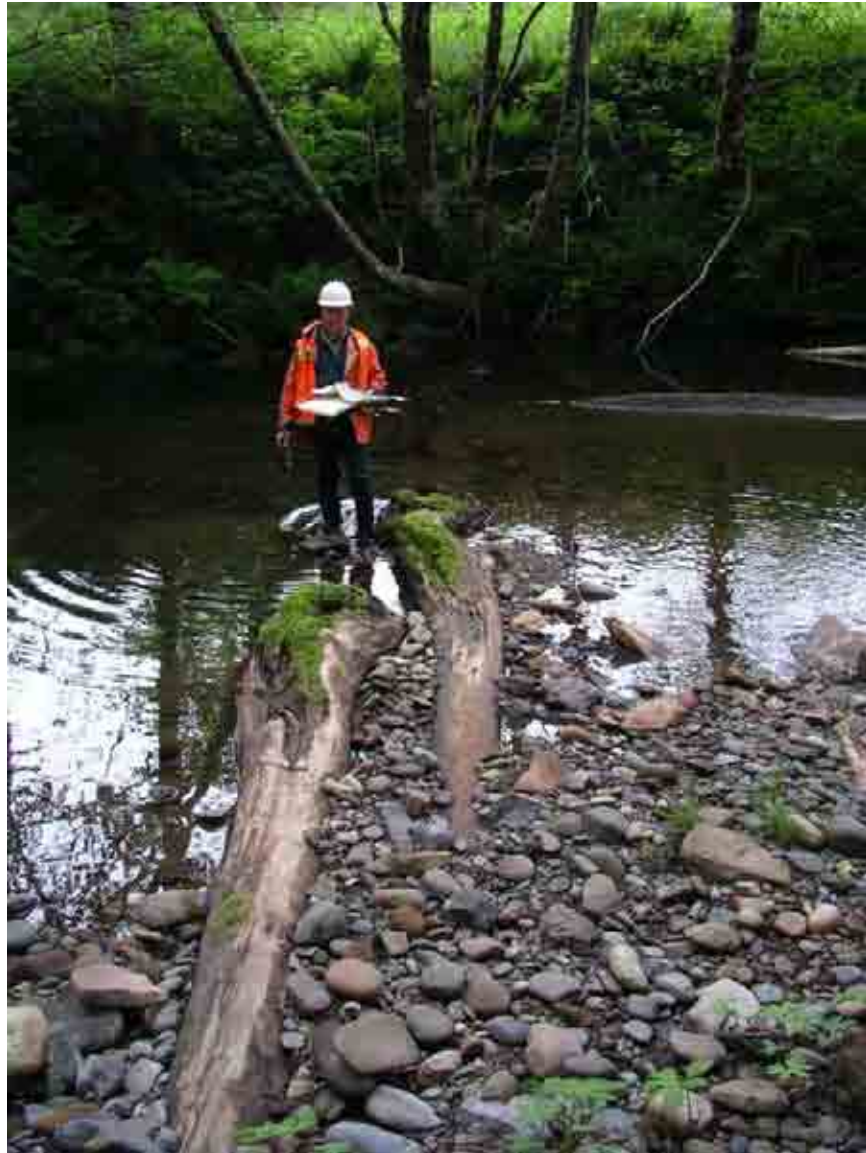
.Photo A-75 Buried logjam of relic wood at RM 5.9 on the Clallam River (May 11, 2005). Relic wood is wood that was recruited to the channel network prior to the harvest or removal of the adjacent riparian community and is identified by a diameter greater than those of tress within the existing community of riparian vegetation. This LWD spanned a significant portion of the active channel width and serves to store sediment and provide grade control that limits any potential downcutting. The coarse substrate conditions encountered during the field survey are visible. Flow is from right to left. (Photo 2345)

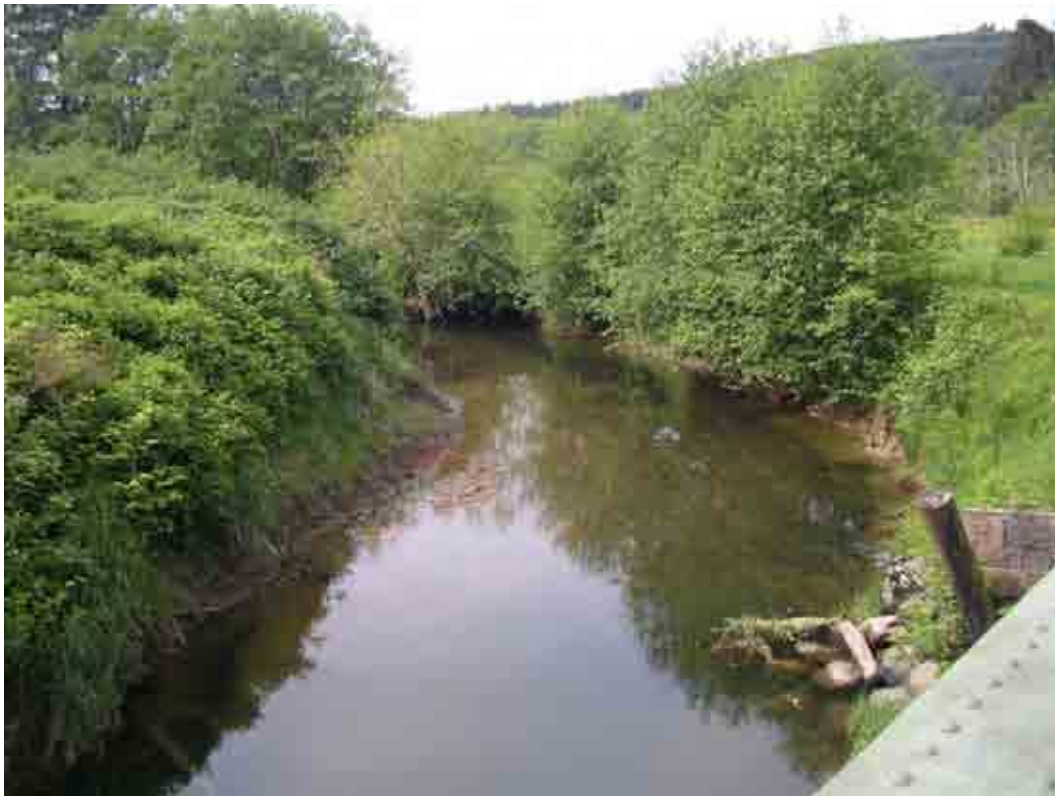
Photo A-76 A low gradient portion of the Clallam River at RM 2.3 (May 12, 2005). Vertical banks consist primarily of silt and sand with some gravel. Riparian vegetation consists of a narrow buffer of deciduous trees and shrubs between the channel alignment and adjacent agricultural fields. The flow direction is towards the camera. (Photo 2577).

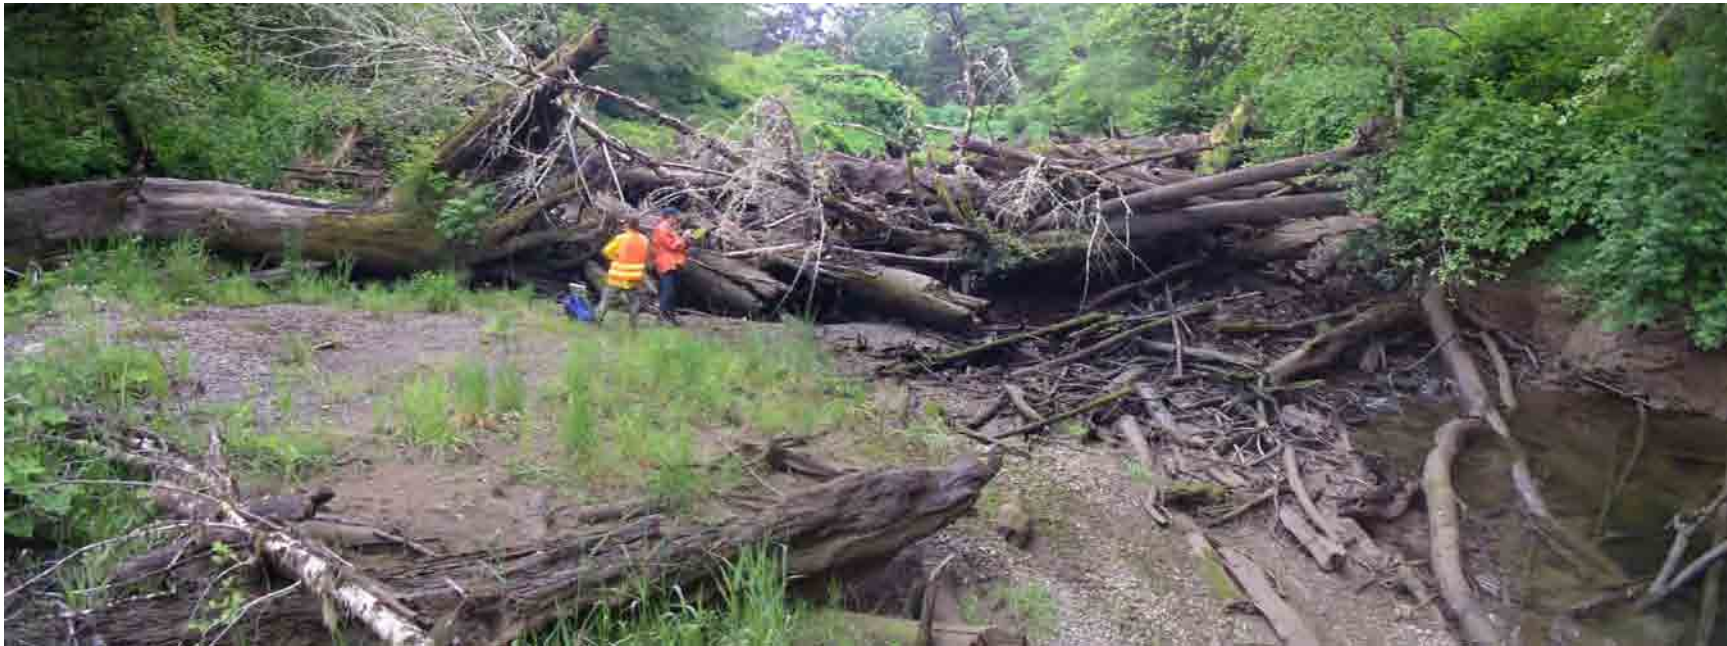
Photo A-77. Looking upstream at a logjam on the Pysht River at RM 2.9 (May 10, 2005). A depositional island of sand and gravel is forming downstream of the logjam. (Photo Pan 2121-2122)
