**Site and Reach Assessment
Evaluation of Treatment Alternatives
SR 20 MP 100.7 (Skagit River)**

Work Order MT0100

December 14, 2007

Washington State Department of Transportation
Environmental and Engineering Service Center
Environmental Services Office

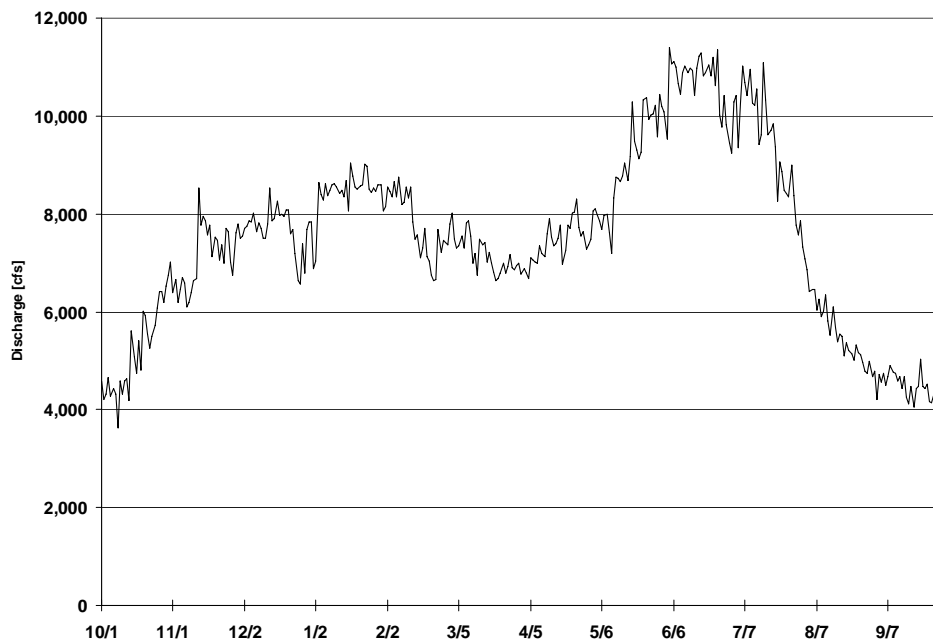
Figure 12. Estimated median daily flow in the vicinity of the reach (WY 1944-2005).

Median daily flows in this reach of the Skagit range from approximately 4000 cfs in late September and early October to approximately 11000 cfs in June and early July (Figure 12). The high flows in June and July are associated with spring/summer melt of the high elevation snow-

pack, and tend to be sustained for three to six weeks depending on air temperature and the amount of snowpack.

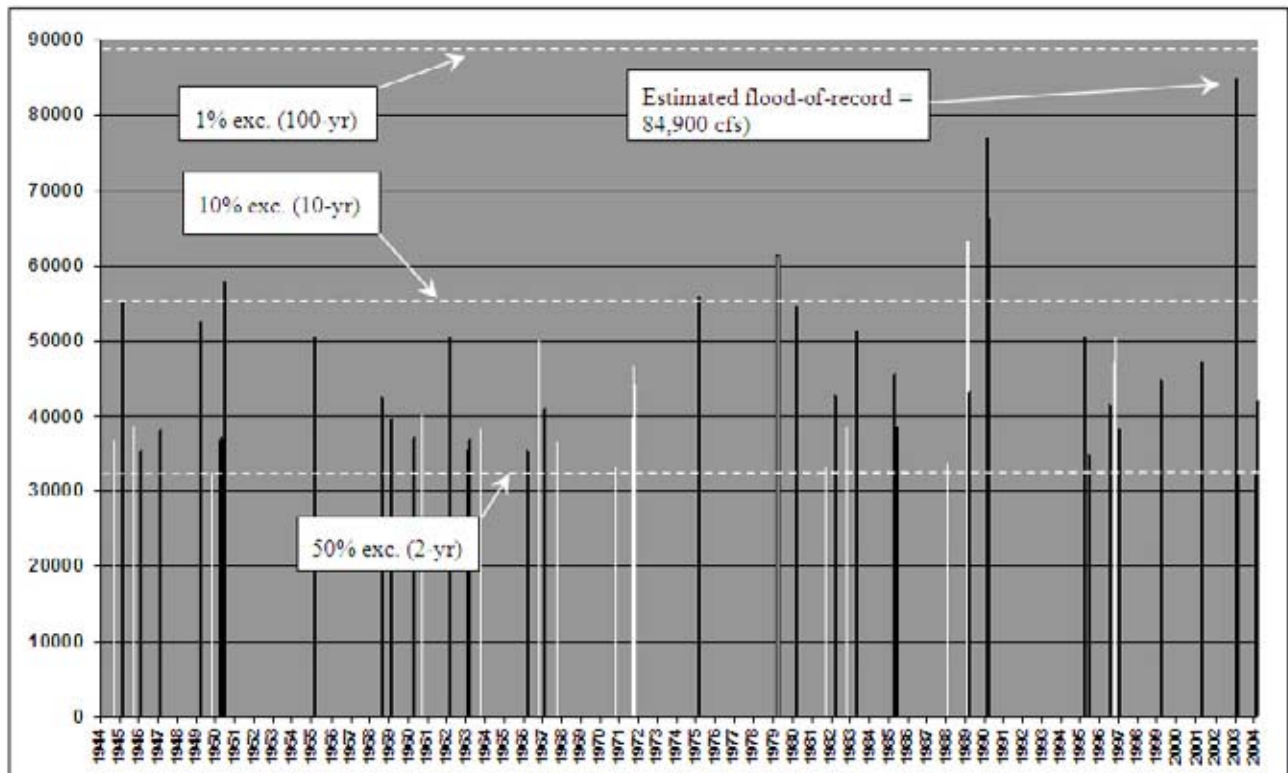
Figure 13. Estimated peak flow time series for assessment reach.

Instantaneous peak flows were also estimated for the reach using daily discharge data from the above stations. The peak daily discharge corresponding to the event which created the instantaneous annual peak at the “Skagit at Concrete” gage was obtained for each station, and the peak daily flow for the reach was calculated using the above formula. This was converted to an estimated instantaneous annual peak discharge by applying a “peaking factor” (ratio of instantaneous peak to daily peak) derived for each event occurring at the “Skagit at Concrete” gage to the peak daily discharge calculated above. A frequency analysis was conducted for this set of instantaneous annual peaks using the PEAKFQ software (USGS, 2005) to determine discharges for selected exceedance probabilities using the standard “Bulletin 17B” methodology. Frequency analysis results are shown in Table 1. All estimated peak flows greater than a 50 percent exceedance (2-year recurrence) event are shown in Figure 13.

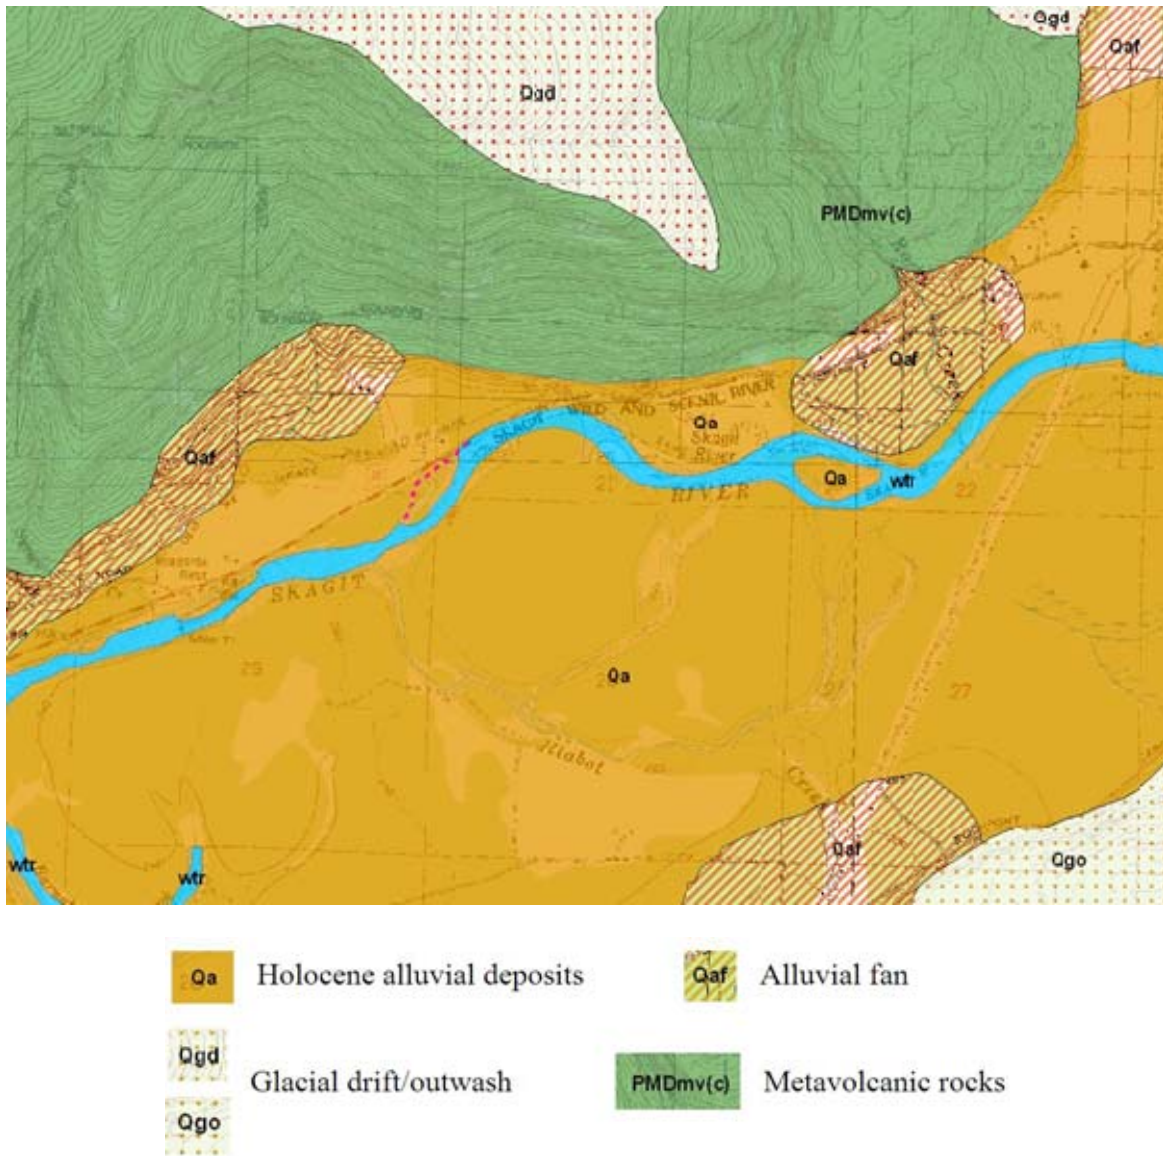
Figure 14. Geology in the vicinity of the assessment reach.

The upper Skagit River basin is made up of steep, mountainous terrain consisting of a complex mélange of metamorphic, marine sedimentary, and volcanic rocks. The valley floor of the Skagit within the assessment reach is made up primarily of recently reworked alluvium; glacial outwash lines a portion of the south valley wall, away from the current course of the Skagit, and alluvial fans line both valley margins where small drainages emerge from the mountains (Figure 14).
