**Reach and Site Assessment for the SR 109/023
Moclips River Bridge, Moclips,
Grays Harbor County, Washington**

Work Order MS 5404
Ed Molash, Environmental Engineer
Jim Park, Senior Hydrologist
WSDOT Environmental Services
Watershed Management Program
Updated April, 2007

Washington State Department of Transportation
Environmental and Engineering Service Center
Environmental Services Office

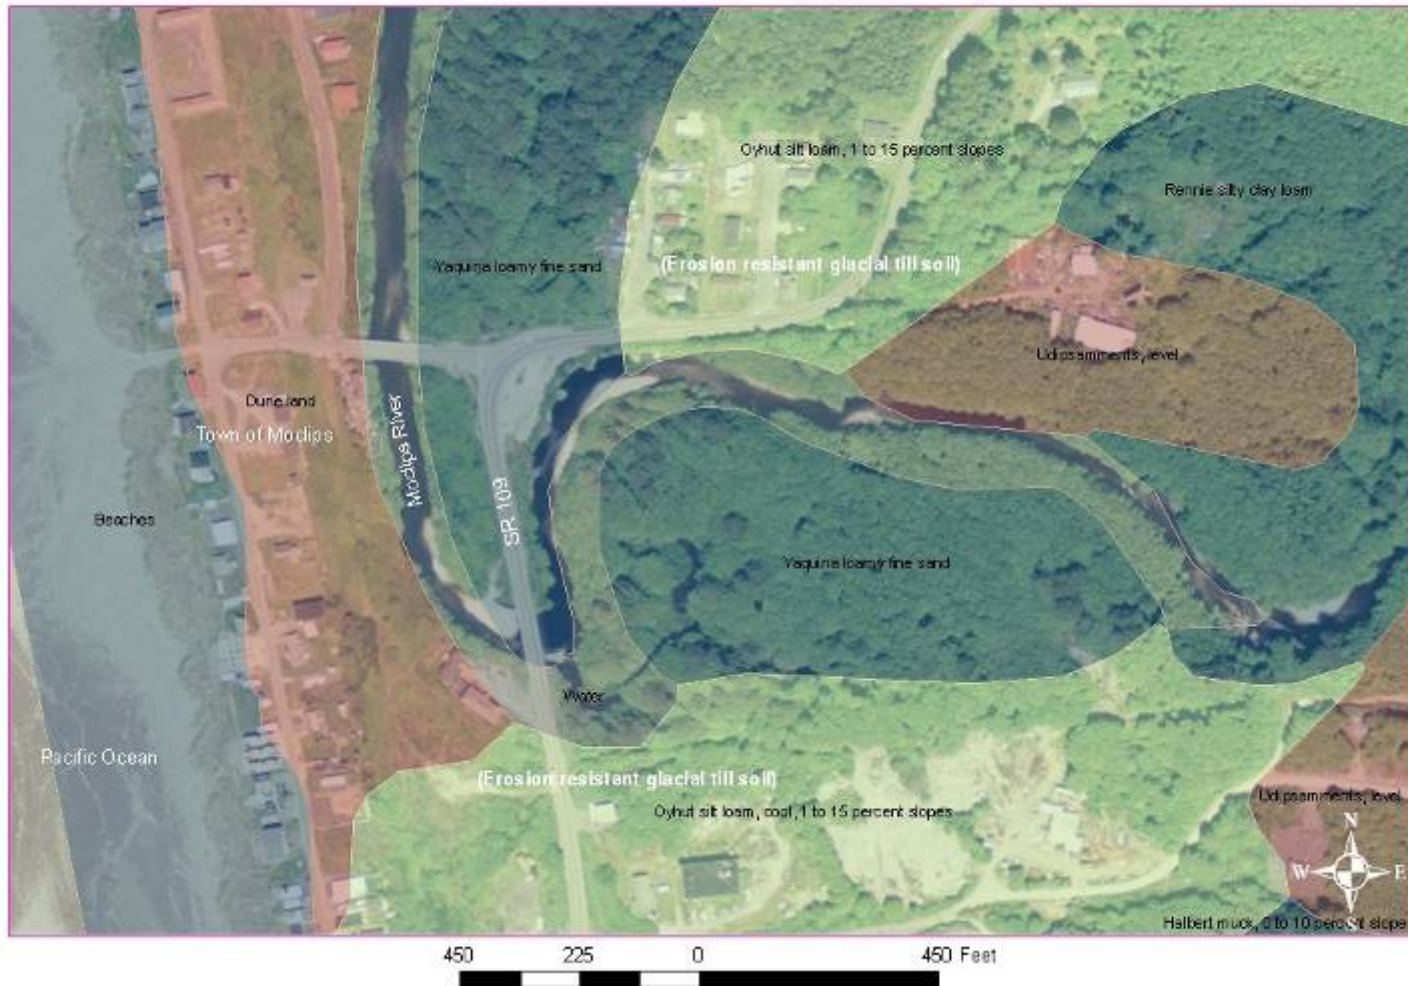
Figure 5. Soils Distributions in the Vicinity of the SR 109/023 bridge.

The left bank underlying the bridge structure is composed of Oyhut silt loam, a cohesive glacial till soil. The floodplain soils are predominately wetland soils derived from tidal deposits. Figure 5 shows the distribution of hydrologic soil groups within the project area.

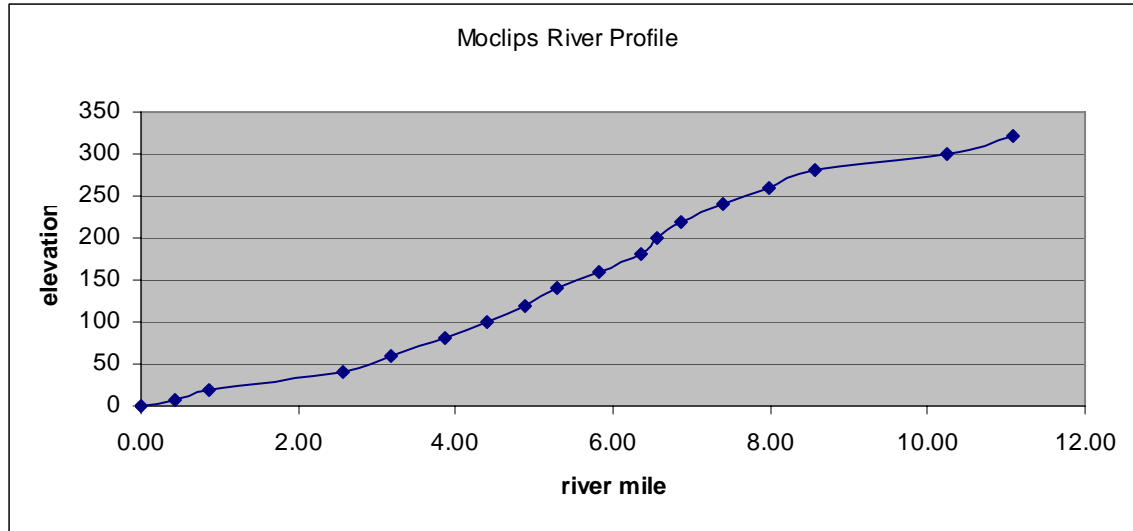
Figure 6: Moclips River Profile

Elevation at the headwaters of the Moclips is approximately 325 feet. The gradient of the Moclips River at the SR 109/023 bridge is very low, approximately 0.25 percent (roughly 14 vertical feet per mile). The entire Moclips watershed from its headwaters to the ocean is similarly low gradient, 0.70 percent or 37 vertical feet per mile on average (see Figure 6).

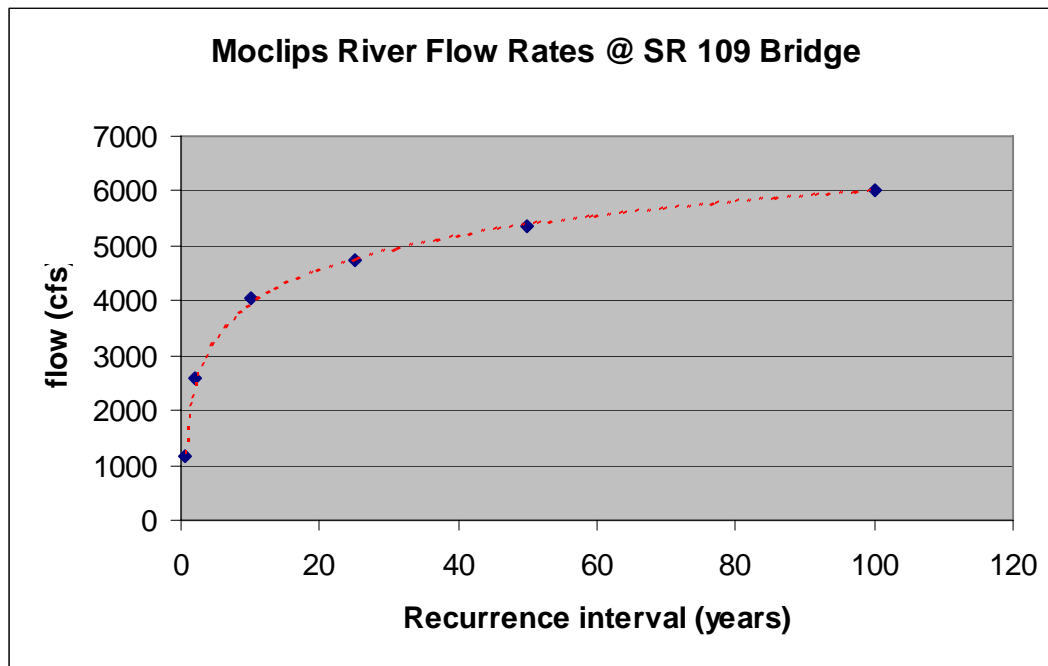
Figure 7. Moclips River Flow Rates.

Parameter	Value
Drainage Area (mi ²)	31.9
Mean Annual Precipitation (in/yr)	91.2 (bridge), 103.5 (headwaters)
Channel Substrate (D50)	Gravel, 4 inches – 6inches
Channel Roughness (Manning's n)	0.030
Channel Gradient (%)	0.026
2-year flow (50% ann. probability, cfs)	2580
10-year flow (10% ann. probability, cfs)	4030
25-year flow (4% ann. probability, cfs)	4740
50-year flow (2% ann. probability, cfs)	5350
100-year flow (1% ann. probability, cfs)	6010

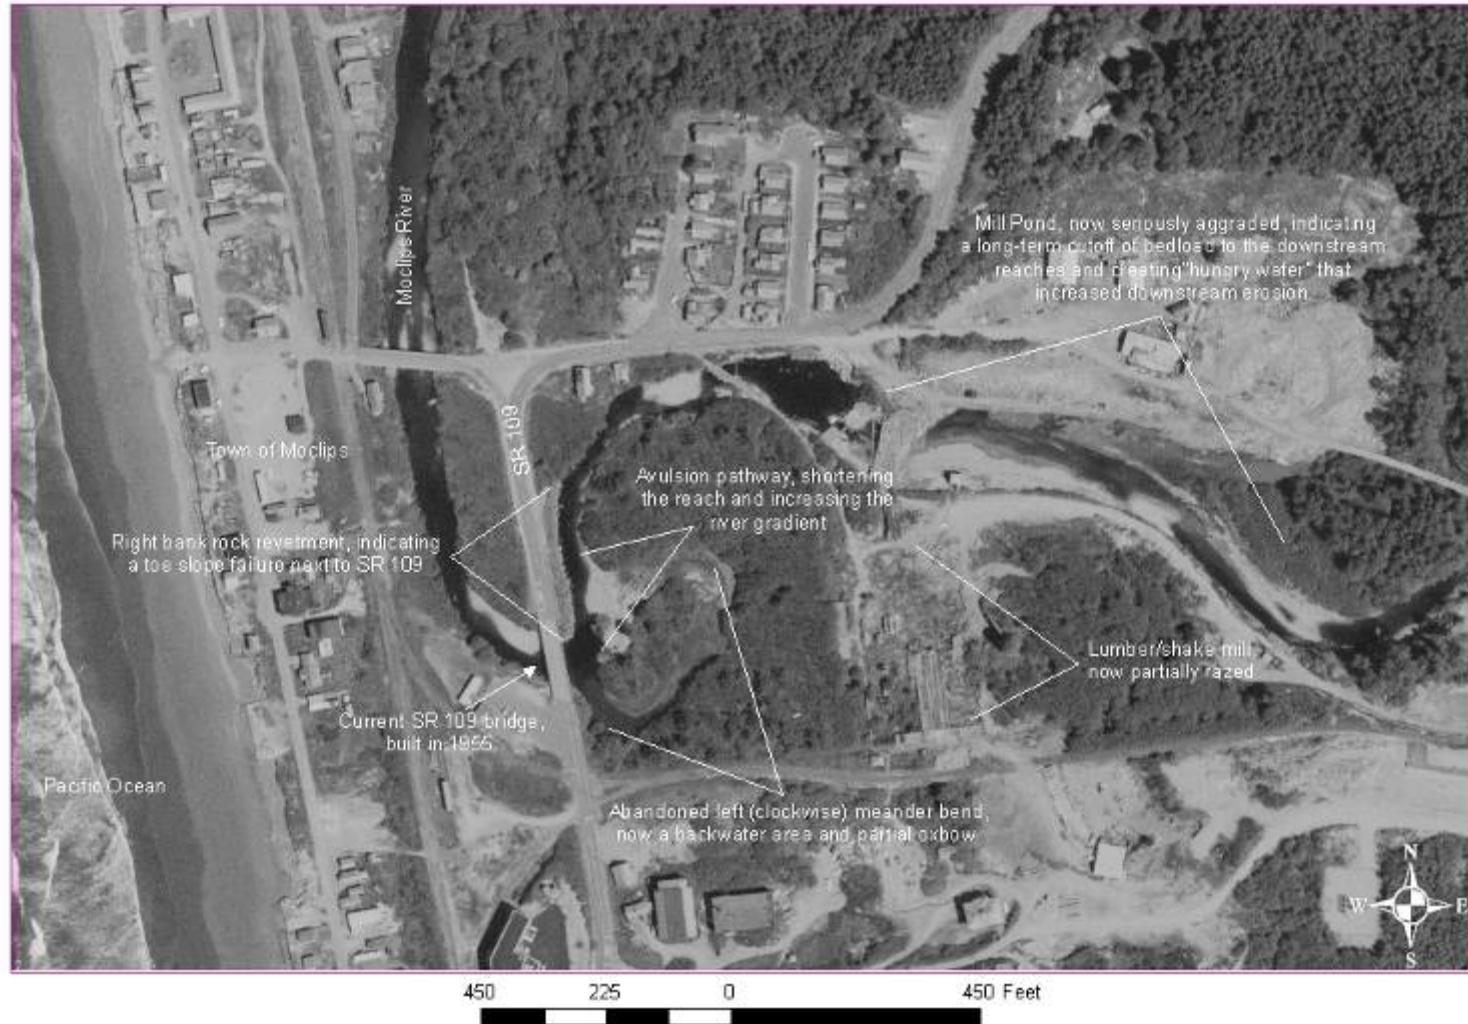
Figure 10. 1971 Aerial Photo in the Vicinity of the SR 109/023 bridge.

The 1952 aerial also shows an in-stream mill pond next to a fairly large shake/lumber mill at RM 1.6, 1000 feet upstream of the SR 109/023 bridge structure. The pond was likely used to temporarily hold logs for milling. In the 1971 aerial photo (Figure 10) shows the avulsion of the nearest upstream left meander, changing the approach flow direction from 45 degrees to the bridge opening to nearly directly at the left bank and the southern bridge abutment. The 1971 aerial photo also illustrates the instream mill pond being seriously aggraded with sediment, indicating that a long-term cutoff of bedload to the downstream reach had occurred over time. The cutoff of bedload to the downstream reach likely created a “hungry water” scenario, where the entrapment of bedload and suspended sediment in the millpond increases the carrying capacity of flows moving downstream. The kinetic energy of the system below the pond is shifted such that the downstream flow velocities and shear stresses increased due to the lack of suspended sediment, and the lack of energy dissipation from bedload movement. This likely increased the erosion rate at the meander just upstream of the SR 109/023 bridge that eventually resulted in the avulsion and the dramatic shift of the river’s attack angle to the bridge structure. Figures 11 through 13 show the aerial photos of the site and reach for 1982, 1992 and 2005 respectively. Figure 8 shows each of the river’s alignments for the aerial photos described above.
