TACOMA NARROWS AIRPORT 2005 PAVEMENT MANAGEMENT REPORT

February 2006

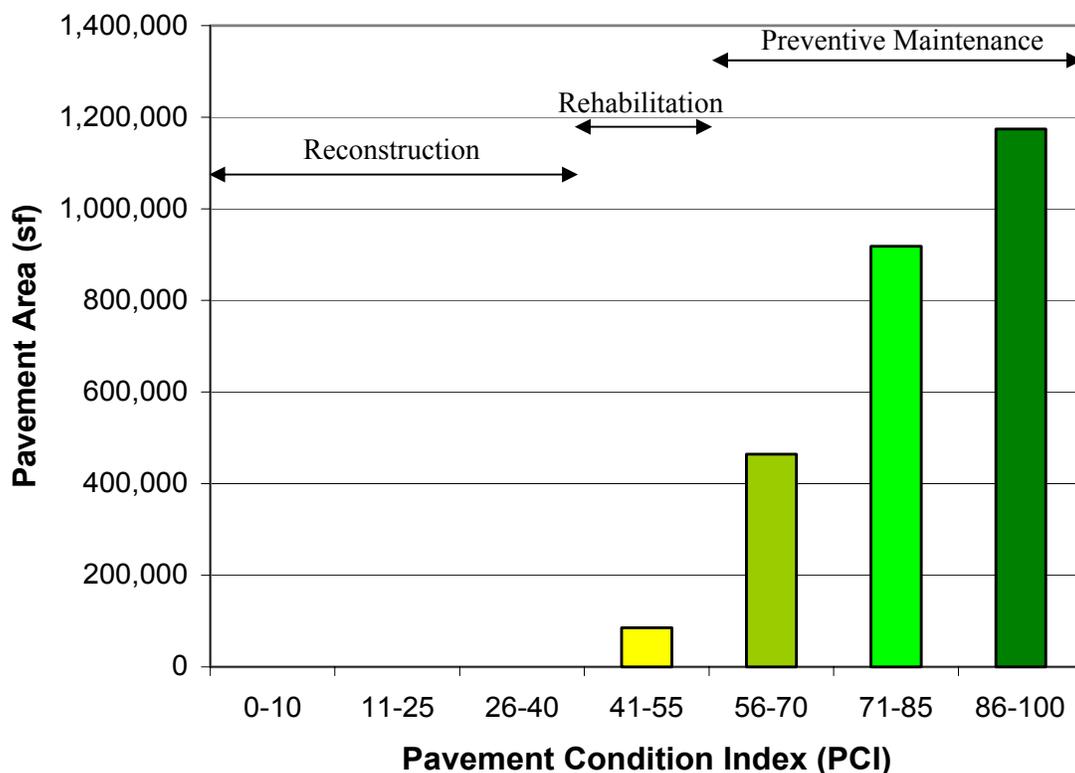
Figure 6. Tacoma Narrows Airport overall condition.

The pavements at Tacoma Narrows Airport were inspected on June 4, 2005. The 2005 area-weighted condition of Tacoma Narrows Airport is 81, with conditions ranging from 48 to 100 (on a scale of 0 [failed] to 100 [excellent]). During the previous inspection in 1999, the area-weighted condition was 77.

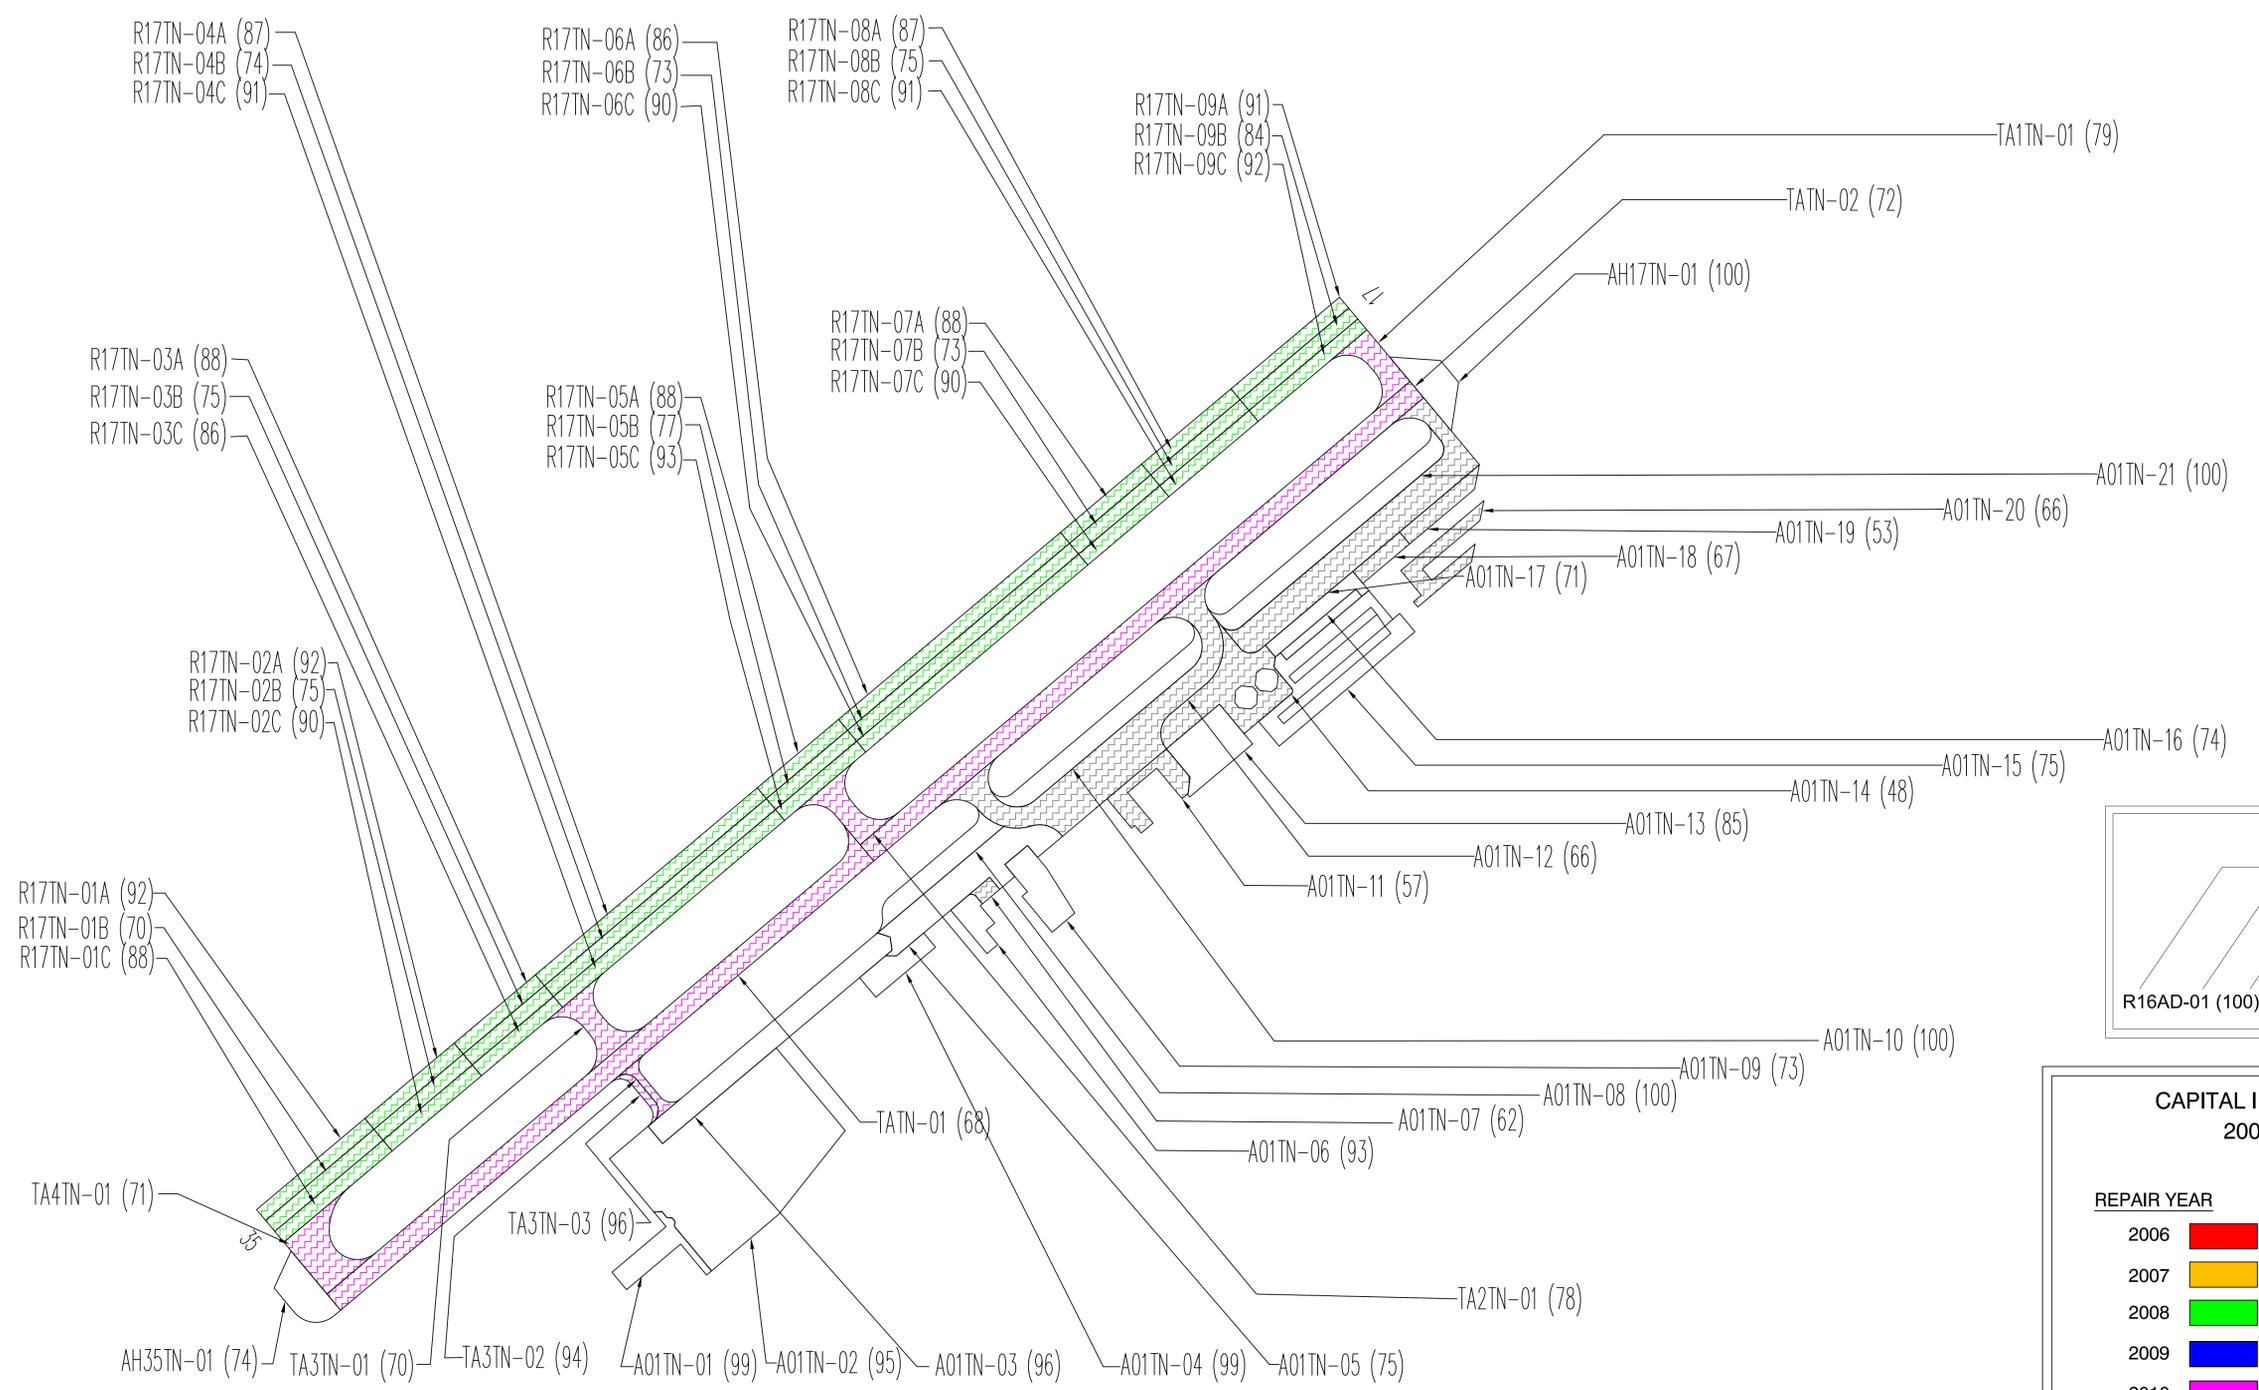
**CAPITAL IMPROVEMENT PROGRAM
2006 THROUGH 2012**

A summary of the pavement repair program for Tacoma Narrows Airport is presented in Table 4 and in Figure 9. Detailed information on the localized maintenance plan for 2006 is contained in Appendix F.
