**Reach Assessment
Clay Creek at SR 410 MP 35.76**

**Rob Schanz, Hydrologist
Jim Park, Senior Hydrologist
WSDOT Environmental Services
Hydrology Program**

December 2009

Washington State Department of Transportation
Environmental and Engineering Service Center
Environmental Services Office

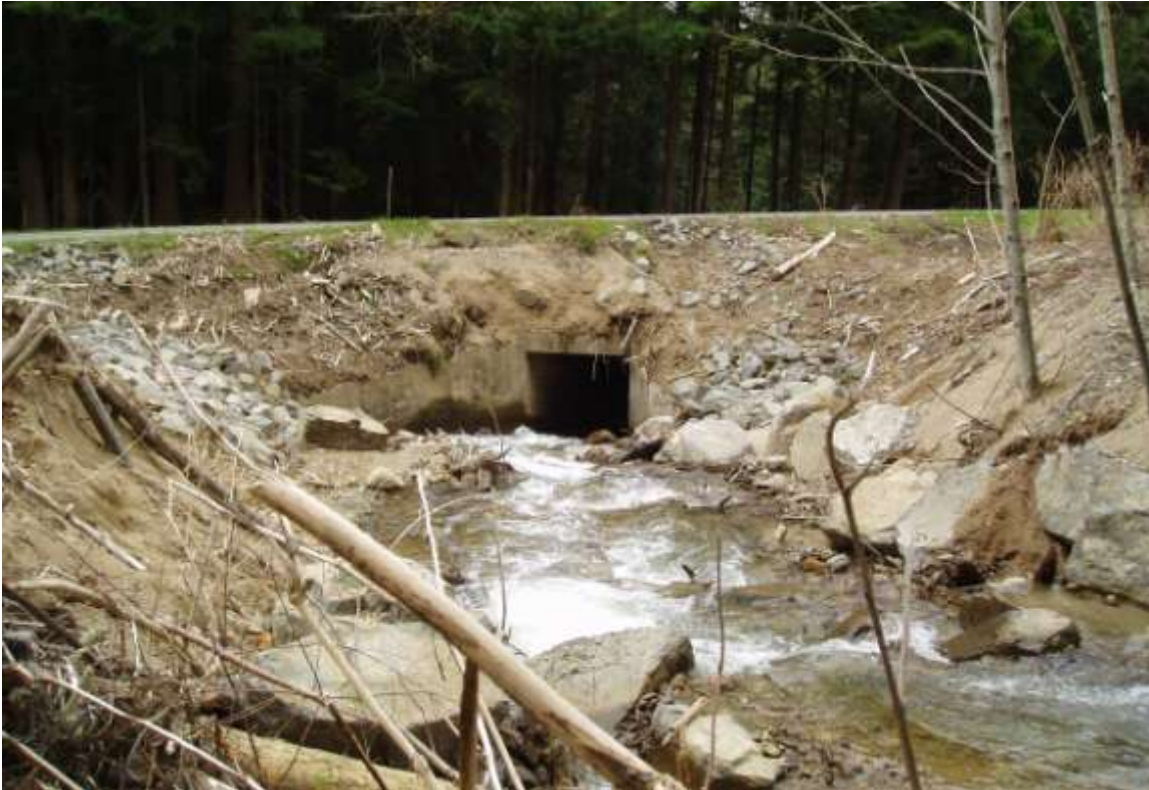
Figure 1. Photo of the Culvert Inlet after the 2009 Repair.

The mechanisms of failure are debris deposition at the culvert inlet and scour/channel incision at the outlet. These are caused by high debris loads from a steep, heavily-logged watershed with numerous landslides. The SR 410 culvert cannot pass this debris, and confines the creek to a single channel as it flows through landslide deposits towards the White River. This starves downstream reaches of the coarse debris needed to maintain a steep gradient. The channel has responded to this by cutting downward, creating a massive drop at the culvert outlet that undermines the culvert apron and wingwalls and prevents fish passage.

Restoring fish passage and debris conveyance in Clay Creek will require a significantly larger bridge, as well as extensive stream grading to re-establish a stable streambed profile. Table 3 summarizes the advantages and disadvantages of the three alternatives. We recommend Alternative 2 (Excavate Upstream) because this alternative has the least impact on existing downstream aquatic habitat, establishes the most stable streambed profile, and provides the highest clearance for debris conveyance under the bridge. This is also the alternative that will require the largest bridge and highest construction cost, but we believe the lower risks of failure and aquatic habitat impacts justify the additional costs. Alternative 1 (Filling Downstream) impacts over 700 feet of habitat downstream, and has a much higher risk of streambed erosion and dewatering. Rerouting the creek to the east gully (Alternative 3) would abandon all existing habitat downstream of SR 410, and would require significant work to widen and stabilize the gully.
