P2 Bridge Preservation - Scour Repair

2009-11 Bien Priority Array

Bridge Foundation Scour Repair

Bridge Preservation Program

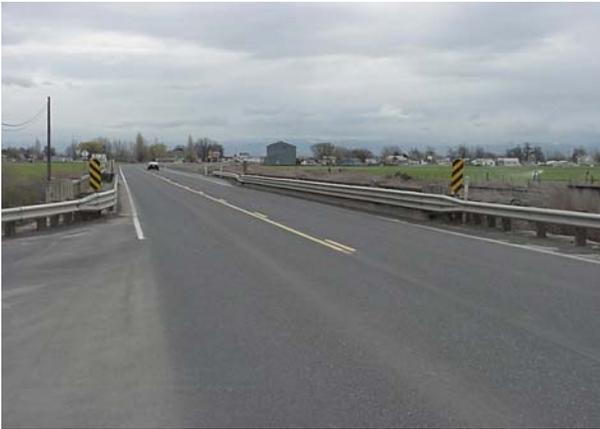
Deficiencies: Rip Rap and Debris at Upstream End of Pier 2, looking southwest. Rip Rap Installed at Downstream End of Span 1 Apron and upstream and downstream ends of Pier 2. Concrete apron has deteriorated.	First Noted: 12/20/2005
	BPO Repair List Priority: 1
	Funding - P2 or M: P2
	07-09 Priority Rank: 1
	09-11 Priority Rank: 1
Recommended Action: BPO - Repair deteriorated concrete apron. Add riprap downstream of bridge. Bridge Management Unit - Repair of Concrete Apron project is under design.	PIN:
	Bridge\$ Est:
	Total\$ Est: \$582,000

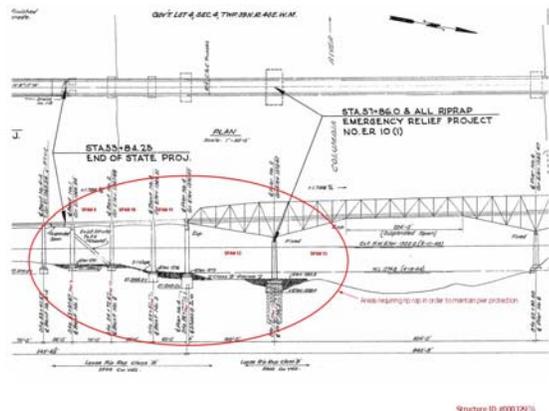
Pier 10 pedestals and the top surface of the footings are exposed. Small scour hole around column 11A. Pier 12 footing is exposed 2 ft vertically at NW corner per underwater inspection report of 10/21/2000. Exposed footing observed in 2006.
