Evaluation of Tieback Performance

WA-RD 269.1

Final Technical Report
January 1993

Final Technical Report
Research Project GC 8719, Task 19
Tieback Performance

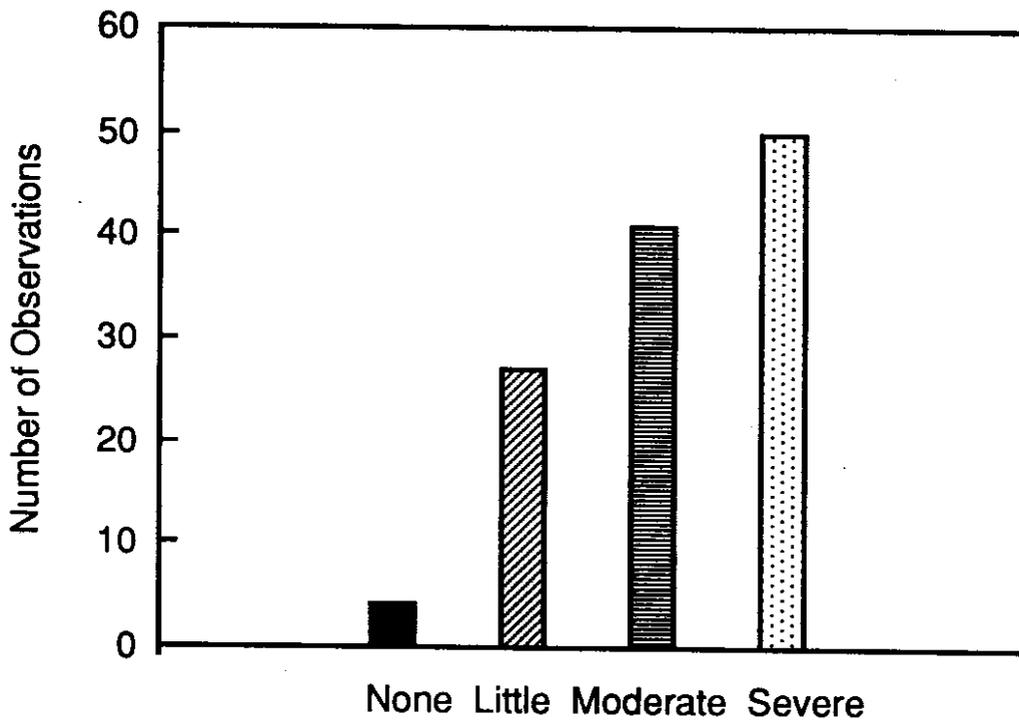
Figure 25. Distribution of Tie Rod Disturbance Observations for Tiebacks with Significant Trumpet Grease Leakage Observations

Correlation between the amount of grease leakage and the amount of anchor tendon disturbance was significant, as indicated in Table 2 and in Figures 22, 23, and 24, which show respective grease leakage observations for little, moderate, and severe disturbance. Figure 25 illustrates the distribution of anchor tendon disturbance associated with observations of significant grease leakage. Even for those in which significant leakage did occur, evidence of significant corrosion of the anchor tendon was not apparent.
