PERFORMANCE OF GEOTEXTILE SEPARATORS

WA-RD 321.2

Final Report
January 1996

Final Summary Report
Research Project T9233, Task 13
Geotextile Separators II

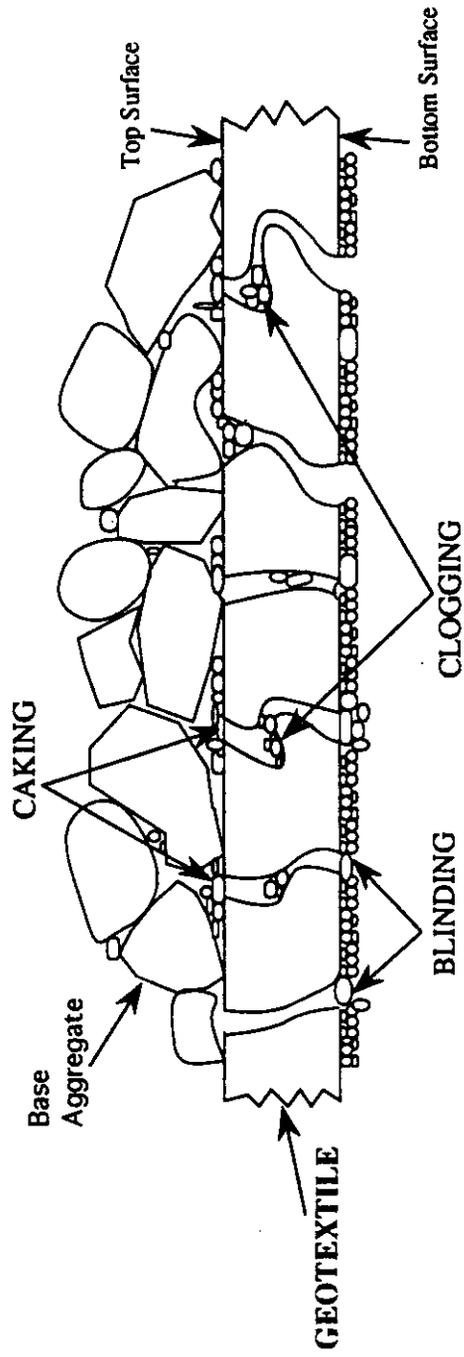
will blind and clog (see Fig. 1 for definitions of these terms) under repeated loads, although in some cases the decrease in permeabilities may not have been detrimental when compared to the subgrade soil permeability. On the other hand, several field studies have showed no migration of fines up through the geotextiles, although a few found some indications of subgrade fines migration through woven slit-films. Thicker geotextiles may be more capable of preventing subgrade fines migrations, and although there is some evidence of clogging and blinding of geotextiles in the field, no negative effects on the pavement system have been reported.

Figure 1. Illustration of Blinding, Clogging, and Caking

Metcalf (4) also examined the geotextiles for possible blinding/clogging and iron staining. He did not observe any heavy blinding on the woven geotextiles, although several were moderately blinded. The nonwoven geotextiles showed varying degrees of clogging, some of which appeared to be heavy-to-severe (Columbia Heights and Carroll Road). Several geotextile had moderate-to-heavy iron oxide deposits; those at the Columbia Heights Road sites were the heaviest. Geotextiles at three sites (SR 14, 49th Ave NE, and SR 16) showed signs of significant caking (see Fig. 1); fine-grained soil particles covered their upper surfaces.
