Trinidad Lake Asphalt Overlay Performance Final Report

WA-RD 710.2

TRINIDAD LAKE ASPHALT OVERLAY PERFORMANCE FINAL REPORT

Contract 6441
SR-16
Tacoma Narrows Bridge – Eastbound
MP 7.28 to 8.41

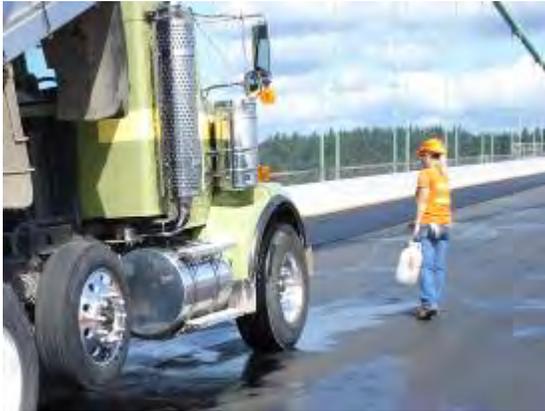
During placement of the base course the Contractor applied water using hand held sprayers ahead of truck tires and vehicle tracks in order to prevent damage to the polymer modified bituminous hot melt adhesive. One area of tack coat incurred damaged by the track on the Terex transfer vehicle. The area may have been more susceptible to damage since the adhesion layer had been repaired earlier in the day. Otherwise this method appeared successful in preventing damage.

Figure 20. Applying water to prevent damage to adhesion layer.

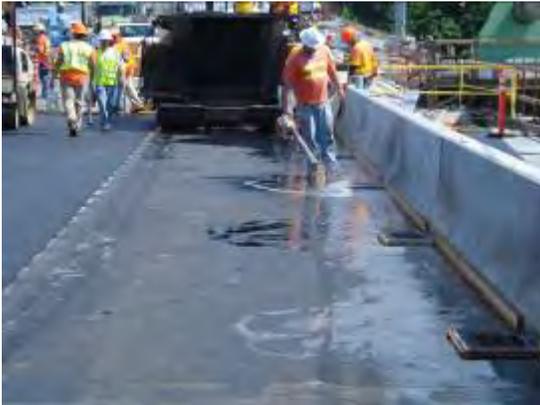
Portions of the base course and tack layer were affected by the water and had to be removed around the bridge scuppers. The repair consisted of reapplying the adhesion layer and replacing the base course material at the end of the next day's paving.

Figure 22. Water being removed prior to paving.

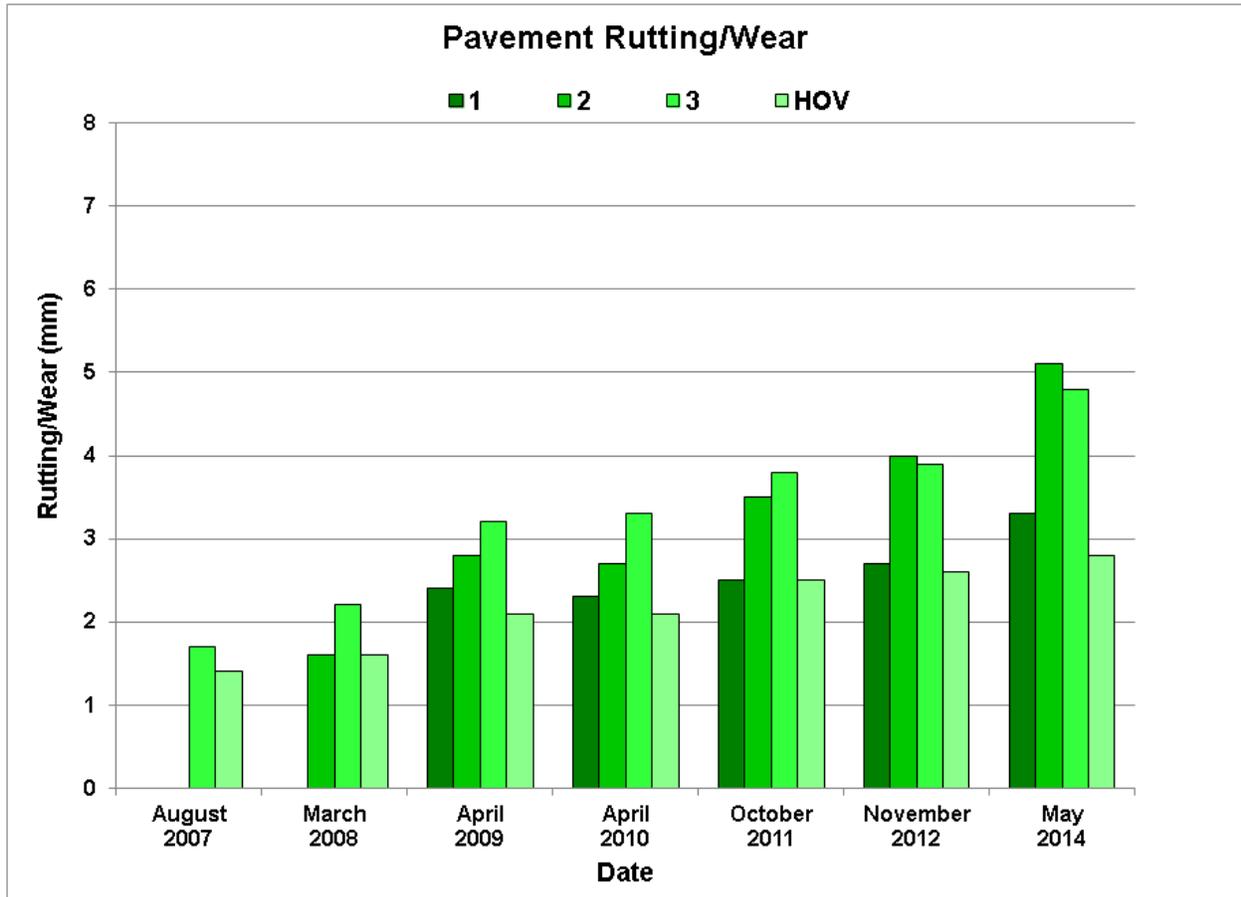
Figure 50. Rutting/wear measurements.

Rutting/wear measurements for each year since construction are listed in Table 12 and shown in the Figure 50 bar graph. The maximum rutting wear for any lane was 5.1 mm (between 3/16 and 13/64 inches) with the average for all lanes at 4.0 mm (5/32 inch). The most heavily trafficked middle lanes (2 and 3) had the highest rutting/wear, as would be expected. The increase in rutting/wear over the 83 months of data collection was, on the average, 2.4 mm (4.0-1.6).

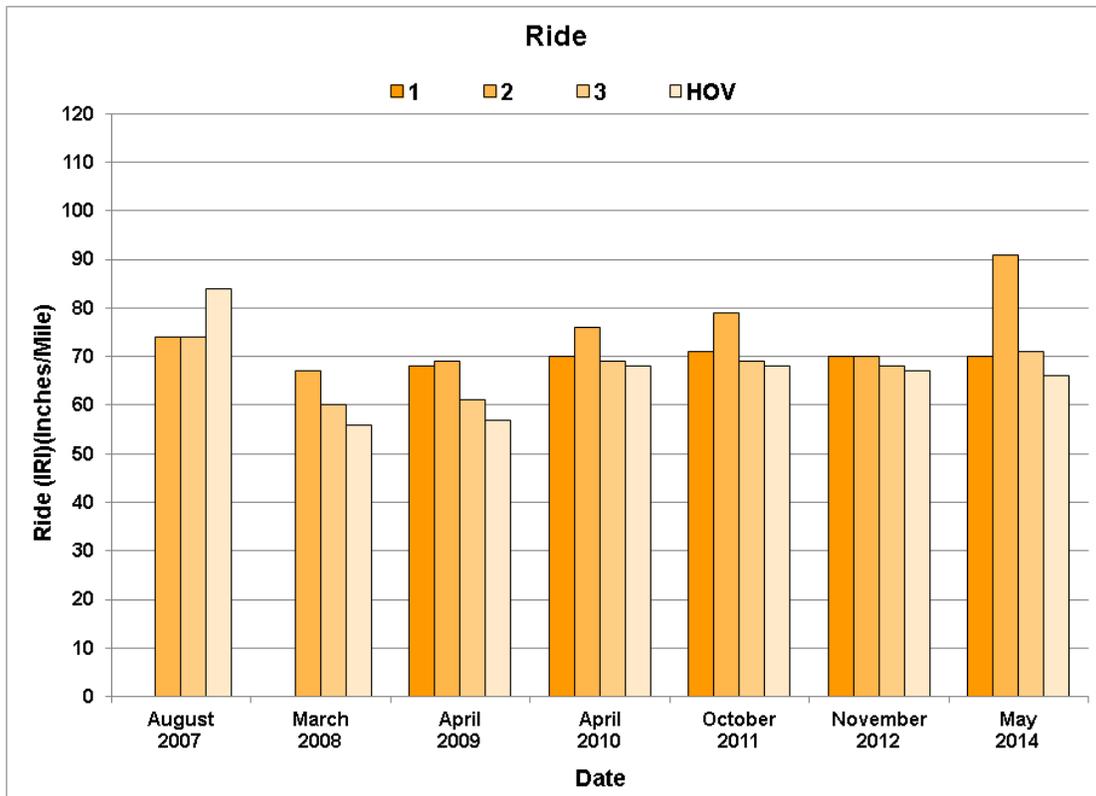
Figure 51. Ride measurements.

Ride measurements for each year since construction are listed in Table 13 and shown in the Figure 51 bar graph. The ride measurements were excellent for all lanes and did not vary to a great degree from lane to lane or from year to year which was not unexpected given the steel deck upon which the overlay rests. Individual values ranged from a high of 84 inches/mile to a low of 56 inches/mile. Averages for each measurement period ranged from 61 to 78 inches/mile. The increase in roughness for Lane 2 may be due to the large number of patches needed to repair deep raveling in the wheel paths.

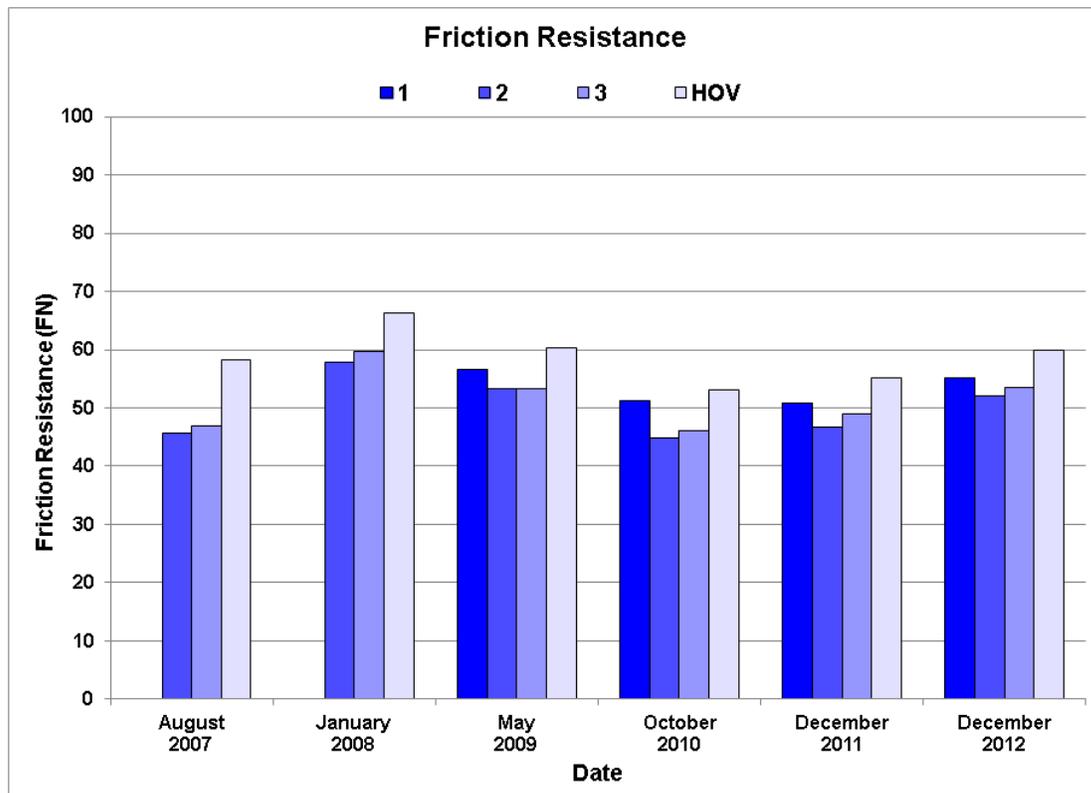
Figure 52. Friction measurements.

Friction measurements are listed in Table 14 and shown graphically in Figure 52. The friction measurements were excellent for all lanes with individual values ranging from a low of 45.6 to a high of 66.3 and yearly friction number averages ranging from 48.8 to 61.3.

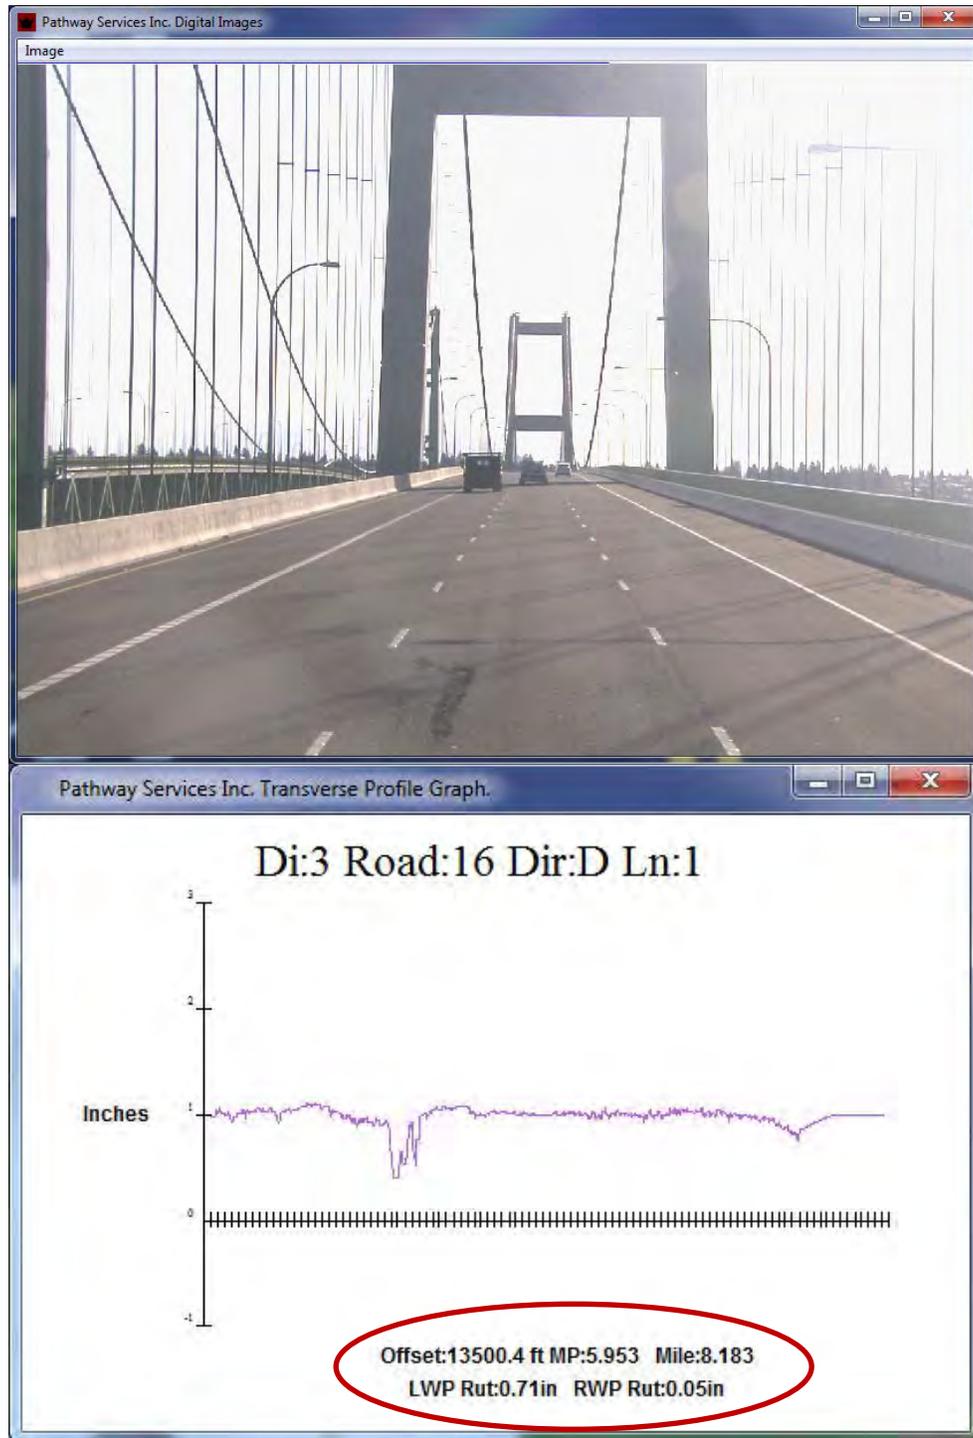
There was visual evidence of wear (raveling) in excess of the allowable wear of 1/4 inch stated in the table. Detailed examination of the data revealed intermittent rutting that exceeding 1/4 inch occurred over approximately 500 lineal feet, primarily in Lane 2 on the bridge. Images of the raveling/wear and the rut depth measurements from the Pathway Van are shown in Figures 65 to 67. The Contractor was required to patch this section on the deck.

Figure 65. Left wheel path wear depth is 0.71 in. Note that the graph is incorrectly labeled as Lane 1.

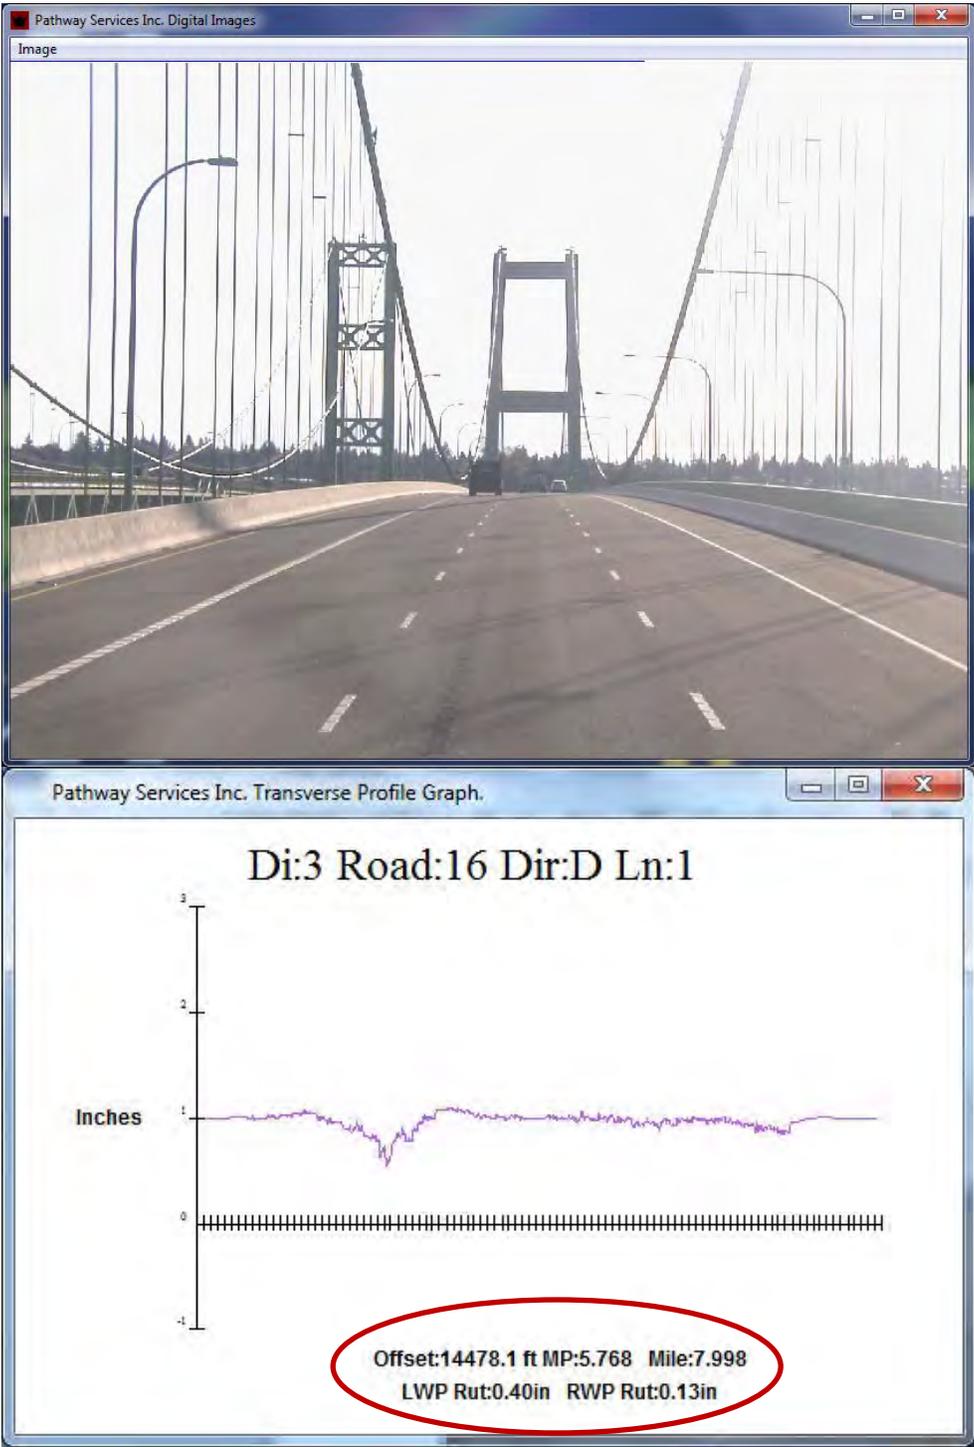
Figure 66. Left wheel path wear depth is 0.40 in. Note that the graph is incorrectly labeled as Lane 1.

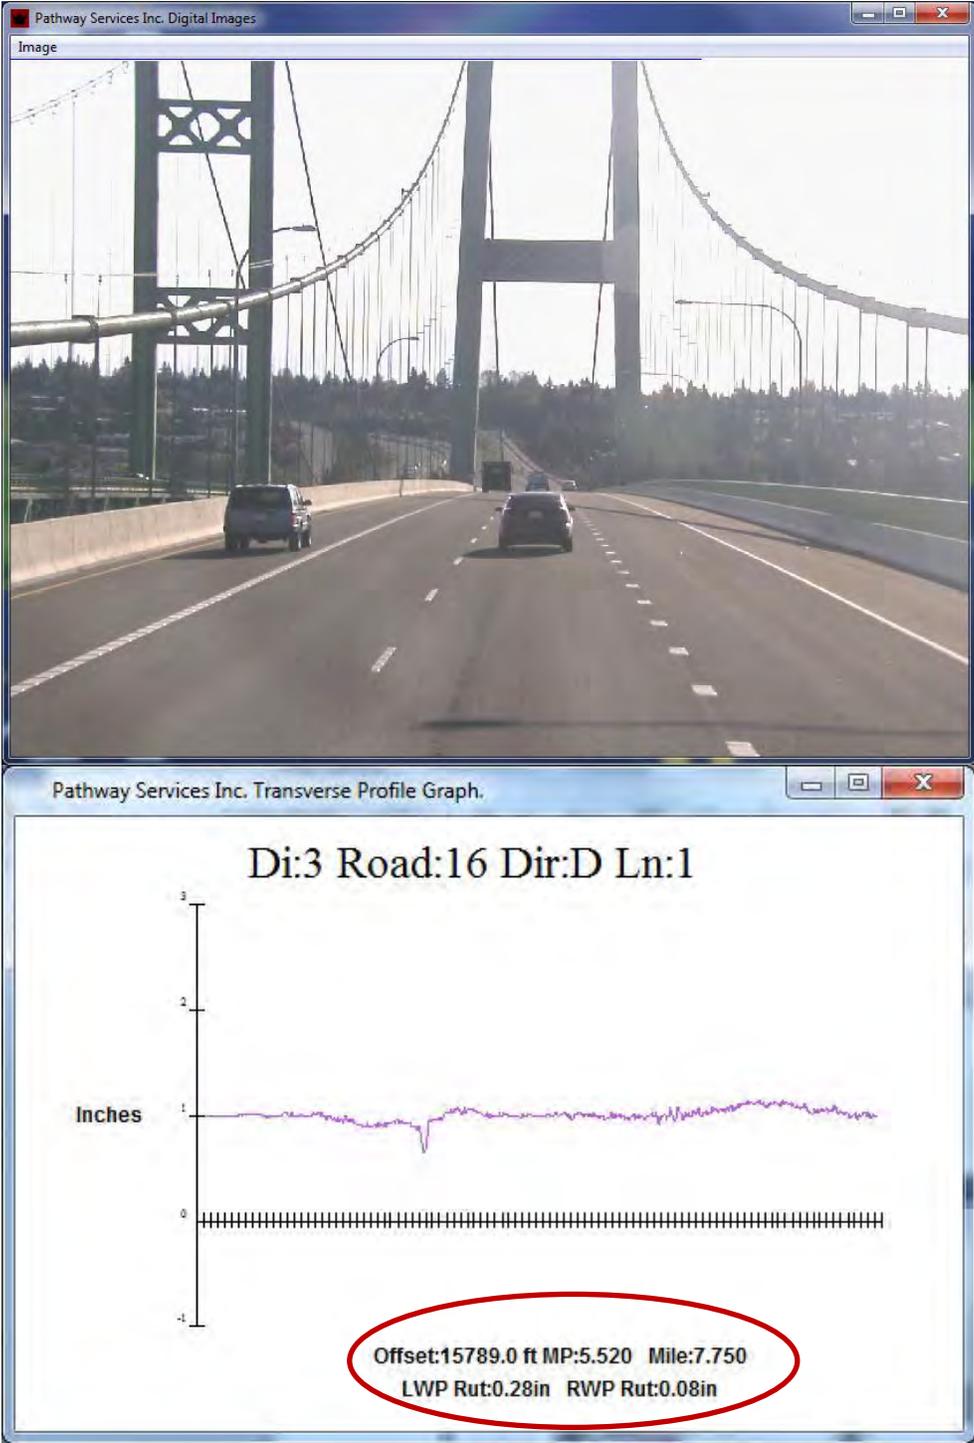
Figure 67. Left wheel path wear depth is 0.28 in. Note that the graph is incorrectly labeled as Lane 1.
