Alaskan Way Viaduct

Report of the

Structural Sufficiency Review Committee

June 28, 2001

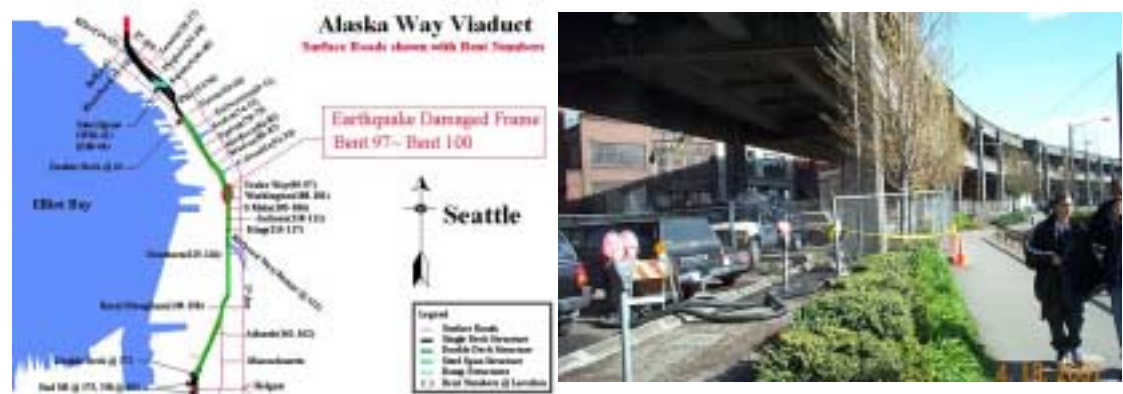
Damage at Bent 100

After the February 28 earthquake, the WSDOT Bridge office conducted a drive-through inspection of the structure to assess major structural condition. The most notable damage was to a curved bridge unit adjacent to Washington Street, comprised of bents 97 – 100.

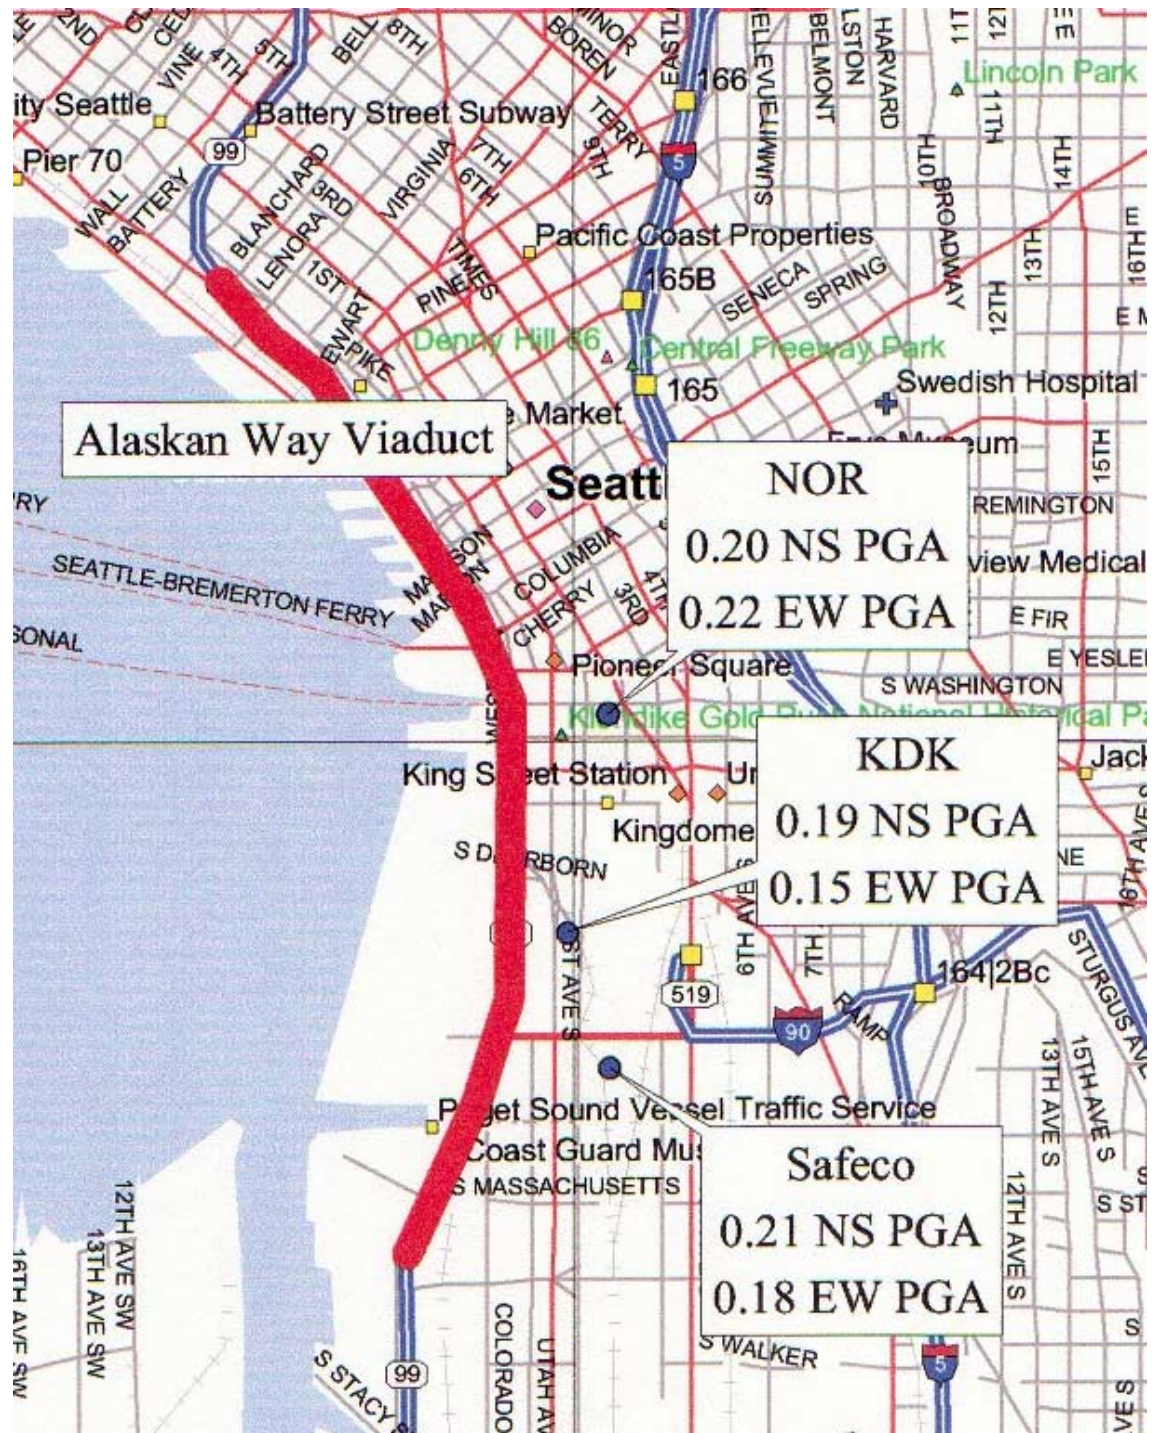
Figure 3

The February 28, 2001, Nisqually Earthquake was widely recorded throughout the Puget Sound region. Fortunately, there were three recording stations within about 1000 feet of the Viaduct. The locations of these stations, along with the peak ground accelerations recorded at each station, are shown on Figure 3. The response spectra for these sites are shown on Figure 4, along with a standard AASHTO spectrum. As indicated on Figure 3, the three stations show an average EW recorded peak ground acceleration of about 0.19g. As reflected on the hazard curve in Figure 2, the 0.19g ground acceleration at the site would have a recurrence interval of about 150 years.
