Root Cause Analysis and Recommendations

Investigation of July-29th Incident on Washington State Ferry - Tacoma

Raeey Regassa, P.E., Ph.D. Candidate
Siemens Industry, Inc.

Date: 10/24/2014

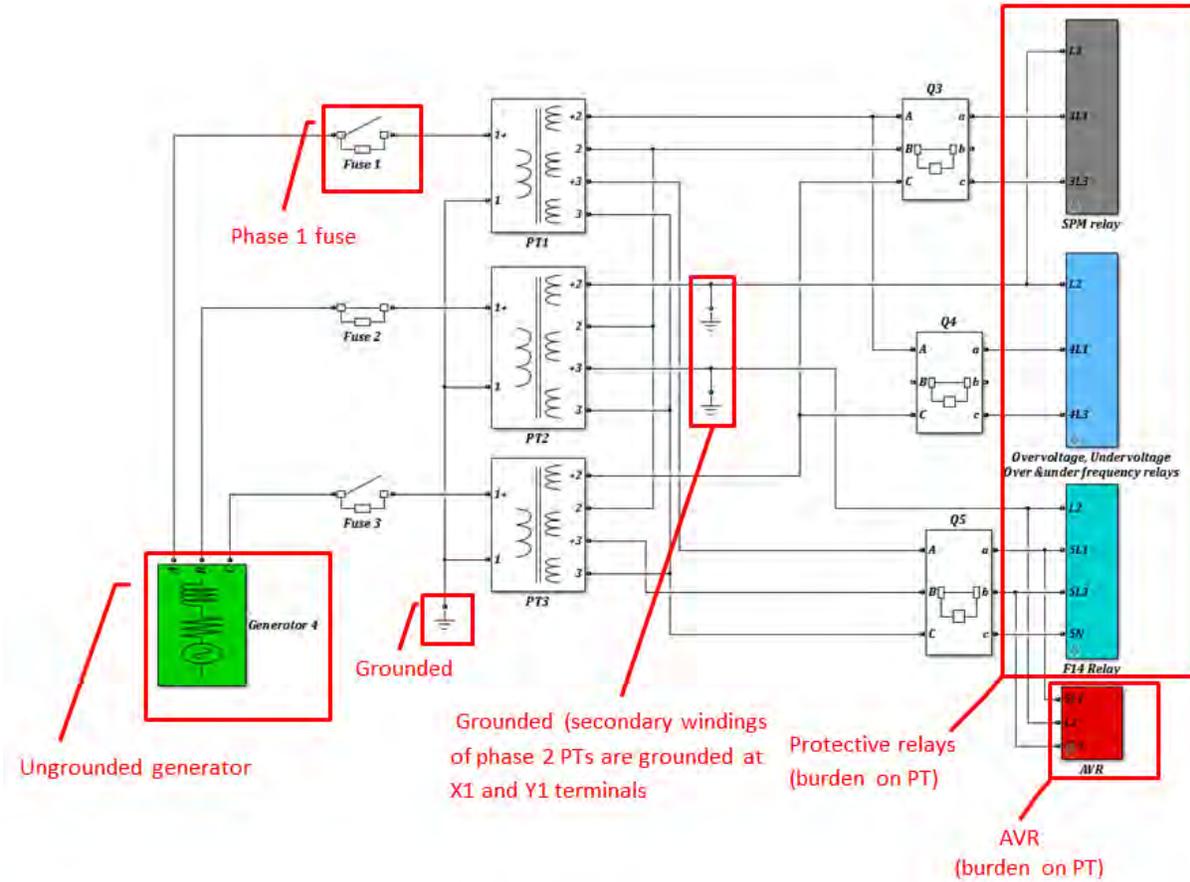
Figure 6: Simulink model of Generator-4 protection scheme

As shown in figure 6, three three-winding transformers are used to model the three PTs. To model Generator-4, a three-phase voltage source model is selected from SIMULINK's library and the neutral is left floating. Since most burden (load) on PTs are mainly resistive, 0.05VA/phase burden is assumed on each relay and a resistance value of $\sim 95K\Omega$ is calculated (the calculated impedance accounts for impedance from conductors connecting the PTs to the protective relays). The fuses are modeled by low impedance single phase breakers (i.e. low voltage drop across the breakers). Fuse loss does not mean the voltage on that line is going to be zero.

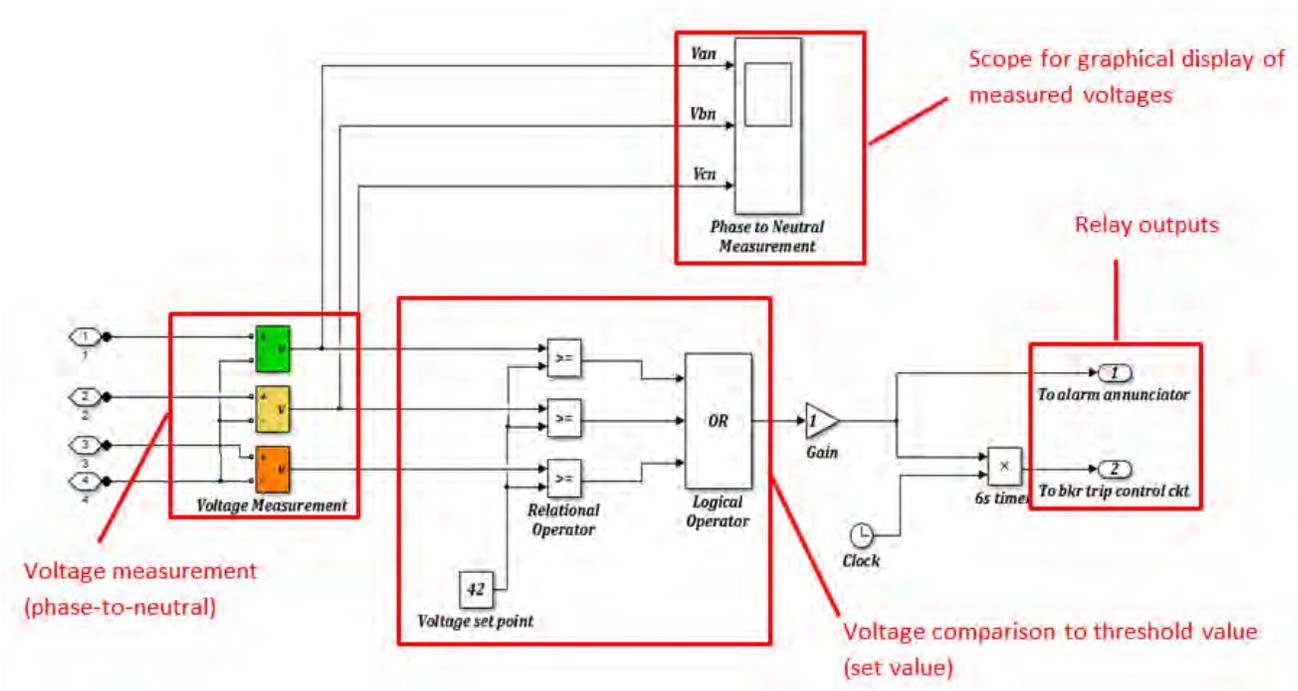
Figure 7: Connections inside F14 Relay block

The F14 Relay block consists of voltage measurement blocks and comparison blocks. A scope is connected to visually display the voltage measured by the F14 measurement blocks. Double clicking the F14 Relay block reveals the inside connection diagram of the F14 relay. Figure 7 shows the inside connection diagram of the F14 Relay block.

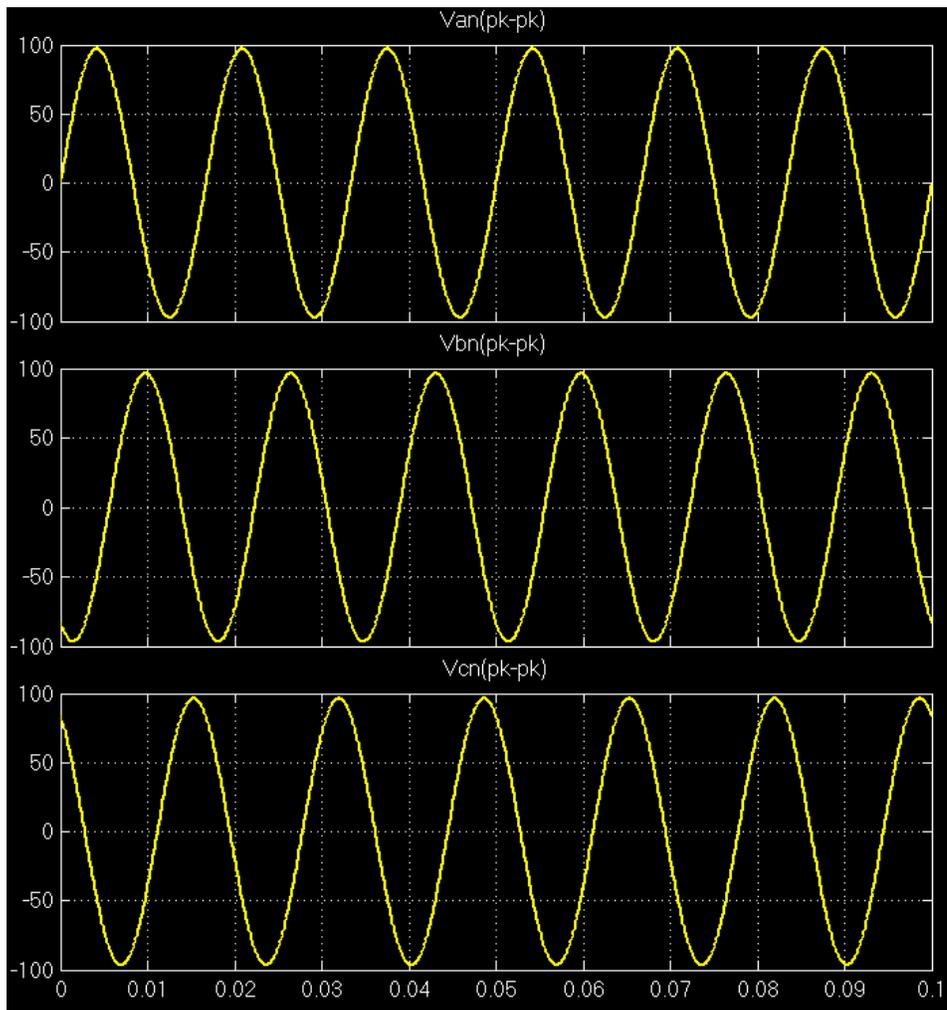
Figure 8: Line-to-neutral voltages measured by F14 relay when all fuses are working

When the model is run with all fuses working, the expected voltage at terminals of the F14 relay is $\frac{120}{\sqrt{3}} = 69.282V_{rms}$ (line-to-neutral) and it is well above the voltage set point (i.e. $42V_{rms}$). Figure 8 shows scope capture of voltages measured at the terminals of F14 relay when all fuses are working. It can be seen from the figure that the measured line-to-neutral voltage of each phase is about $\sim 98V_{pk}$ ($\sim 69V_{rms}$).

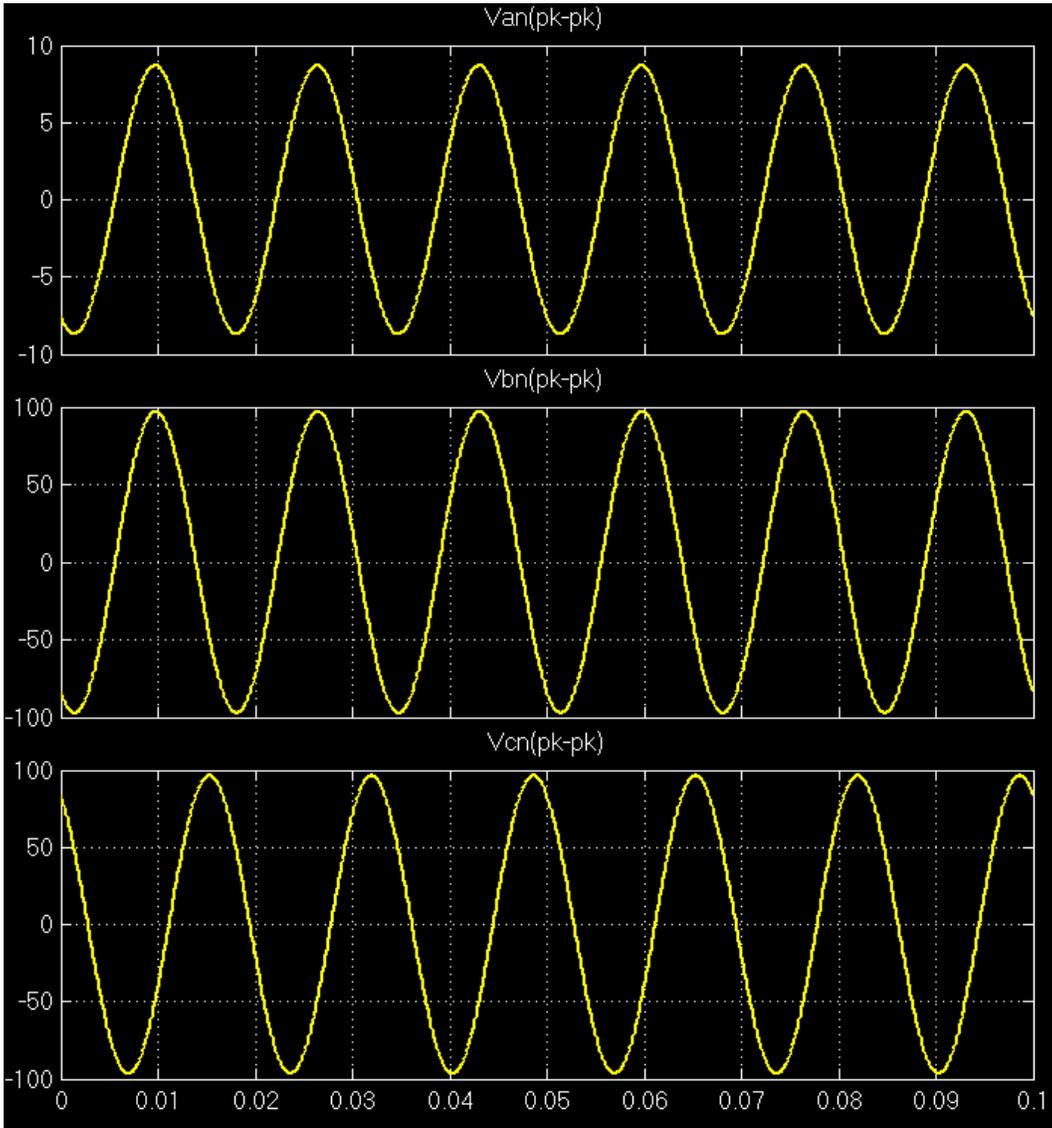
Figure 9: Line-to-neutral voltages measured by F14 relay when phase 1 fuse is blown

For this simulation, phase 1 fuse is opened and line-to-neutral voltages measured by F14 relay are captured by the scope.

As seen from figure 9, the line-to-neutral voltage measured by the F14 relay is almost $\sim 98V_{pk}$ ($\sim 69V_{rms}$) for phases 2 and 3, but it is about $\sim 9V_{pk}$ ($\sim 6V_{rms}$) for phase 1. Phase 1 voltage measured is well below the set threshold value of $42V_{rms}$ and the relay will trip the breaker after six seconds.

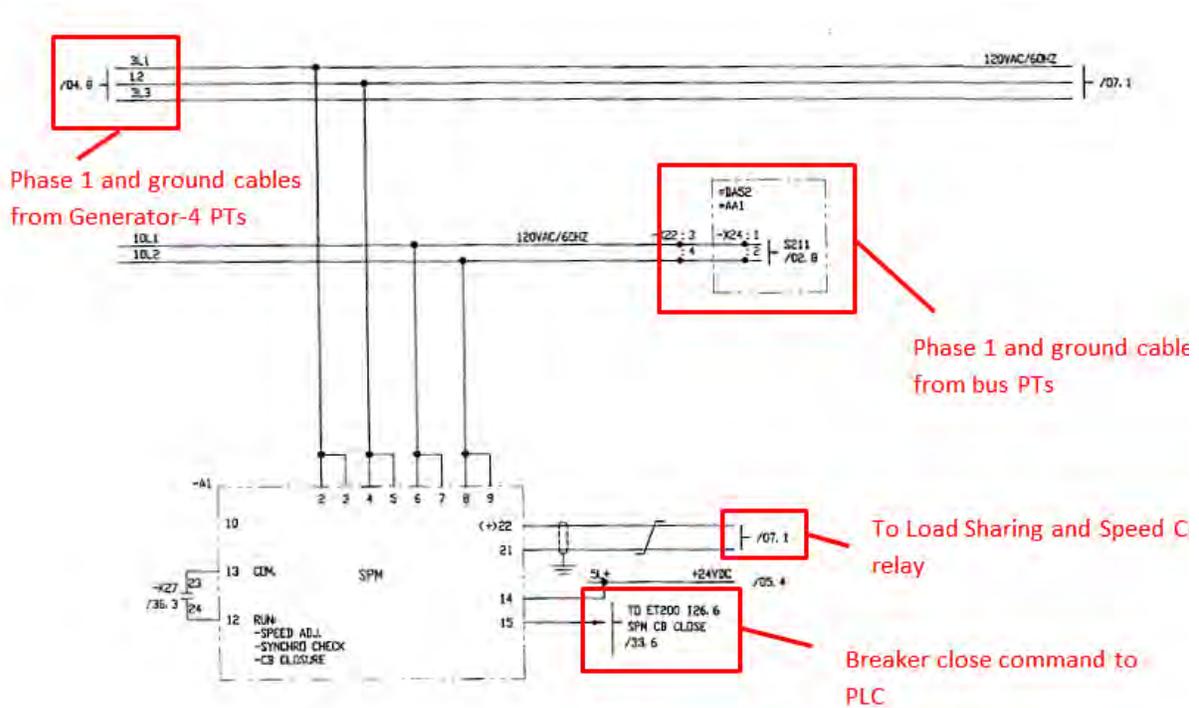
Figure 12: Generator-4 SPM connection diagram

When an offline generator is about to be put online, the synchronizer (WOODWARD TYPE SPM 9905-001) relay compares the generator's phase 1 phase angle against phase 1 of the 4.16KV bus and if they don't match within $\pm 10^\circ$ tolerance, it either speeds up or slows down the generator through the Load Sharing and Speed Control relay. If there is phase angle match, the SPM relay sends signal to the PLC (E200) to close the generator breaker. Figure 12 shows the connection diagram of Generator-4 SPM relay.

The magnitude of voltage measured by the SPM relay is well below the line-to-neutral voltage value of $\sim 70V_{rms}$ (as shown in figure 13) when two of the three fuses burn out. If the SPM relay model installed on the ferry had a capability to compare voltage magnitudes besides phases, it would have caught the voltage magnitude difference between Generator-4 PTs and PTs on the 4.16KV bus 2. It would not have sent the “close” command to the PLC and the PLC in turn wouldn’t have closed Generator-4 breaker with such severe voltage mismatch.

recommends replacing the SPM relay with a WOODWARD SPM 9905-003 model that has the capability of checking both phase and voltage match (5% tolerance) between two lines.
