PAVEMENT RESEARCH  
at the  
WASHINGTON STATE UNIVERSITY  
TEST TRACK

DO NOT REMOVE  
From Research Office  
VOLUME THREE  
EXPERIMENTAL RING NO. 3: A STUDY OF UNTREATED,  
EMULSION TREATED, AND ASPHALTIC-CEMENT TREATED BASES

Research Project Y-993

Report to the Washington State Department of Highways  
on Research Project Y-993

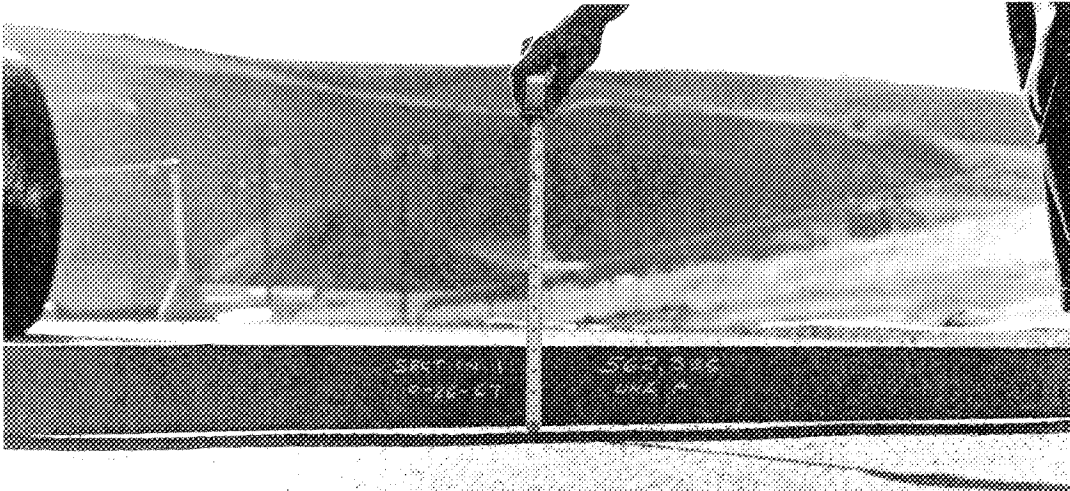
FIGURE 22. PERMANENT SETTLEMENT OF PAVEMENT IN SECTION 1 AFTER 562,335 WHEEL LOAD REPETITIONS ON LINE D-- OCTOBER 26, 1967.
