# Evaluation of Tieback Performance

WA-RD 269.1

Final Technical Report  
January 1993

**Washington State Department of Transportation**

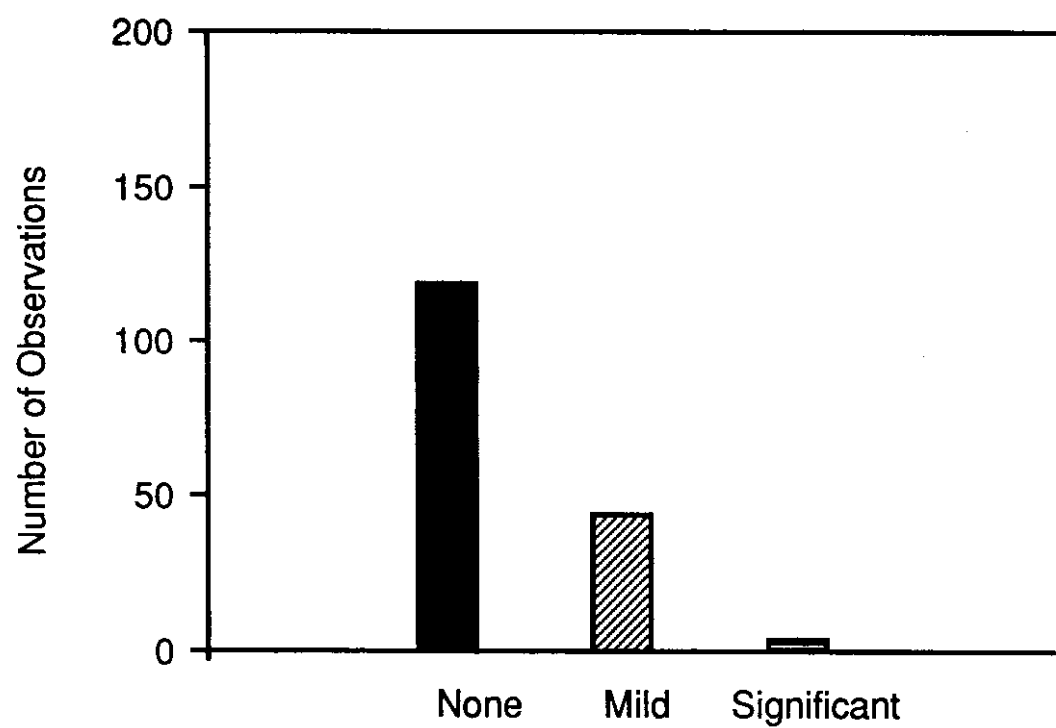
Figure 21. Distribution of Grease Leakage Observations among Trumpets for Which No Disturbance Was Observed

The most useful of these observations were those for which no evidence of anchor tendon disturbance was visible. As illustrated in Figure 21, over 71 percent of the undisturbed trumpets exhibited no noticeable leakage, and only 2.4 percent exhibited significant leakage. Even for those in which significant leakage did occur, evidence of significant corrosion of the anchor tendon was not apparent.

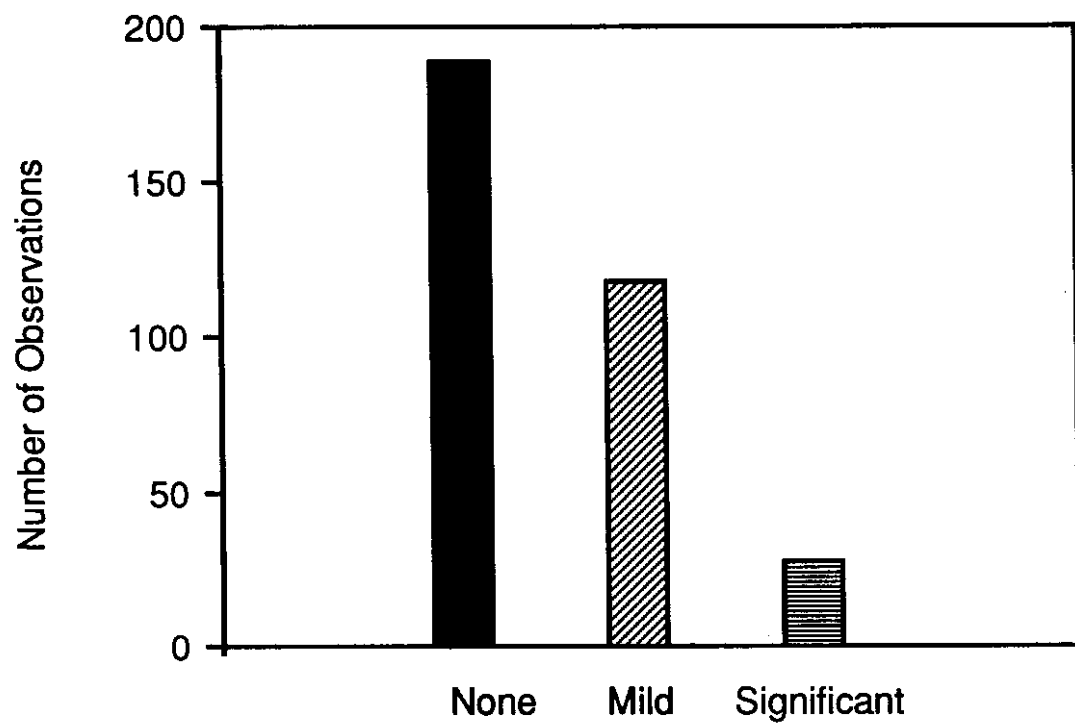
Figure 22. Distribution of Grease Leakage Observations among Trumpets for Which Little Disturbance Was Observed

Correlation between the amount of grease leakage and the amount of anchor tendon disturbance was significant, as indicated in Table 2 and in Figures 22, 23, and 24, which show respective grease leakage observations for little, moderate, and severe disturbance. Figure 25 illustrates the distribution of anchor tendon disturbance associated with observations of significant grease leakage. Even for those in which significant leakage did occur, evidence of significant corrosion of the anchor tendon was not apparent.
