# Trinidad Lake Asphalt Overlay Performance Final Report

WA-RD 710.2

July 2014

**Contract 6441**  
**SR-16**  
**Tacoma Narrows Bridge – Eastbound**  
**MP 7.28 to 8.41**

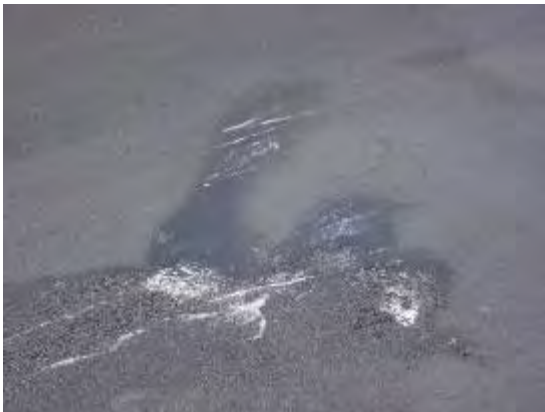
During placement of the job control strip for the base course the large rollers began picking up mix from the newly laid mat. Pickup occurred between 300 and 700 feet from the west end of the bridge. The mix had to be removed from the roller drums before the roller could continue, delaying the compaction operation. Voids left in the mat were repaired by carrying mix back to the damaged area in shovels and a wheelbarrow. Despite the repair efforts voids and open areas remained in the mat. The voids were more or less centered about 6.5 feet from the face of the barrier. The problem ceased when the large rollers were removed from the paving operation and replaced by smaller rollers.

Figure 18. Area of mix pickup after completion of rolling.

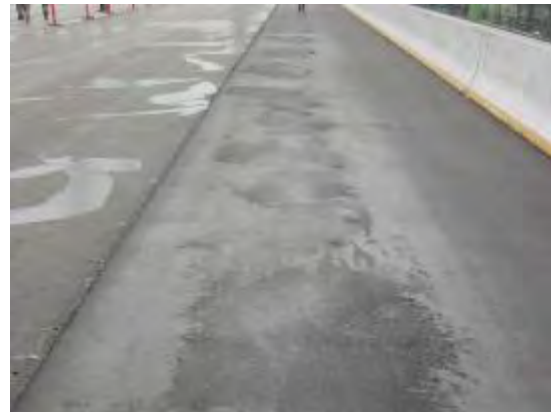
Figure 19. Area of mix pickup prior to the next day's paving.

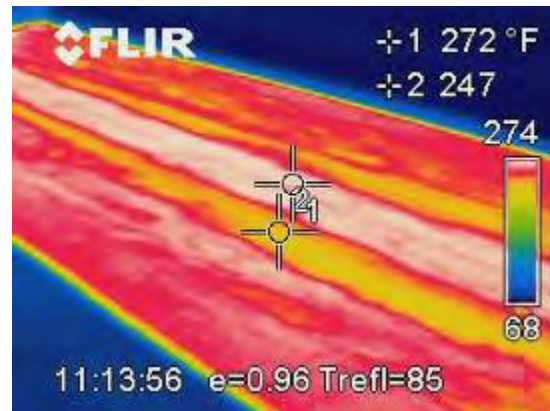
Figure 28. Warmer center in base course.

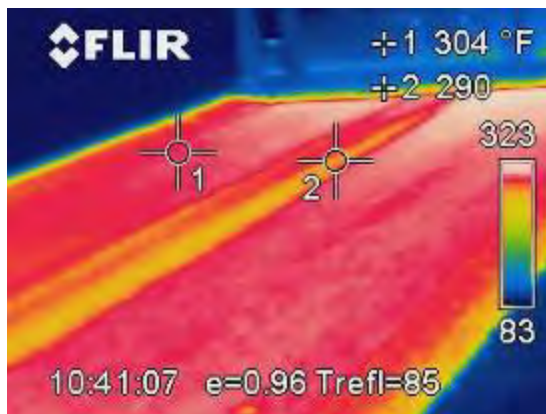
Figure 29. Mat with cooler center recorded on June 20.

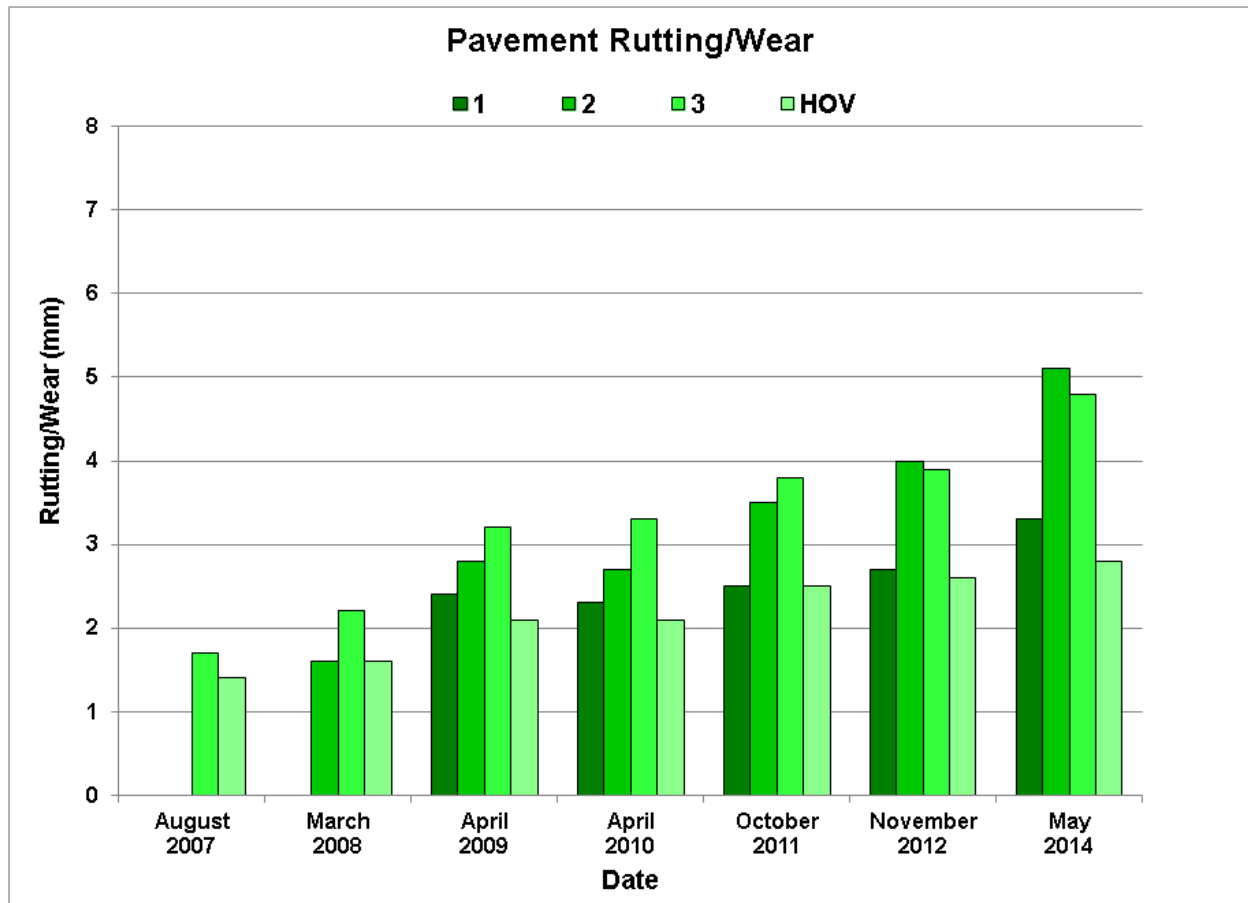
Figure 50. Rutting/wear measurements.

Rutting/wear measurements for each year since construction are listed in Table 12 and shown in the Figure 50 bar graph. The maximum rutting wear for any lane was 5.1 mm (between 3/16 and 13/64 inches) with the average for all lanes at 4.0 mm (5/32 inch). The most heavily trafficked middle lanes (2 and 3) had the highest rutting/wear, as would be expected. The increase in rutting/wear over the 83 months of data collection was, on the average, 2.4 mm (4.0-1.6).

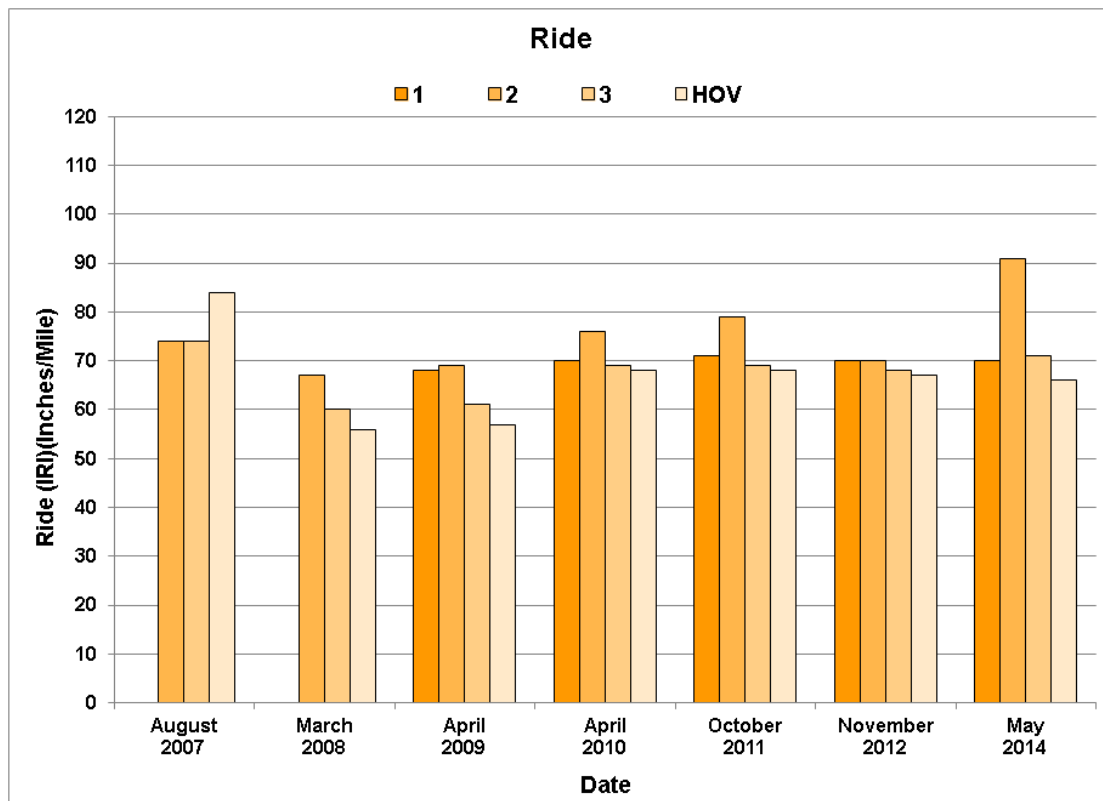
Figure 51. Ride measurements.

Ride measurements for each year since construction are listed in Table 13 and shown in the Figure 51 bar graph. The ride measurements were excellent for all lanes and did not vary to a great degree from lane to lane or from year to year which was not unexpected given the steel deck upon which the overlay rests. Individual values ranged from a high of 84 inches/mile to a low of 56 inches/mile. Averages for each measurement period ranged from 61 to 78 inches/mile. The increase in roughness for Lane 2 may be due to the large number of patches needed to repair deep raveling in the wheel paths.

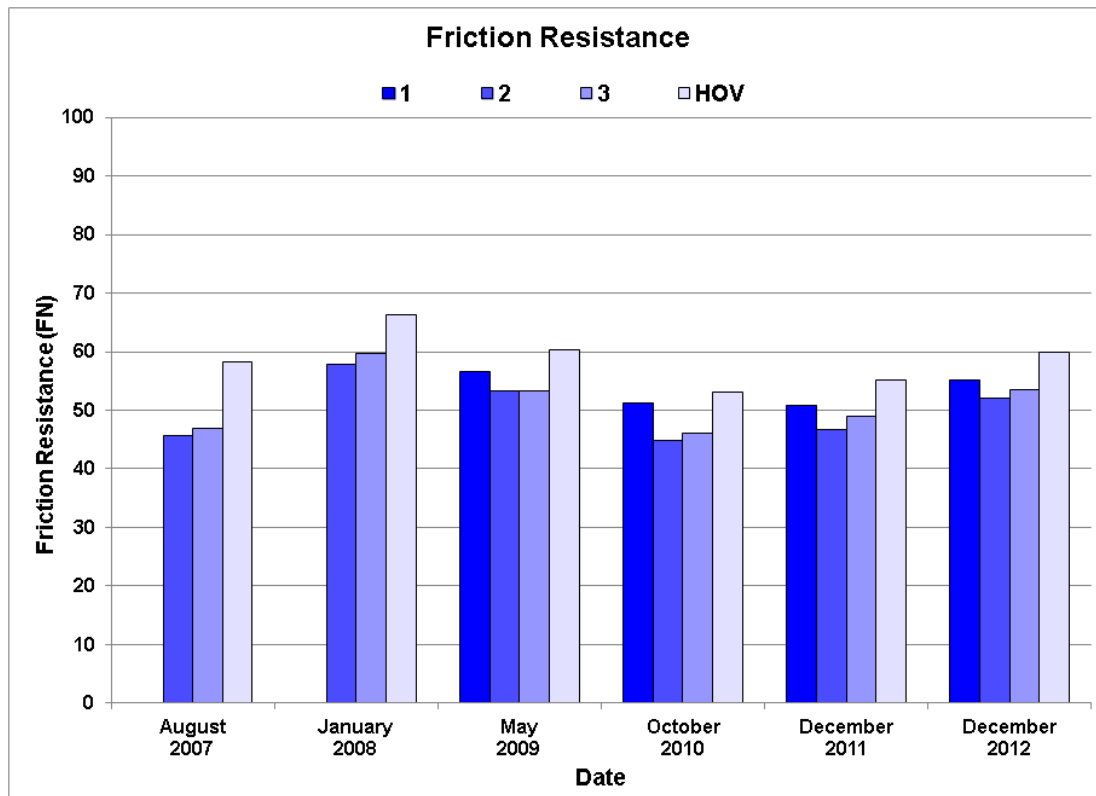
Figure 52. Friction measurements.

Friction measurements are listed in Table 14 and shown graphically in Figure 52. The friction measurements were excellent for all lanes with individual values ranging from a low of 45.6 to a high of 66.3 and yearly friction number averages ranging from 48.8 to 61.3.

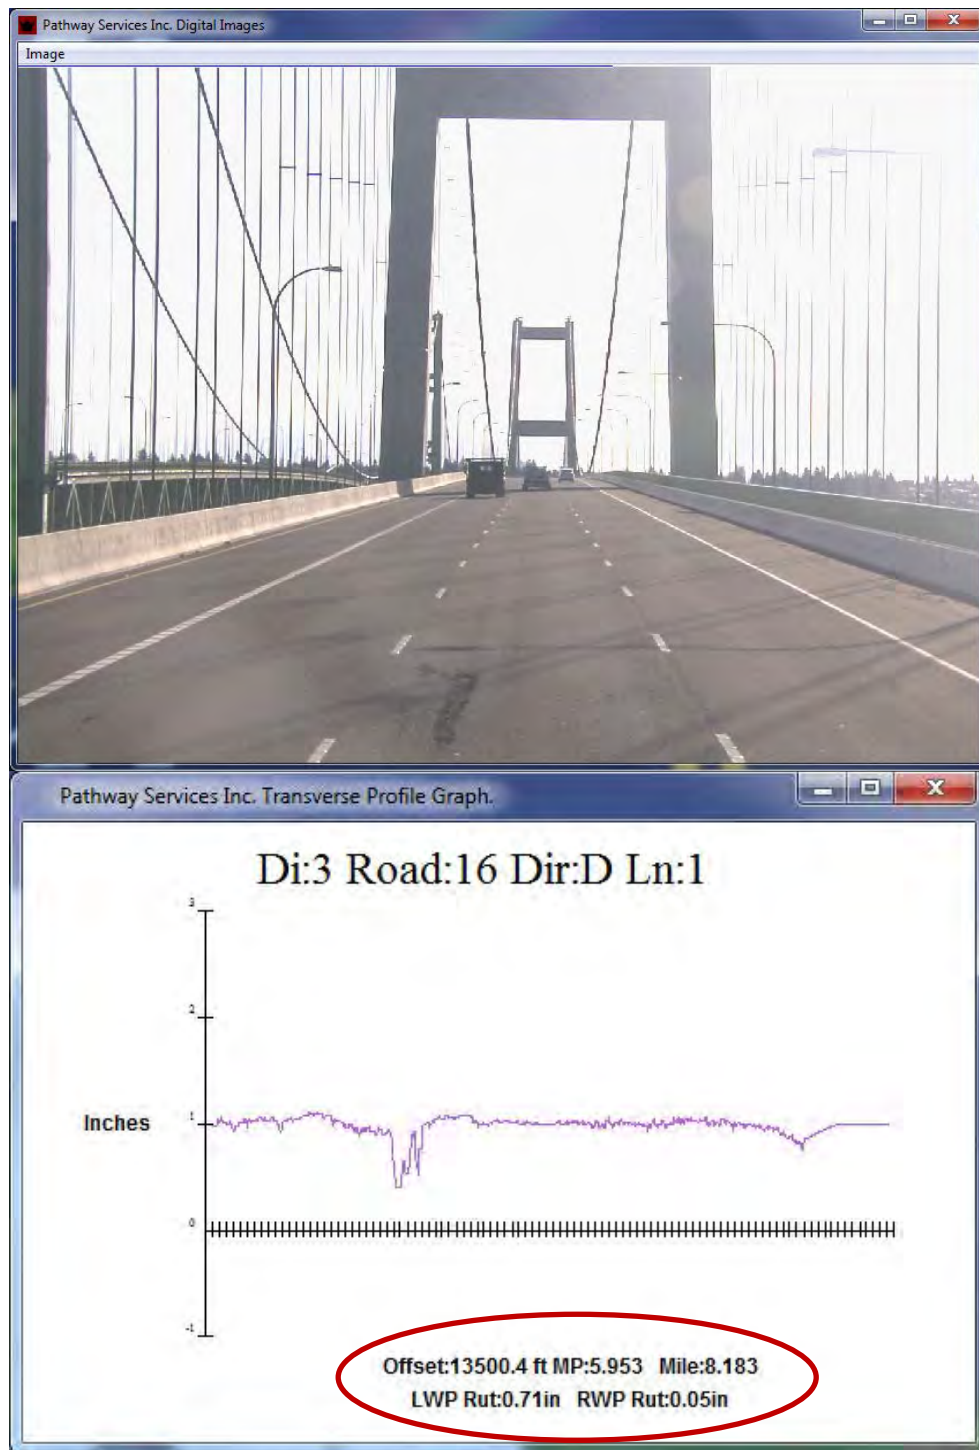
There was visual evidence of wear (raveling) in excess of the allowable wear of 1/4 inch stated in the table. Detailed examination of the data revealed intermittent rutting that exceeding 1/4 inch occurred over approximately 500 lineal feet, primarily in Lane 2 on the bridge. Images of the raveling/wear and the rut depth measurements from the Pathway Van are shown in Figures 65 to 67. The Contractor was required to patch this section on the deck.

Figure 65. Left wheel path wear depth is 0.71 in. Note that the graph is incorrectly labeled as Lane 1.

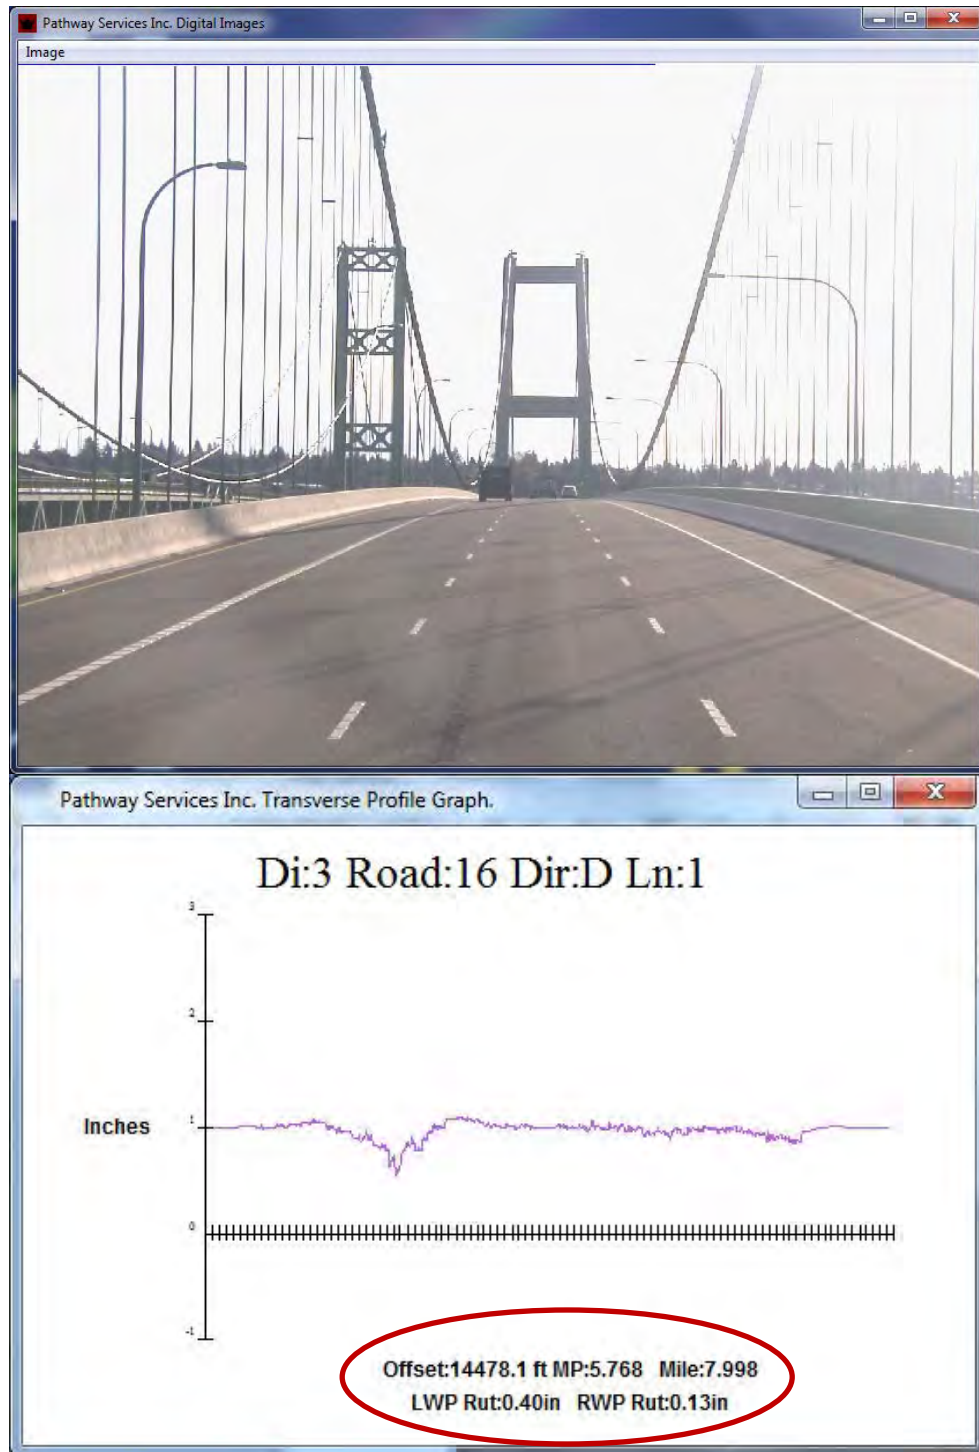
Figure 66. Left wheel path wear depth is 0.40 in. Note that the graph is incorrectly labeled as Lane 1.

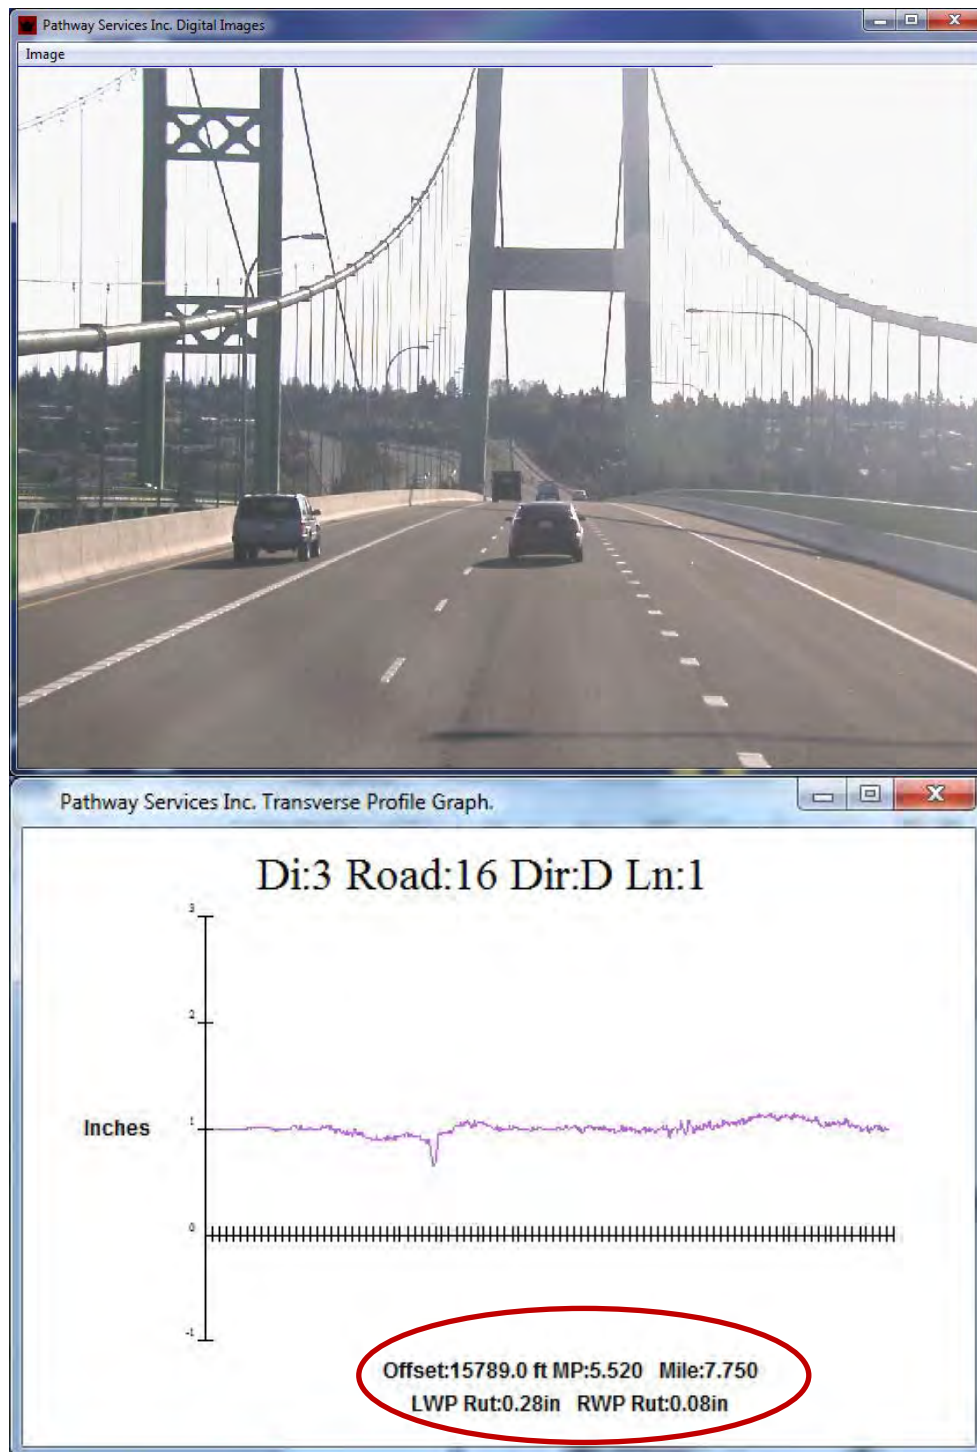
Figure 67. Left wheel path wear depth is 0.28 in. Note that the graph is incorrectly labeled as Lane 1.
