De-Bonding of Hot Mix Asphalt Pavements in Washington State: An Initial Investigation

WA-RD 712.1

WSDOT Research Report

Final Technical Report TNW 2008-10 TransNow Budget No. 61-4026 and 61-5916 De-Bonding Cracking

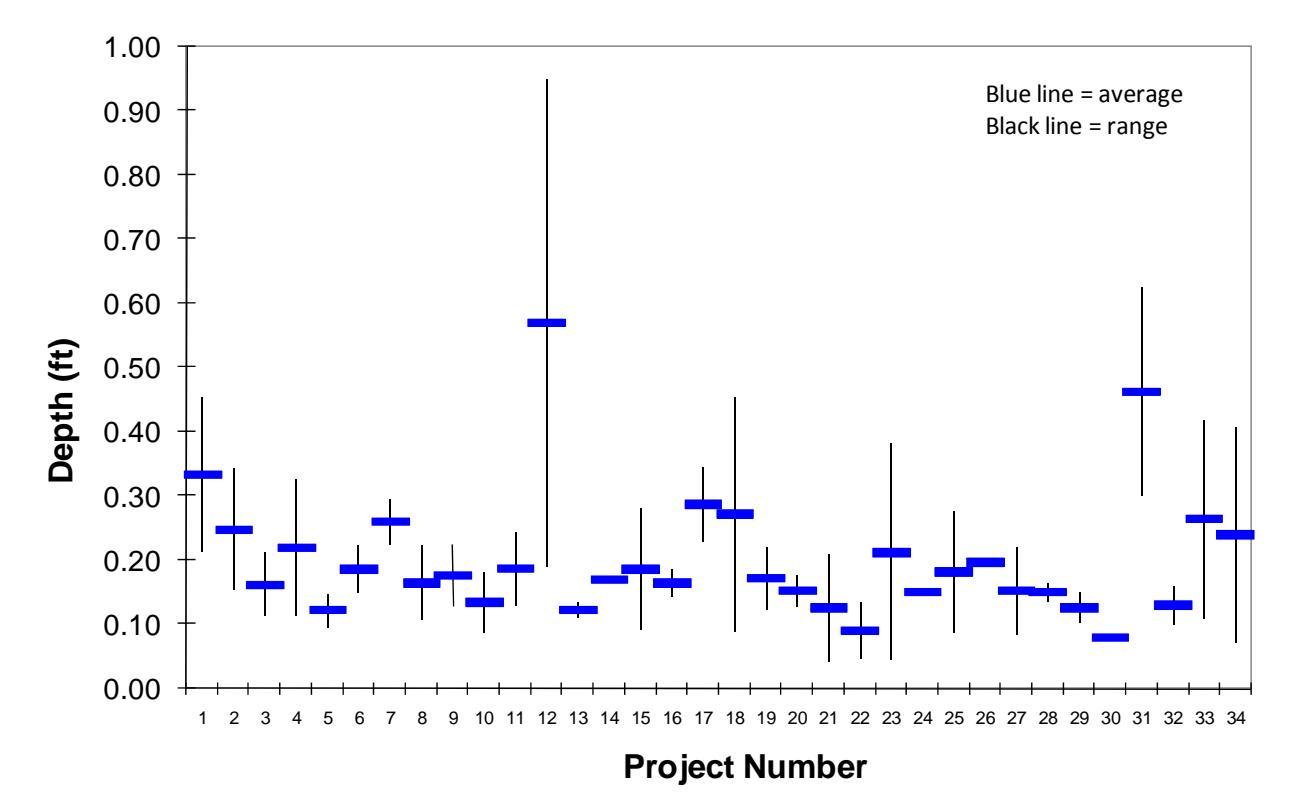
Typical WSDOT overlay thickness is 0.15 ft, which corresponds closely with the average depth to the first de-bonding in those cores with observed de-bonding (Figure 3).

FIGURE 3: Recorded depth to first de-bonding for all de-bonded projects with recorded de-bonding depths. Note that some projects had a wide range of de-bonded depths (e.g., project 12).

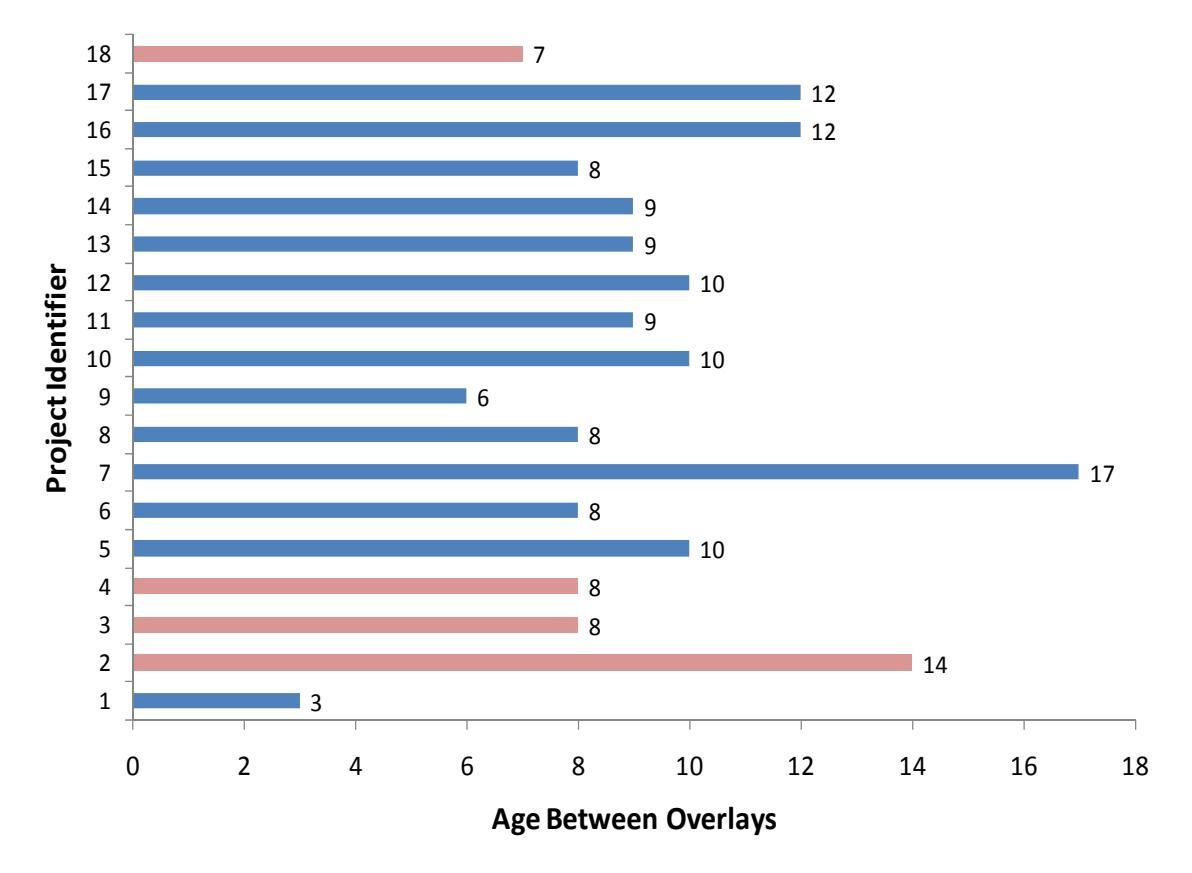
ranges from about 14 to 18 years in Western Washington and 8 to 12 years in Eastern Washington. All 18 projects showing de-bonding are located in Eastern Washington (since a vast majority of projects in this core sample are from Eastern Washington or mountain passes – about 85% – this may or may not be significant). Figure 4 shows that most de-bonded cores come from surfaces that tend to last on the short end of the typical 8 to 12 year life range for Eastern Washington projects. This suggests that these projects with de-bonding might deteriorate faster however considering the non-randomness of the samples and lack of other project data this is a weak suggestion.

FIGURE 4: Age between the overlay that was de-bonded and the subsequent overlay in preparation for which the coring was done. This gives an idea of how long the de-bonded surface lasted. Red (light) shaded bars represent projects that were not yet overlaid as of 2006.

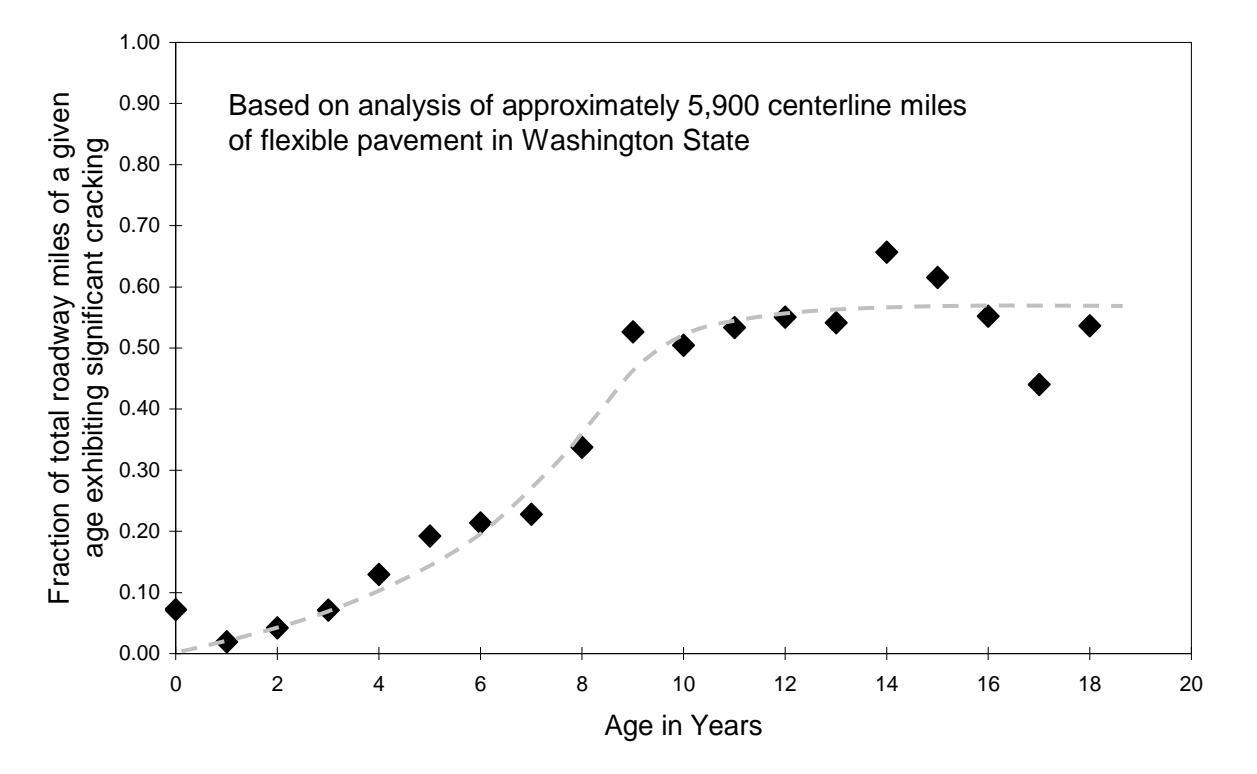
FIGURE 7: Initiation of Cracking in WSDOT Flexible Pavements (Muench, et al., 2004). "Significant cracking" is defined as cracking in at least 0.5% of the total roadway surface.

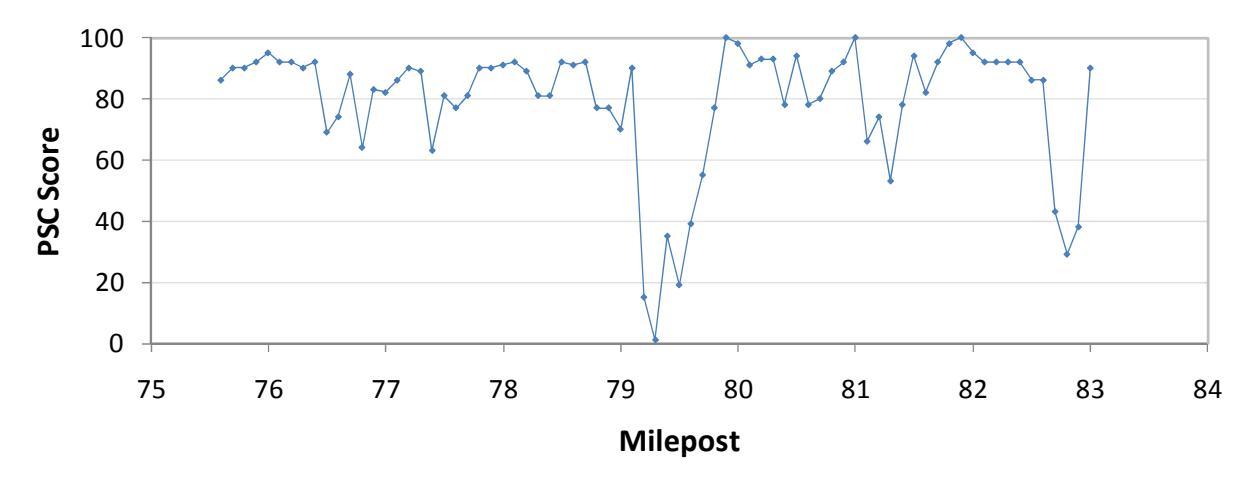
- Even jobs that show significant cracking still have PSC scores that are generally above 80, which is still quite good. This probably means that cracking has started earlier than average but is not yet advanced enough to severely affect PSC scores. It should be noted that PSC scores are not linearly related to the amount of cracking. As cracking increases beyond about 1-5%, PSC scores are designed to drop dramatically (Kay et al., 1993).
- Jobs that score below a PSC of 90 generally do so because isolated sections score significantly lower than the average. Project 5841 is typical of this (Figure 8).

FIGURE 8: Project 5841, SR 27 MP 75.66 to 83.10 (paved in 2000 – 6 years old) showing PSC vs. milepost. Each data point represents the PSC score for one survey unit.

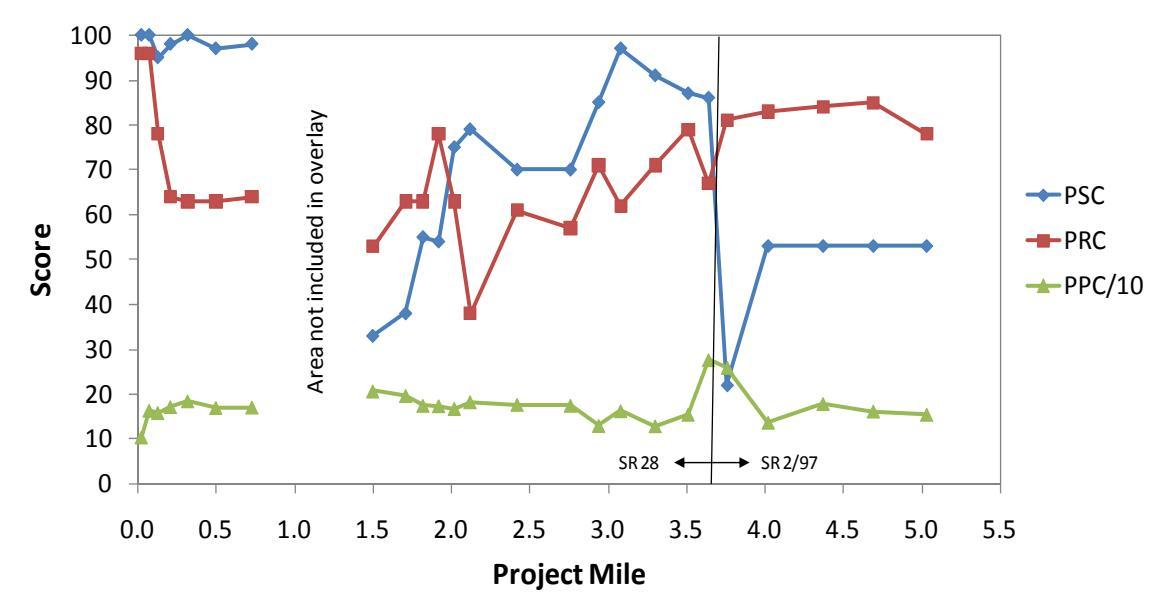
Figure 11 shows the 2006 (most current year available) condition of this project in terms of pavement structural condition (PSC), pavement rutting condition (PRC) and pavement profile condition (PPC) from the Washington State Pavement Management System (WSPMS). Of note, a score of 50 or less is the trigger for rehabilitation and scores are projected out into the future. Therefore, scores shown from 2006 data are likely higher than the actual scores in 2008 when the rehabilitation was done. Explanations of these condition calculations are contained in Kay et al. (1993). Figure 11 shows that the existing pavement is exhibiting generally low scores for rutting and structural condition (cracking). Although it is not reflected in WSPMS, the SR 28 section also shows significant flushing/bleeding (Figure 10).

FIGURE 11: SR 28 and SR 2/97 pavement condition by project mile. Note the transition from SR 28 to SR 2/97 at 3.64 miles.

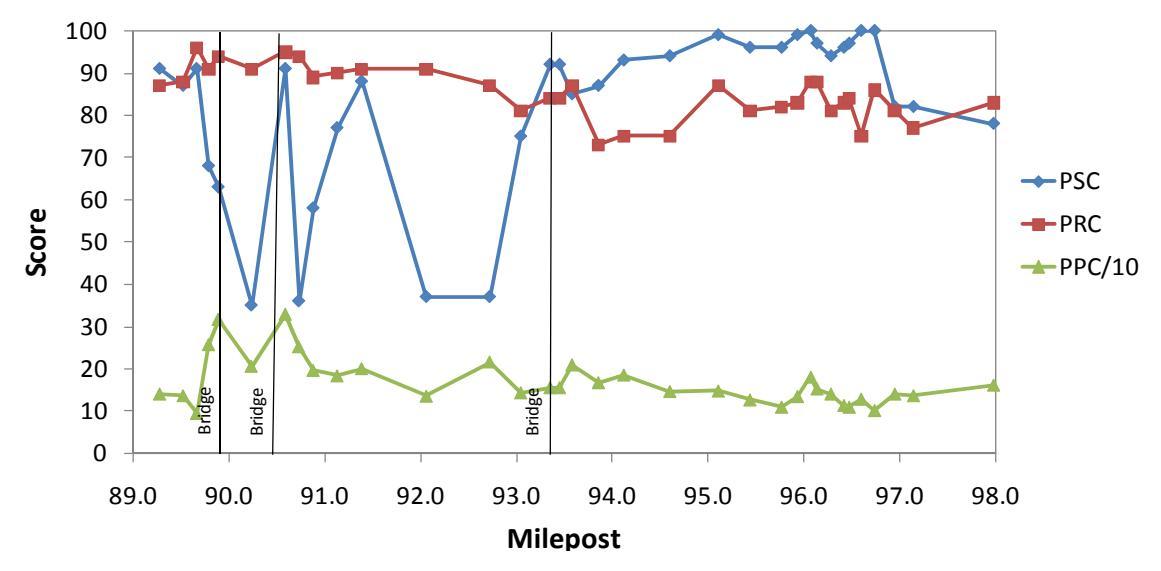
Figure 23 shows the 2006 (most current year available) condition of this project in terms of pavement structural condition (PSC), pavement rutting condition (PRC) and pavement profile condition (PPC) from the Washington State Pavement Management System (WSPMS). Figure 23 shows that the existing pavement is exhibiting generally low scores for structural condition (cracking).

FIGURE 23: SR 2 pavement condition by milepost. Note the three bridge locations.

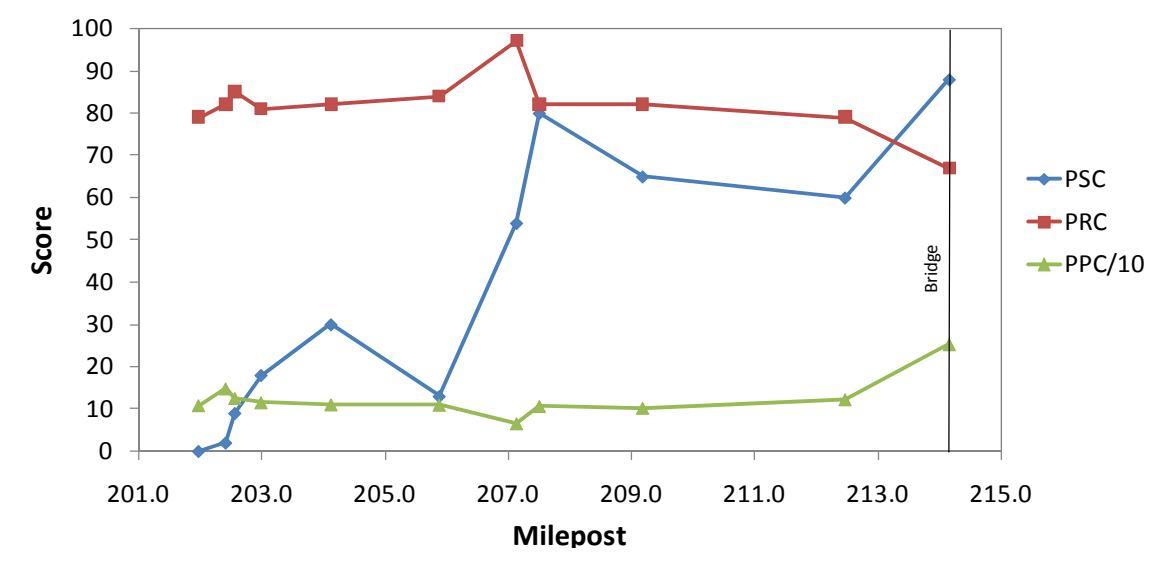
Figure 32 shows the 2006 (most current year available) condition of this project in terms of pavement structural condition (PSC), pavement rutting condition (PRC) and pavement profile condition (PPC) from the Washington State Pavement Management System (WSPMS). Figure 32 shows that the existing pavement is exhibiting generally low scores for structural condition (cracking).

FIGURE 32: SR 97A pavement condition by milepost. Note the location of the bridge.
