Detection of Voids in Prestressed Concrete Bridges using Thermal Imaging and Ground-Penetrating Radar

WA-RD 717.1

December 2008

Research Report

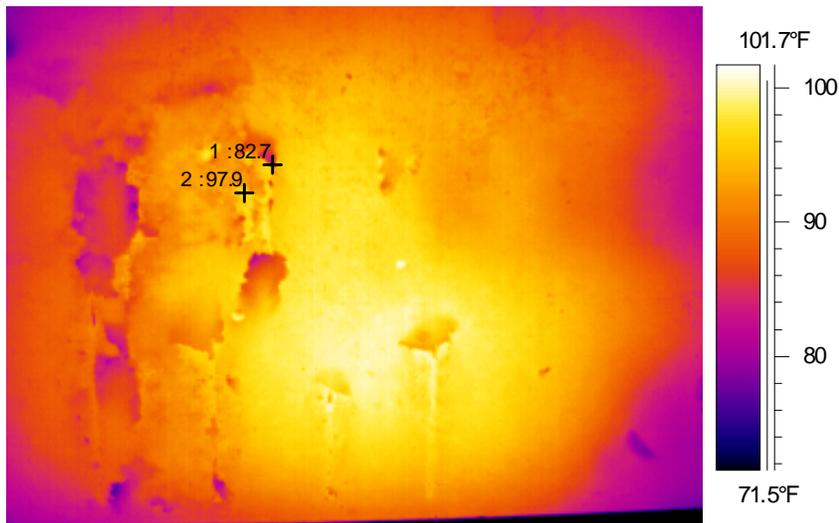
Figure 26 –Thermal image and photo of Heating Location # 5

Figure 26 shows both a photo and thermal image of Heating Location # 5. This figure is helpful because one can see exactly how each area in the photo appears in the thermal image. An example is the steel reinforcement. It is seen exposed in the photo, and then as a warmer line in the image, designated by circled area 1 in the figure. Most of the longitudinal rebar can be traced in a similar manner.

Circled area 2 in Figure 26 shows an interesting irregularity. The area doesn't display anything significant in the photo except a small amount of discoloration, but the thermal image demonstrates inconsistencies in the material in the form of great temperature differences. The thermal imaging software showed an approximate 5 °F difference between areas within the circle. This may be due to delamination, poorly consolidated concrete, or another irregularity, but there is no way to be certain of the specific cause until further tests are completed (either "sounding" with a hammer, or chipping out the loose concrete). This does, however, reveal that there may be a problem at this location. There are also a few other areas in the figure that exhibit similar temperature anomalies.

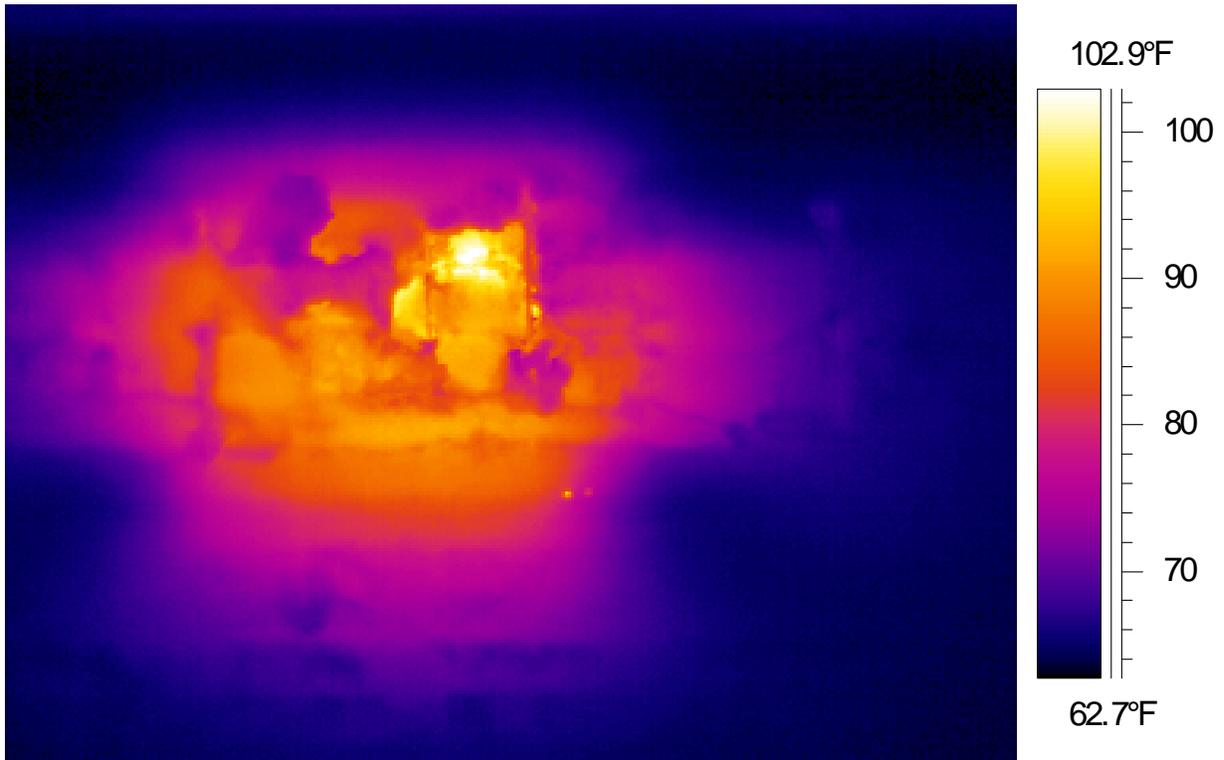
Figure 30 – Thermal image of Heating Location # 9

Figure 30 shows a thermal image of Heating Location # 9. There is great thermal variation in this image with temperature differences between 10°F and 25°F in the middle of the heated area. With Method 1 heating, irregularities like delamination appear as cool regions because the images were taken of the unheated surface. At delaminations, heat propagates at a slower rate than through a section of concrete with no irregularities, and thus a cool spot occurs on the unheated surface of a delaminated region.

The thermal image in Figure 30 was taken near the end of the heating process, at approximately 1:55 (hh:mm) after heating began. When heat propagates through a material as in Method 1, thermal images may still be obtained after the heat input has been removed. Even with no heat source, the heat already within the concrete will still propagate toward regions of lower temperature. During this inspection, thermal images were taken for two hours following the removal of the heat source.

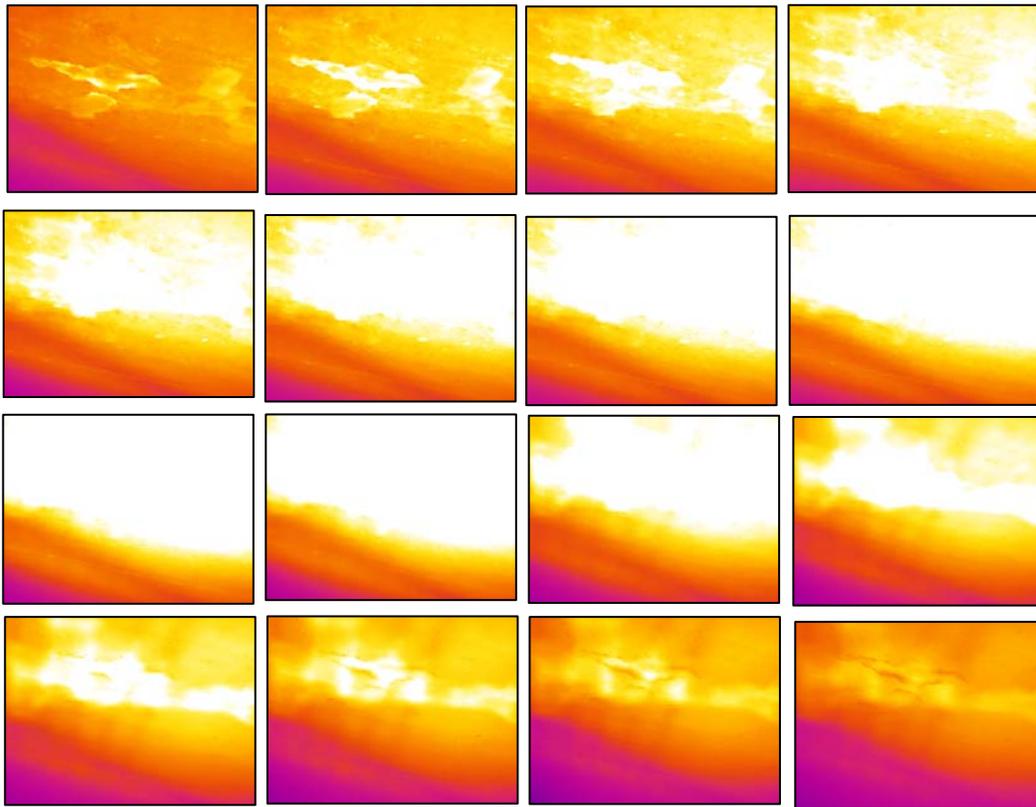
Figure 37 – Thermal image progression at Heating Location # 1

The thermal images in Figure 36 were taken in order to help locate areas that, with further heat input, might reveal subsurface flaws. The circled region shows what looks like a flaw, so the heater was moved so that its center was directly underneath this region, and then heating commenced again. From here, thermal images were taken every two minutes. Figure 37 shows a typical image progression during heating, or what one would see from the camera display. Figure 38 shows a single image from the progression.

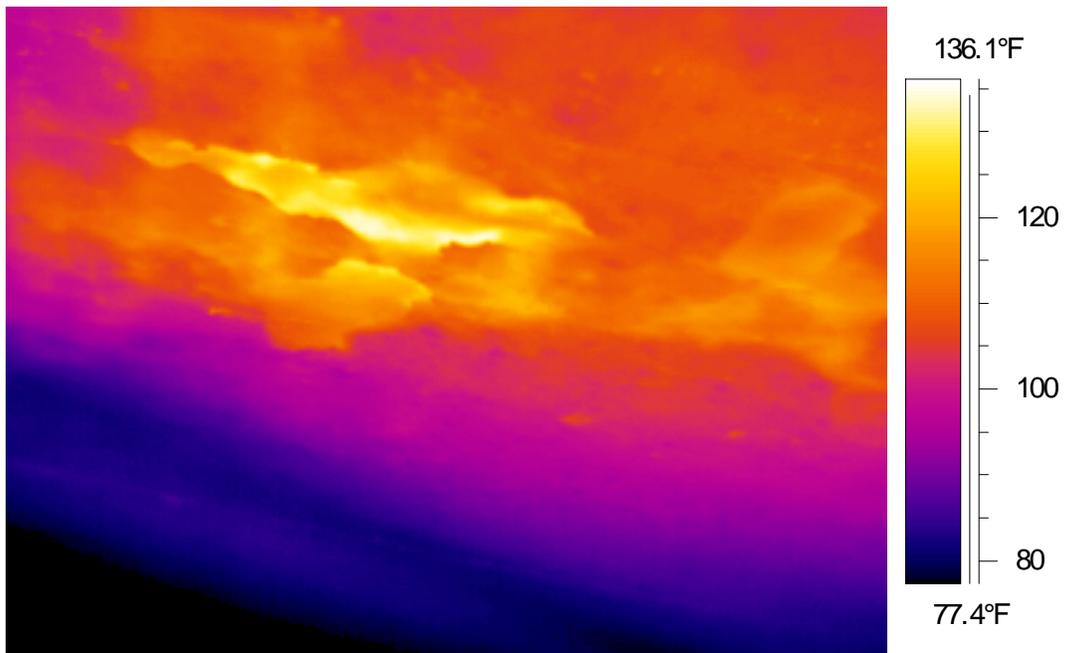
Figure 38 – Thermal image of Heating Location # 1 at middle of time interval

Heating Location # 1 was a very important inspection because, after heating was stopped, the surface was examined with a rock hammer. Tapping confirmed what was seen in the thermal images. A WSDOT inspector tapped part of the surface that had no apparent flaws (either visually or thermally) and then tapped at suspected flaw locations. Sound differences were easily discernable between the two locations, and then the pick end of the hammer was used to remove surface concrete and excavate the flaw. Delamination and poorly consolidated concrete (small air voids) were discovered. Figure 39 shows a thermal image of a WSDOT employee excavating the delaminated concrete at the flaw location shortly after thermal imaging inspection. This was the first inspection location where flaws discovered thermally were confirmed using physical means (tapping and excavation).

Field Inspection 2, conducted at an I-5 overpass (Bridge 5/537E-N) in Seattle, WA, was very successful because what was detected with thermal imaging was confirmed by “tapping” and excavation of the heated surface (at Heating Location # 1). The thermal images (Figures 36 and 38) suggested some sort of flaw (hypothesized as delamination), which was then verified by a WSDOT employee using a rock hammer to excavate the flaw. These inspections also confirmed that flaws can be visible in thermal images after only about 10 minutes of heat input (such as at Heating Location # 1).

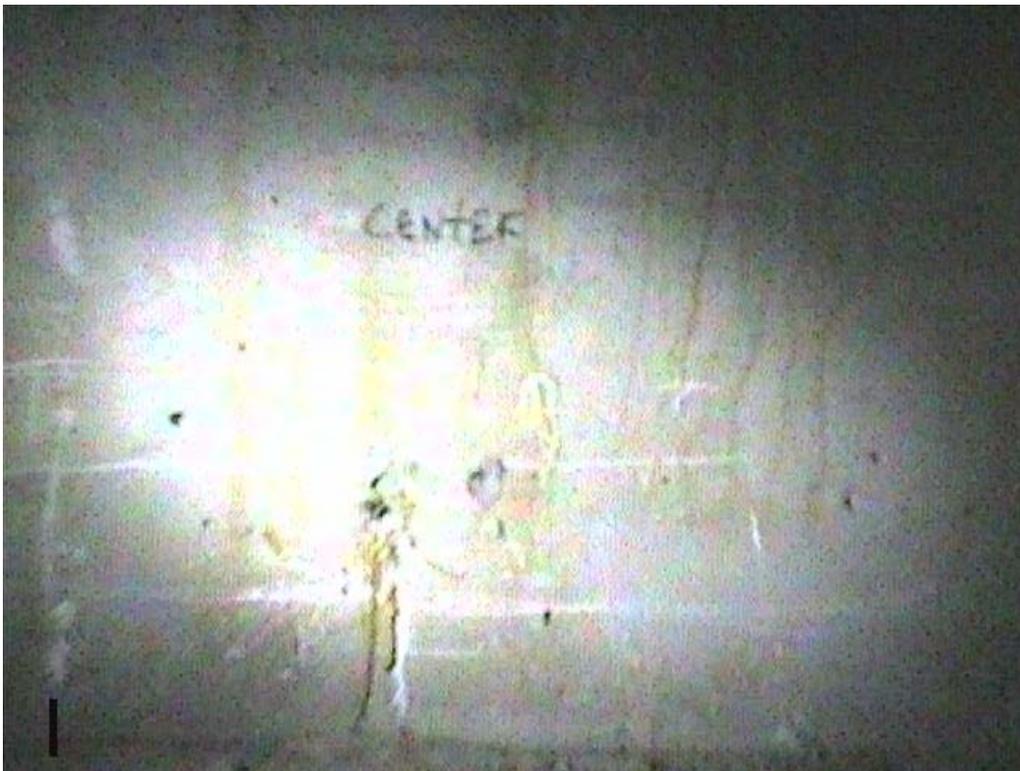
Figure 41 – Photo of Heating Location # 1

Heating Location # 1 was inspected on August 14th, 2007 using inspection Method 2. Figure 41 shows the inspection point of the interior web inside the box girder, which was located approximately at the midspan of the bridge, 12.2 m (40 ft.) from the edge of the access hatch. The surface was heated for a total time of 3:00 (hh:mm). This location entailed orienting the heater horizontally (so that the longer edge of the heater ran longitudinally along the box girder) on masonry blocks to raise the heater above the floor. The heater was approximately 61 cm (24 in.) from the heated surface and thermal images were obtained both during heating and for one hour afterward. During heating, the infrared camera was situated to the side of the heater and angled toward the heated surface.

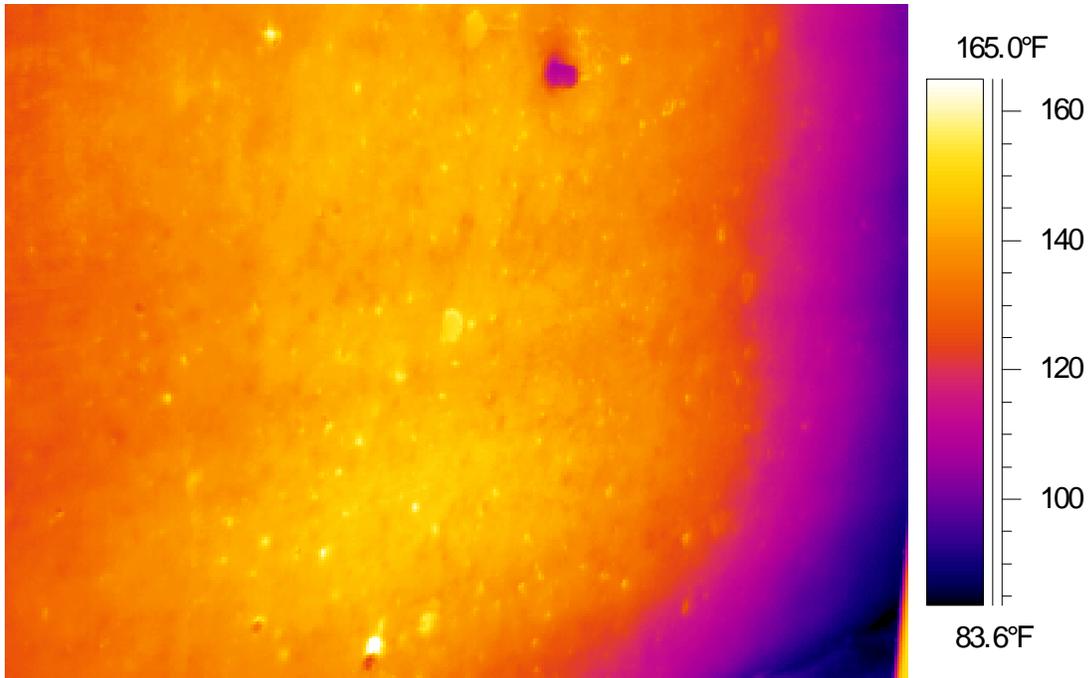
Figure 42 – Thermal image of Heating Location # 1 (30 minutes after heating began)

Figure 42 shows a thermal image of Heating Location # 1 taken approximately 30 minutes after heating commenced. This image illustrates the state of the concrete surface and its characteristics. A few hot and cool spots can be seen, but this image primarily reveals surface characteristics of the concrete.

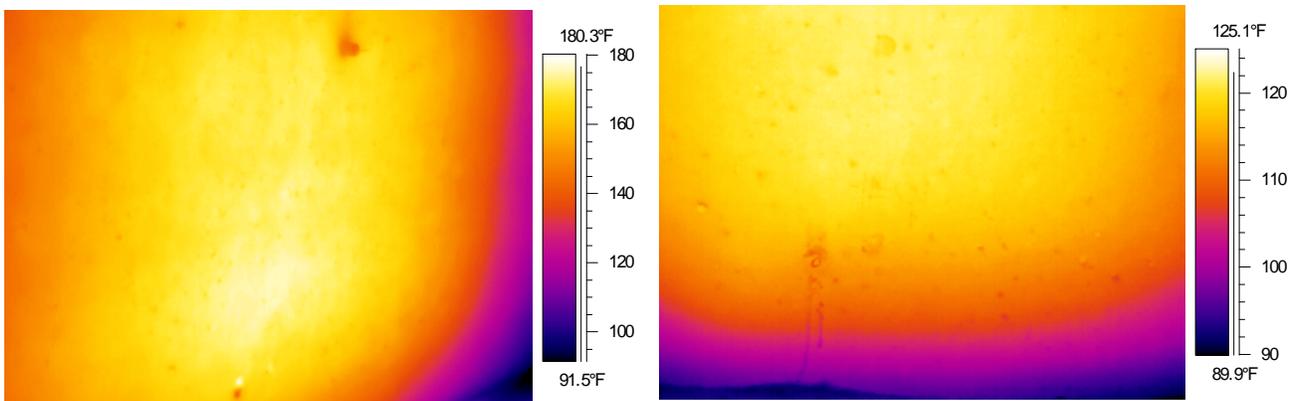
Figure 43 –Thermal images of Heating Location # 1:
a) after 2:55 (hh:mm) of heating (left)
b) 0:45 (hh:mm) after heating stopped (right)

The next two thermal images, shown in Figure 43, do not reveal anything regarding materials embedded in the concrete box girder web. The first image on the left was taken after 2:55 (hh:mm) of heating. The second image on the right was taken after the camera was moved directly in front of the heated surface, about 0:45 (hh:mm) after heating ended. None of the PT-ducts are visible in any of the thermal images, which indicates a couple of different things. First, three hours of heat input may not be enough to provide thermal images showing PT-ducts embedded in 30 cm (12 in.) thick concrete. Second, it is likely that the inspection setup was not

ideal for detecting the ducts. Inspection Method 2 involves taking thermal images from the same side as the heat input, and specimen inspections conducted in the lab indicated that Method 2 does not yield images showing inner-surface characteristics. Also, due to the confined area inside the box girder, the camera could not be placed as far from the heated surface as desired. Thus the camera lens could not capture the entire heated surface area. Unfortunately, since access to the opposite face of the box girder web was not available, Inspection Method 2 was the only option available.

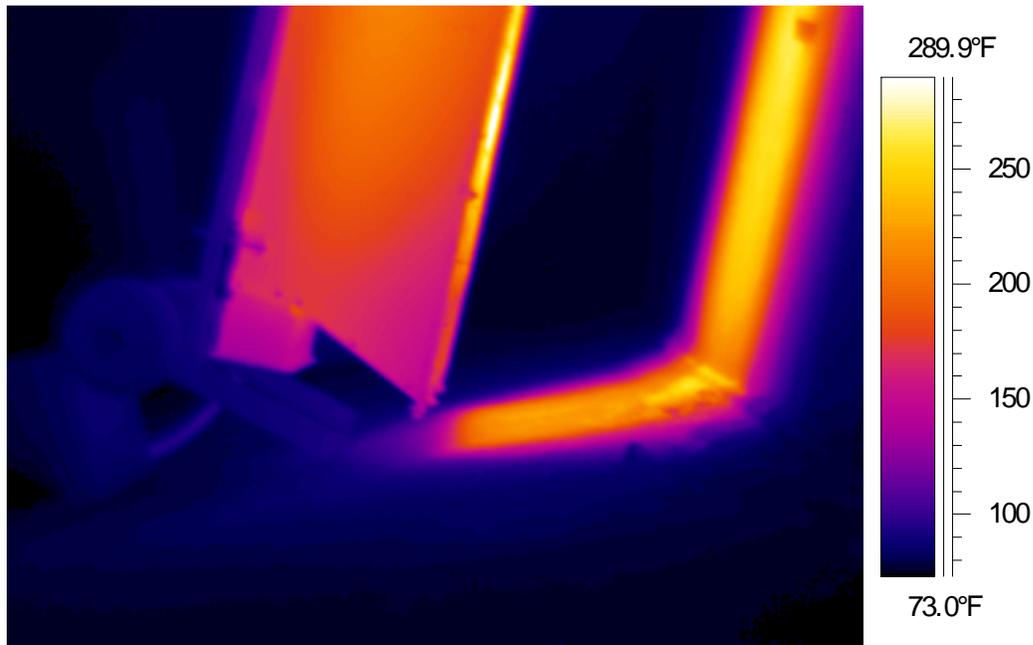
Figure 44 – Thermal image of Heating Location # 2 showing heater setup

The heater was not elevated, so both the box girder wall and floor were heated, as shown in Figure 44. Thermal images were obtained both during heating and for 40 minutes after heating ended.

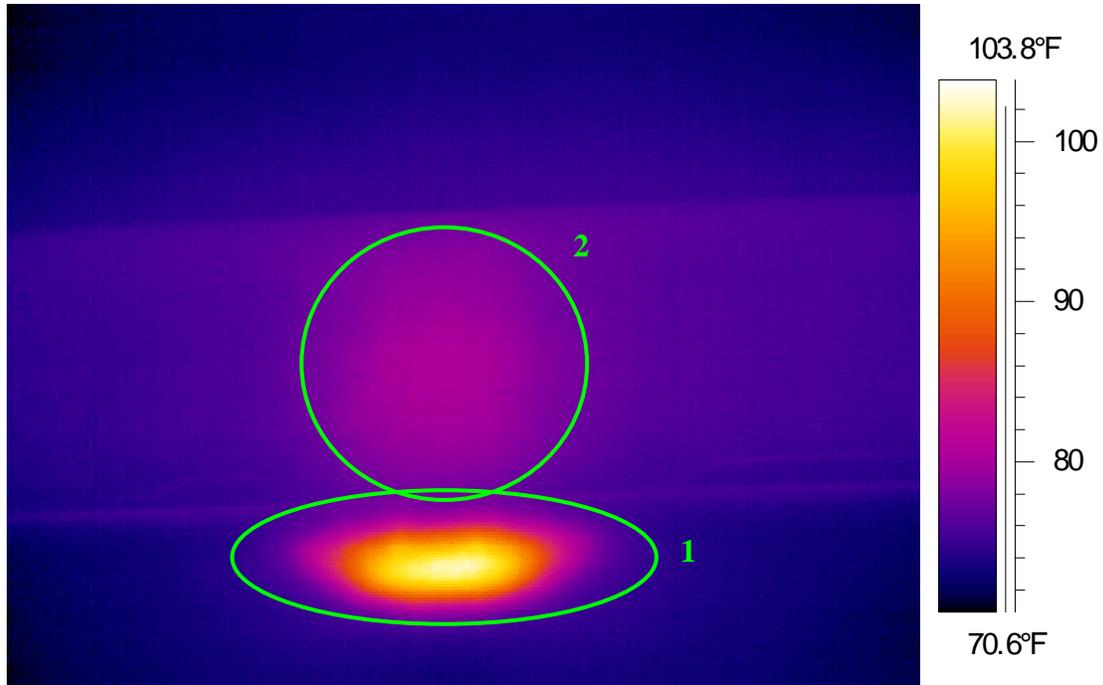
Figure 45 – Thermal image of Heating Location # 2 taken of the unheated surface

The inspection setup for this location allowed for two kinds of thermal images to be obtained. The first kind of image was of the unheated surface, taken from ground level outside the box girder (Method 1). Due to the large distance from the camera to the surface, images had less detail and a large viewing window. Figure 45 shows one such image taken about three hours after heating began. From the image, one can see that the heated surface (wall) was not as warm as the floor of the box girder. This is due to the fact that the wall is thicker than the floor (12 in. versus 8 in.), and it takes longer for heat to propagate through thicker concrete. After only three hours of heat input, there were no PT-ducts or flaws visible in the thermal image. In Figure 45, circled area 1 shows the floor, while circled area 2 shows the wall of the box girder. Thermal

images taken of the unheated surface after five hours of heating did not reveal the PT-ducts in the box girder wall.

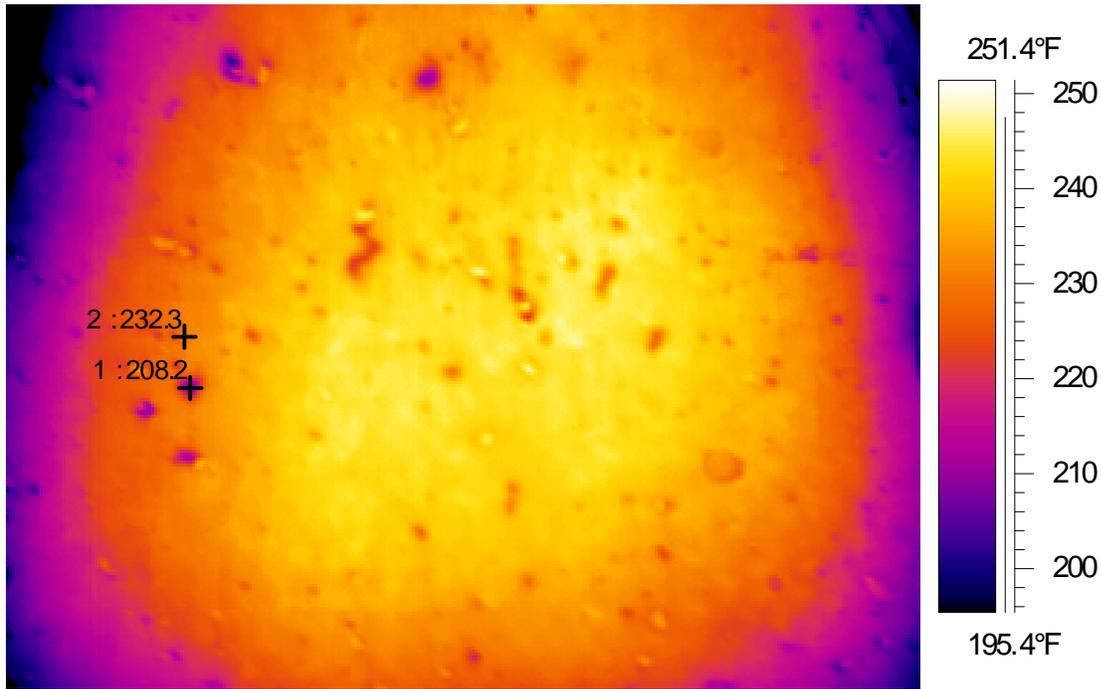
Figure 46 – Thermal image of Heating Location # 2 taken of the heated surface

Images of the heated surface were also obtained from inside the box girder after heating ended. Figure 46 displays one such image where surface characteristics are visible. However, as with Figures 44 and 45, the image does not show any PT-ducts. The flaws shown are mostly surface irregularities and small surface voids. Points 1 and 2 in Figure 46 show a temperature difference of approximately 24 °F in a span of only a few inches.
