# Long-Term Performance of a Hot In-Place Recycling Project — Final Report

WA-RD 738.2

## Long-Term Performance of a Hot In-Place Recycling Project Final Report

Contract 7648  
SR-542  
Britton Road to Coal Creek Bridge Vicinity  
MP 3.38 to MP 19.27

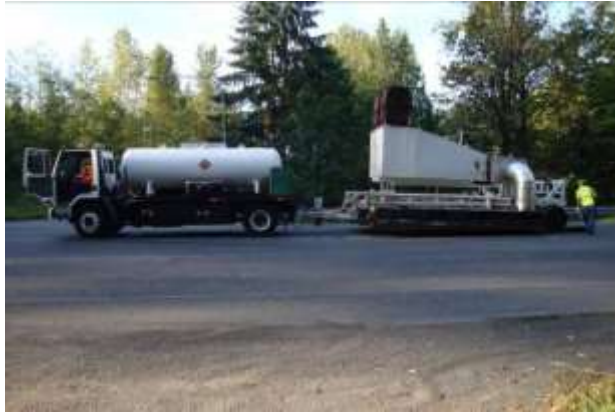
Figure 2. Preheater unit consisting of a propane truck and trailer with propane fired heaters.

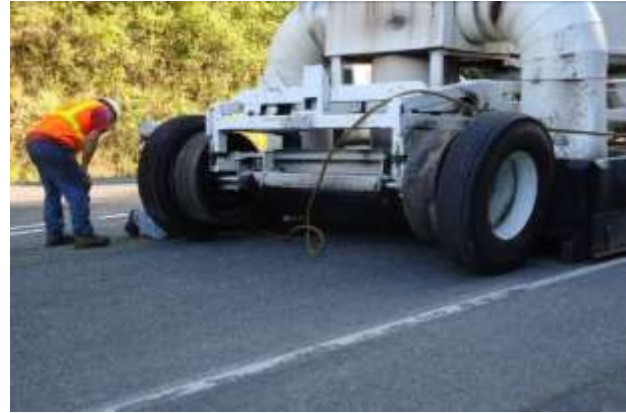
Figure 3. Removing rubber tires prior to paving.

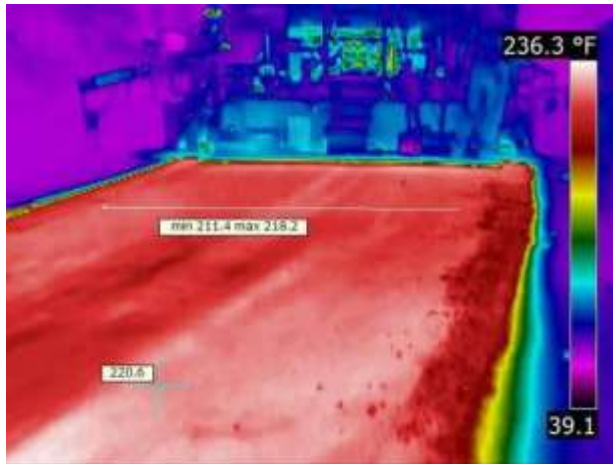
Lay down temperature for the HIPR pavement was lower and more uniform than with conventional HMA paving. Thermal images (Figure 14 and 15) showed a temperature range of 195°F to 240°F behind the screed. GreenRoads Recycling indicated that compaction temperatures on the SR 542 project were typical for HIPR paving. The recycling agent assists in making the mix more compactable allowing adequate compaction at temperatures lower than conventional HMA (Stothert, 2009).

Figure 14. Thermal image showing uniform temperature across the mat.

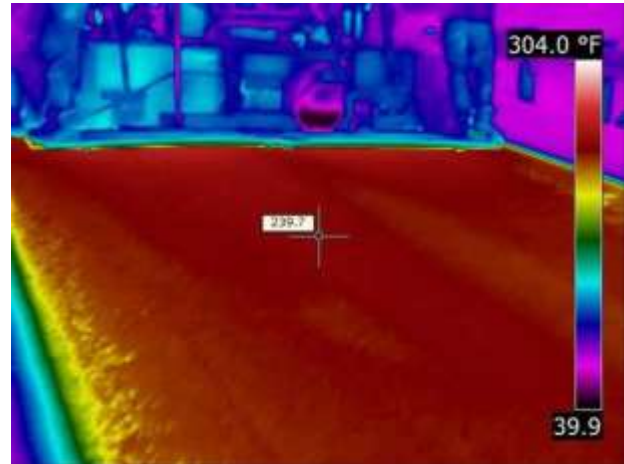
Figure 15. Maximum mat temperature was approximately 240°F.

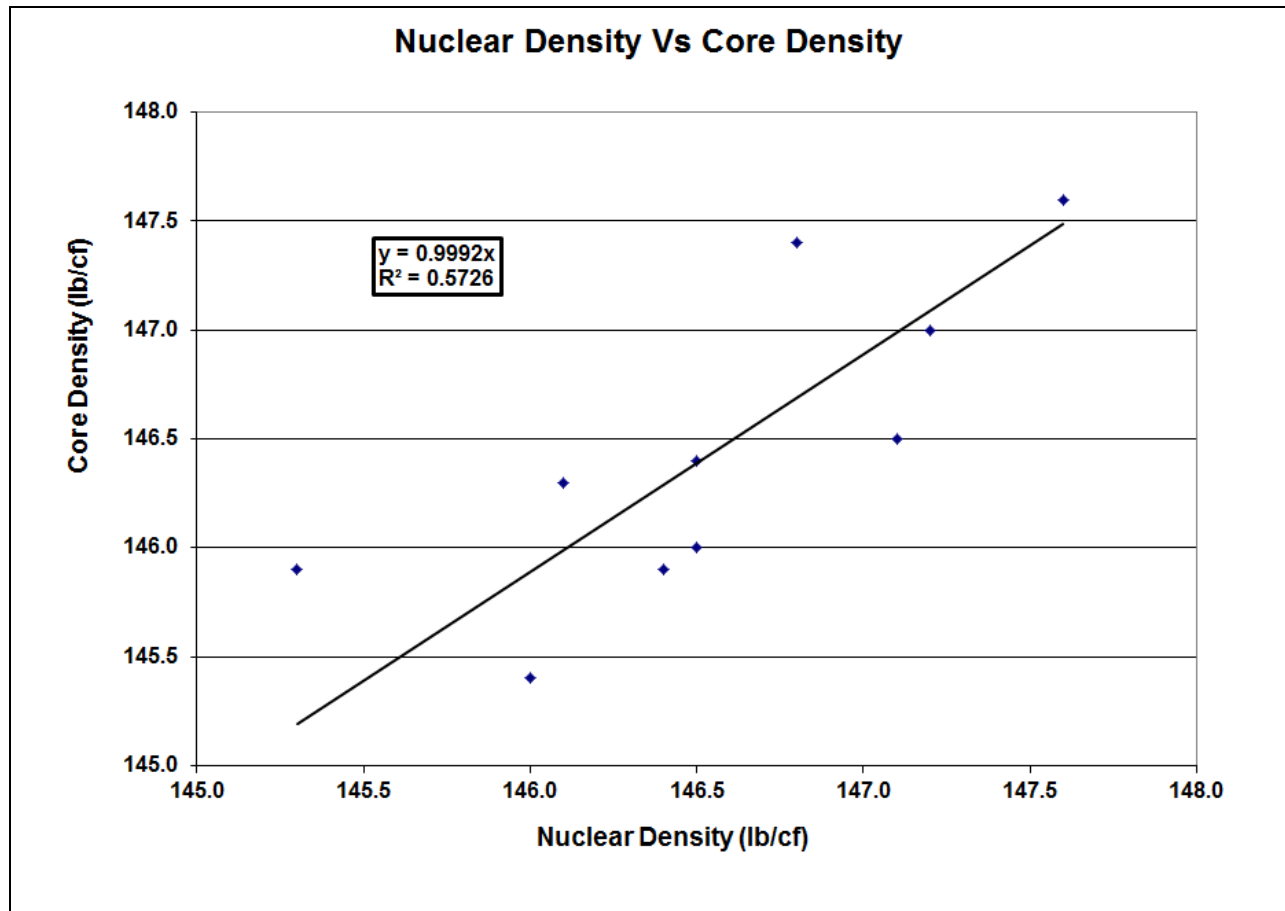
Although WSDOT did informational density testing on the entire project, the only HIPR pavement correlated to the nuclear density gauge was the section of existing HMA pavement paved under contract 3455. Figure 16 shows a plot of the nuclear density gauge readings compared to the corresponding core density used to correlate the nuclear density gauge. The plot shows a fair correlation ( $r^2 = 0.57$ ) between the two test methods indicating a linear relationship between the nuclear density gauge and core density.

Figure 16. Plot of nuclear density gauge readings vs. core density results.

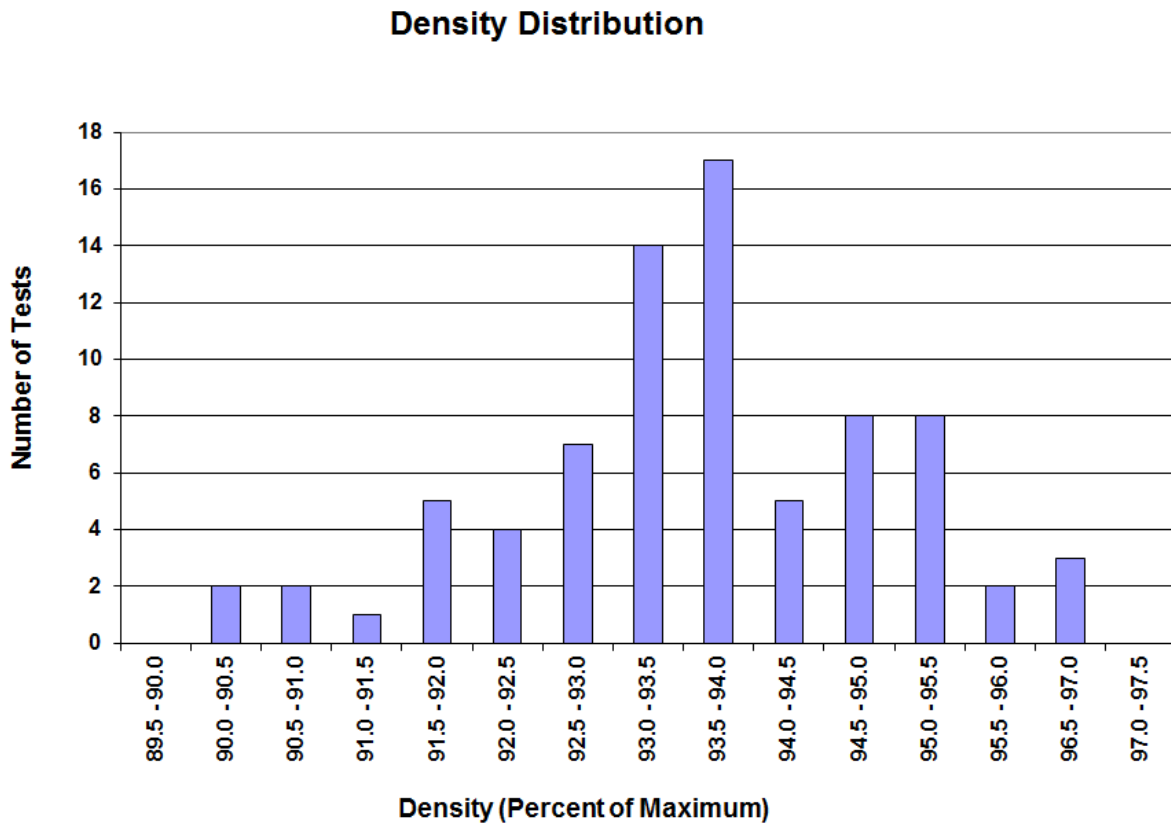
Within the limits of contract 3455, milepost 14.09 to 19.27, the average density from the corrected nuclear density gauge was 93.5 percent of theoretical maximum with a standard deviation of 1.37. The percentage of tests below WSDOT's 91.0 percent minimum density requirement was 4.7 percent. Figure 17 shows the distribution of test results. Appendix E includes complete density testing results.

Figure 17. Distribution of corrected nuclear density test results for milepost 14.09 to 19.27.

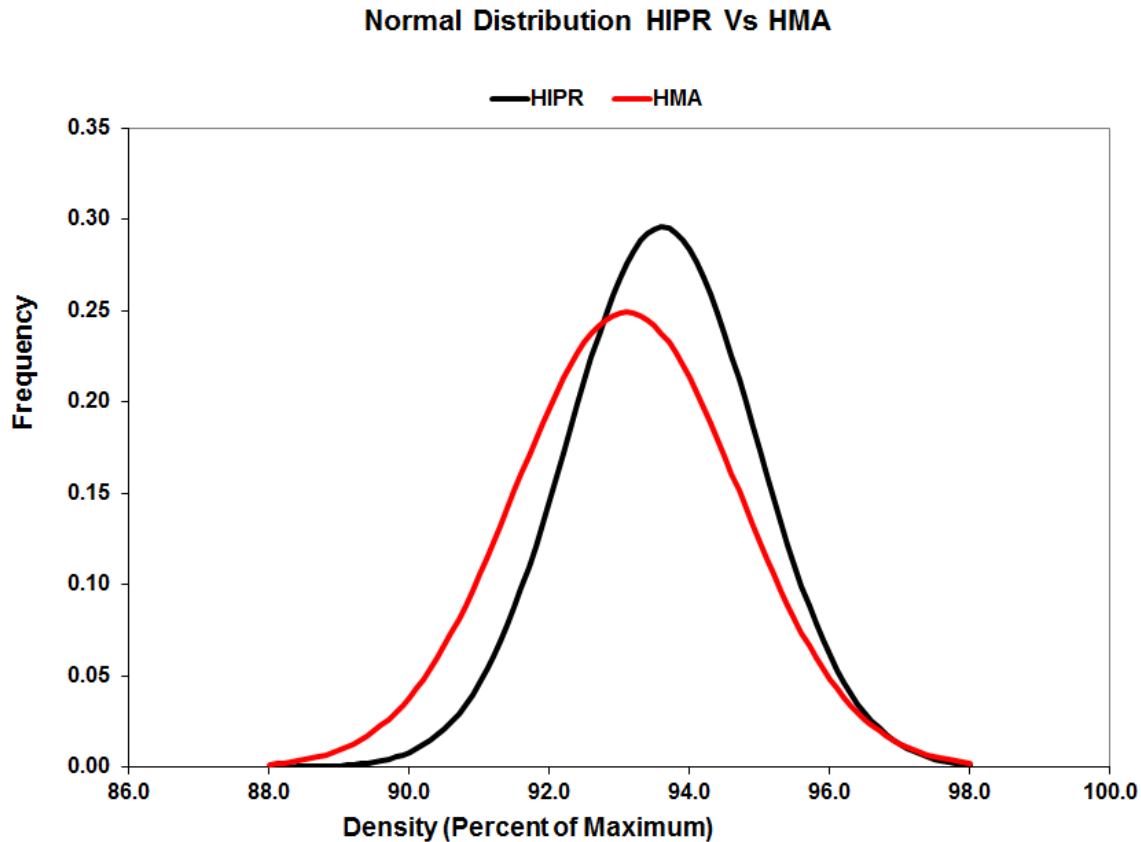
Figure 18 compares the normal distribution of HIPR density tests between milepost 14.09 and 19.27 with that of WSDOT HMA density tests taken between 1990 and 2005. The similarity of the two distributions suggests that HIPR is capable of achieving in place densities comparable to HMA paved on WSDOT projects.

Figure 18. Normal distributions of HIPR density test results vs WSDOT HMA.

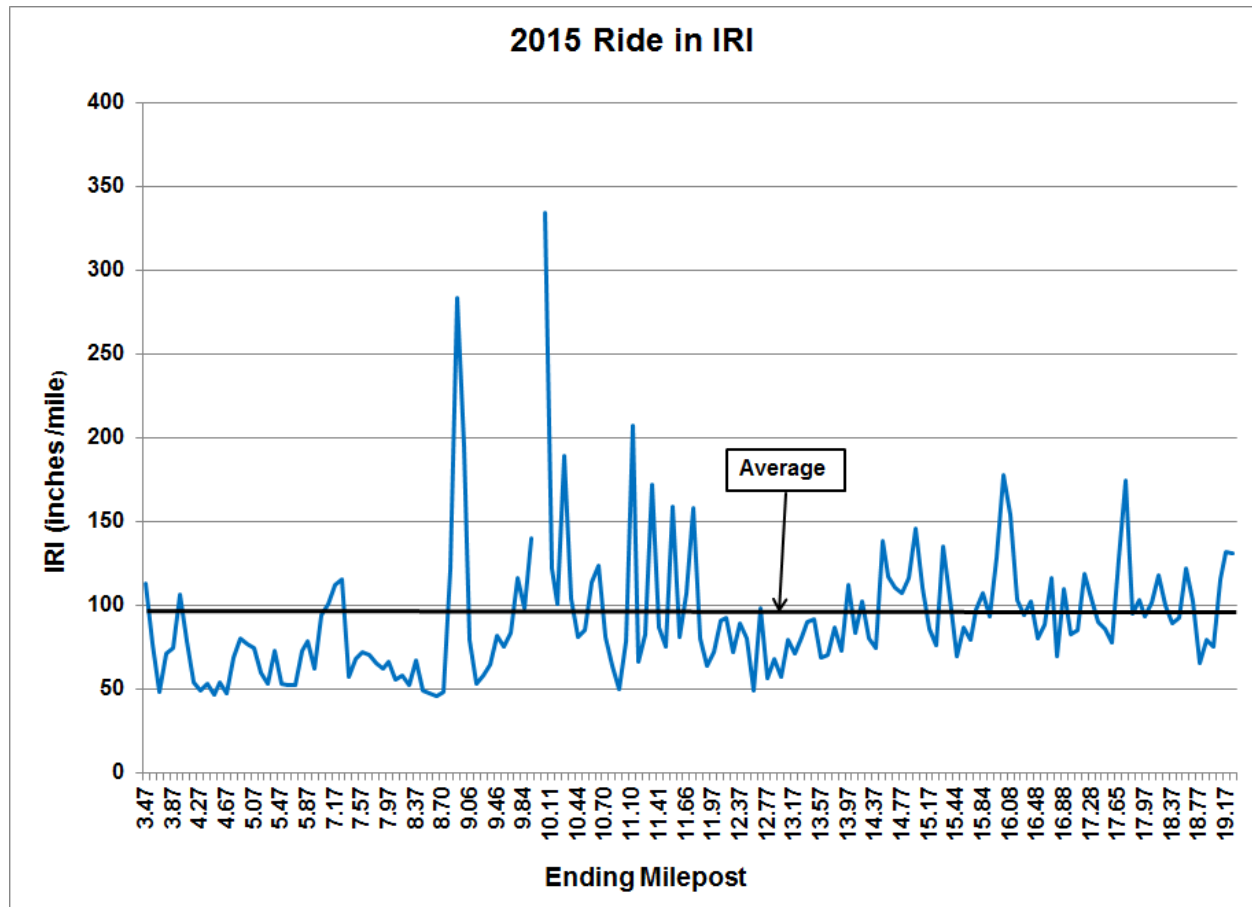
Figure 19. Ride measurements for 2015 showing average of 93 inches/mile.

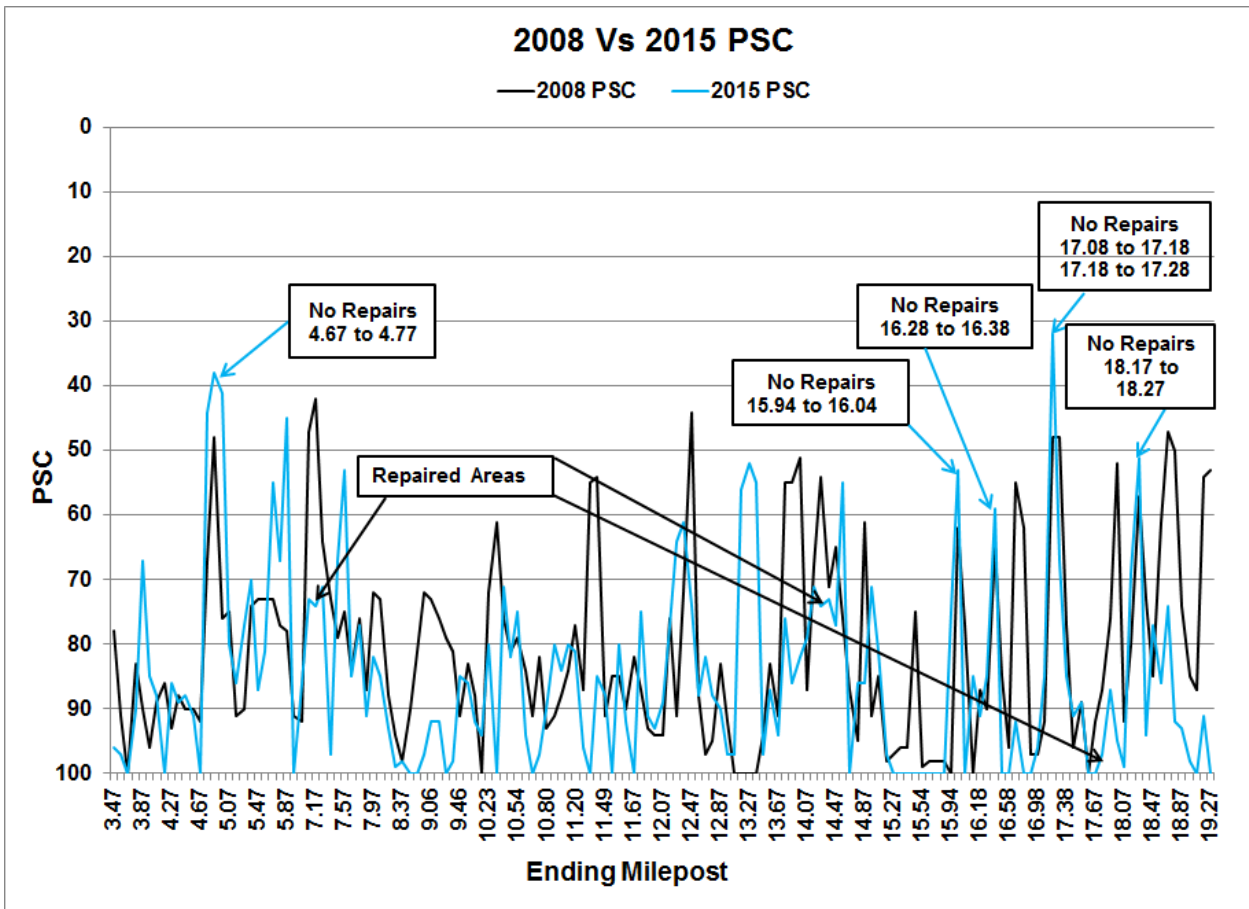
The underlying structure of the roadway appears to be the source of some of the cracking noted in the HIPR pavement at locations other than those repaired prior to the construction of the HIPR pavement. The WSPMS pavement structural condition (PSC) ratings for 2008 (black line) and 2015 (blue line) are compared in Figure 20. The repaired areas from Table 13 are noted. Areas noted with blue arrows have low PSC's (less than 70) in both 2008 and 2015 surveys indicating the possibility that the underlying pavement structure is having a negative effect on the performance of the HIPR pavement. Table 14 lists the segment locations and the 2008 and 2015 PSC's. The possibility exists that additional full depth repairs in these segments may have improved the cracking performance of the HIPR pavement.

Figure 20. PSC readings from 2008 and 2014.
