# Evaluation of Tyregrip® High-Friction Surfacing -- Final Report

WA-RD 788.2

Experimental Feature 10-02

014 S2 00794 Ramp

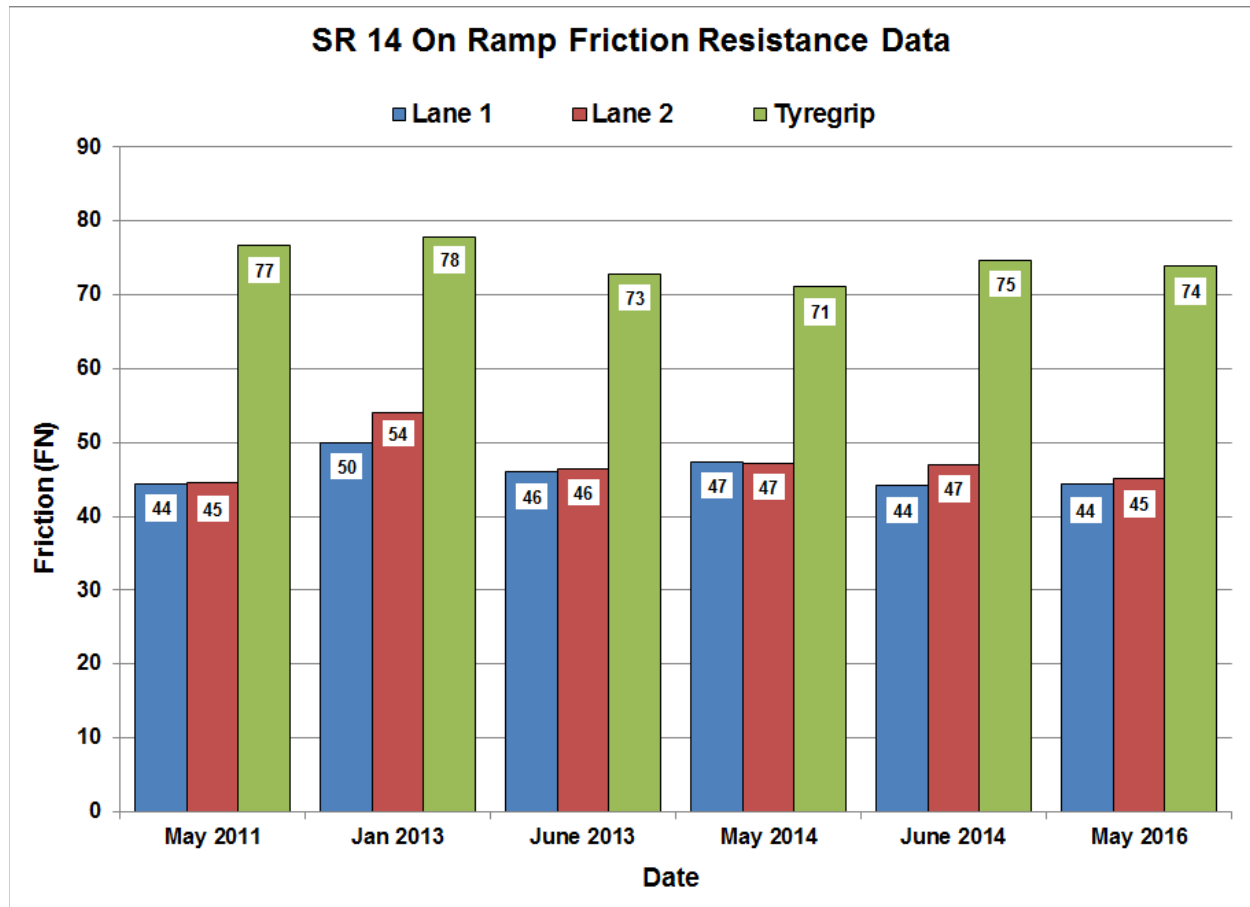
The friction measurements recorded in Table 2 are on the Tyregrip® and adjacent untreated pavement beginning immediately after the second installation of the Tyregrip® and once per year for the five-year life of the overlay. A locked wheel skid tester and rib tire meeting ASTM E274-06 and ASTM E501-94 standards, respectively, was used to measure the friction resistance. The measurements are also shown in graphic form in Figure 22. The values were exceptionally high for the Tyregrip® from initial to the final readings in the low to high 70's.

Figure 22. Friction resistance measurements, FN at 40 mph.

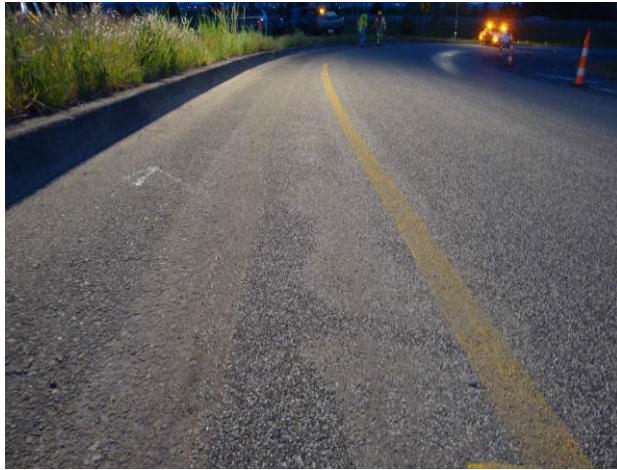
Figure 23. Tyregrip® with excess aggregate on top.
