Field Analysis of Wood Guardrail Post Decay

WA-RD 890.1R

Research Report
Research Project T1462, Task 16
WA-RD 890.1R

Adam R. Phillips and Qiyang Luo
Department of Civil and Environmental Engineering
Washington State University
Pullman, WA 99164

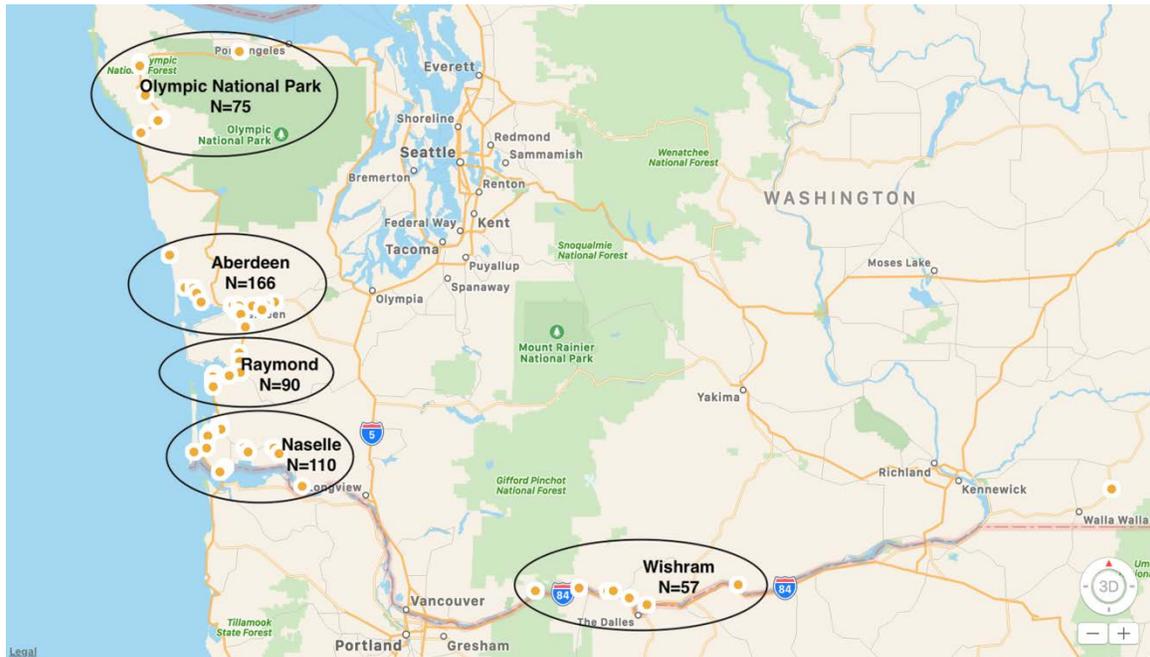
Figure 2. Timber post inspection regions

Five geographic regions were targeted for field inspection based on WSDOT's recommendations and a Scheffer Decay Hazard Index map, shown in Figure 2. Four of the regions are located on the western coast of Washington, which is the wettest part of the state based on annual precipitation data. One region, Wishram, was used as a baseline measurement for comparison and was assumed to be similar to the rest of the state east of the Cascade mountain

range, where annual precipitation is much lower. Figure 2 also shows the number of field inspections that were conducted in each region.

The decay rate of the inspected posts can be further classified by inspection region (shown in Figure 2), presented in Table 3. The Raymond and Naselle regions had the highest decay rates of approximately 38% and 33%, respectively. The Olympic National Park and Wishram regions had the lowest decay rates of approximately 8% and 5%, respectively. Scheffer climate index was used to quantify the environmental conditions in each region and was calculated as the average climate index for the posts located in that region. Figure 10 presents the decay rate for each region and Figure 11 shows the decay rate for each region versus climate index.

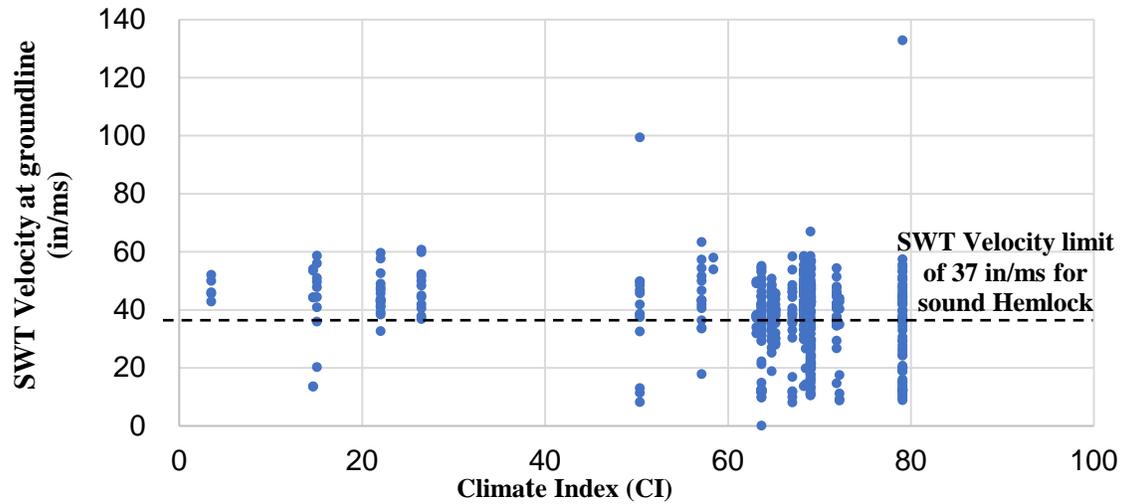
Figure 12. SWT velocity at the ground level versus climate index for field inspection sample

Figure 11 clearly shows that the regions with higher climate index (CI) had significantly higher rates of decay. To understand more about the relationship between the climate index and wood post decay, the individual posts SWT velocity at the ground level (GL) were plotted versus the climate index of their location, shown in Figure 12. Based on the SWT Equation 1, a wave velocity for sound Hemlock was calculated to be approximately 37 in/ms in Equation 13. In Equation 13, E_D is the dynamic modulus of elasticity and was assumed to be equal to the average of the radial direction modulus, E_R , and tangential direction modulus, E_T , as all posts were tested along the radial or tangential direction. The radial and tangential moduli were calculated using their ratio compared to longitudinal modulus, $E_R/E_L = 0.058$ and $E_T/E_L = 0.031$, as provided by the *Wood Handbook* (FPL 2010). The longitudinal modulus for Hemlock, E_L , was taken as 1300 ksi, per the design modulus of elasticity for the Hem-Fir species group, which included Western Hemlock, from the NDS (AWC 2015). The gravitational acceleration constant, g , is equal to 386 in/sec² and the specific gravity of Western Hemlock is approximately 0.45 (FPL 2010).

For values of CI less than 40 only a handful of posts fell below the sound wood velocity of 37 in./ms, whereas for values of CI above 60 approximately 40% of the posts had velocities below 37 in./ms.

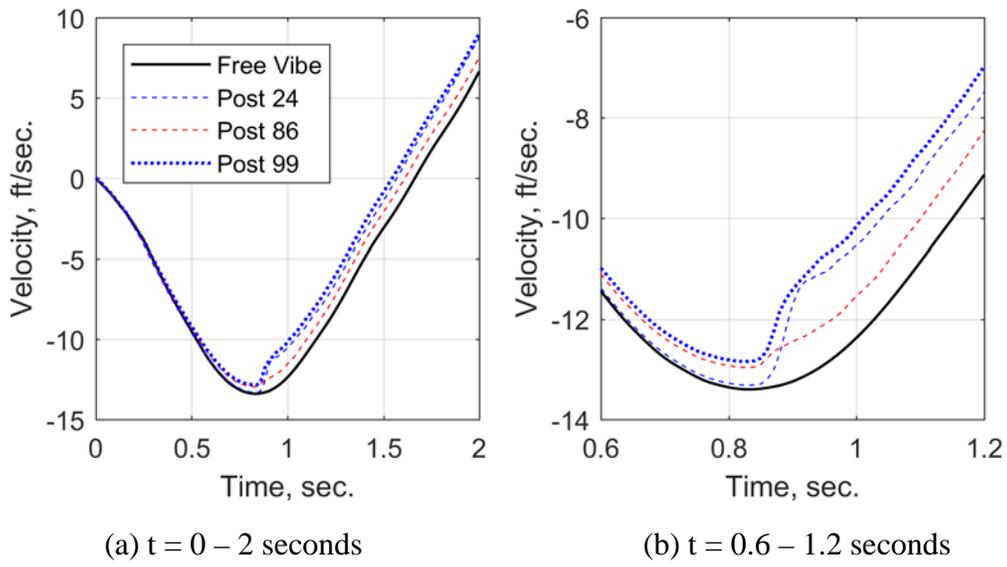
Figure 14. Pendulum velocity for posts with SWT velocities at the ground level greater than 37 in/ms

Figure 13 and 14 show the velocity response of the severely decayed and sound posts, respectively. It can be seen in Figure 13b that the average change in velocity immediately following impact was approximately 0.75 fps for the severely decayed posts. For the posts without noticeable decay, the average change in velocity immediately following impact was approximately 2.25 fps, or 3 times more than the severely decayed posts. This difference in the change in velocity shows that the decayed posts had less fracture energy than the sound posts.
