***WSF BAINBRIDGE ISLAND FERRY TERMINAL PRESERVATION
PROJECT***

**UNDERWATER SOUND LEVELS
ASSOCIATED WITH PILE DRIVING AT
THE BAINBRIDGE ISLAND FERRY
TERMINAL PRESERVATION PROJECT**

*Prepared by:
Jim Laughlin
Washington State Department of
Transportation
Office of Air Quality and Noise
15700 Dayton Avenue North, P.O. Box
330310
Seattle, WA 98133-9710*

November 2005

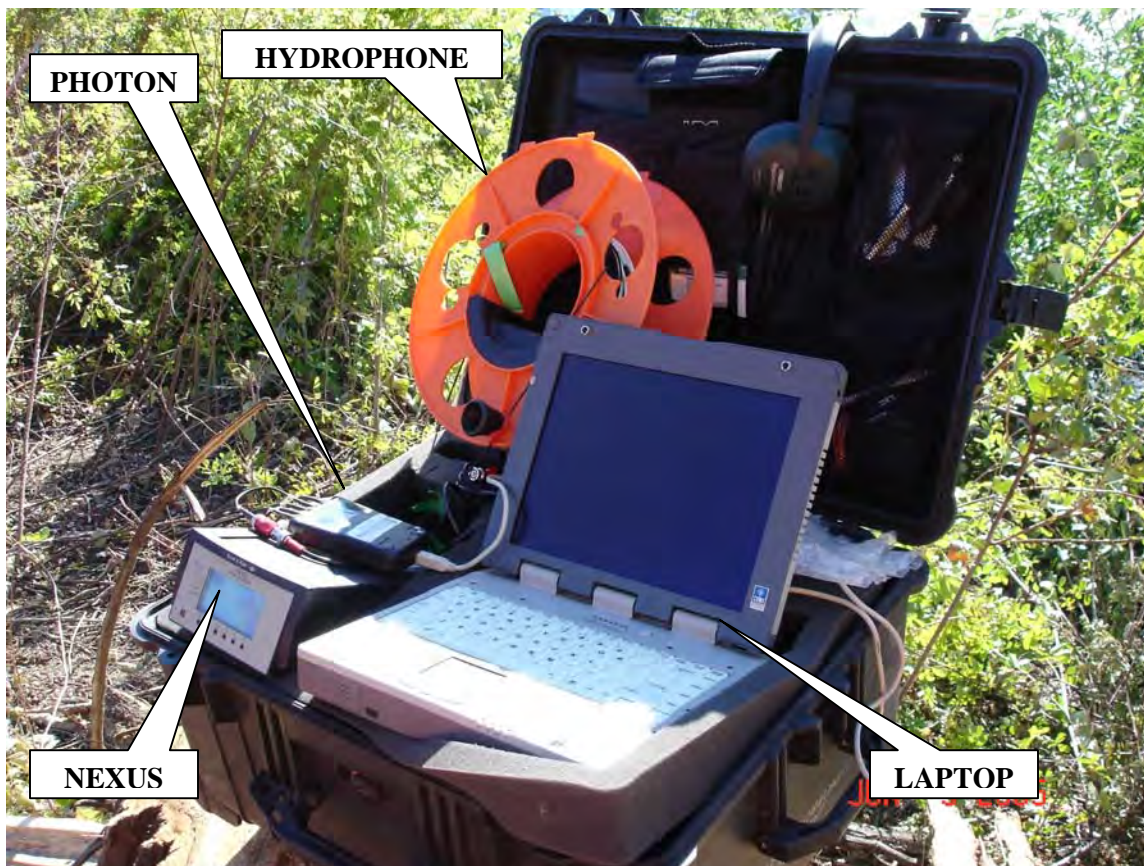
Figure 3: Underwater Sound Level Measurement Equipment

Underwater sound levels were measured using two Reson TC 4013 hydrophones. One hydrophone was positioned approximately at mid-water level. The second hydrophone was positioned approximately one foot from the bottom. The hydrophones were located at a distance of 33 feet from the pile being monitored. The measurement system includes a Brüel and Kjær Nexus type 2692 4-channel signal conditioner, which kept the high underwater sound levels within the dynamic range of the signal analyzer (Figure 3). The output of the Nexus signal conditioner is received by a Dactron Photon 4-channel signal spectrum analyzer that is attached to an Itronix GoBook II laptop computer. The waveform of the pile strikes along with the number of strikes, overpressure minimum and maximum, absolute peak values, and RMS sound levels, integrated over 90% of the duration of the pulse, were captured and stored on the laptop hard drive for subsequent signal analysis. The system and software calibration is checked annually against a NIST traceable standard. The operation of the hydrophone was checked in the field using a GRAS type 42AC high-level pistonphone with a hydrophone adaptor. The pistonphone signal was 146 dB re: 1 μ Pa. The pistonphone signal levels produced by the pistonphone and measured by the measurement system were within 1 dB and the operation of the system was judged acceptable over the study period. A photograph of the system and its components are shown in Figure 4.

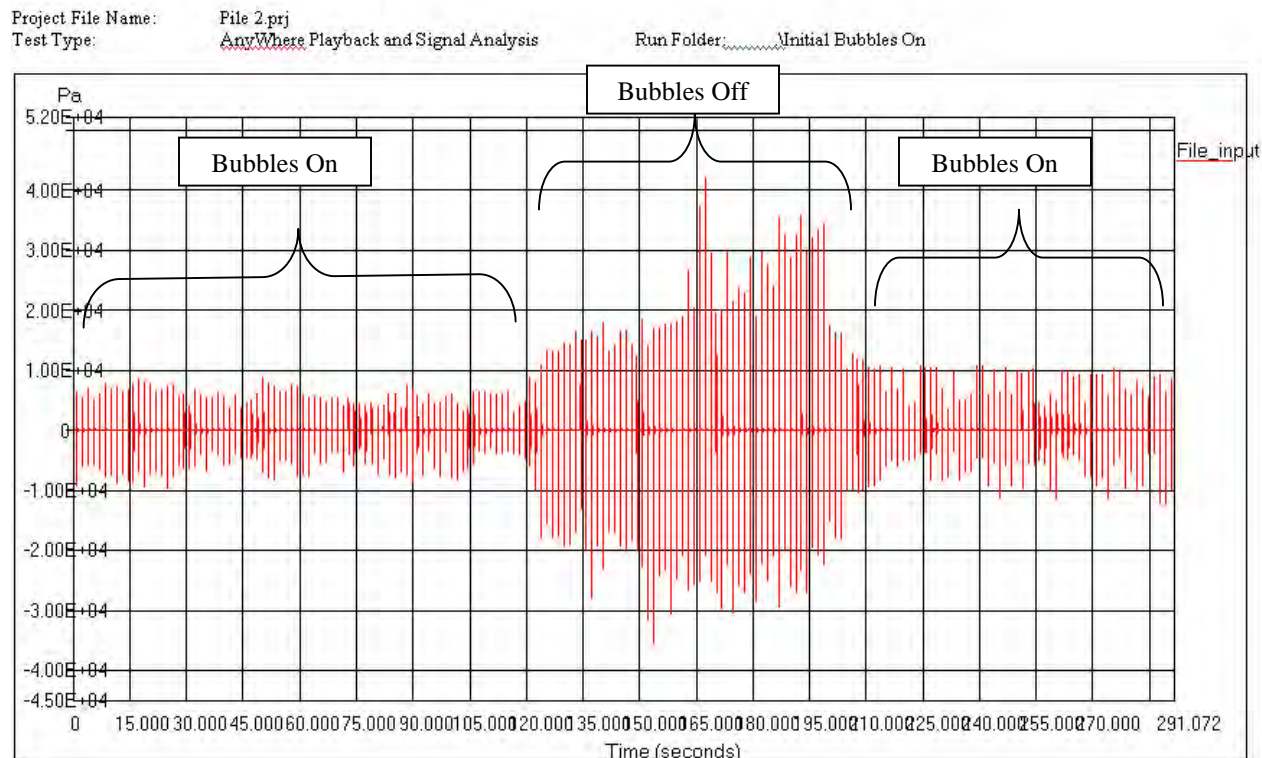
Figure 5: Waveform recording indicating the effects on amplitude with bubble curtain on versus bubble curtain off for pile 2.

Pile 2 was driven in water depth of 11 feet. The contractor started the pile driving with the bubbles turned on then after two minutes, the air was turned off. The air remained off for 1.5 minutes and then turned back on for 1.75 minutes. Figure 5 indicates the visible changes in signal amplitude with bubbles off versus bubbles on.

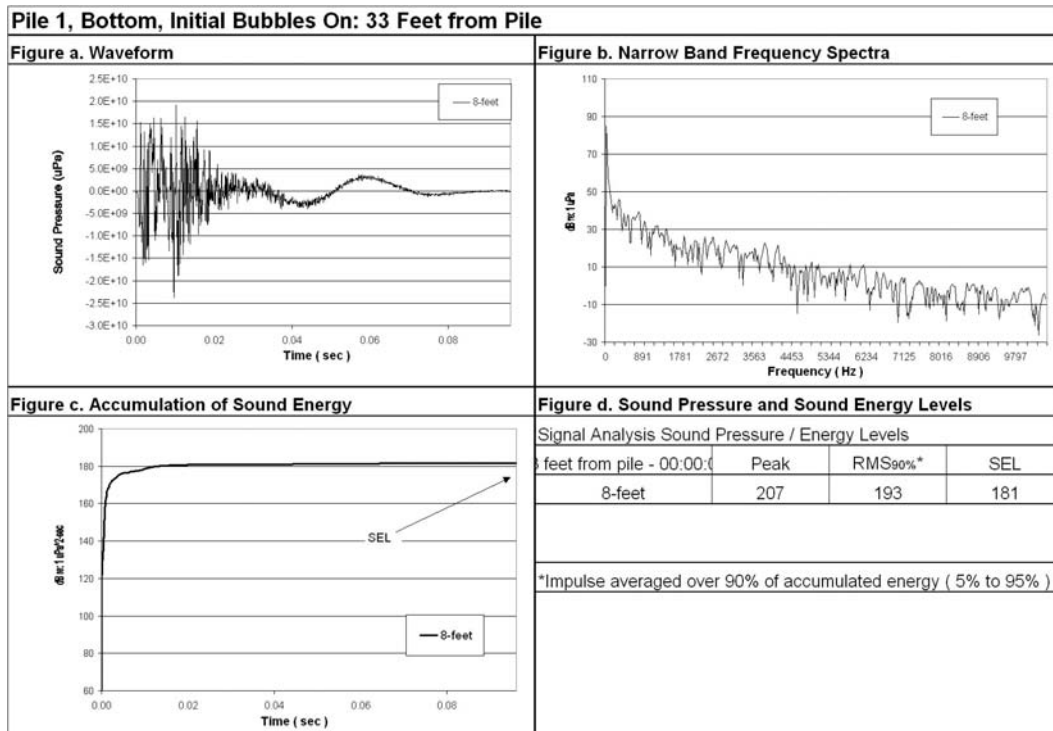
Figure 7a

Figure 7: Waveform Analysis of Pile 1 Sound Pressure Levels with Bubble Curtain Initial On, Midwater and Bottom.

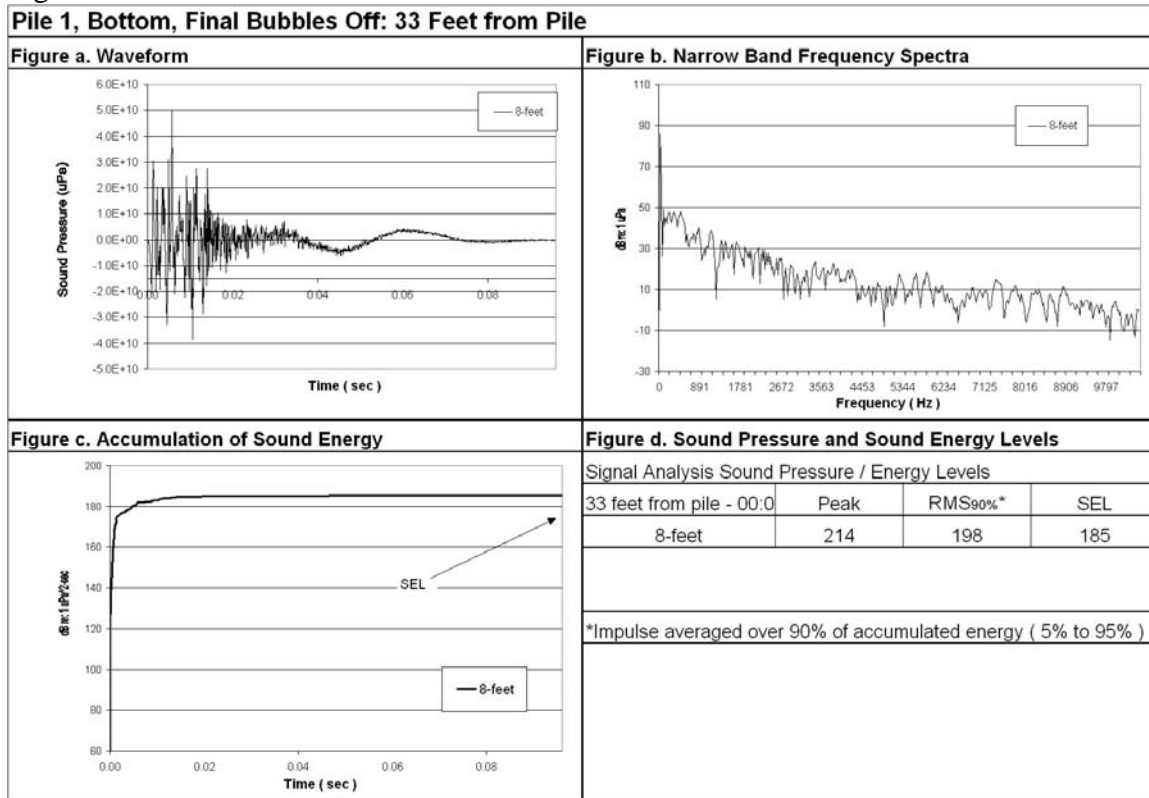
Figure 8a

Figure 8: Waveform Analysis of Pile 1 Sound Pressure Levels with Bubble Curtain Final Off, Midwater and Bottom.

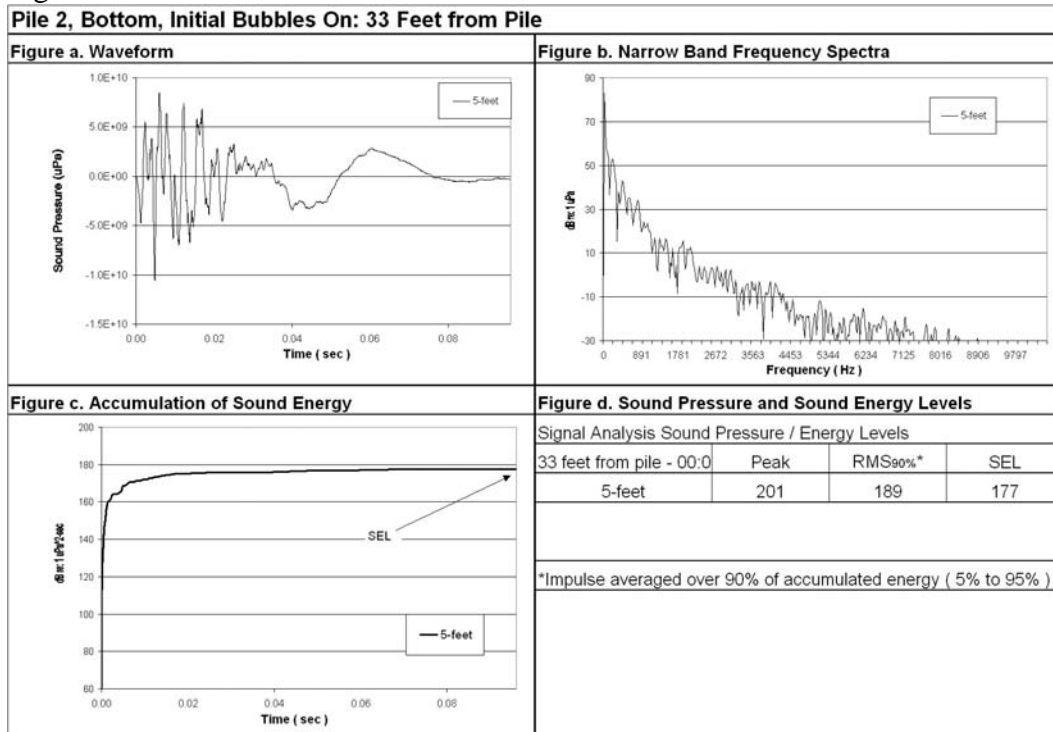
Figure 10a

Figure 10: Waveform Analysis of Pile 2 Sound Pressure Levels with Bubble Curtain Initial On, Midwater and Bottom.

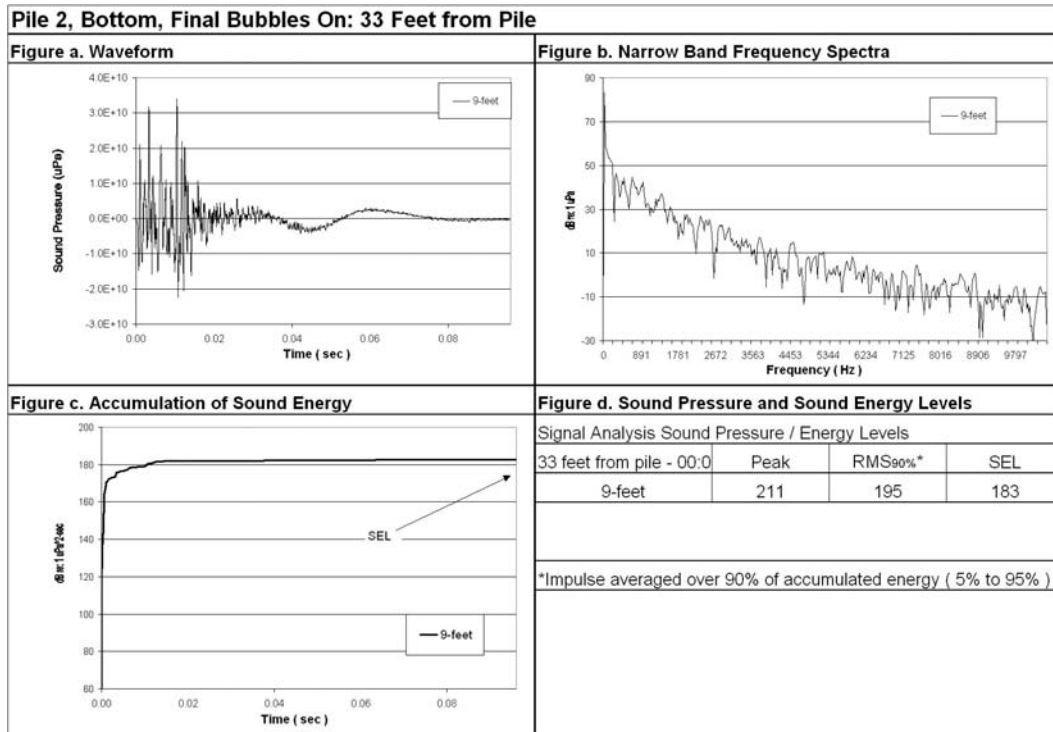
Figure 12a

Figure 12: Waveform Analysis of Pile 2 Sound Pressure Levels with Bubble Curtain Final On, Midwater and Bottom.

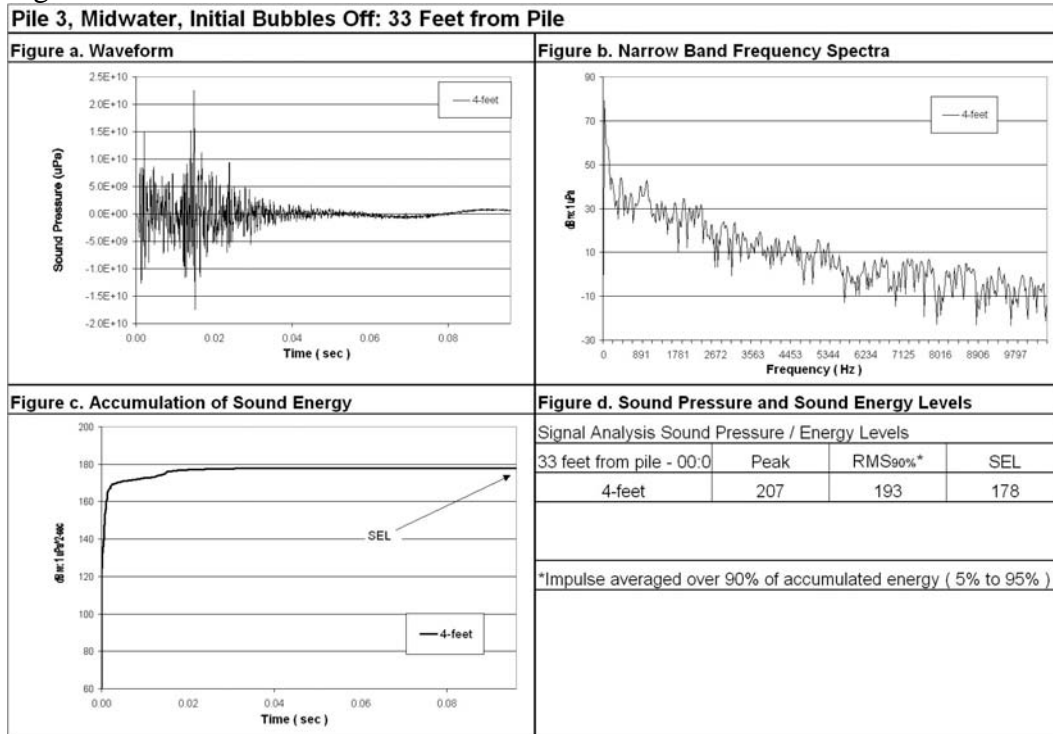
Figure 13a

Figure 13: Waveform Analysis of Pile Number 3 Sound Pressure Levels with Bubble Curtain Initial Off, Midwater and Bottom.

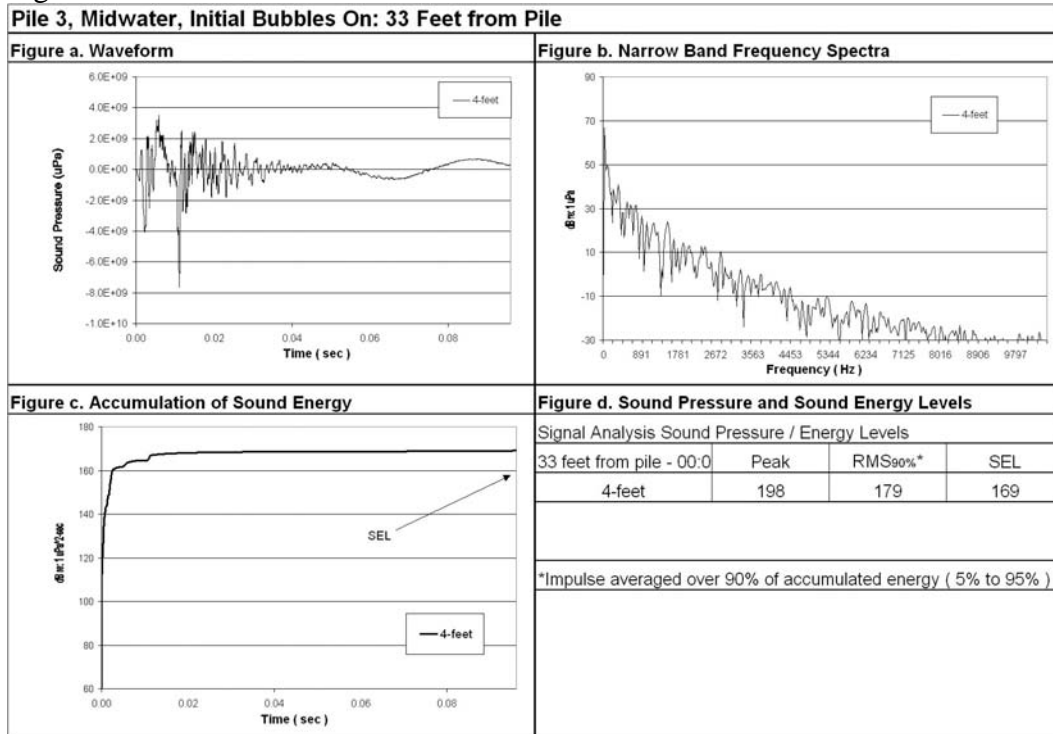
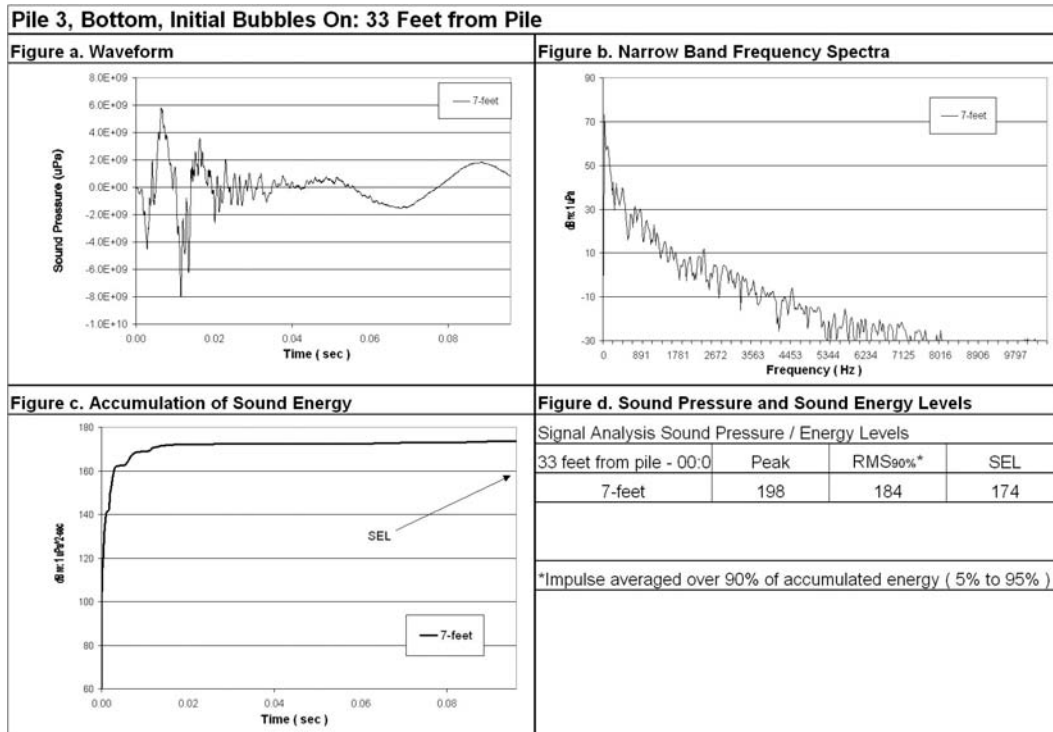
Figure 14a

Figure 14: Waveform Analysis of Pile Number 3 Sound Pressure Levels with Bubble Curtain Initial On, Midwater and Bottom.

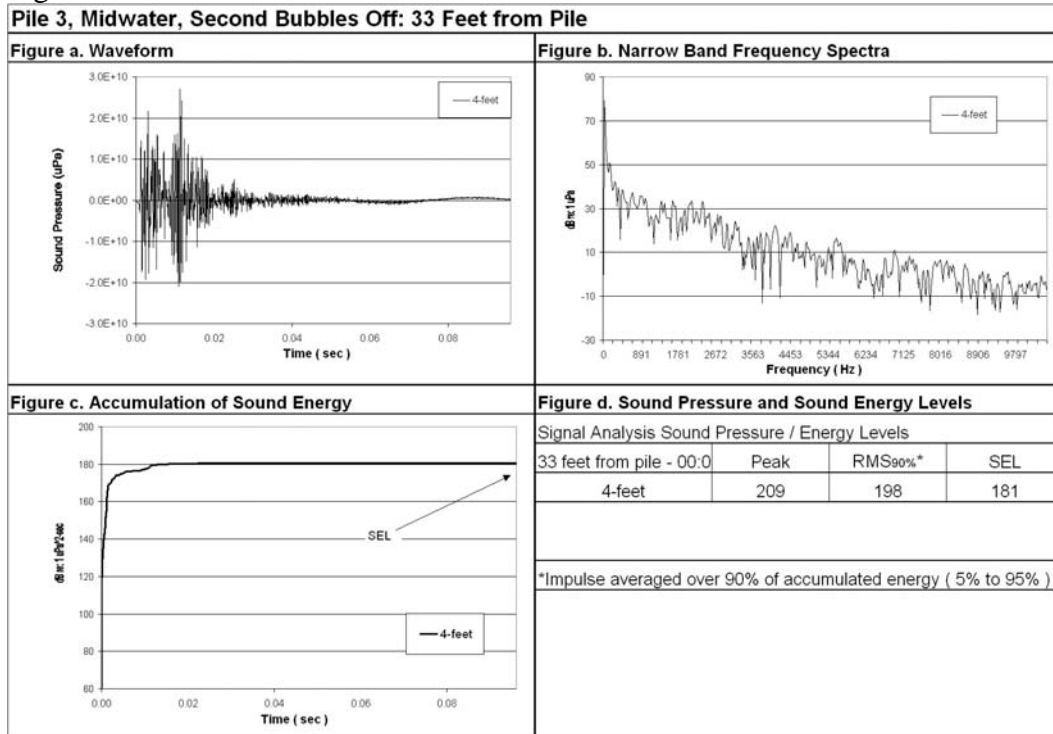
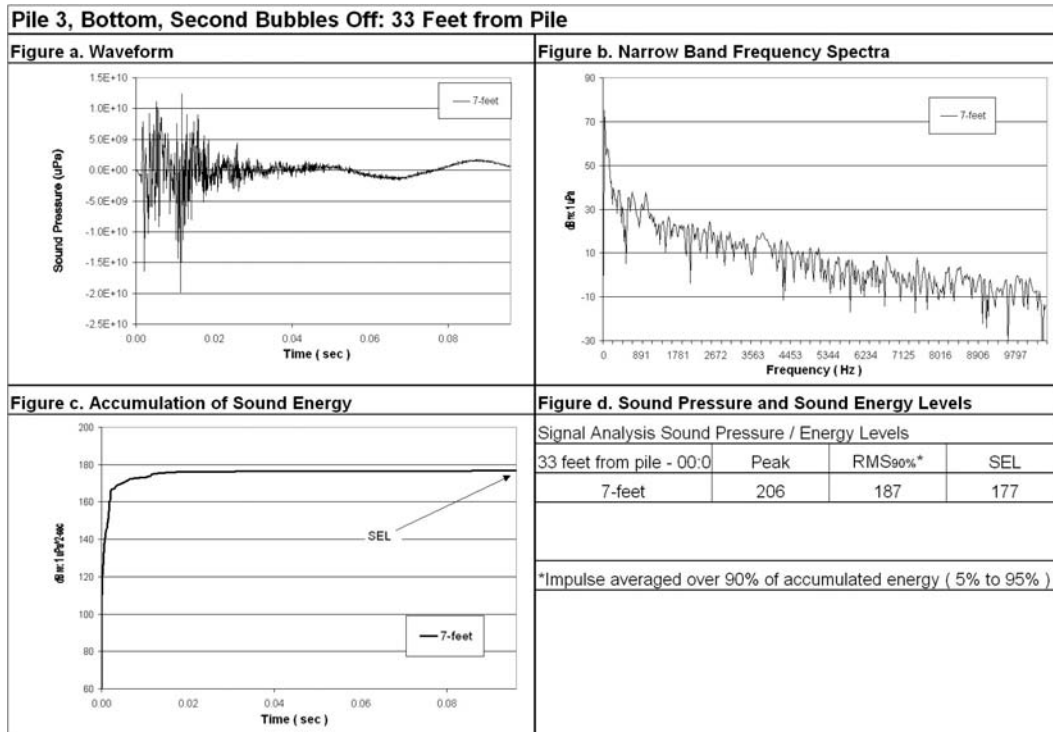
Figure 15a

Figure 15: Waveform Analysis of Pile Number 3 Sound Pressure Levels with Bubble Curtain Second Off, Midwater and Bottom.

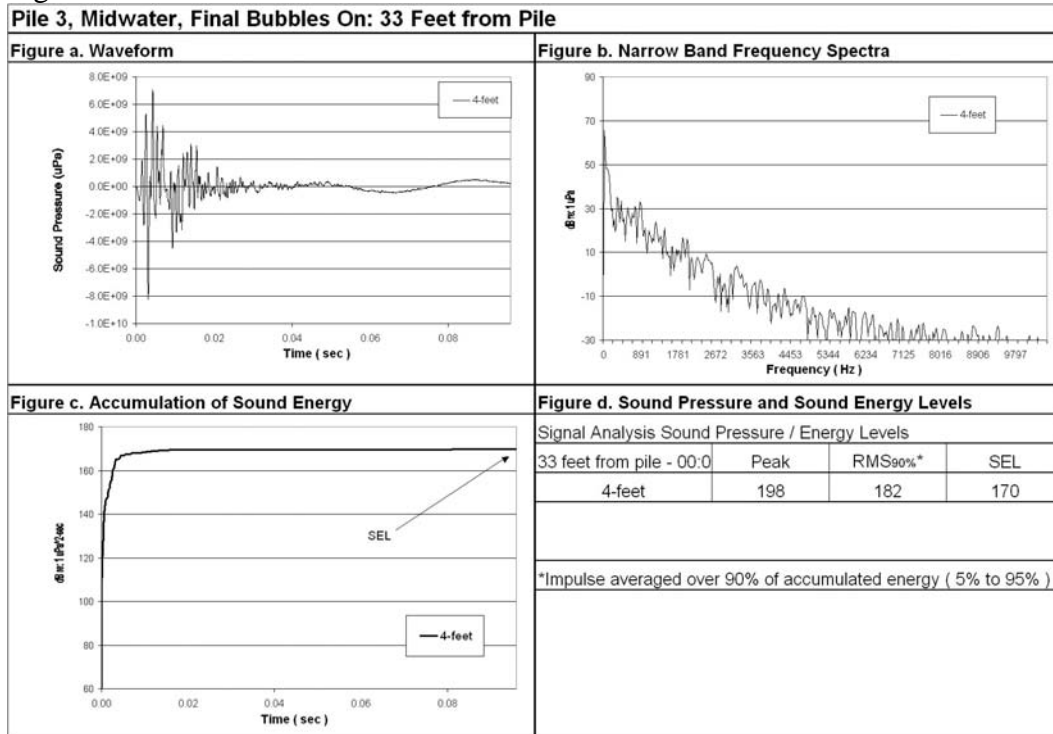
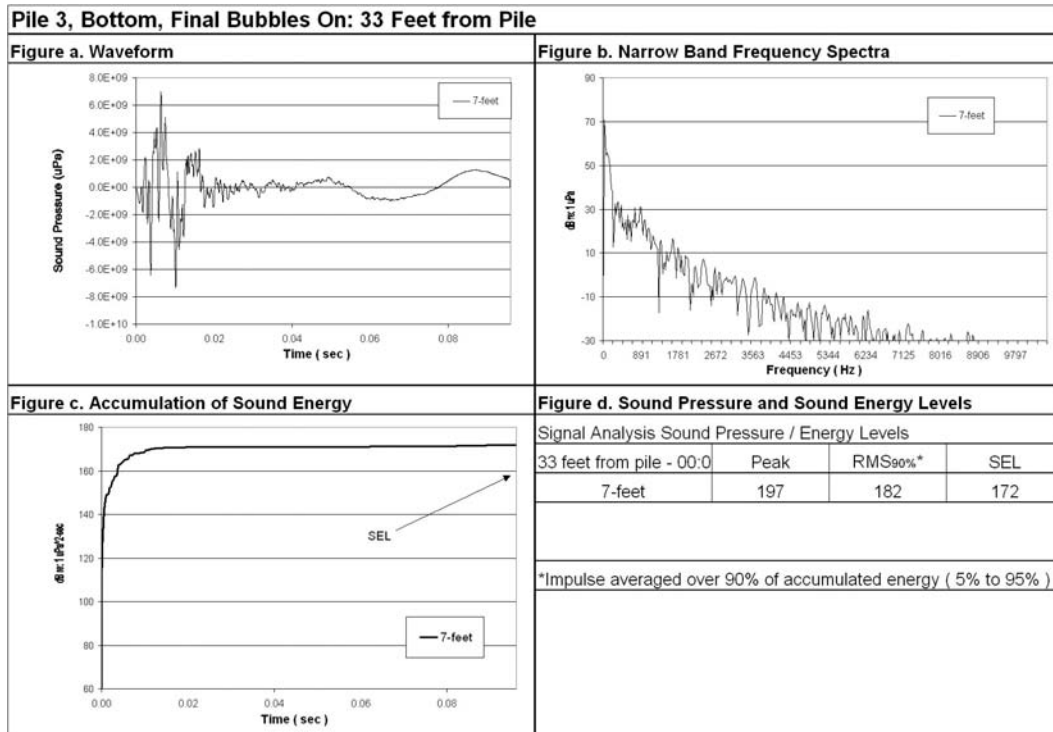
Figure 18a

Figure 18: Waveform Analysis of Pile Number 3 Sound Pressure Levels with Bubbles Curtain Final On, Midwater and Bottom.

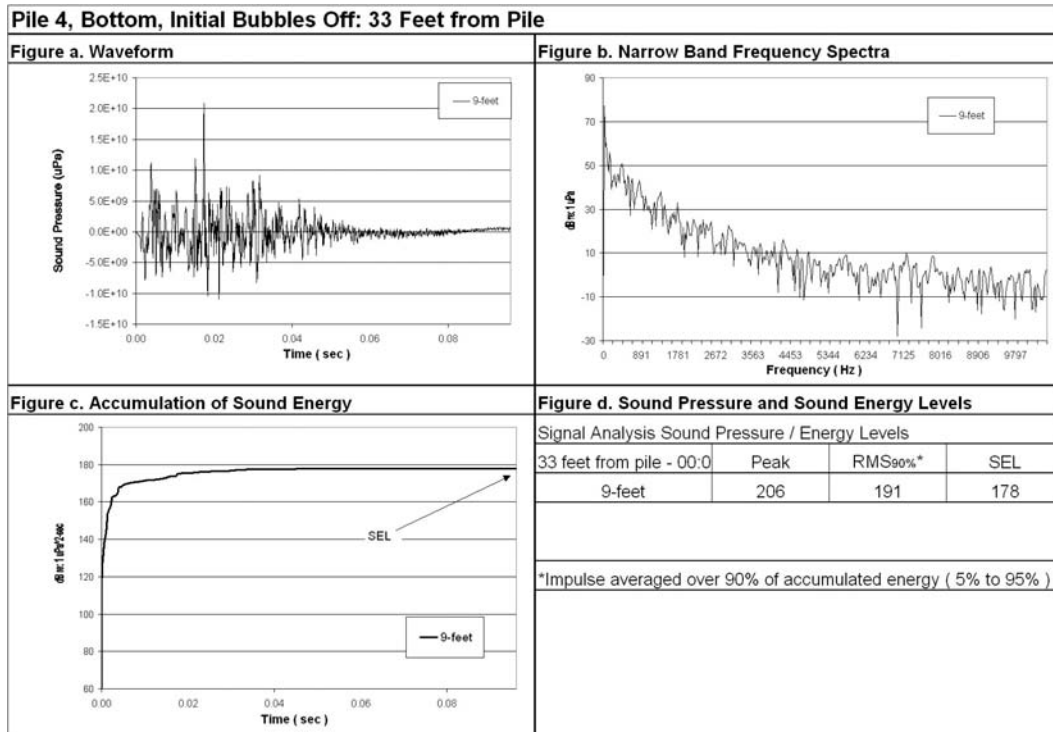
Figure 19a

Figure 19: Waveform Analysis of Pile Number 4 Sound Pressure Levels with Bubbles Curtain Initial Off, Midwater and Bottom.

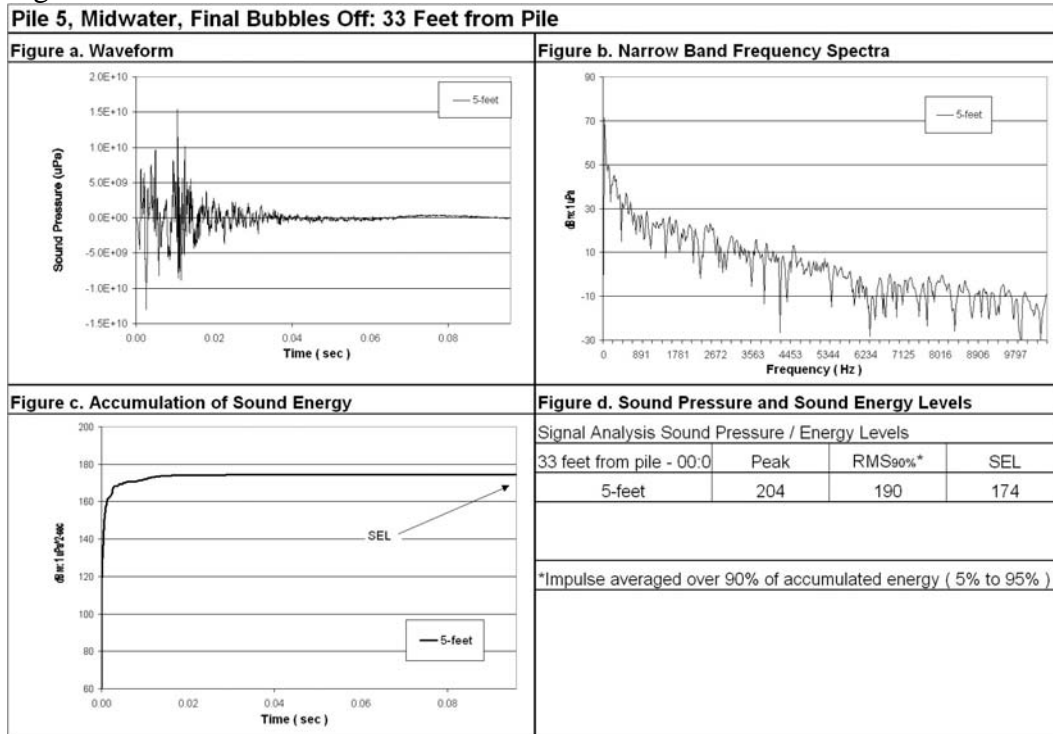
Figure 25a

Figure 25: Waveform Analysis of Pile Number 5 Sound Pressure Levels with Bubbles Curtain Final Off, Midwater and Bottom.
