Evaluation of Long-Term Pavement Performance and Noise Characteristics of Open-Graded Friction Courses – Project 2: Post-Construction and Performance Report

WA-RD 691.1

Post-Construction and Performance Report
Experimental Feature 07-01

Contract 7353
SR-520
Eastside Quieter Pavement Evaluation Project
MP 4.24 to MP 5.82

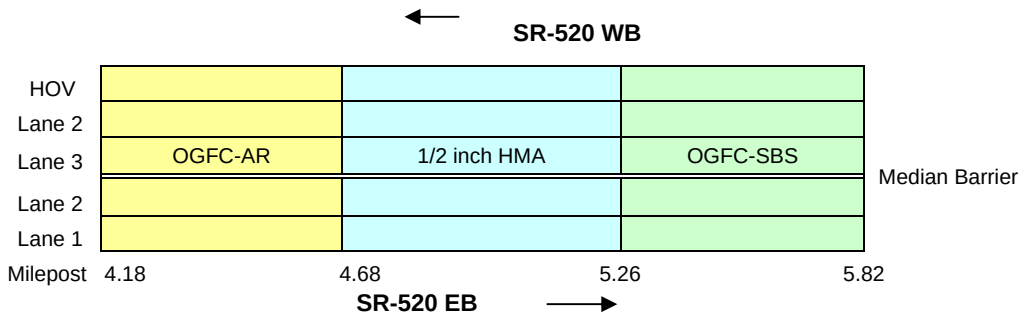
Figure 2. Plan map of section layout.

The open-graded sections were placed 0.06 feet thick on the two general purpose lanes in each direction and on the HOV lane in the westbound direction. The HOV lane on SR-520 is the outside lane instead of the normal location on the inside. The Class ½ inch Hot Mix Asphalt (HMA) was place 0.15 feet thick on all lanes including the HOV with an 18 foot taper section at each end to transition to the thinner open-graded sections. The paving limits for three different

pavement types are shown in Figure 2. This was a simple overlay process with no pre-leveling required.

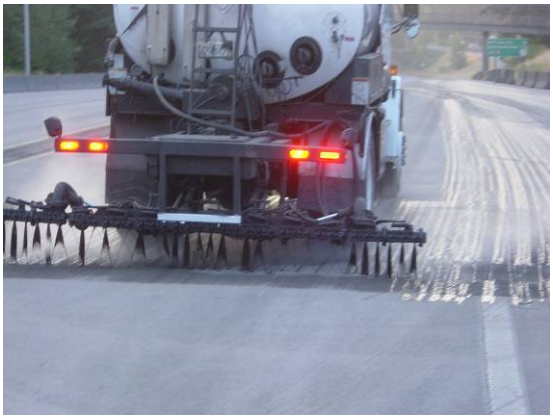
Figure 3. Distributor applying tack coat.

The paving operation is capture in Figures 3 through 14. There were minor problems that included occasional spills of materials in front of the paver, stoppage of the paver waiting for mix, less than full coverage of the tack coat application, and minor problems at the plant. The inspectors' daily reports indicate that the roller operators were rolling the pavement well beyond the cessation temperature (the point at which no further compaction can occur) and this caused some aggregate breakage as can be seen in Figure 13. Temperature differentials were not a problem on this project due to the use of the Shuttle Buggy material transfer vehicle (MTV) that was specified in the Special Provisions (Appendix B). A detailed report of the construction that includes infrared images is included as Appendix C.

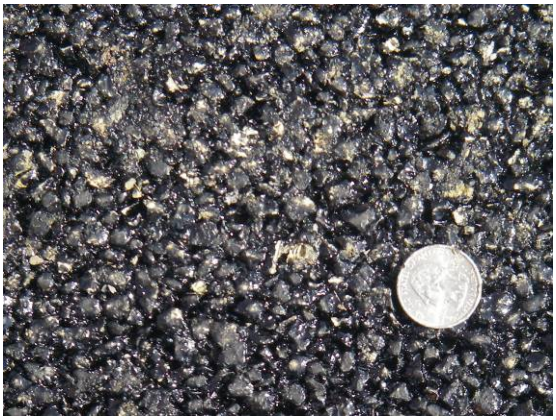
Figure 13. Close-up of OGFC-AR showing aggregate breakage.

Generally, the rollers met the requirement to be within 300 feet of the paver; however, the operators had trouble knowing when to get off the mat after the surface temperature of the pavement reached the Special Provision requirement of 200ºF. This was not caused by excessively low temperatures of the OGFC at arrival but seemed to be caused by lack of checking surface temperature while rolling. This caused aggregate breakage to occur during OGFC placement.

- Slow the speed of the paver until rollers have completed the work at a construction joint.
- Mat surface temperature should be monitored regularly so that aggregate breakage is minimized. Aggregate breakage may be the link to wearing of the OGFC (note where the aggregate breakage is occurring…in the wheelpaths).

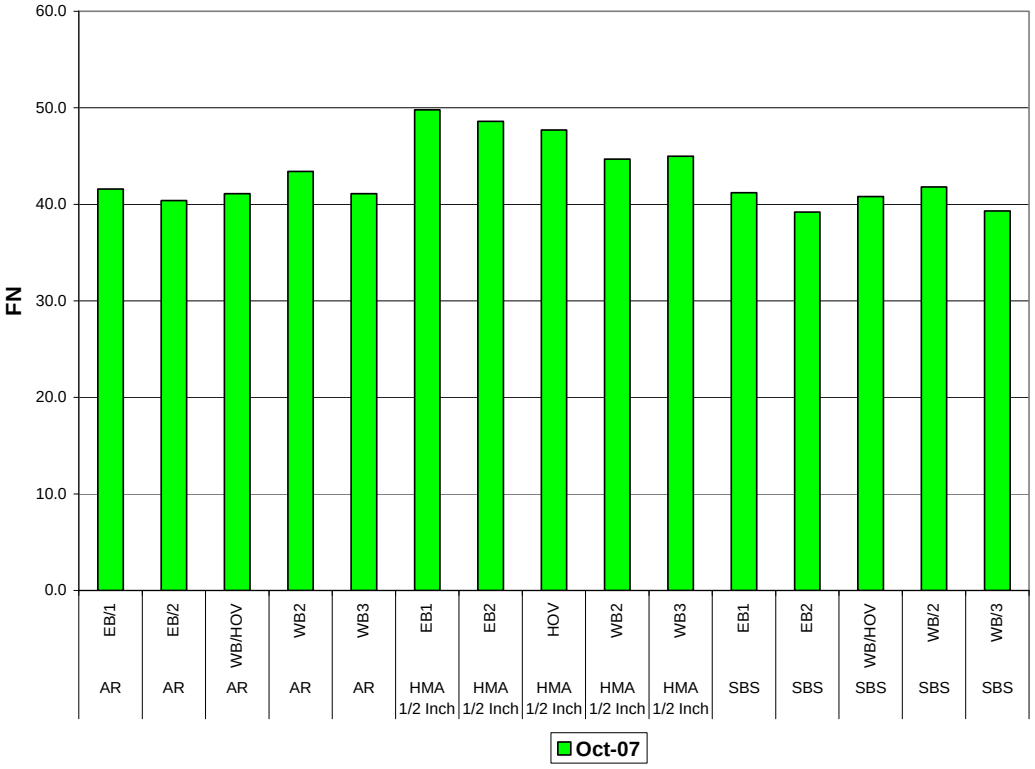
Figure 15. FN values from October 31, 2007.

Friction tests were performed with a ribbed tire using a locked-wheel friction tester meeting ASTM E-274 requirements. The friction number (FN) results are listed in Table 6 and plotted in Figure 15. The friction numbers are all in the acceptable category with the Class ½ inch HMA having the highest average for all lanes of 47.2. The average for all lanes of the OGFC-AR was 41.9 while the average for all lanes of the OGFC-SBS was slightly lower at 40.5.

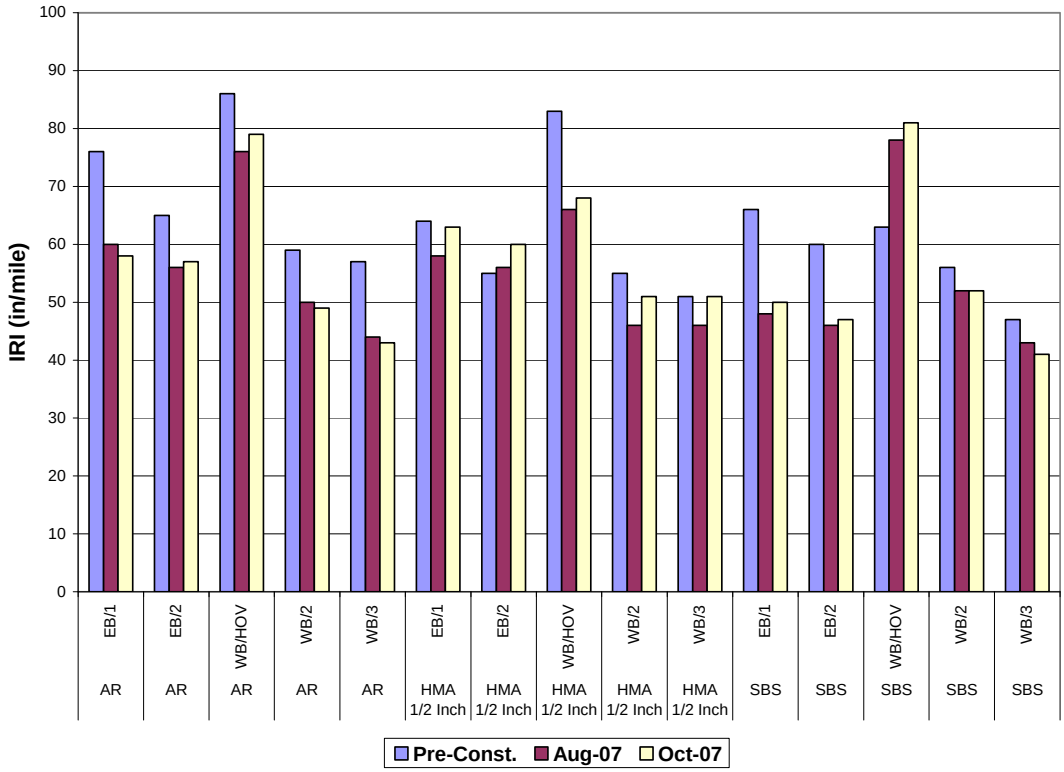
The ride improved on most of the lanes with the new overlays. In some cases it remained the same and in two cases it got slightly worse. The trend of the ride readings can be seen in Figure 16 which plots the three sets of readings listed in Table 7.

Figure 16. IRI measurements pre-construction, August and October 2007.

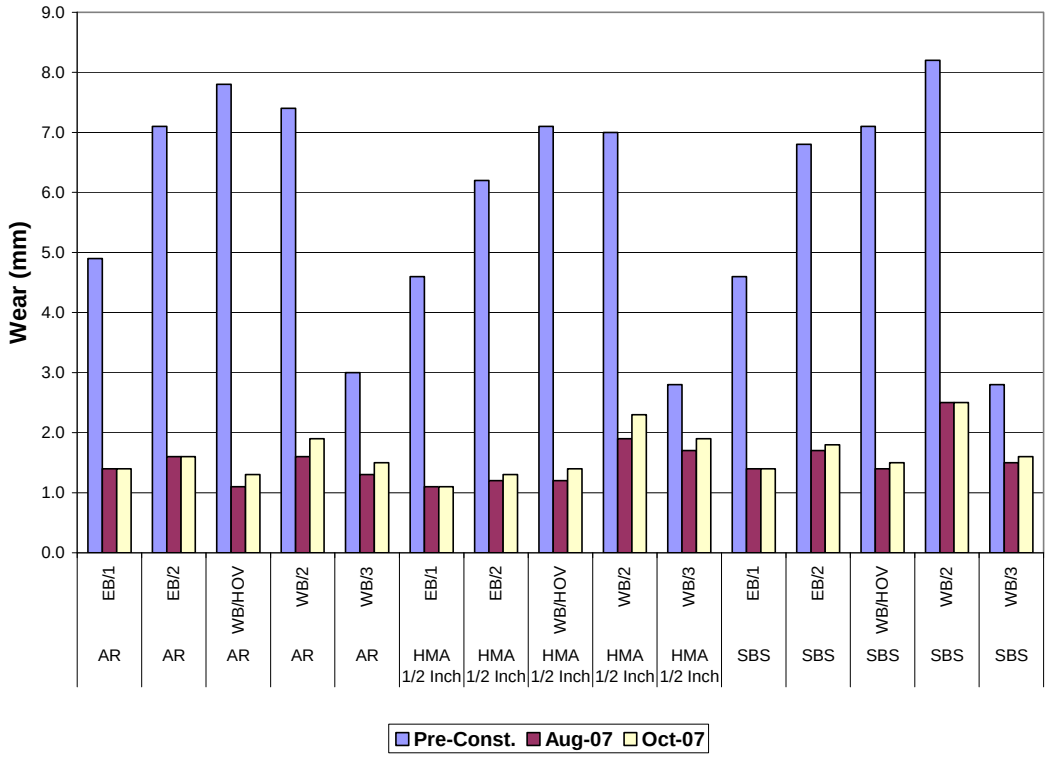
The transverse profile measurements, which indicate the wear or rutting in the wheel paths, are listed in Table 8 and shown graphically in Figure 17. The decrease in wear/rutting provided by the new surface is quite evident as the average for all lanes decreased from 5.8 mm prior to construction to 1.6 mm in the most recent measurement. The wear/rutting in the westbound Lane 2 for all three sections is greater than any of the other lanes which may indicate that the wear/rutting of the existing pavement may be reflecting through the overlay. The data was collected using the WSDOT's Pathway Pavement Condition Collection Van at the same time that the ride data was collected.

Figure 17. Wear/rutting measurements.

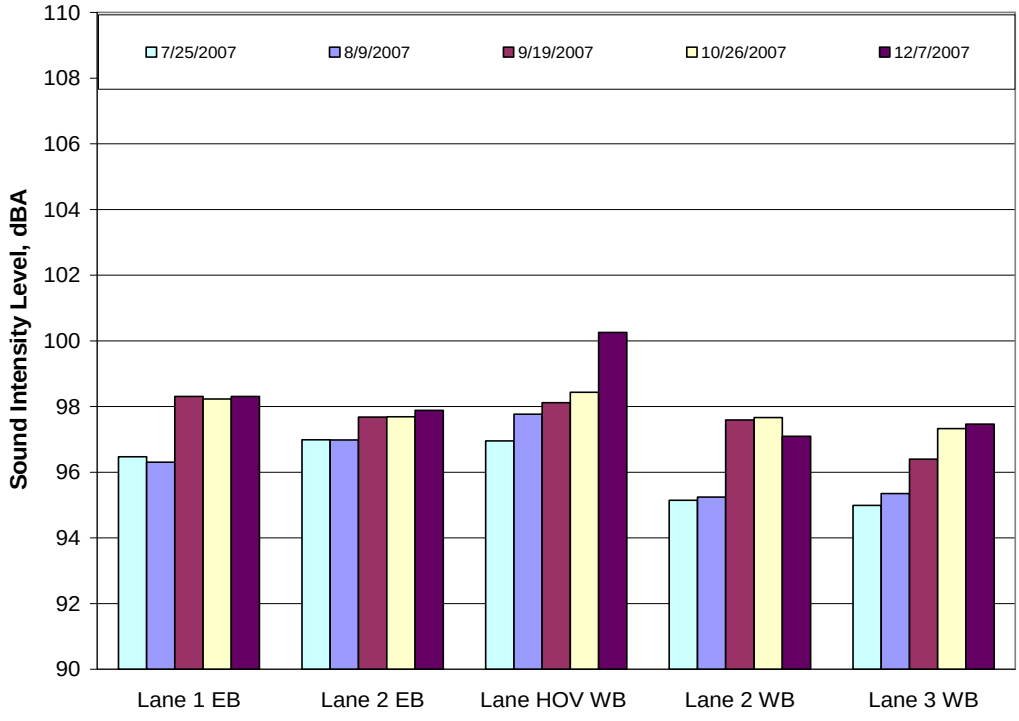
Figure 18. Sound intensity level (dBA) measurements for OGFC-AR section.

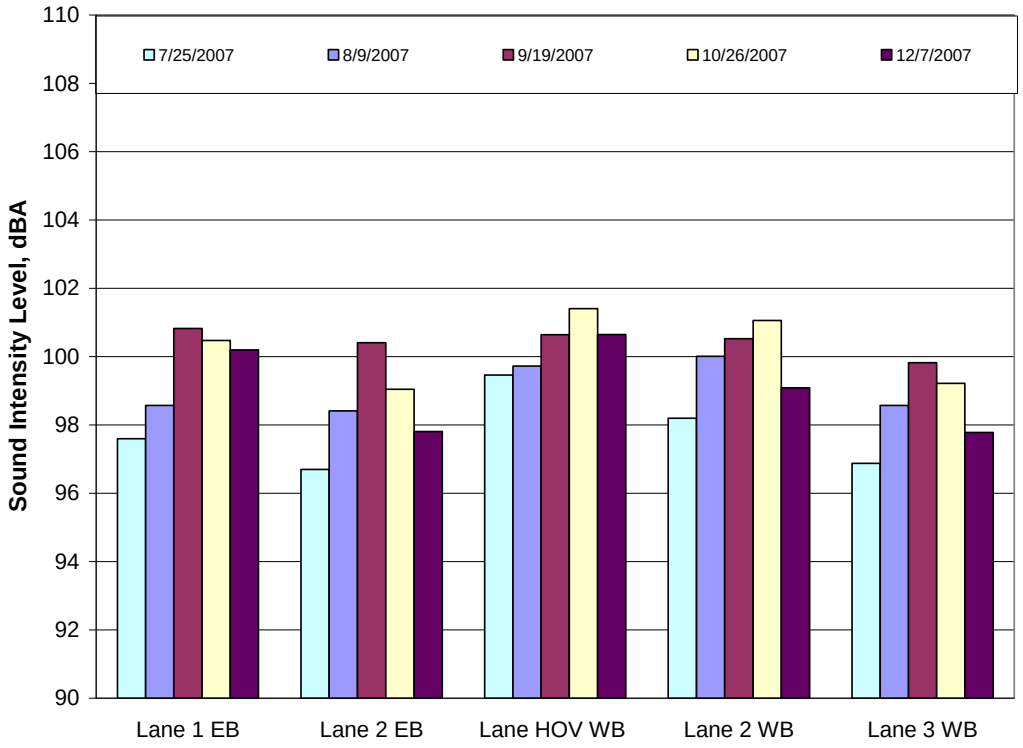
Table 10 lists the sound intensity measurements for the OGFC-SBS section. Figure 19 shows that the noise level of the OGFC-SBS section has increased and then decreased over time as contrasted with the OGFC-AR section which has shown only a gradual increase over time.

Figure 19. Sound intensity level (dBA) measurements for the OGFC-SBS section.

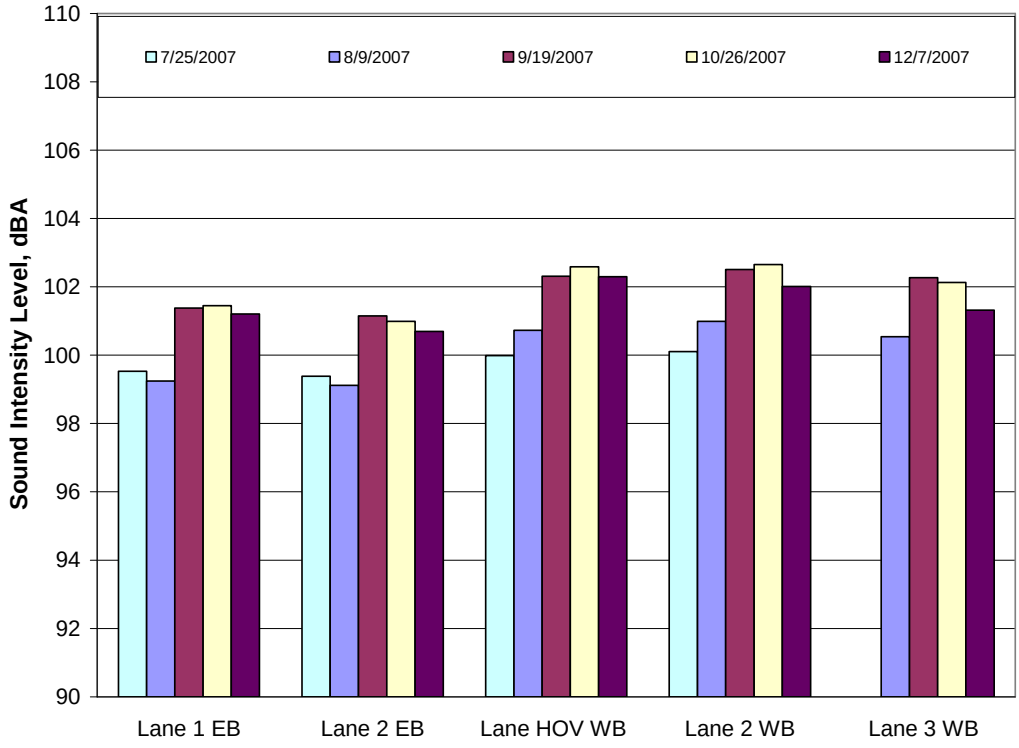
Table 11 lists the sound intensity level measurement for the control section of Class ½ inch HMA. Figure 20 shows that the levels are mimicking the pattern of the OGFC-SBS with and increase and then a decrease over time for each lane.

Figure 20. Sound intensity level (dBA) measurements for the Class ½ inch HMA section.

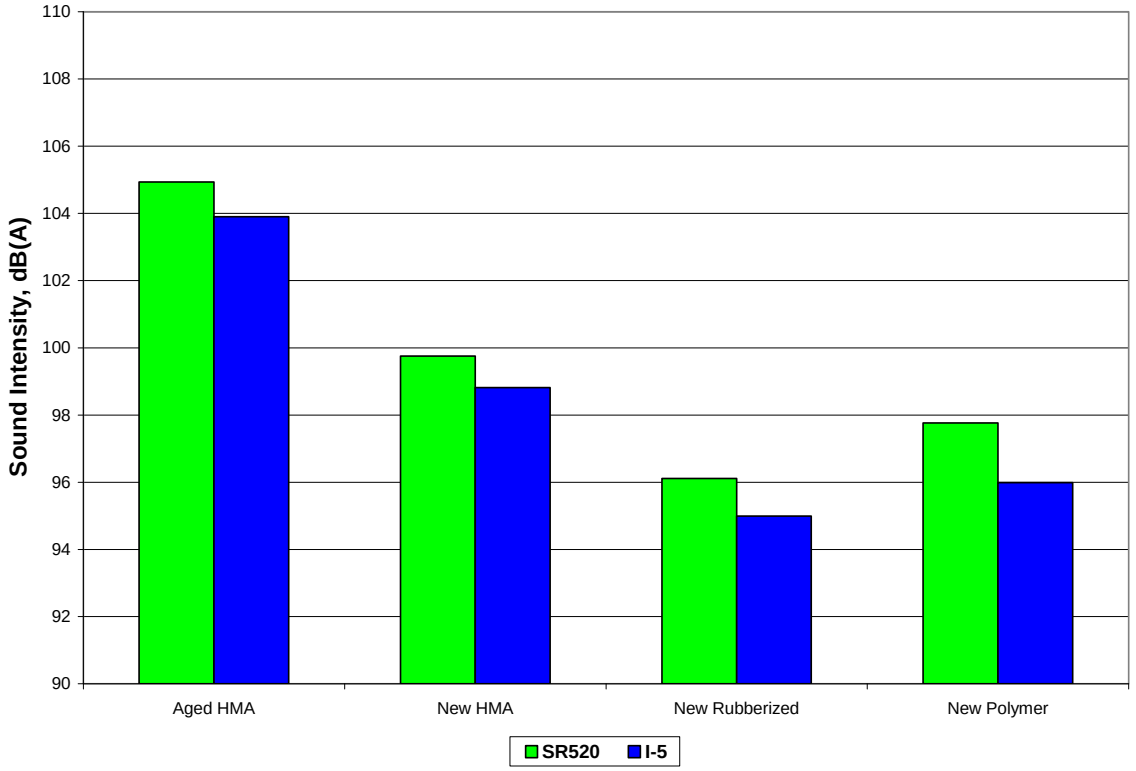
The sound intensity levels measured immediately after construction are higher for all three types of pavement on this project than on the Lynnwood project as can be seen in Table 13 and Figure 21. A discussion of the probable causes for the higher readings is contained in the following section of the report.

Figure 21. Comparison of sound intensity levels immediately after construction.

Several observations can be made in comparing the results from this project to the previous open-graded project done in 2006 on I-5 near Lynnwood, Washington (Anderson et al., 2008). The initial sound intensity level measurements for this project follow the same pattern as the Lynnwood project with the AR section having the lowest OBSI readings, the SBS next and the HMA the highest (note that on the Lynnwood project the SBS section has seen less deterioration over time and is, as of the publication date of this report, quieter than the AR section). It should be noted that the SR-520 readings are between one and almost two dBA higher than the Lynnwood project with the largest difference occurred on the SBS section with a difference of 1.8 dBA between initial readings on the two projects.

There were minor differences between the two projects even though the same contractor was used and essentially used the same equipment to produce the mix and pave each of the sections. The OGRC-SBS had the largest difference in the mix design asphalt content (8.3 percent for I-5 versus 8.8 percent for SR-520). Perhaps the higher asphalt content resulted in a pavement surface that was lower in voids than the I-5 project, or perhaps the over rolling noted by those observing the construction of the SR-520 project worked in concert with the higher asphalt content to decrease surface voids. It is probably not profitable to spend a great deal of time or energy trying to find the cause or causes for the difference noted in the sound intensity levels between the two projects. It is sufficient to state that there was a difference in the initial readings following construction.

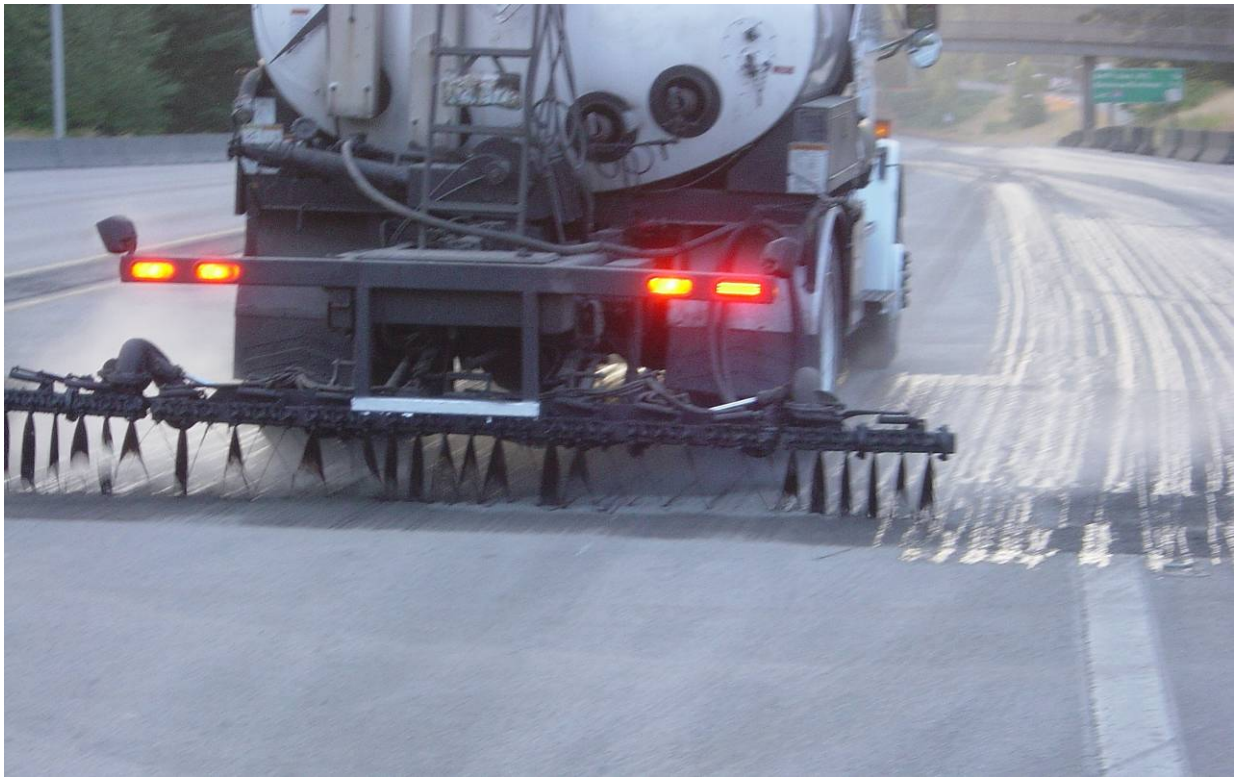
Tack coat for both the OGFC test sections was applied by an Etnyre distributor. The application of the CRS-2P tack was the item of concern because the snivies would plug quickly due to the tack material itself. The tack application was sporadic with streaking in the eastbound lanes of the OGFC-AR but the application was fairly uniform on the westbound lanes. The tack applied on the OGFC-Polymer was also erratic with streaking. Some tracking of the tack coat by the Shuttle Buggy and delivery trucks was observed in the wheelpaths but it was not as substantial as that which occurred on the OGFC project on I-5 near Lynnwood.

Figure 22. Image of typical tack application with some pickup visible in the wheelpaths.

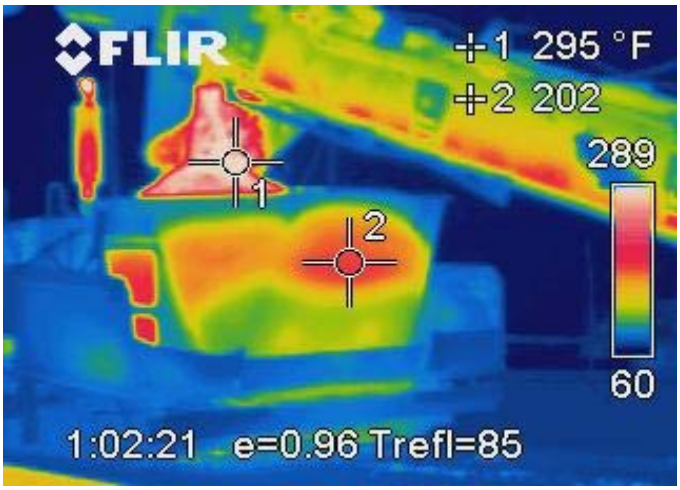
Figure 23. Thermal image of the mix as it leaves the SB and enters the paver hopper at 295 ° F.

The use of tarps on the HMA delivery trucks and trailers was seen throughout the paving operations for both the OGFC materials. Two ROADTEC Shuttle Buggy (SB) material transfer vehicles were used throughout the project. The SB has excellent remixing and storage capabilities and specifying it in the contract special provisions was a wise choice. The temperature of the mix as it was transferred from the SB into the paver hopper was typically around 290ºF. The insulating and remixing capability of this device resulted in consistent temperatures across the mat and behind the screed. The only exception to this consistent pattern of temperatures occurred because of problems with one of the pavers as detailed later.

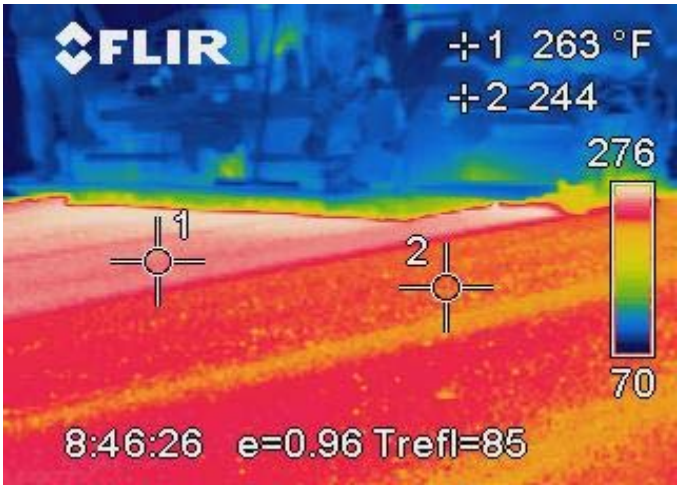
Figure 26. Streaking OGFC of first paver (spot 2) and the consistent mat behind second paver (spot 1).

Most of the problems with streaking and globs of material were eliminated once the speed of the paving operation stabilized. This was also true during the paving of the OGFC-Polymer. Paving was conducted in a side-by-side operation and longitudinal joints were eliminated by hot-lapping of the joint from the simultaneous paving operation.

- Specify that tarps be used on all trucks and trailers to ensure maximum heat retention in the mix between the plant and the paving operation.
- Specify a material transfer vehicle be used on all thin lift open-graded friction course projects.
- Specify that a paver retrofit kit be used on all applicable models and that the kit is in working order as recommended by the manufacture.
- Specify that auger extensions be used when the screed is extended a certain specified distance or that the contractor will take necessary measures to minimize longitudinal streaking at the screed extensions.
