1. Abstract

This study investigated retrofit measures for improving the seismic performance of cruciform-shaped columns in the Aurora Avenue Bridge located in Seattle, Washington. Tests on column specimens representing as-built conditions resulted in shear failures at modest displacement levels, accompanied by severe strength and stiffness degradation. Tests on column specimens retrofitted with FRP jacketing resulted in improved performance compared to that obtained for the as-built column specimens. It was found that the FRP jacket needs to be anchored in the reentrant corners of the cruciform-shaped columns to be effective. In addition, the FRP jacket does not provide adequate confinement to prevent flexural hinge degradation. The final retrofit design incorporating reentrant corner anchorage and grout-filled steel collars at the plastic hinge regions produced a ductile flexural response.

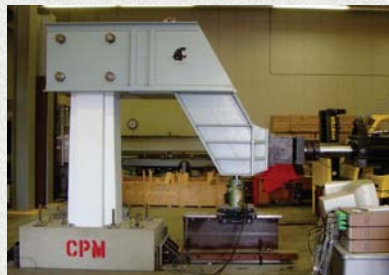
Figure 3. Testing Setup.

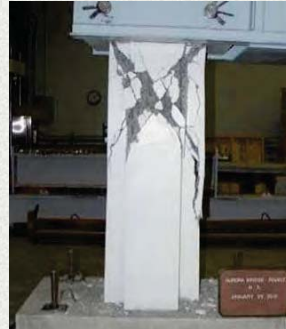
Figure 4. As-Built Column Shear Failure.

Columns 1 and 5 were representative of the as-built conditions in the columns in the Aurora Avenue Bridge. The overall response of the two as-built column specimens was essentially the same, with early shear cracks forming followed by flexural cracks forming at the top and bottom of the column. Yielding of the transverse reinforcement occurred near the peak lateral force level followed by opening of large shear cracks (Figure 4). The final failure mode was a shear failure with modest ductility. Load-displacement hysteresis curves for Column 5 are given in Figure 5.

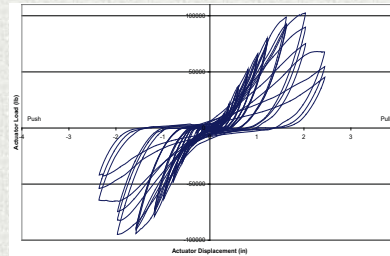
Figure 5. As-Built Load-Displacement Curves.

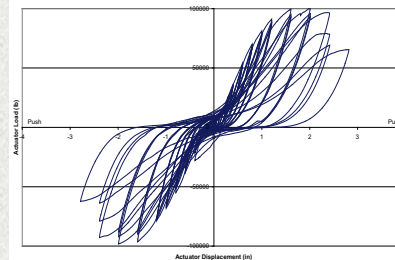
Figure 6. Column 2 Load-Displacement Curves.

Column 2 exhibited slightly improved energy dissipation capacity and ductility as compared with those for the as-built columns (see Figure 6). Initially, no shear distress was observed in the column. After cycling several times near the peak load, the FRP jacket began to pull away from the reentrant corners at the top and bottom of the column, resulting in a significant decrease in the lateral load. Removal of the FRP jacket after testing revealed that the final failure mode for the column was in shear.

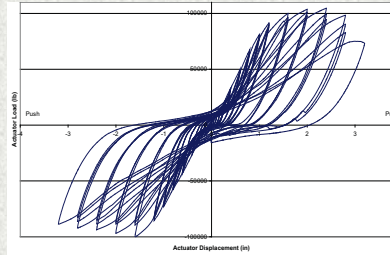
Figure 7. Column 3 Load-Displacement Curves.

Column 3 was identical to Column 2 except that the FRP jacket was anchored in the reentrant corners of the column with bent steel plates anchored to the column using epoxy anchors. Column 3 showed improvement in the overall cyclic response with significant enhancement of energy dissipation and displacement capacity (Figure 7). Failure in Column 3 was caused by bulging of the FRP jacket in the plastic hinge regions, leading to flexural hinge degradation and reentrant corner anchorage failure (Figure 8).

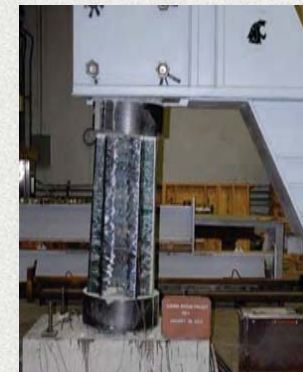
Figure 9. Column 4 During Testing.

Column 4 was identical to Column 2 except that the FRP jacket was anchored in the reentrant corners of the column with FRP anchors over the full-height of the column (Figure 9). The column also incorporated steel collars at the top and bottom of the column to restrain bulging from plastic hinging.

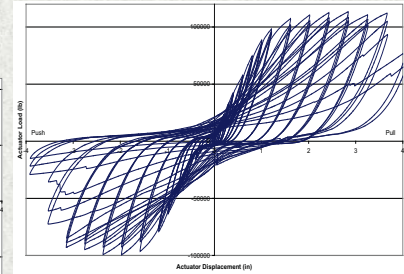
Figure 10. Column 4 Load-Displacement Curves.

Column 4 retrofitted with a FRP jacket with reentrant corner anchorages consisting of FRP anchors along with steel collars in the hinging regions provided the best cyclic response (Figure 10). Good energy dissipation along with a ductile response was achieved. Failure in Column 4 occurred due to extensive flexural hinging leading to low-cycle fatigue fracture of several of the longitudinal reinforcing bars.
