The Alaskan Way Viaduct & Seawall Replacement Program

A Retrofit is Not Enough

Review of Retrofit Proposal

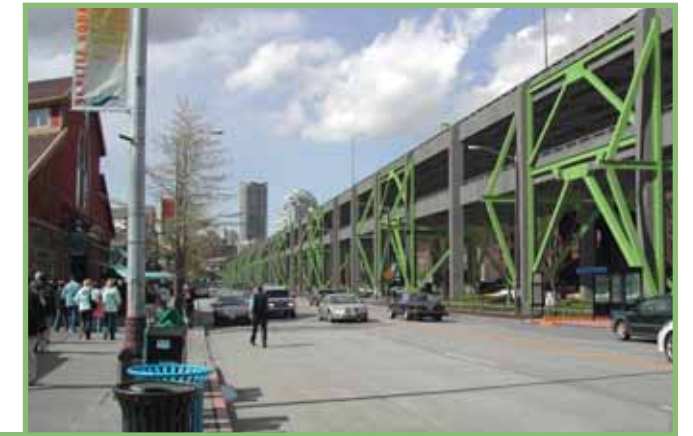
Streetscape rendering of the viaduct with the retrofit proposal.

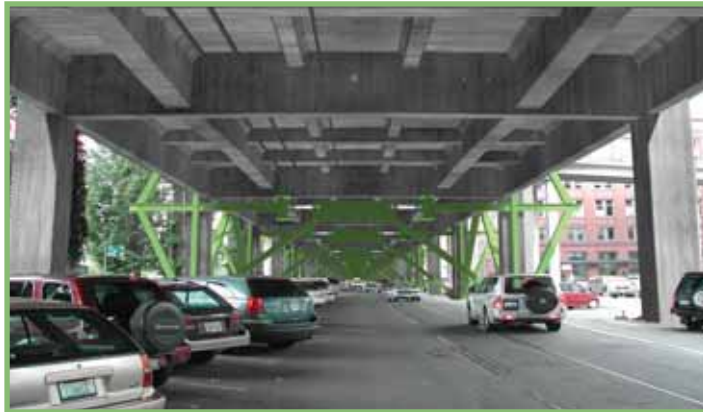
Rendering of retrofit proposal for area under the viaduct.

- Installation of steel strengthening frames running crosswise and lengthwise at the middle columns and bays of each viaduct section. The proposal did not include specific dimensions for these pieces of steel so T.Y. Lin International estimated the appropriate sizes.

- Wrapping of steel jackets around the base of some of the columns to provide additional strength to the structure. T.Y. Lin International believed these jackets would be required for all of the columns and so added them to the proposal.

- Placing of shock absorbers within the middle bay of the viaduct. Additional shock absorbers were shown between adjacent sections to prevent them from banging into each other during an earthquake. Because the evaluation looked at one section of the viaduct, these were not included. However, T.Y. Lin International concluded that these shock absorbers may serve to "lock" the sections together, synchronizing the movement of each section together.

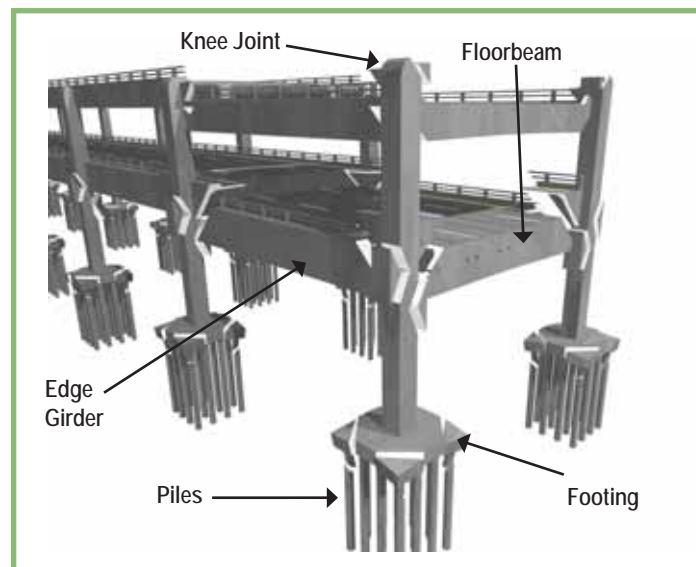
The viaduct has many weak points that could cause it to collapse in a very bad earthquake.

- The **footings** of the viaduct would be subject to higher shear and flexural demands, and higher joint shears than for the bad earthquake. Severe damage of the footings is likely.
- The **piles** would be subject to higher compressive forces that cause severe damage to the footings.

- The **columns** will rock on the pilings, which they were not designed to do. This rocking may result in severe impacts to the adjacent viaduct sections. The columns are very brittle and the loads from the rocking plus the damage to the footings would likely cause the viaduct to collapse.
- Other parts of the viaduct will also be severely damaged and could fail. For example, the **floorbeams** will suffer from negative bending at the connection with the columns. **The knee joints** – some of which failed in the Nisqually earthquake – could also fail.

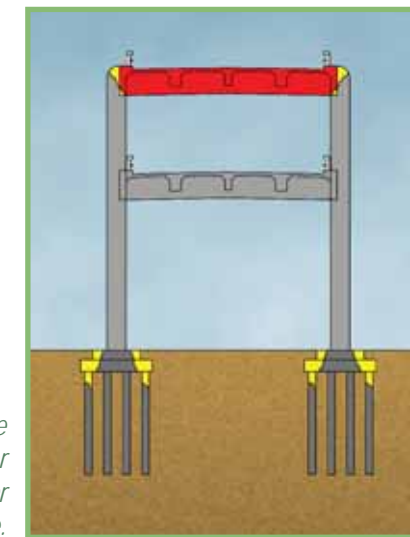
Shown in red is the expected damage for the design for 500-year earthquake.

- The footings of the viaduct require a retrofit.
- The lower floor beam / column joints need to be strengthened.
- The joints between the columns and upper floor beams need to be replaced.
