# Alaskan Way Viaduct

## Evaluation of Seismic Retrofit Options

**September 25, 2008 | Final Report**

Andrew W. Taylor, PhD, SE, FCI  
KPF Consulting Engineers  
Alaskan Way Viaduct Independent Project Management Team  
KPF Project No. 107583.10

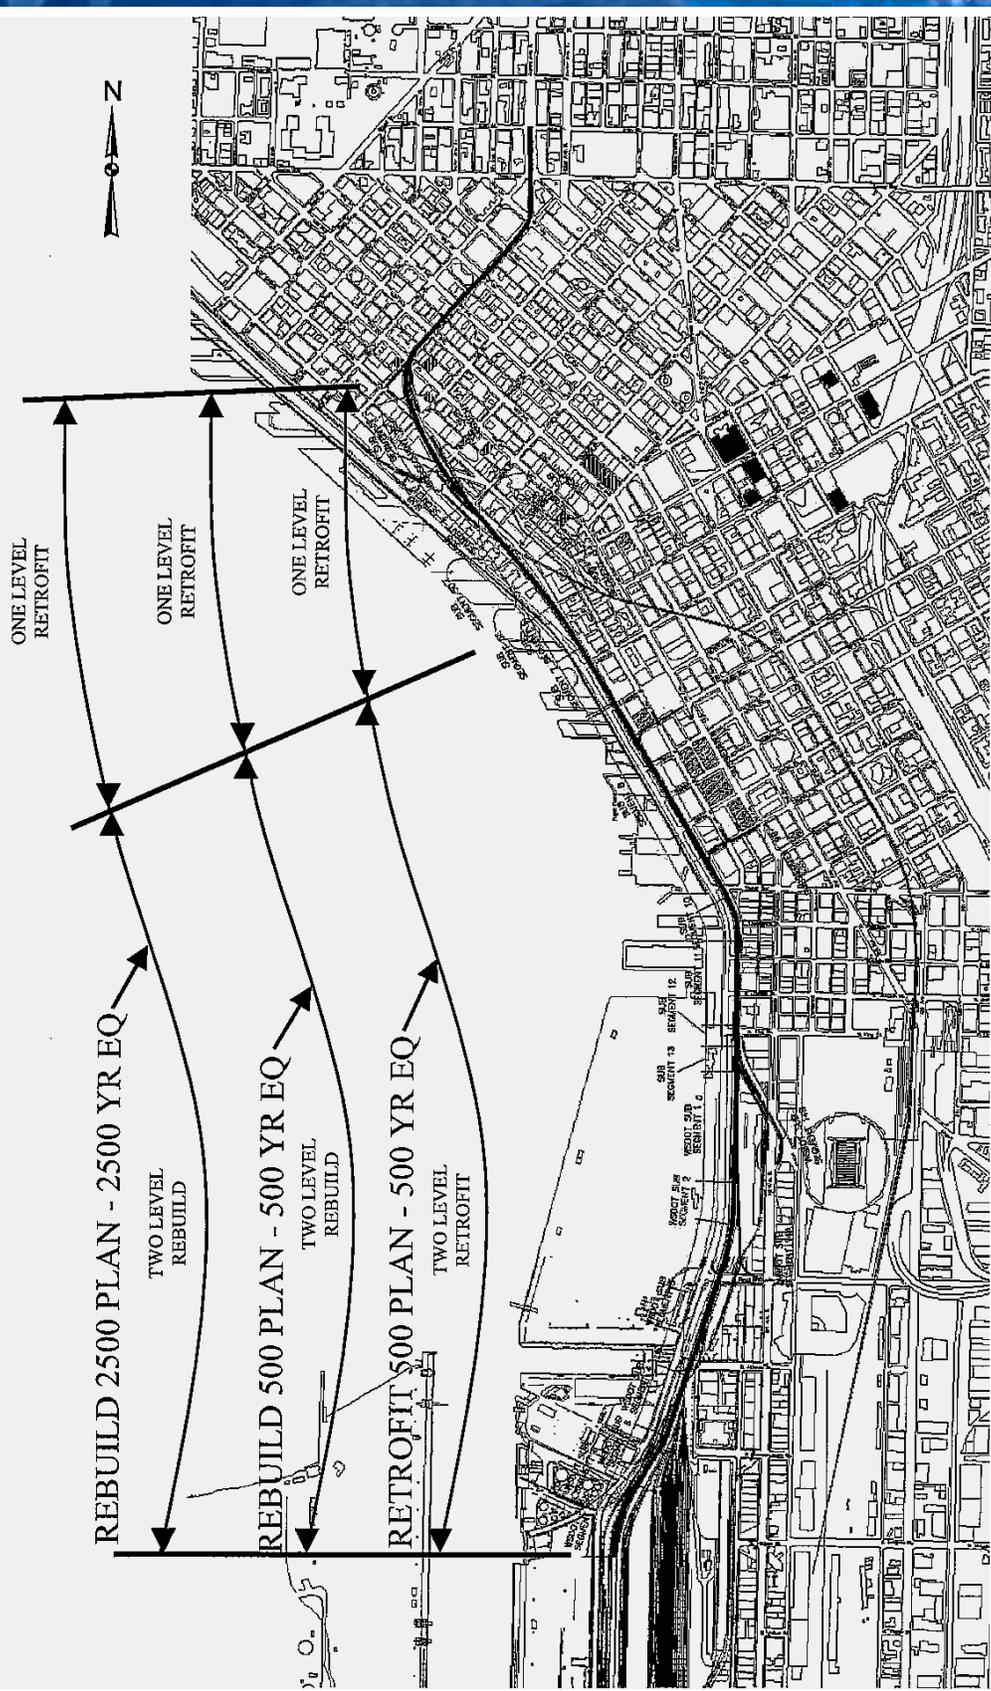
Figure 1-1: Figure 1 of Document 6 “Rebuild 2500 Plan, Rebuild 500 Plan, and Retrofit 500 Plan Location Map”

For this comparison, two locations on the existing viaduct and seawall were chosen as being representative of the typical configurations found on the structures. The only variable was the seismic design earthquake standard with either a 2500-year return period (Rebuild 2500 Plan) or a 500-year return period (Rebuild 500 Plan and Retrofit 500 Plan). The results of this analysis are summarized in Table 1, Figure 2 (Table 1-1 and Figure 1-1 of this report), and following:
